*Star Princess* – Safety Centre

Observations from Warsash reconstruction

## Phase Three – Review of reconstruction

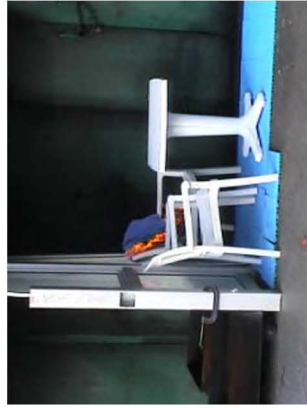
T+ 1 min

| Time (min:sec) | OBSERVATIONS |
|---|--|
| 01:19 | Towel on back of chair alight. Flames up to height of chair. |

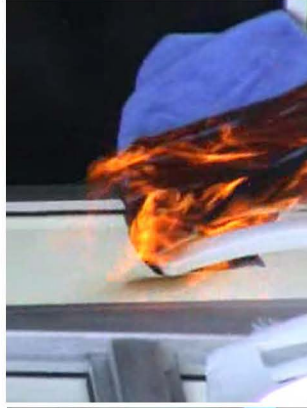
T+ 2 min

| Time (min:sec) | OBSERVATIONS |
|---|--|
| 02:22 | Ignition of privacy panel. |

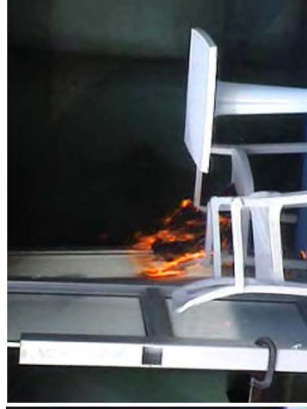
T+ 3 min

| Time (min:sec) | OBSERVATIONS |
|---|--|
| 02:57 | Entire back of chair fully involved in fire. Flames attacking outer chair seat. |

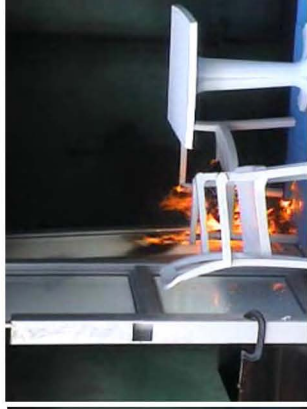
T+ 4 min

| Time (min:sec) | OBSERVATIONS |
|---|--|
| 04:26 | Thick black smoke developing. |

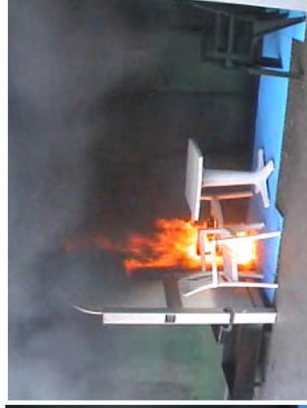
T+ 5 min

| 05:15 | Flames about 1m above chair height. Flaming becoming more vigorous due to windy conditions. |

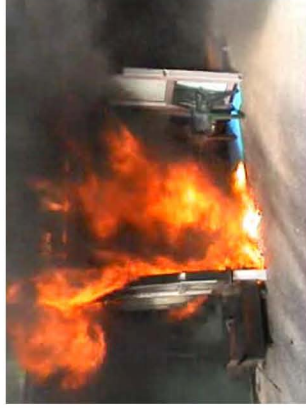
T+ 7 min

| 07:03 | Partial collapse of outer chair back rest. Flames about 1m above privacy panel. |

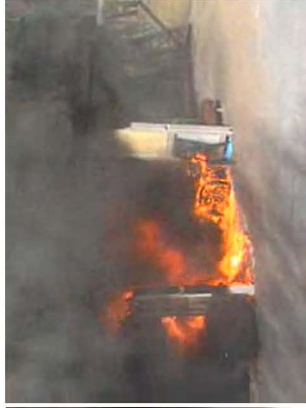
T+ 8.5 min

| 08:28 | Front edges of chairs on opposite side of room ignited. |

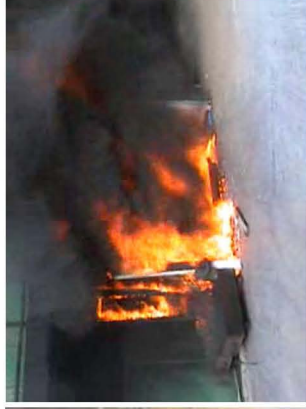
T+ 10 min

| 10:24 | Upper quarter of privacy screen closest to the outer edge of the compartment burning. |

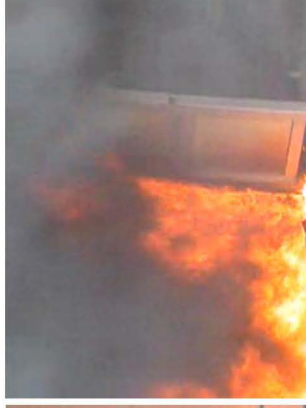
T+ 13.5 min

| 14:16 | Flame penetration of opposite screen with burning debris falling onto the floor of the adjoining compartment (RHS). |

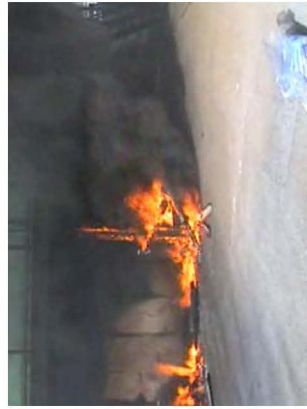
T+ 18 min

| 18:27 | Water applied to fire. |

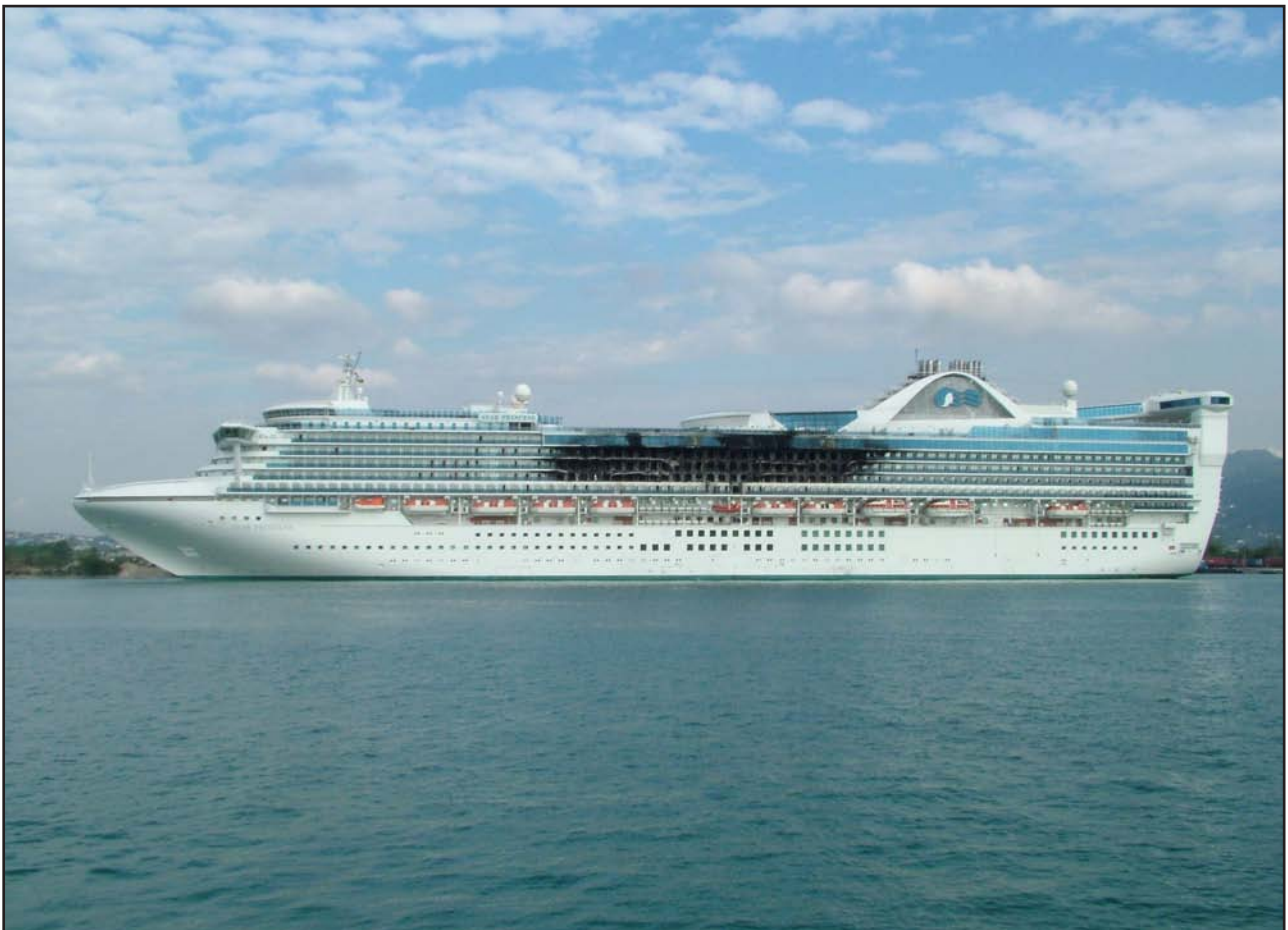
Figure 1

The cause of the fire has yet to be determined. However, the seat of the fire was on an external stateroom balcony sited on deck 10 on the vessel's port side. The fire spread rapidly along adjacent balconies, and within 10 minutes had spread up to decks 11 & 12 and onto stateroom balconies in two adjacent fire zones. It also spread internally as the heat of the fire shattered the glass in stateroom balcony doors, but was contained by the fixed fire-smothering system fitted in each of the staterooms. As the fire progressed, large amounts of dense black smoke were generated from the combustible materials on the balconies, and the polycarbonate balcony partitions. This smoke entered the adjacent staterooms and alleyways, and hampered the evacuation of the passengers. One passenger died as a result of smoke inhalation, and 13 others were treated for the effects of the smoke.

The fire was extinguished about 1.5 hours after it had started. The crew fought the fire with water hoses from adjacent external areas, and from internal alleyways. Difficulty was experienced in reaching the fire due to the construction and partitioning of the balcony areas. A total of 79 cabins were condemned after the fire, and a further 204 were either water or smoke damaged. The damaged area covered 3 vertical fire zones on 5 decks (**Figures 1, 2 and 3**).

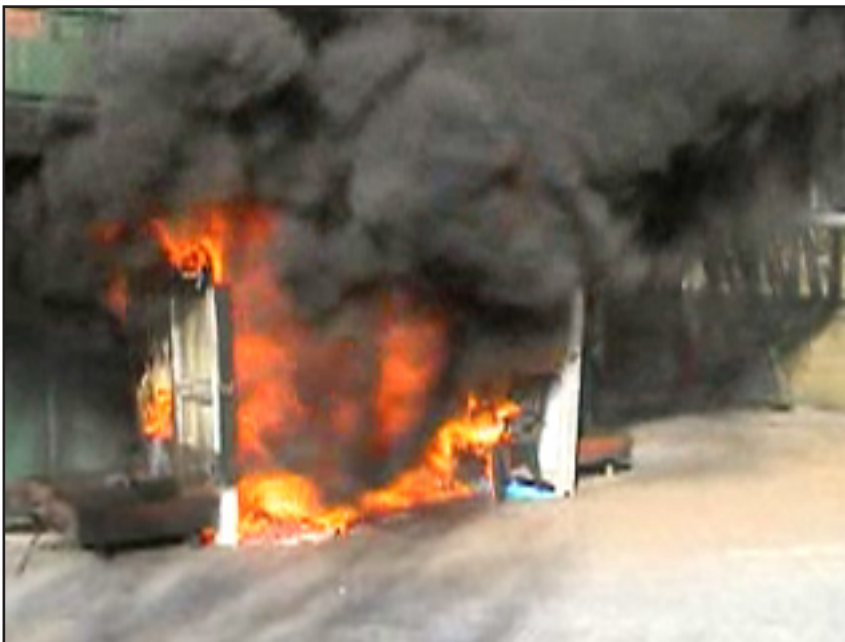
Figure 4

Following the accident, it has been determined by practical tests that the materials at the seat of the fire were readily ignitable, and that the polycarbonate balcony divisions generated intense heat and copious amounts of dense black smoke as they burned (**Figure 4**).

- consider the issue comprehensively, with a view to urgently developing appropriate amendments to the 1974 SOLAS Convention, to address hazardous external areas of passenger ships, such as balconies, and ensure that they meet appropriate standards of fire protection, such as those currently applicable to internal areas of passenger ships;
- in the interim, issue appropriate urgent guidance on fire protection of external areas of passenger ships, such as balconies.
