MAIB SAFETY BULLETIN 1/2006

Fire on board the Bermuda registered cruise ship

Star Princess

on 23 March 2006

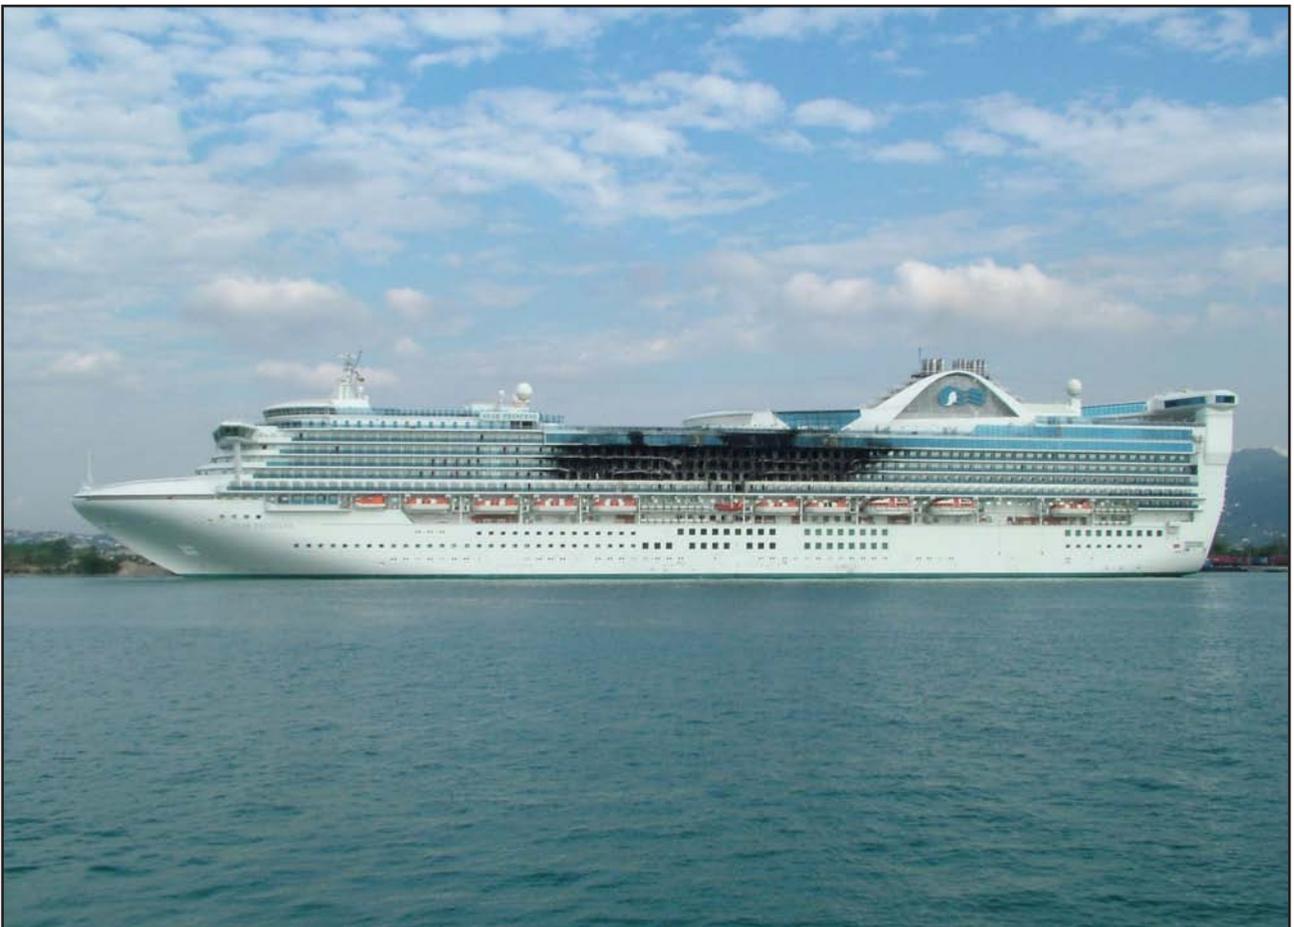
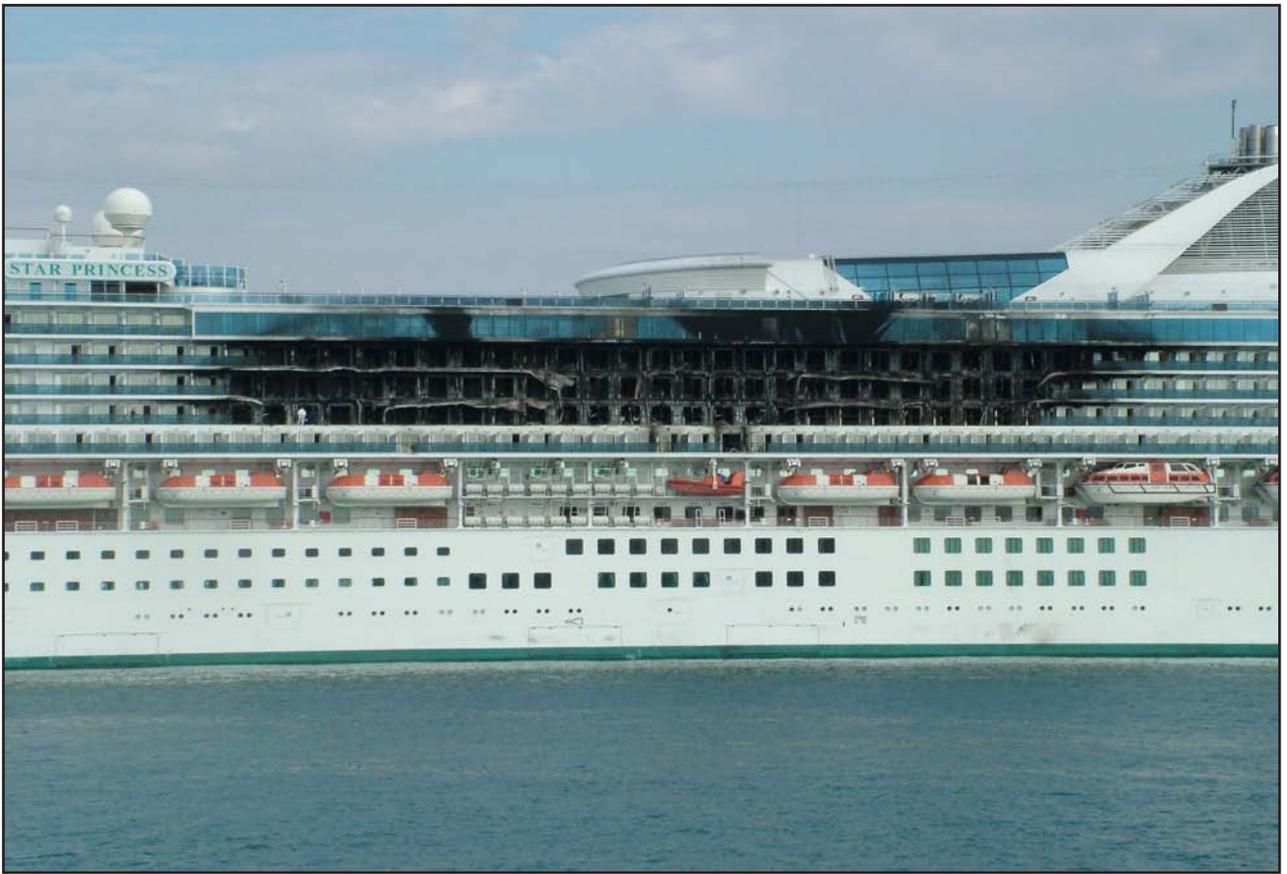
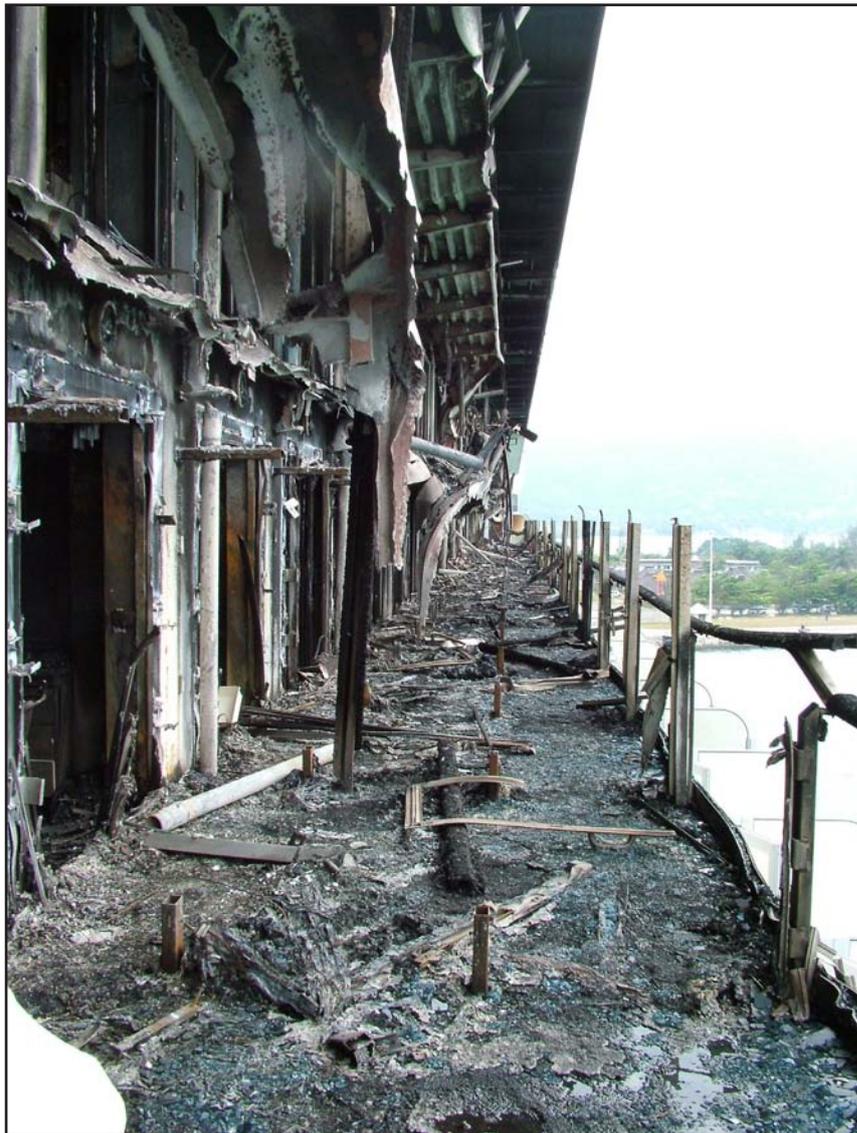
The cause of the fire has yet to be determined. However, the seat of the fire was on an external stateroom balcony sited on deck 10 on the vessel's port side. The fire spread rapidly along adjacent balconies, and within 10 minutes had spread up to decks 11 & 12 and onto stateroom balconies in two adjacent fire zones. It also spread internally as the heat of the fire shattered the glass in stateroom balcony doors, but was contained by the fixed fire-smothering system fitted in each of the staterooms. As the fire progressed, large amounts of dense black smoke were generated from the combustible materials on the balconies, and the polycarbonate balcony partitions. This smoke entered the adjacent staterooms and alleyways, and hampered the evacuation of the passengers. One passenger died as a result of smoke inhalation, and 13 others were treated for the effects of the smoke.

The fire was extinguished about 1.5 hours after it had started. The crew fought the fire with water hoses from adjacent external areas, and from internal alleyways. Difficulty was experienced in reaching the fire due to the construction and partitioning of the balcony areas. A total of 79 cabins were condemned after the fire, and a further 204 were either water or smoke damaged. The damaged area covered 3 vertical fire zones on 5 decks (**Figures 1, 2 and 3**).
