## SYNOPSIS

On 17 March 2006, a 9 metre leisure yacht was being delivered from Hamble to Plymouth. On board were the owner and a delivery skipper. At about 2330, the delivery skipper went overboard. Due to electrical power problems on board, the GPS was not functioning, and although the alarm was raised by VHF radio, the owner was unable to give his position, and the VHF radio soon stopped operating. A search and rescue operation involving three RNLI lifeboats, five merchant ships and a coastguard helicopter, eventually located both the skipper's body and the yacht.

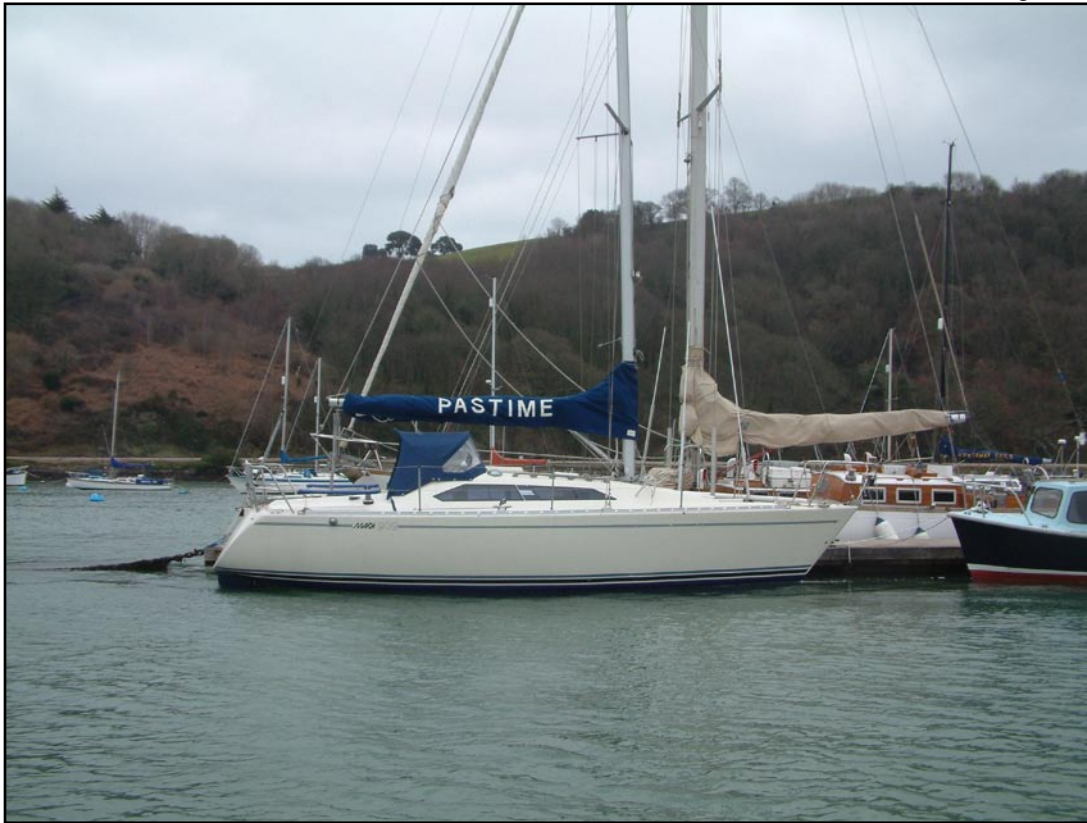
Figure 1

*Yacht Pastime*
