Report on the investigation of

Red Falcon's

contact with the linkspan at

Town Quay, Southampton

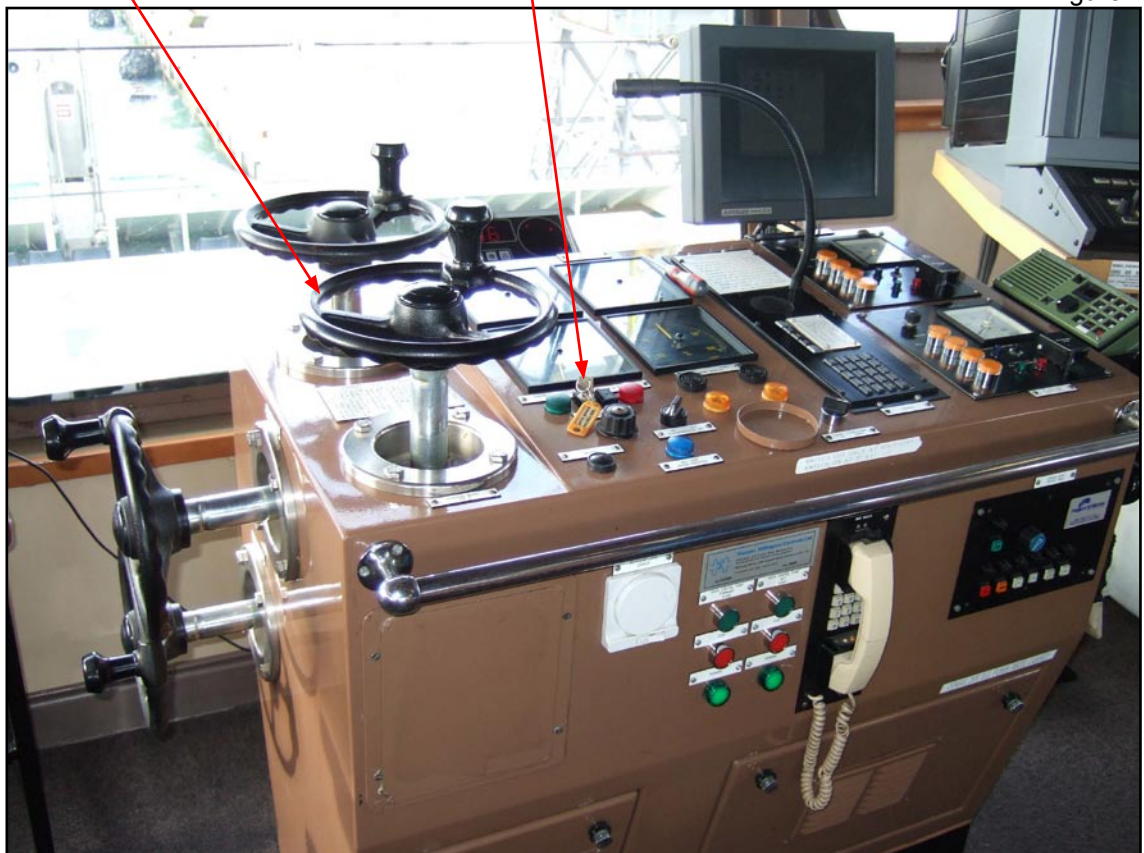
Figure 2

The master desynchronised the Voith Schneider units from the forward centre control panel and silenced the audible alarm, which had sounded to indicate the units were now desynchronised. The master silenced this alarm by turning a key which was permanently located on the panel. There were four identical control panels on the bridge, each fitted with an audible alarm which sounded when the propulsion units were desynchronised (**Figure 2**). On this occasion, the alarm on the centre forward panel was the only one to sound because the alarms on the other three panels had previously been isolated with the key switch.

Vessel is steered using the
after wheel

Audible alarm switch

Centre control panel

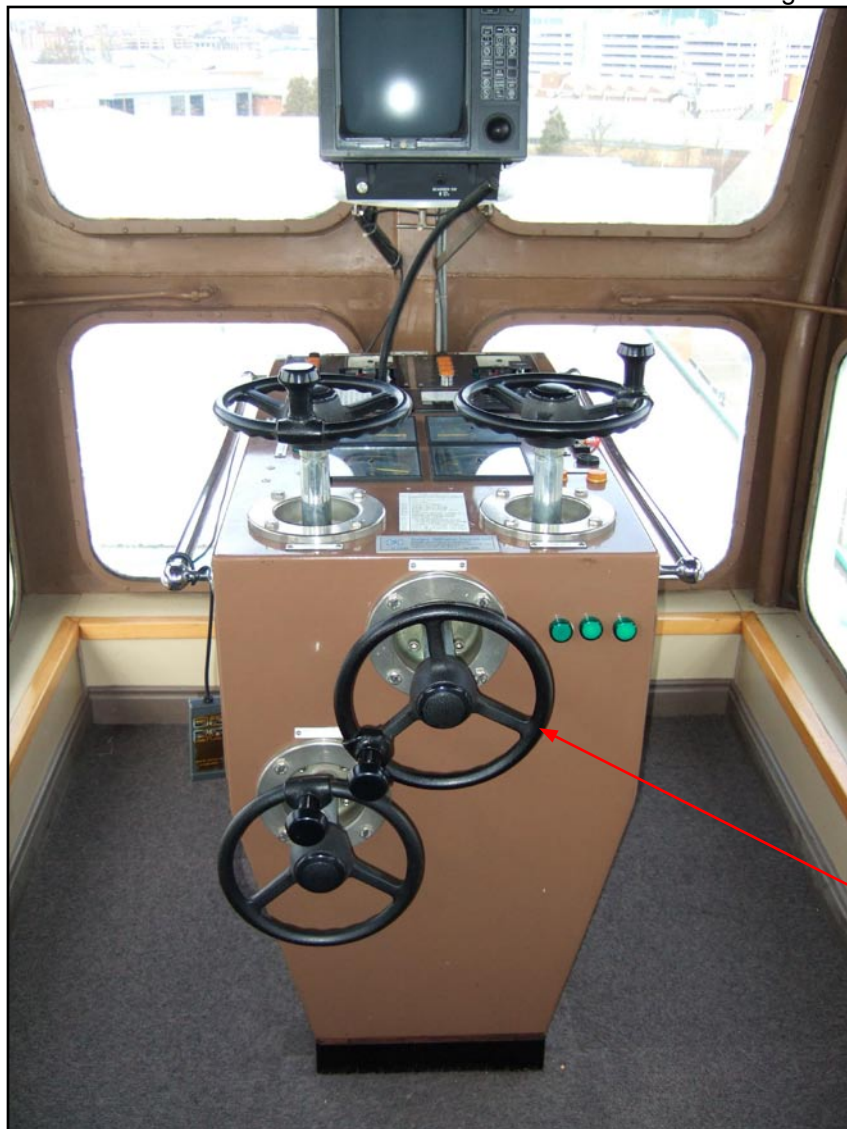
Figure 5

However, as he wound back the upper control wheel, with the units desynchronised, the chief officer was in fact only reducing the pitch on the aft Voith Schneider unit (**Figure 5**). He failed to notice that the forward unit remained at 100% ahead pitch at full power. As normal, he attempted to adjust the approach of the vessel to the linkspan by visual reference to the approaching berth and marks on Town Quay, and was not, at that time, actively looking at the various dials on the console.

Chief Officer operated this wheel to reduce vessel's speed, thinking the control units were synchronised

Starboard console

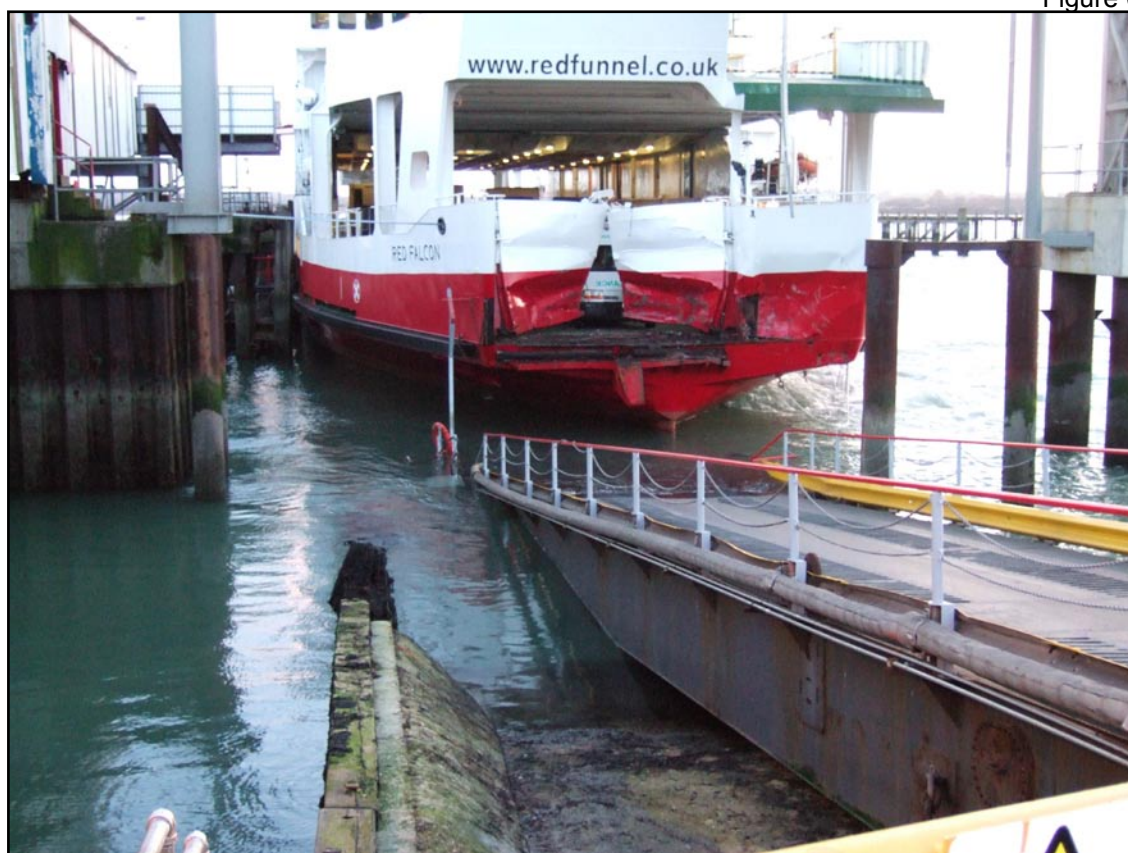
Figure 6

Red Falcon's damaged bow area

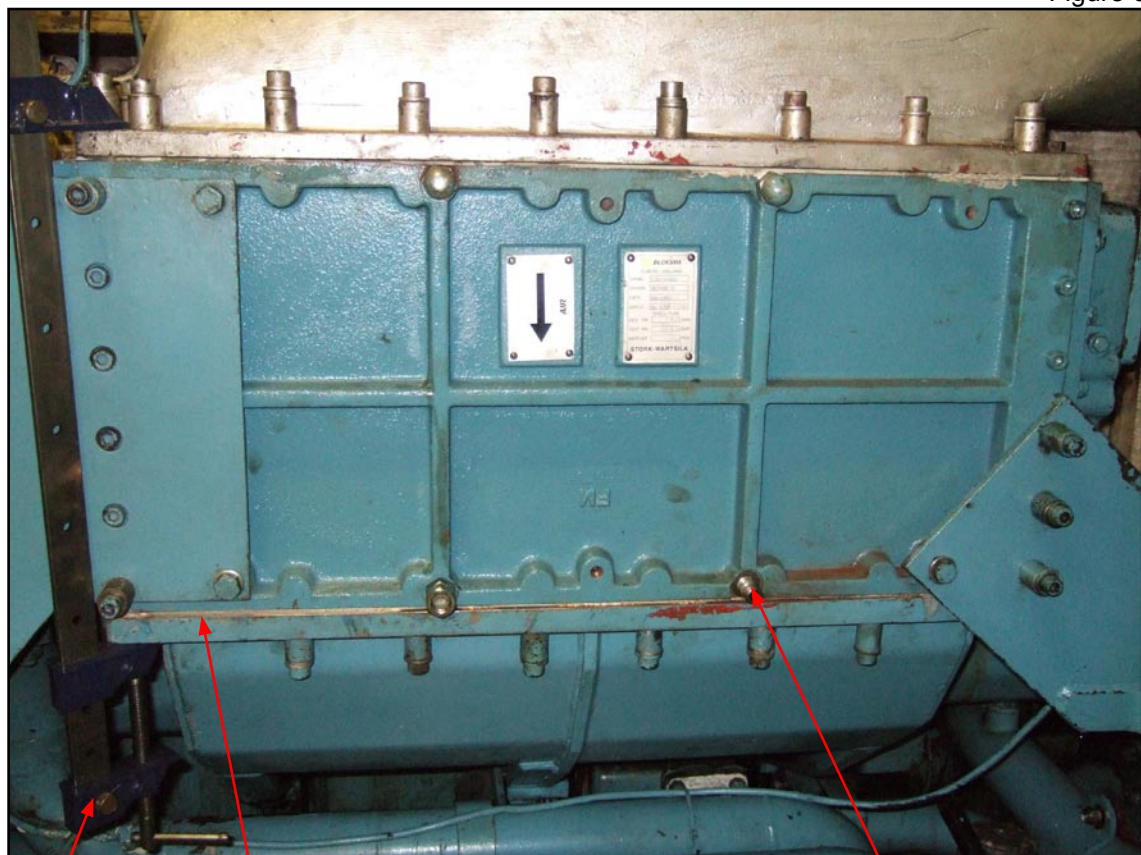
Figure 8

On 10 March, during the regular inspection of the charge air cooler, the early morning shift duty chief engineer found that three bolts securing the bottom flange to the cooler housing had failed. This resulted in failure of a section of jointing between the flange and housing. A temporary repair was made using silicon sealant to replace the failed jointing, and a sash cramp was used to prevent further movement between the flange and the housing.

Charge air cooler

Sash cramp

Failed jointing temporarily
repaired with silicon sealant

After the accident with the linkspan, the MCA, as part of its investigation, required Red Funnel to remove the air cooler from the aft engine. Five of the eight tie bolts were found to have suffered thread damage where they would have attached to the supporting brackets, and which prevented them from being properly secured. This thread damage probably occurred either when the cooler was refitted during the previous refit, or sometime before. There are no records of similar incidents which could indicate a failure pattern or engine design defect. An investigation of why the bolts had suffered thread damage was not undertaken by Red Funnel to determine the cause.

Although the temporary repair to the cooler, using a sash cramp and silicon sealant was considered reasonable, the underlying causes of the fault were not known. As stated earlier, five of the eight tie bolts had suffered thread failure, preventing them from effectively supporting the cooler. Had the remaining supporting arrangements (and therefore, the associated cooling system) suffered catastrophic failure, it is entirely likely that *Red Falcon* would have had to return to port on one engine, and would have been immobilised for considerably longer. It is considered that insufficient consideration was given to investigating the underlying causes of the slack tie bolts, and that any future faults on main propulsion machinery should be effectively diagnosed and, if necessary, a decision taken to withdraw the vessel from service to enable a full repair to be done.

The cooler had been removed during the annual refit only a few weeks earlier. It would appear highly likely that this had some bearing on the failure of the bolts. However, it is unclear what, if any, supervision of the contractors was carried out by Red Funnel employees while they were refitting the cooler. Sufficiently robust processes should be in place to ensure the effective supervision of maintenance work that is carried out by contractors during refit periods.

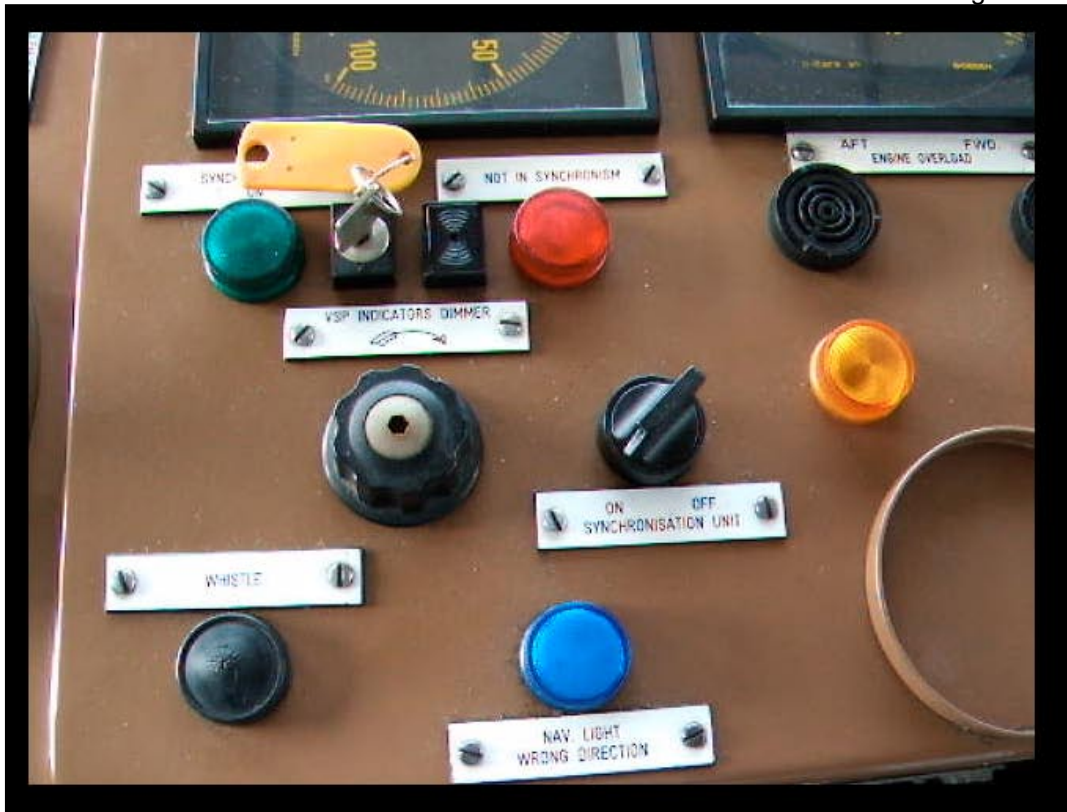
Figure 10a

When the Voith Schneider units are synchronised, the green lamps on the consoles will remain lit, the red lamps are unlit and the buzzer silent. When desynchronised, the illumination of the lamps changes and the buzzer sounds. The buzzer will sound on each console and has to be cancelled at each console with a key switch. However, the synchronisation switch position will only indicate that it is off at the console at which

Control console showing synchronisation switch and alarms

desynchronisation was selected. Thus, at the other consoles, the switch will remain in the “on” position to indicate that the units are synchronised when, in fact, they are not. The red light, indicating that the units are desynchronised, will be illuminated on all the consoles.

On this occasion, the chief officer failed to notice that the red out of synchronisation light on the console was illuminated when he took over the controls. This demonstrates that, as a control measure, this is not a sufficiently robust method of alerting the operator that the Voith Schneider units are being operated out of synchronisation, especially as no warning notice had been displayed as required by the company's procedures.

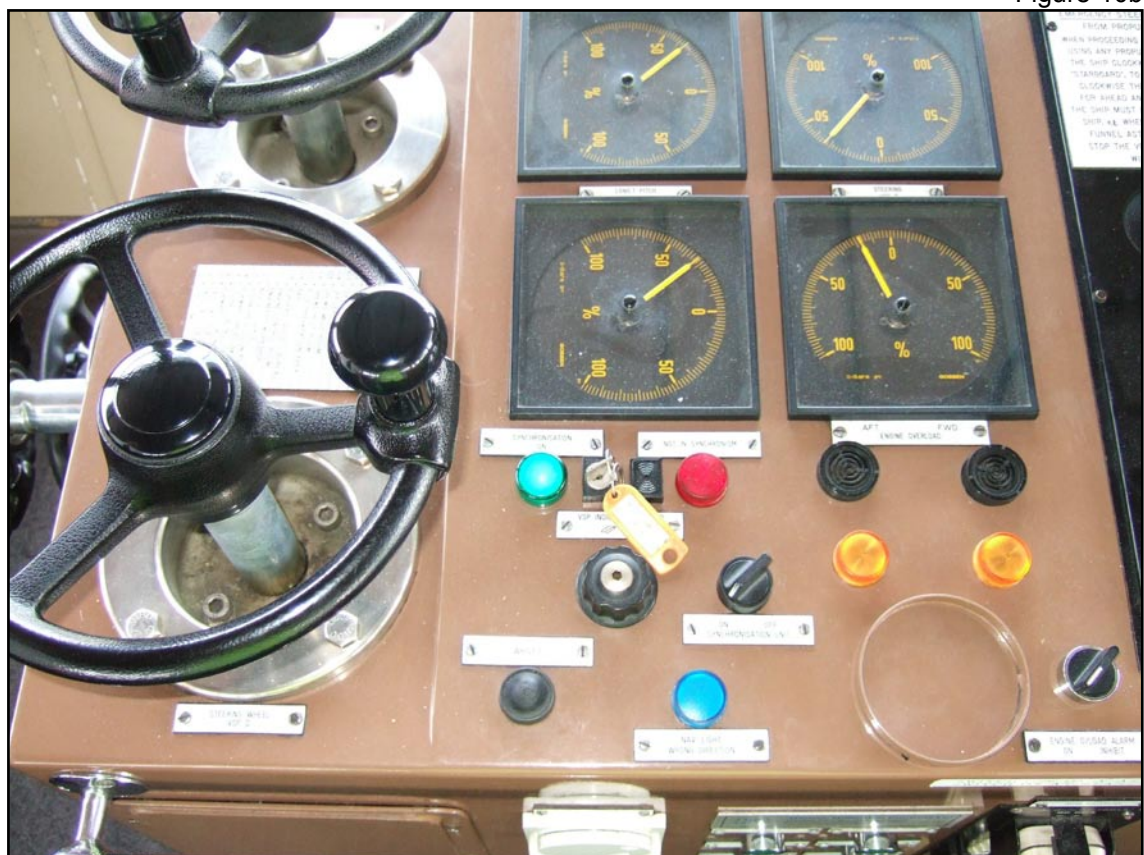
Figure 10b

Control console showing pitch indicators
