Report on the investigation of
the grounding of
mv Kathrin
Goodwin Sands
Dover Strait
12 February 2006

Marine Accident Investigation Branch
Carlton House
Carlton Place
Southampton
United Kingdom
SO15 2DZ

Report No 24/2006
September 2006

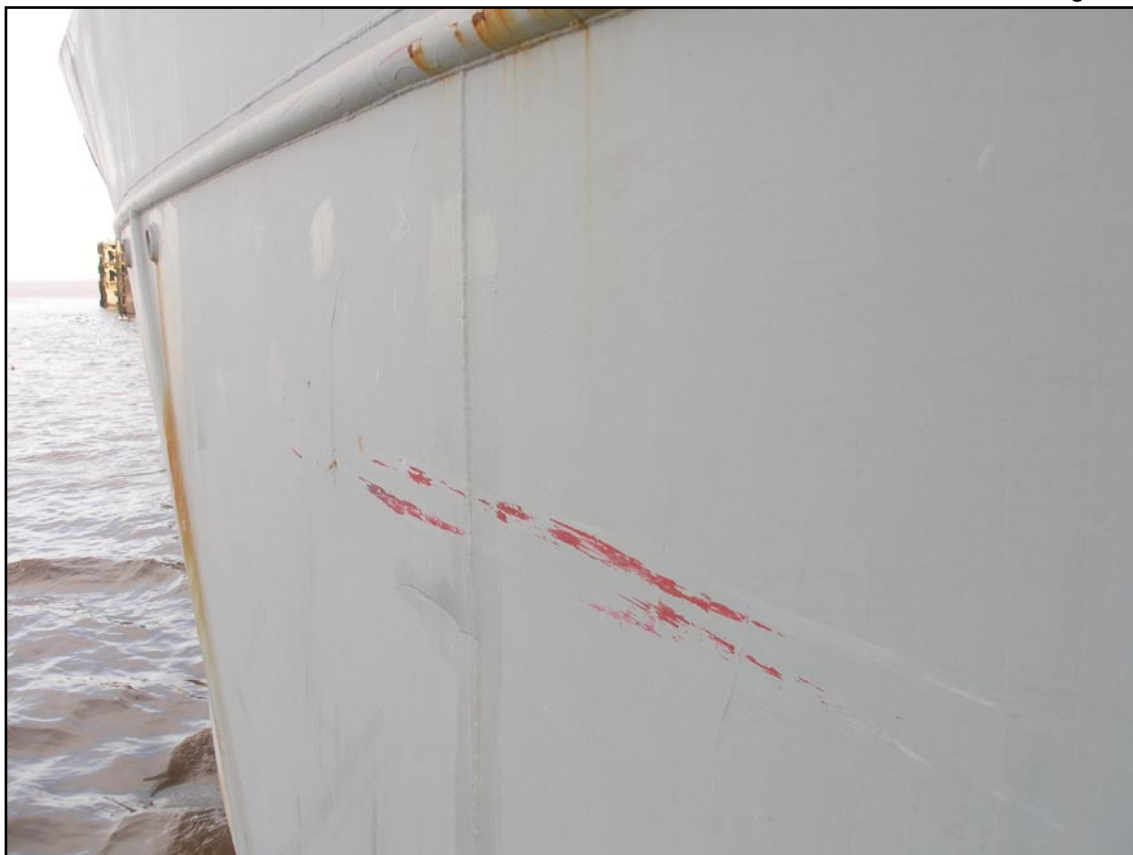
Figure 2

During the visit of MAIB inspectors to *Kathrin* in New Holland, there was no visible damage to the ship, but a red paint streak approximately 2m in length was evident on the vessel's port bow (**Figure 2**). The East Goodwin Lightship (**Figure 3**) was checked by Trinity House, but no damage was evident. *Kathrin* was allowed to sail from New Holland for passage to Warrenpoint, Northern Ireland, after a relief master had joined the vessel, and a condition of Class had been imposed by Lloyd's Register requiring that the underwater portions of the vessel be examined by the end of March 2006.

Photograph of *Kathrin's* port bow

Figure 12 shows that *Kathrin* passed very close to the East Goodwin Lightship (**Figure 3**), which was painted red. However, although **Figure 2** indicates that the vessel had been in contact with a red object, and there was a deflection in her course made good as she passed the lightship, it cannot be certain that *Kathrin* made contact as no damage could be found during a subsequent inspection of the lightship.

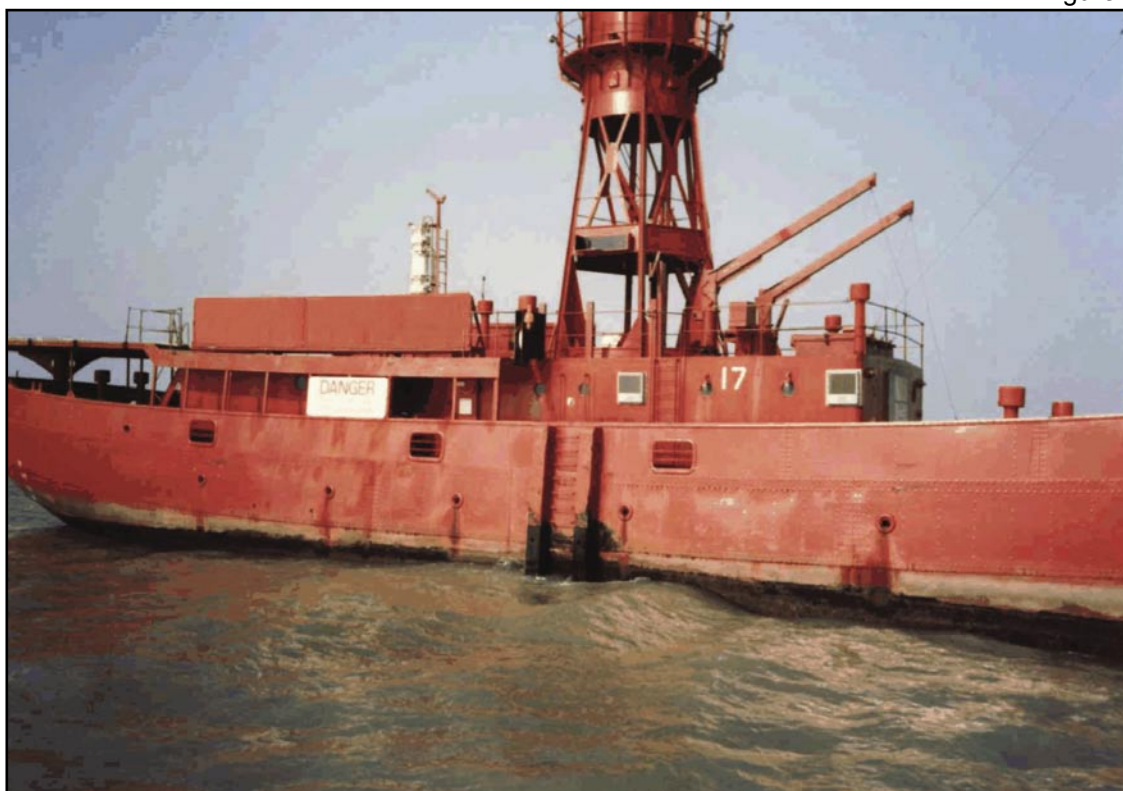
Figure 3

Photograph of East Goodwin Light Vessel

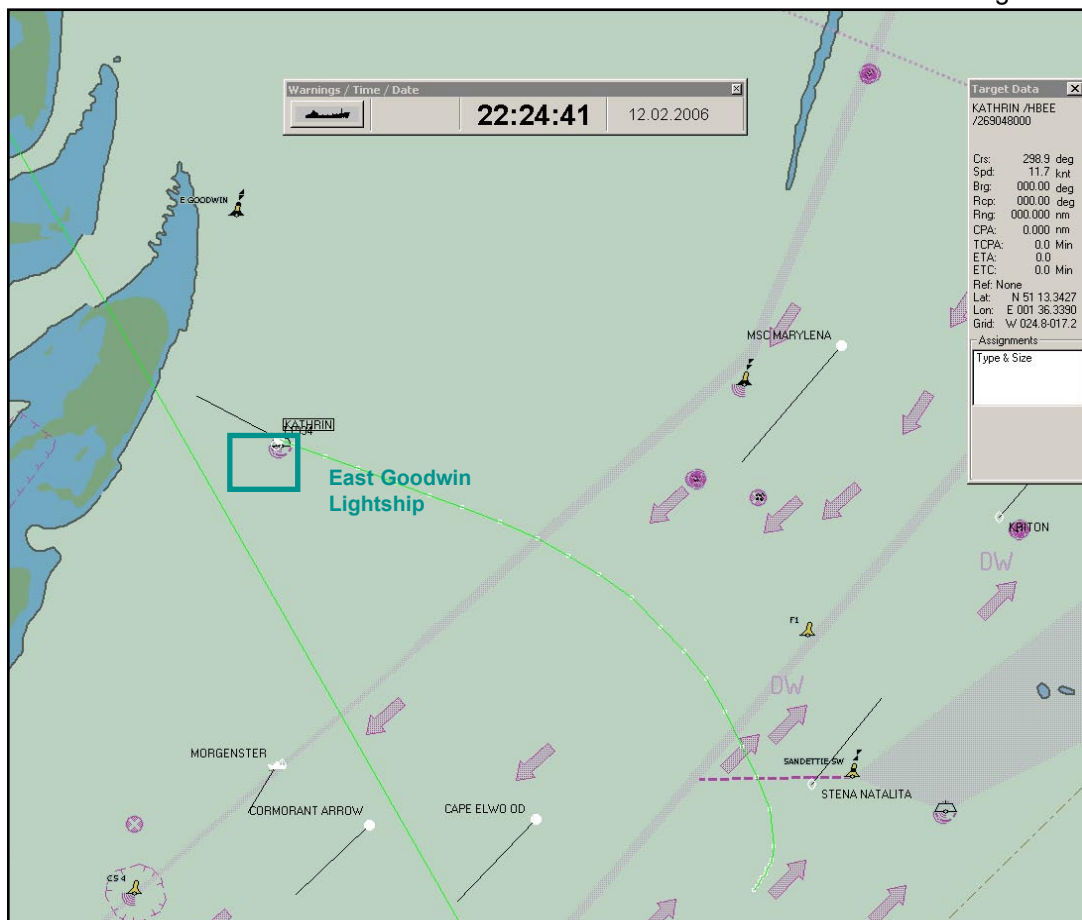
Figure 12

CNIS radar plot 2224:41

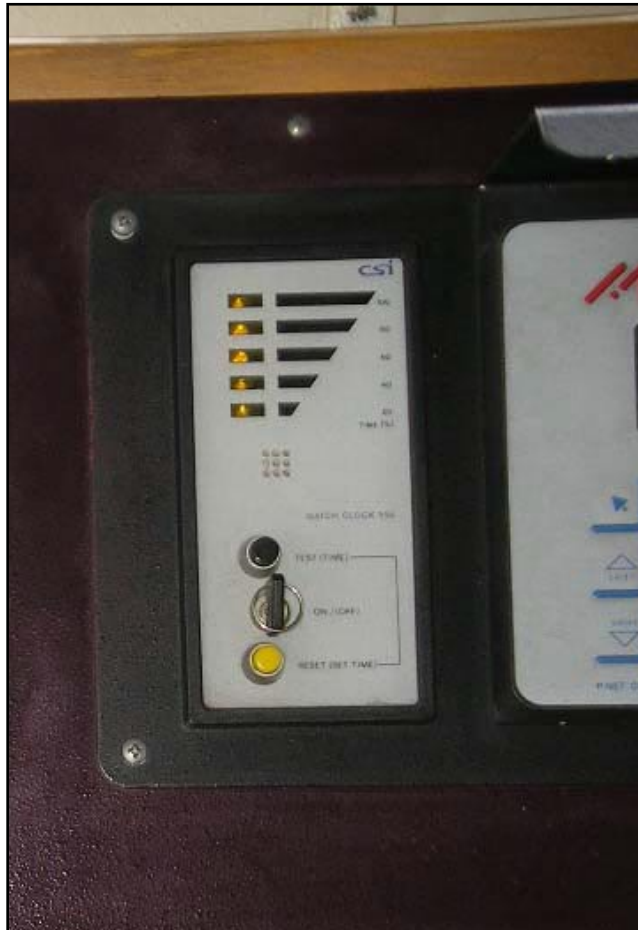
Figure 16

A watch alarm was sited to the left of the port radar display (**Figure 16**), next to the forward GPS. The alarm interval was capable of being set between intervals of 1 and 15 minutes. If not accepted within 1 minute by personnel on the bridge, an alarm sounded in the master and chief officer's accommodation. Both the chief officer and second officer were aware of the watch alarm but had never used it during their time onboard. The master was not aware that a watch alarm was fitted. A photograph showing the general layout of the bridge is at **Figure 17**.

Photograph of bridge watch alarm

Kathrin grounded as a result of her master's incapacitation due to fatigue, alcohol, or both. Regardless of the nature of his incapacitation, which could also have been caused by loss of consciousness through illness as well as sleep, the grounding could have been prevented had an additional lookout been employed as required by both STCW and company procedures. It could also have been avoided had the watch alarm been utilised.
