Report on the investigation of
the loss of cargo containers overboard from

P&O Nedlloyd Genoa

North Atlantic Ocean

Report No 20/2006
August 2006

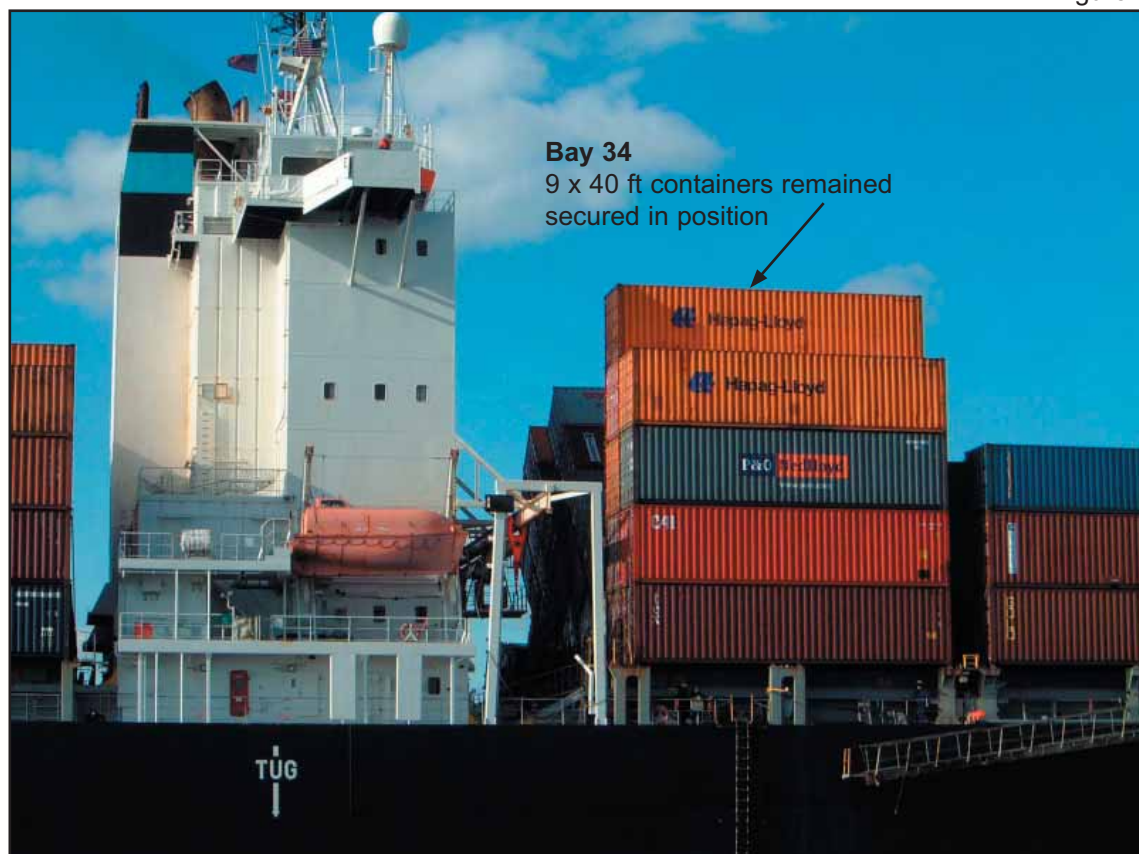
Figure 1

Examination of bay 34 showed that 27 forty foot deck containers were lost overboard, and 28 forty foot deck containers had collapsed. Only 9 forty foot deck containers from bay 34 remained secured in position (**Figure 1**). A steel pedestal, designed to support the port outboard extremity of the containers in row 12, suffered catastrophic failure (**Figures 2 and 3**). Closer inspection of the remaining deck cargo showed that four containers on the bottom tier of bay 14, port side, had also been damaged by compression forces. All of the lashings in bay 14 had remained intact.

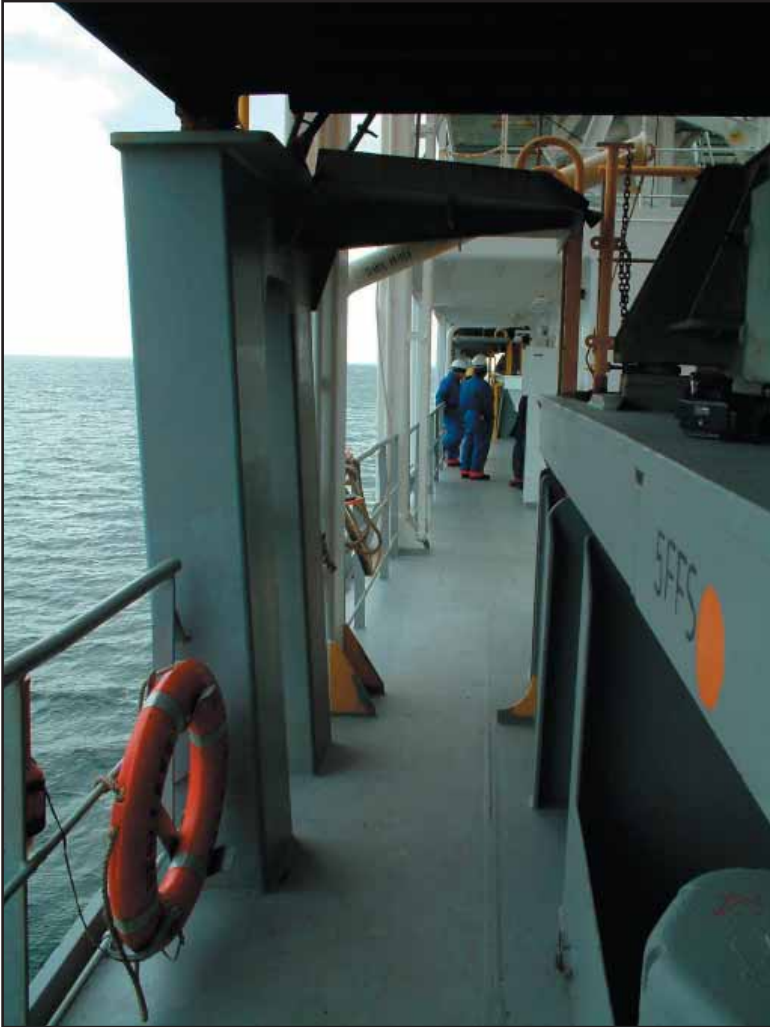
Figure 2

Pedestal support pre-accident

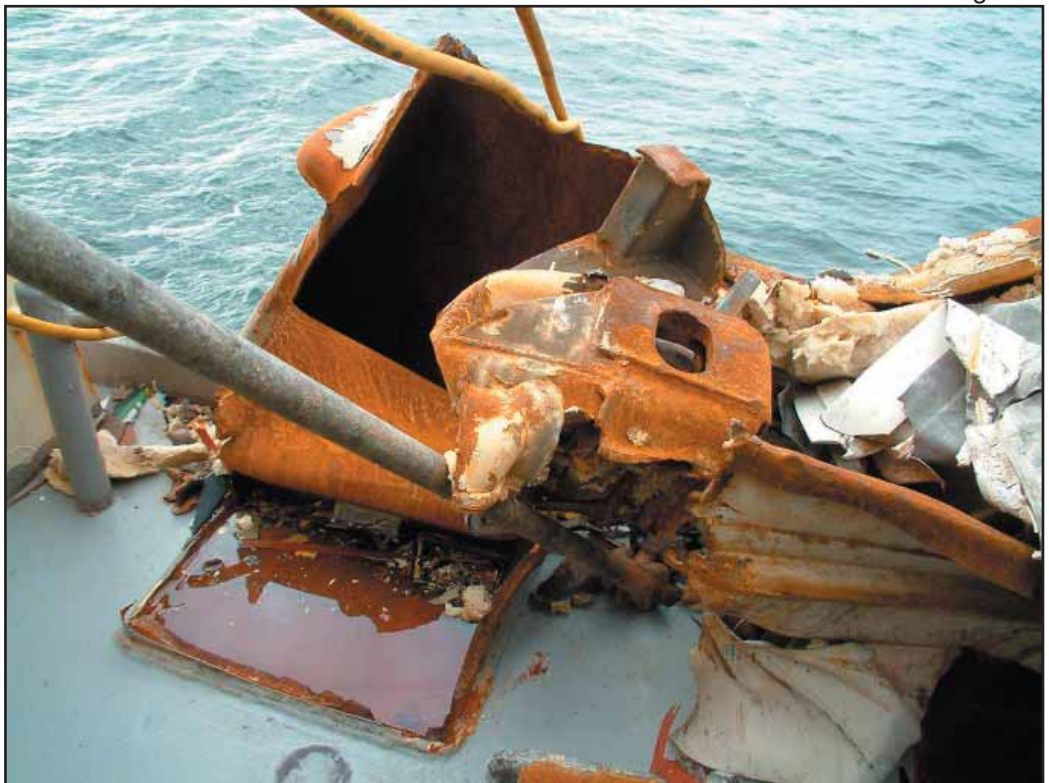
Figure 3

Pedestal support post-accident

Structural damage to the vessel was contained to bay 34, and consisted of damage to the hatch top securing arrangements and collapse of the outboard row pedestal support.

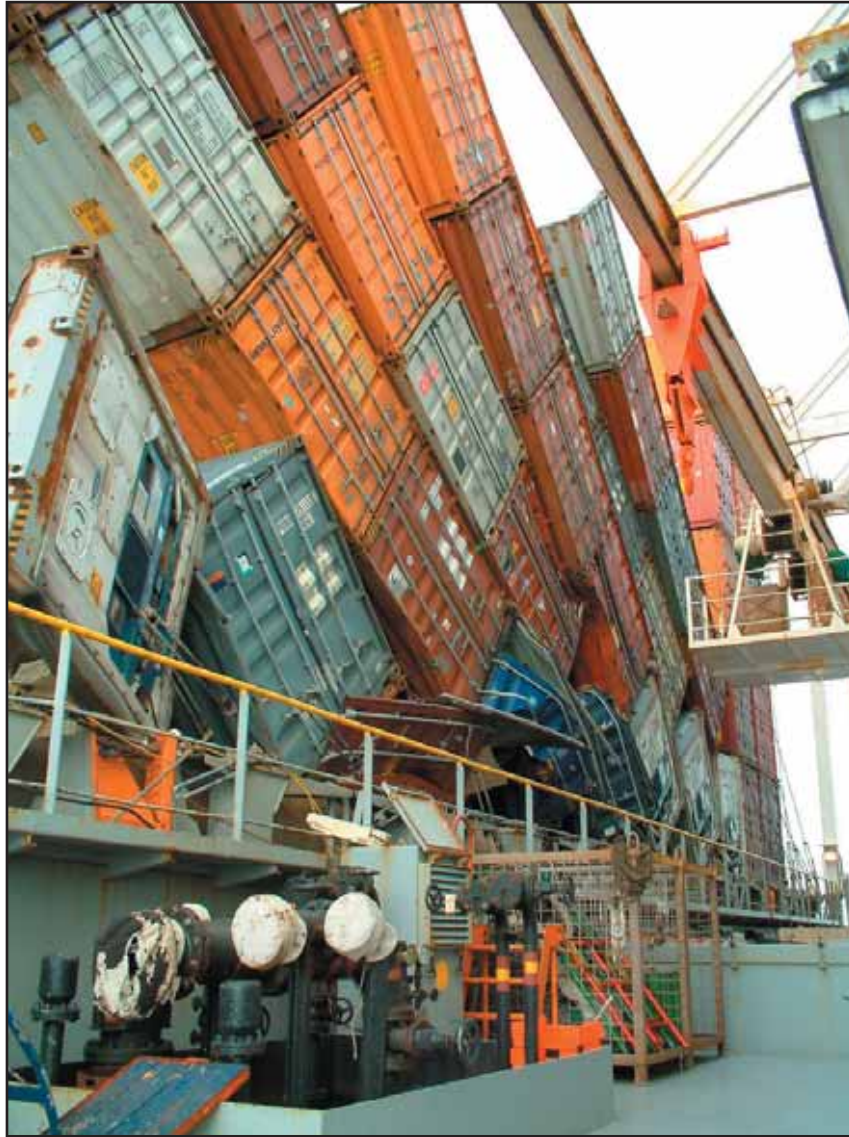
Remaining containers in bay 34

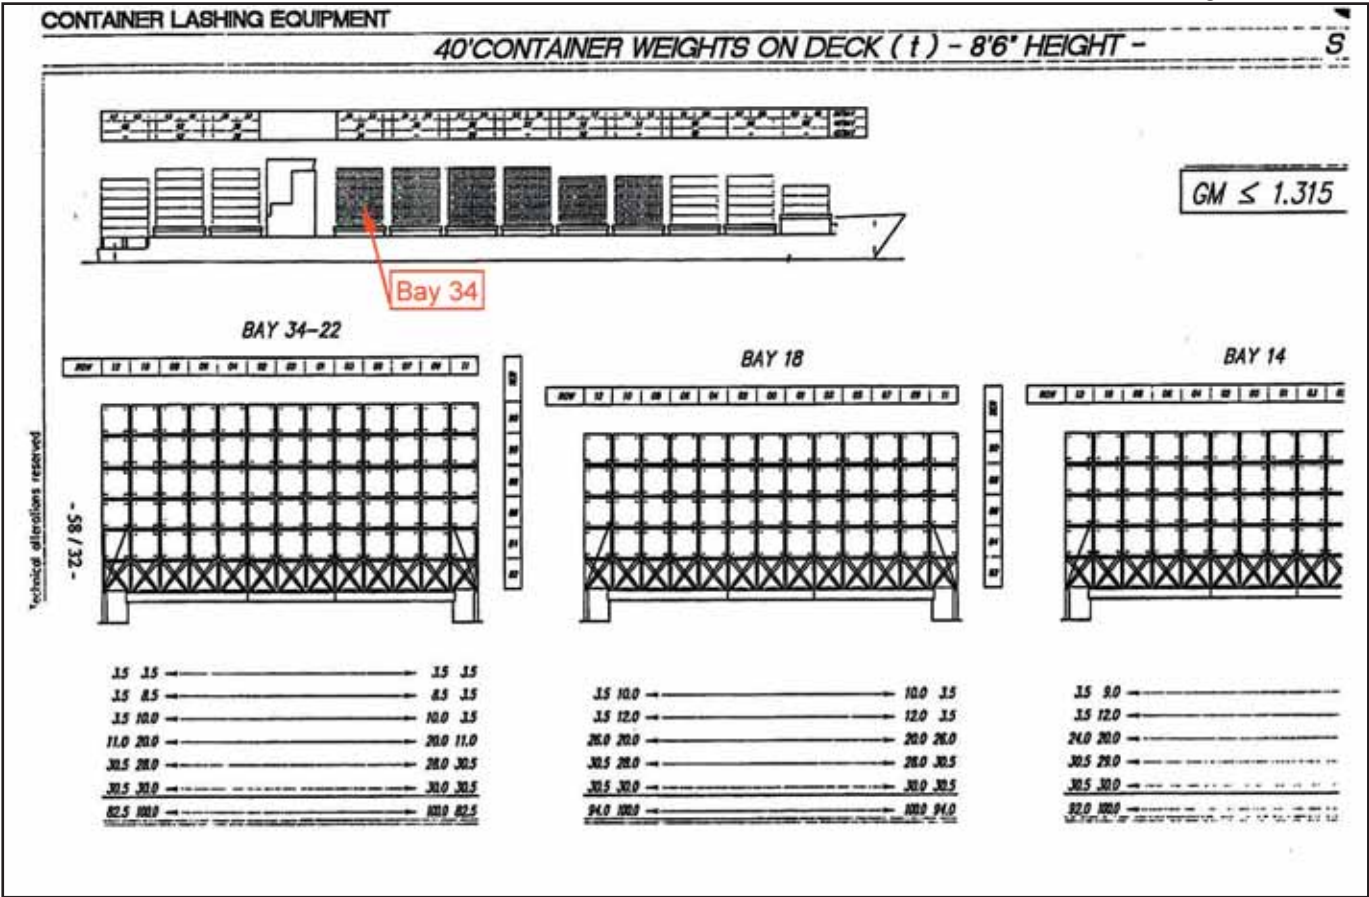
No reference could be found within the manual that drew the crew's attention to alternative lashing arrangements for containers stowed in different configurations.

Arrangement for 8' 6" high containers at bay 34

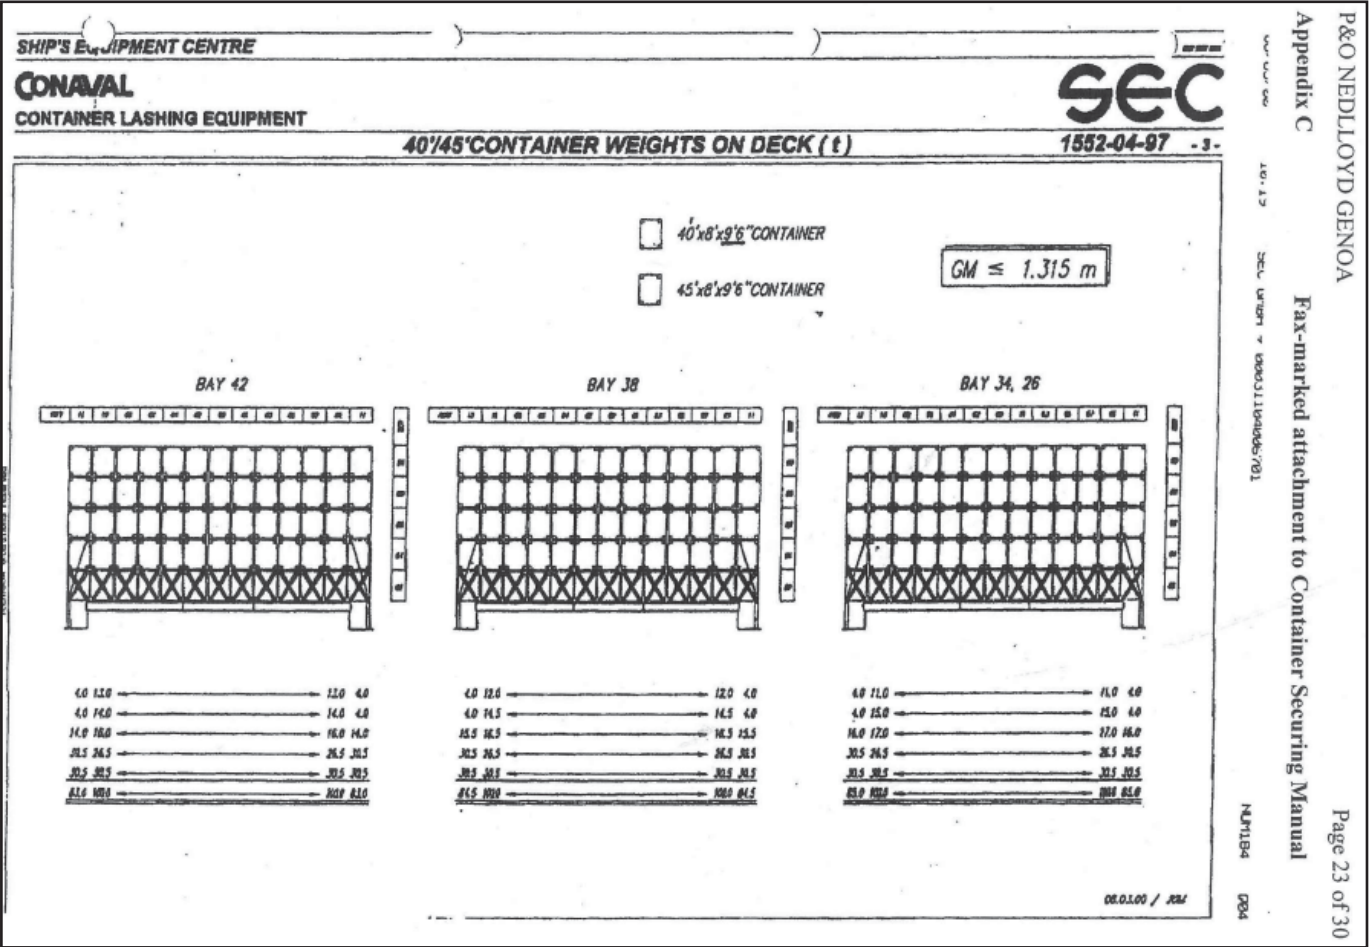
Arrangement for 9' 6" high containers (t) at bay 34
