Report on the investigation of the grounding of the vessel

CP Valour

in Baia da Praia do Norte, Faial, Azores

**Report No 22/2006
August 2006**

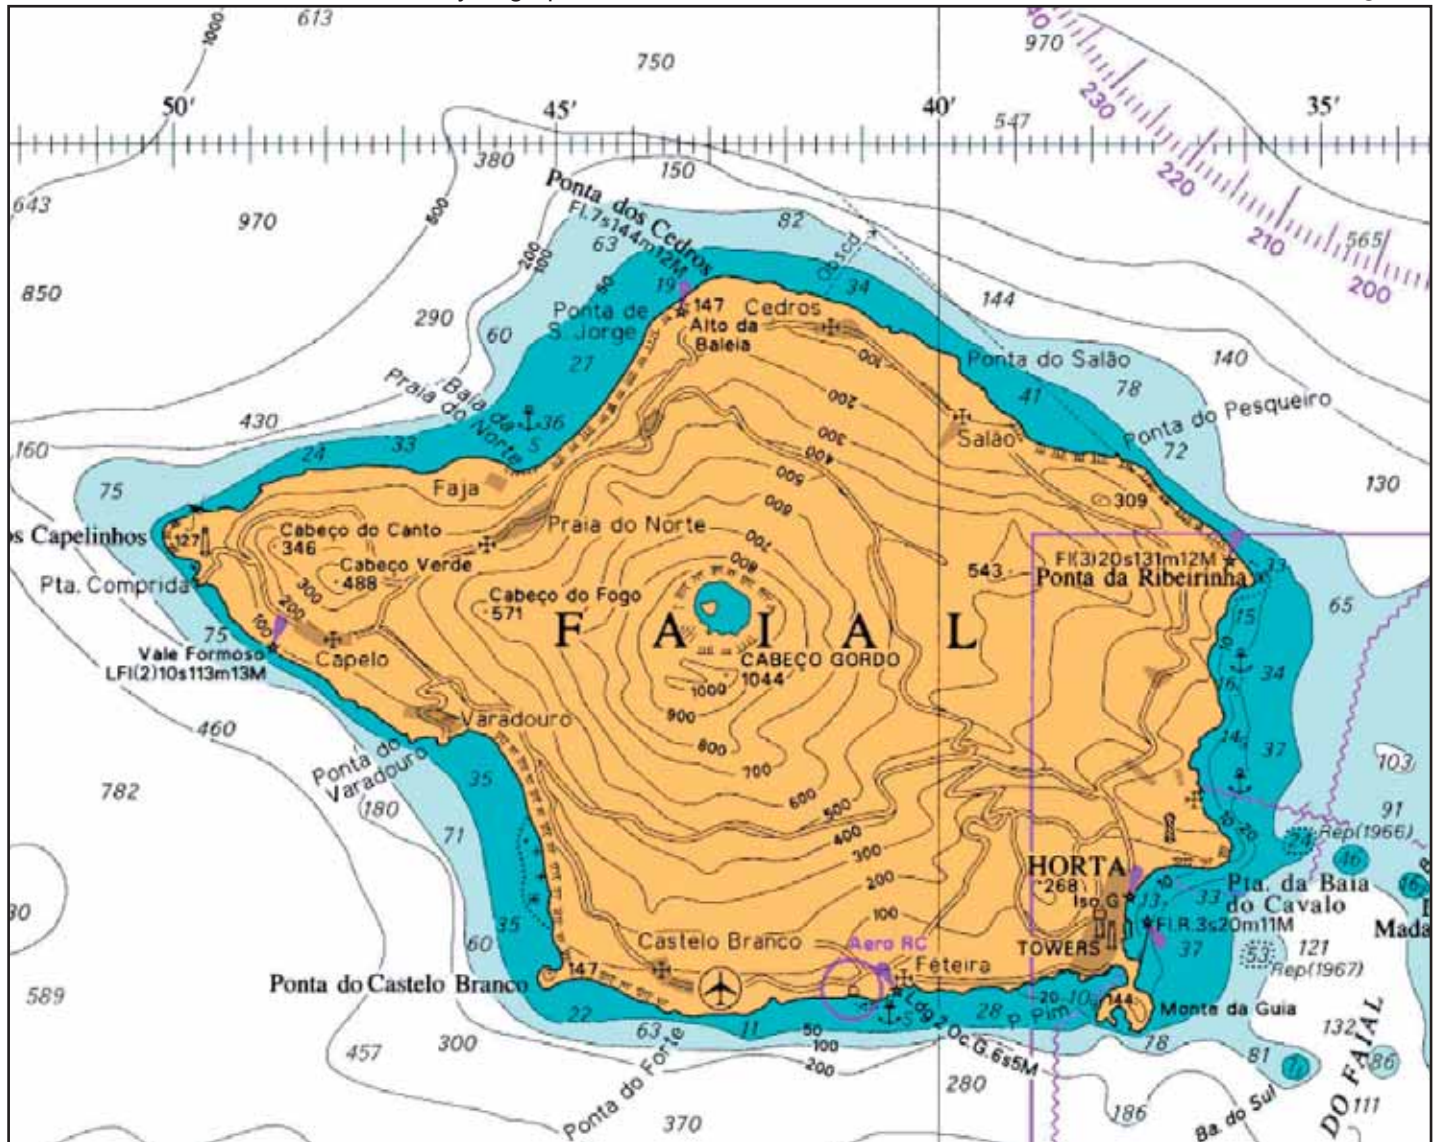
Faial Island on chart BA1956

The master consulted the British Admiralty (BA) charts of the Azores, and nautical publications, including the appropriate Admiralty Sailing Directions. He dismissed possible anchorages off Flores and Horta because he felt they were too exposed to the south. However, he found a designated anchorage on the BA charts situated in a bay off the north-west coast of the island of Faial. The bay appeared to provide good shelter from the prevailing weather. The vessel was just 7 hours steaming from the bay, which gave an estimated time of arrival (ETA) in daylight. It was also close to their intended track, involving a diversion of fewer than 10 miles. The Admiralty Sailing Directions described the anchorage as being about 4 cables north of the head of the bay in 35 metres water depth (**Figure 2**).

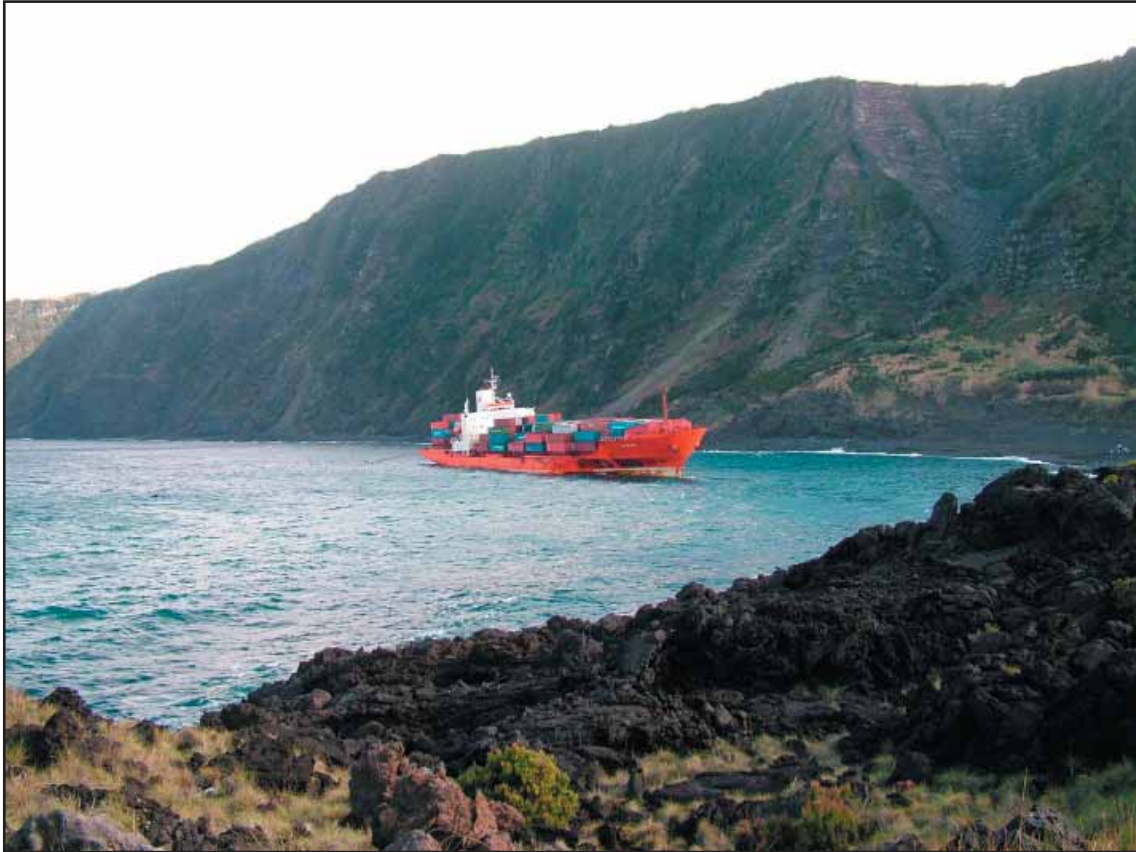
Figure 4

The hull was found to be intact at this time, and there was no evidence of water ingress or pollution. The vessel's draughts were confirmed as 7.20m forward and 8.10m aft; a change from the predicted arrival draughts of 8.05m and 9.05m respectively.

Vessel aground on 13th December 2005

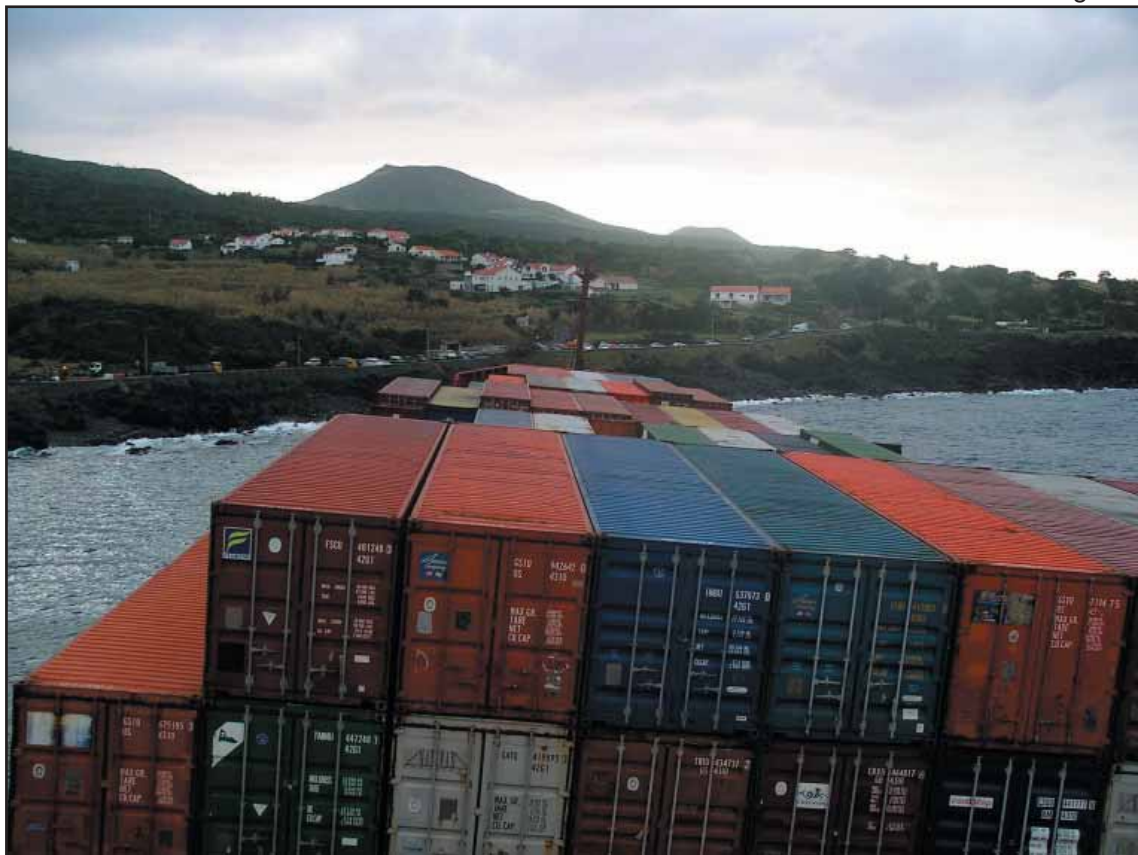
Figure 5

View from bridge over deck containers

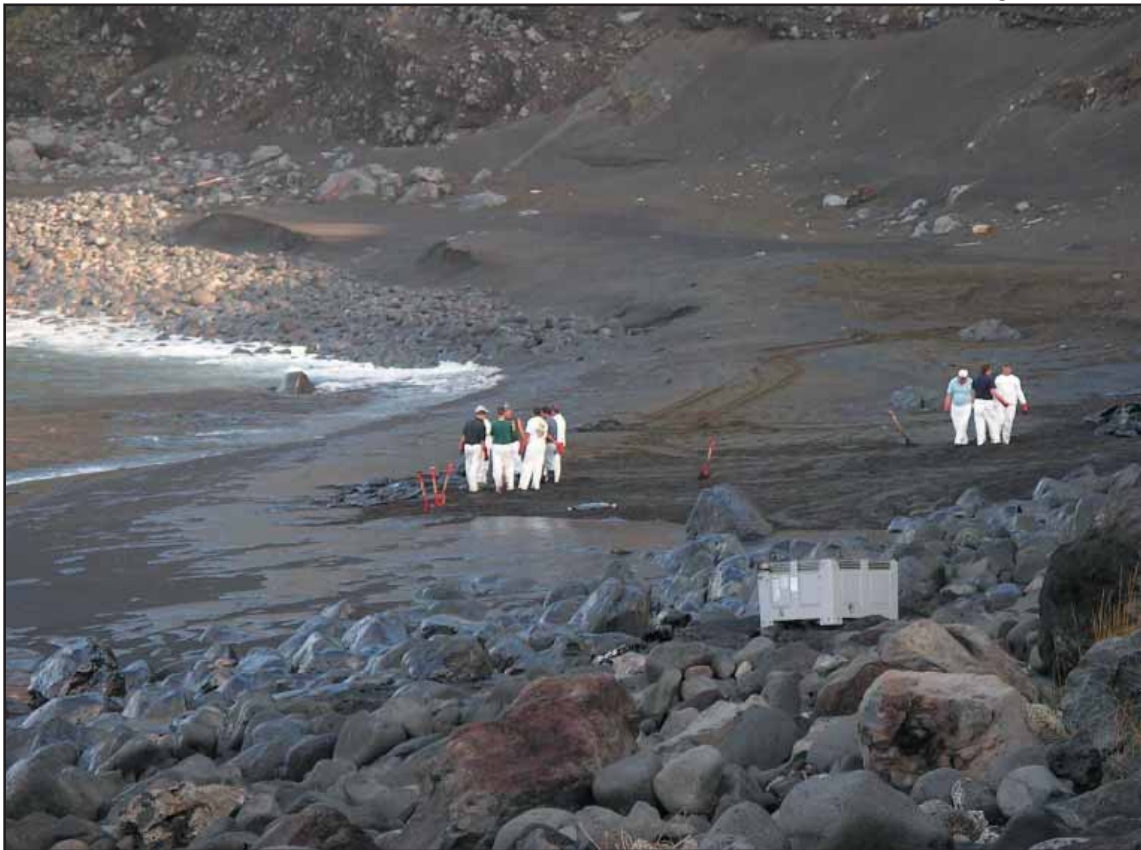
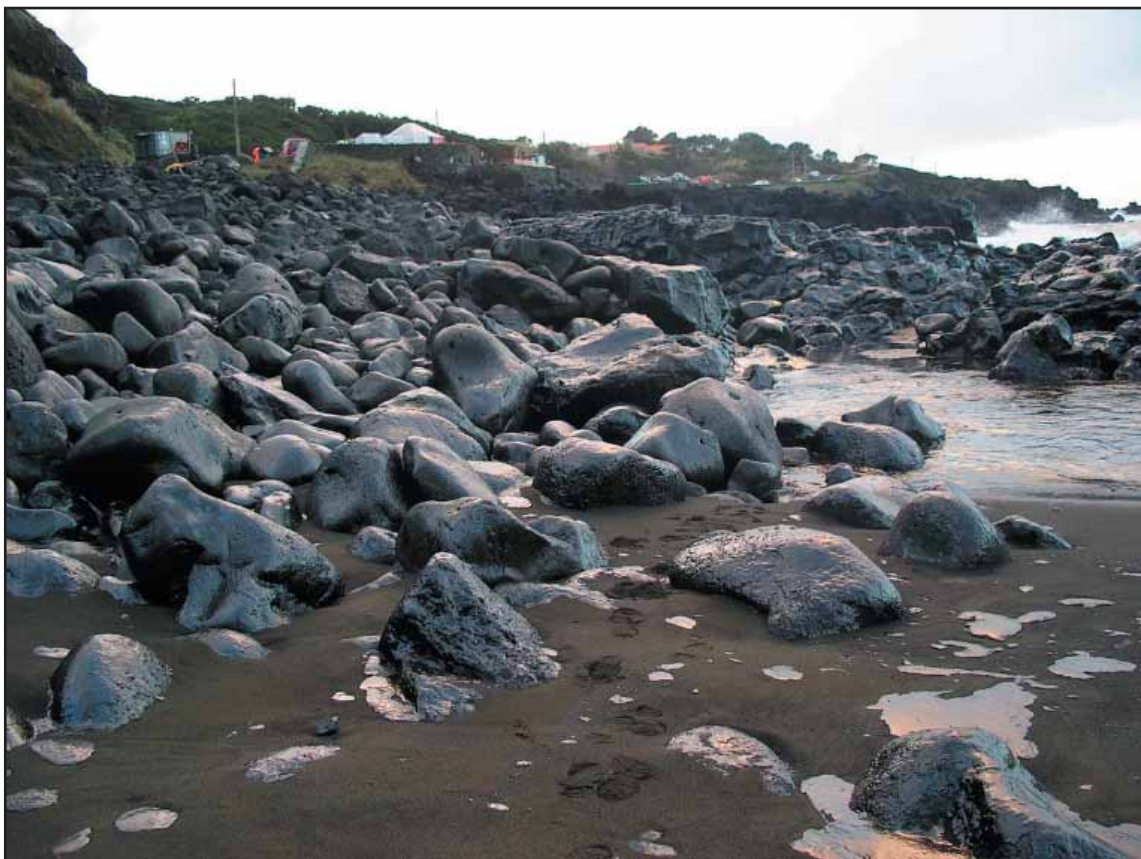
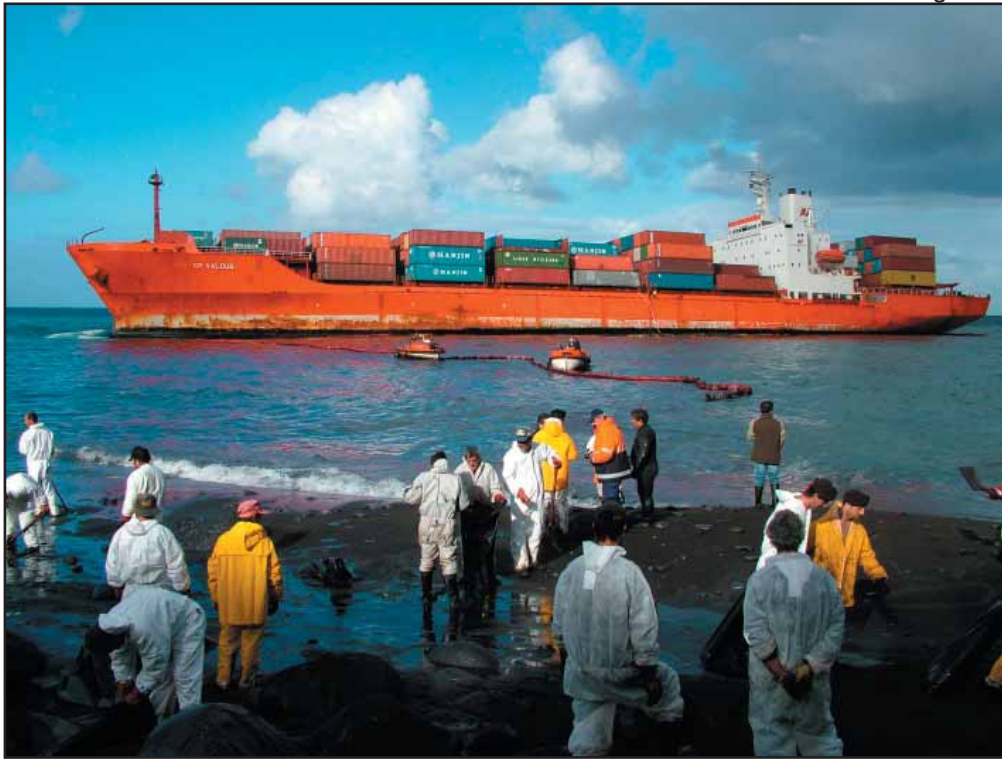
That afternoon, the full length of *CP Valour's* double bottom began to sustain fractures, and fuel oil, gas oil and ballast tanks became open to the sea (**Figures 6, 7 and 8**).

Oil clean up operation

Oil boom and clean up operations

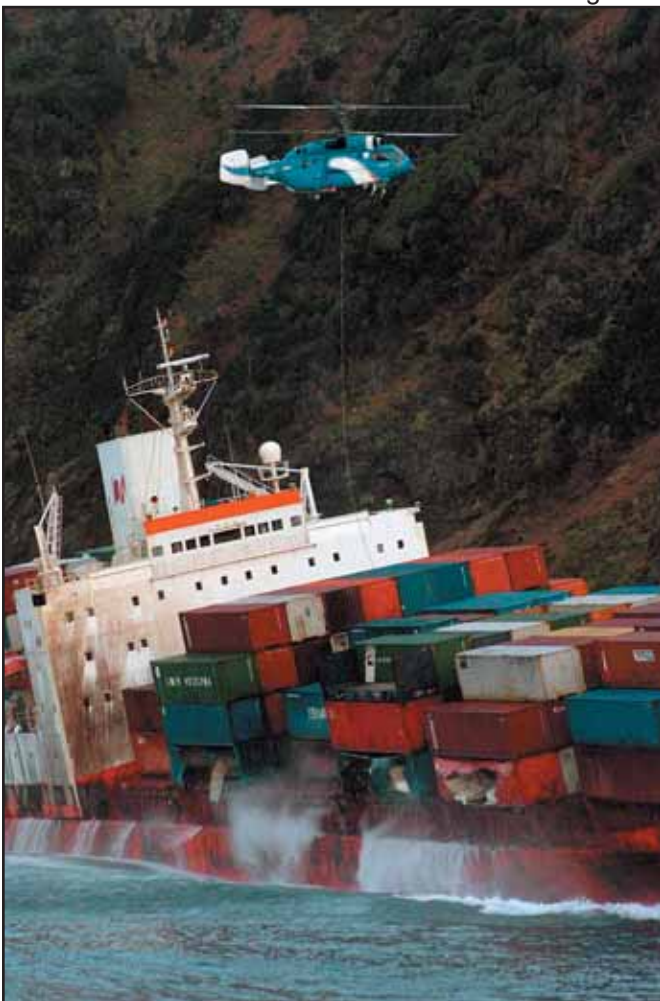
Figure 9

Helicopter operations to remove the hazardous cargo

The vessel was finally abandoned, and the salvage attempts were called off on 25 December. By that time all of the IMO classified hazardous cargo had been removed by helicopter (**Figure 9**), and about 450³m of oil and water had been removed into a barge.

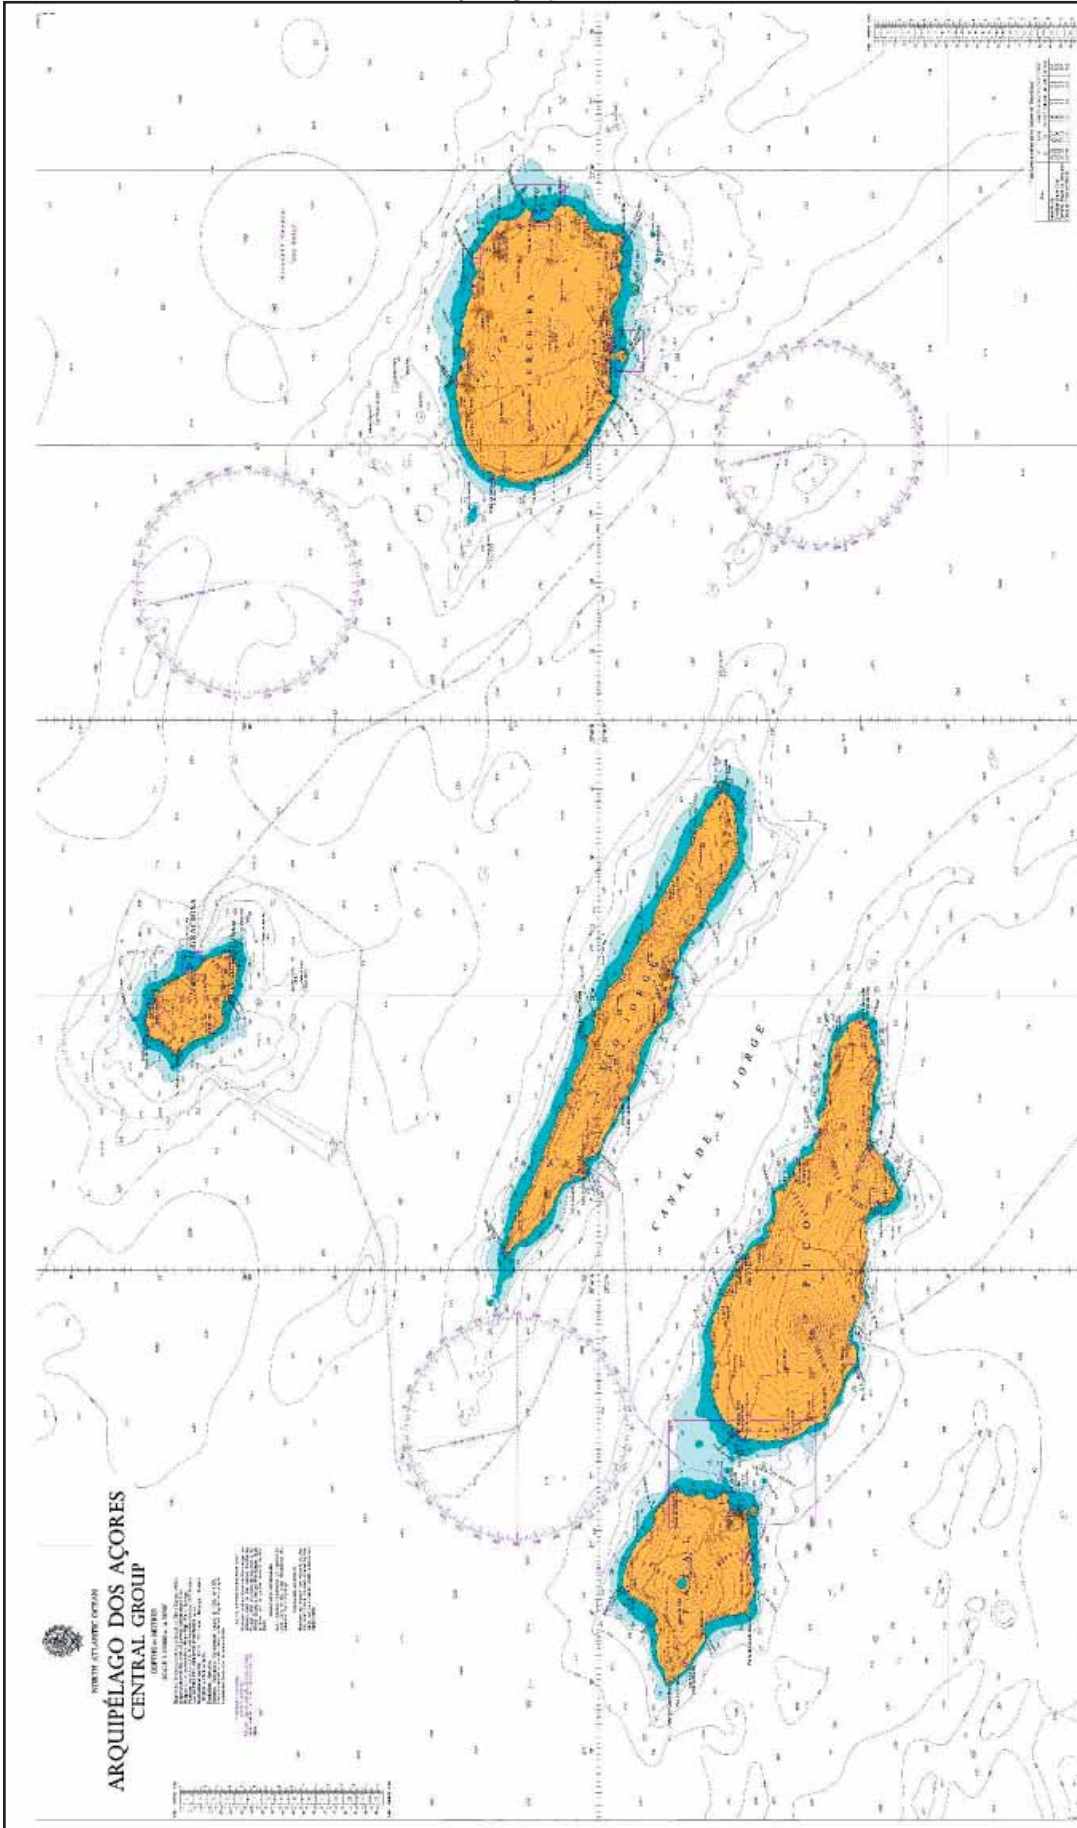
Chart BA 1956

The bay contained a charted designated anchorage, but the largest scale British Admiralty chart of the island was of 1:175,000 scale. Such a chart is not normally considered suitable for close inshore navigation. There was only a single sounding of 36 metres in the bay.

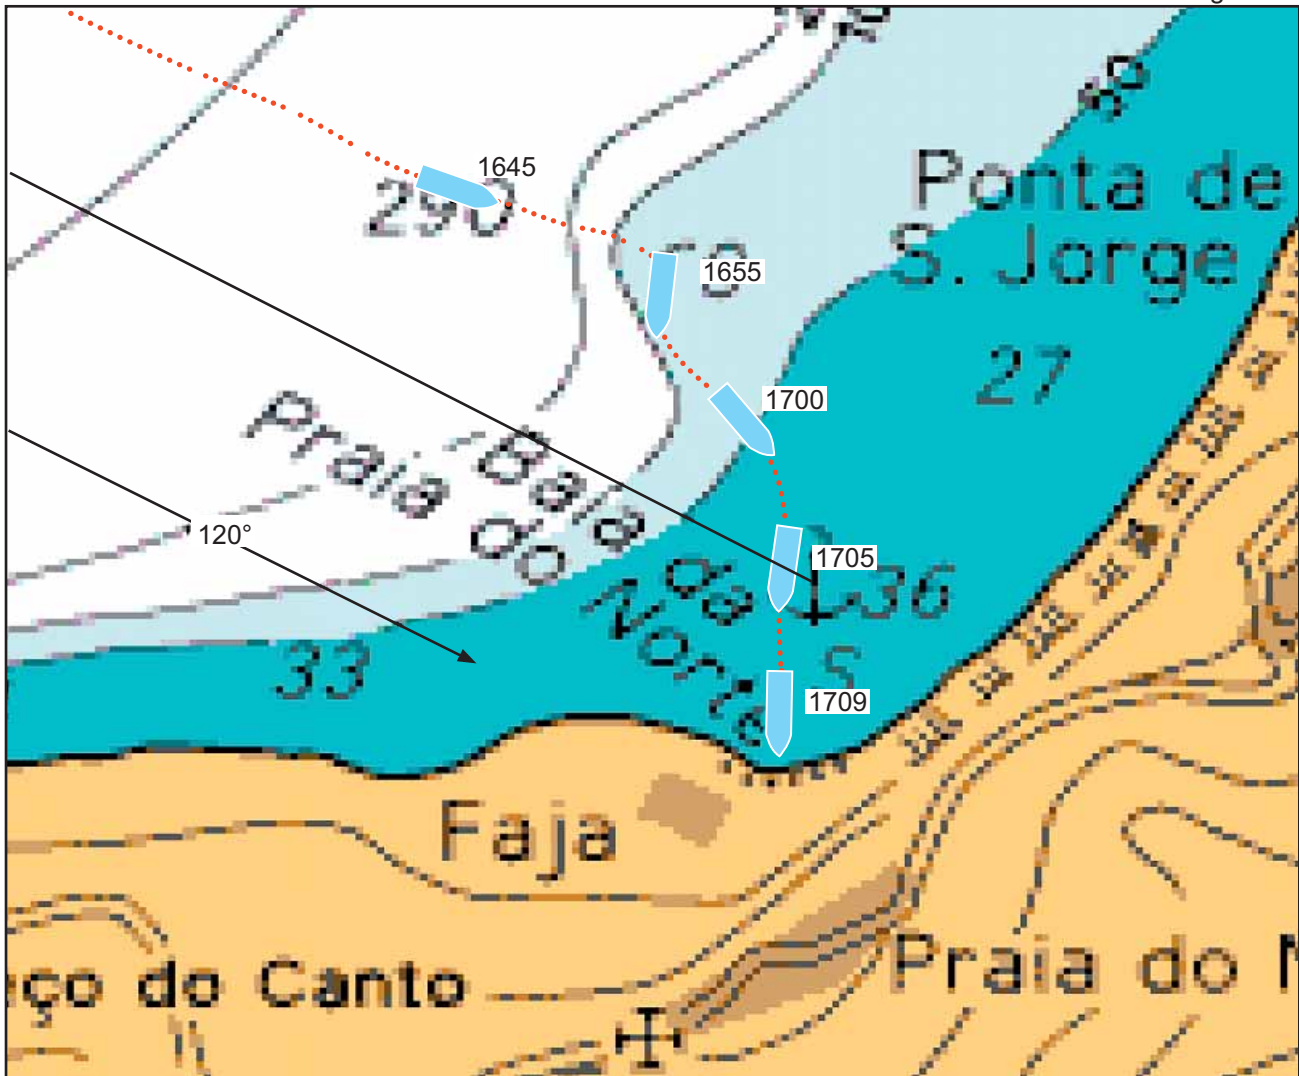
No one on board noticed *CP Valour* taking the ground, when she did so at 6 knots. However, the seabed in that location consisted of rocks covered by sand, and it is possible that she slowed gently. The master on the bridge, and the chief officer on the forecastle, considered the vessel to have stopped in the water. The master ordered the anchor to be walked back as he put increasing astern power on to help lay out the cable. It was only the fact that the vessel did not move that alerted the crew that they were aground. By that time, 5 shackles of cable had piled up on the seabed.

Plot of the vessel's track

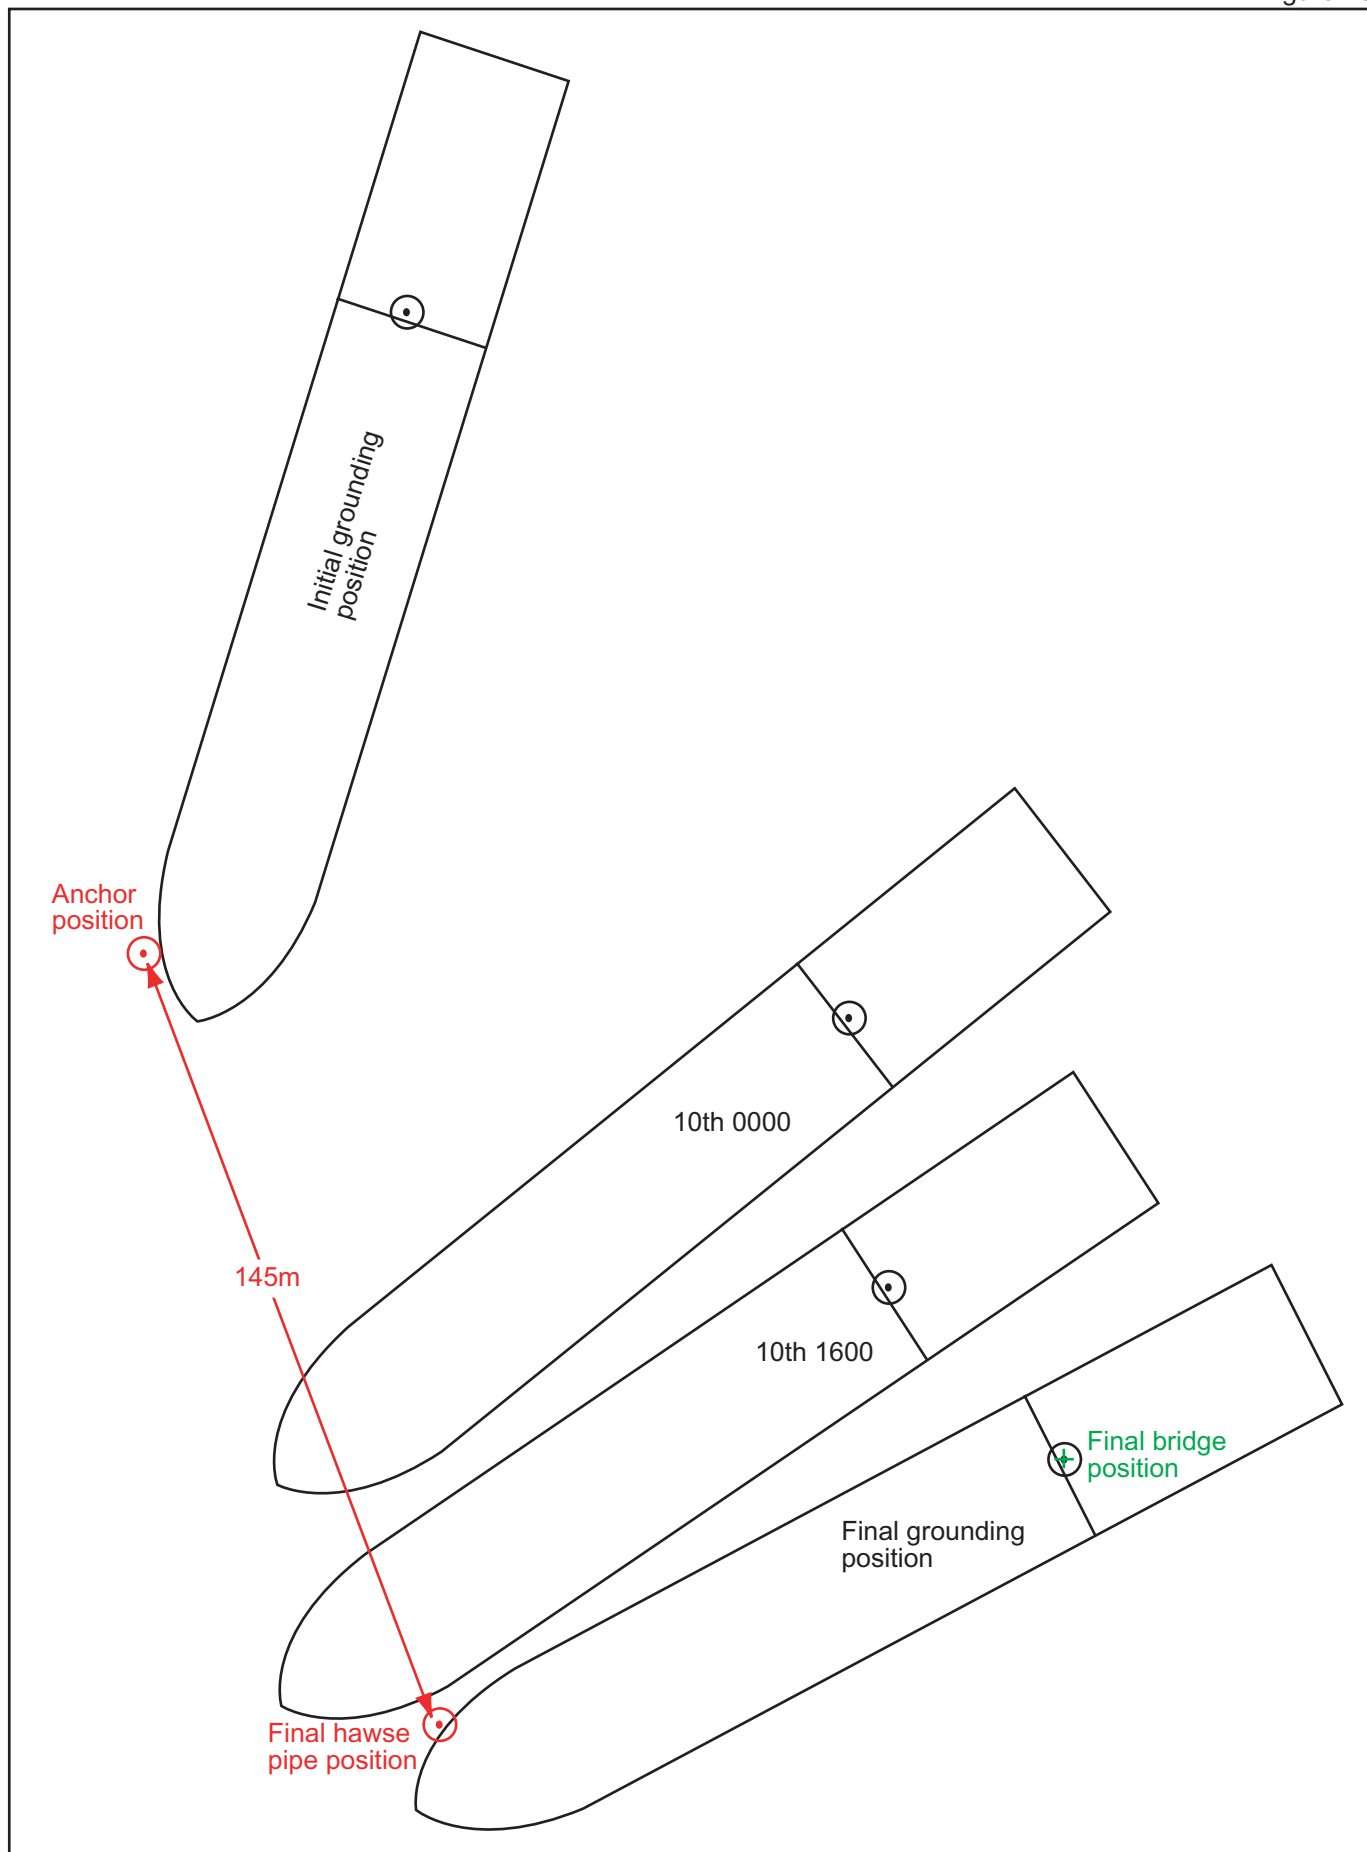
Over the next 2 days, the vessel was driven further ashore under the influence of an onshore current, and later wind and waves. She finally came to rest at noon on 11 December. Had the master decided to leave the anchor down, he would have had 5 shackles of cable laid on the seabed on 11 December. In that situation, it is unlikely the anchor could have been used to keep the vessel from being driven further aground. However, in many circumstances, it is good practice to leave it out (**Figure 15**).

Grounding positions

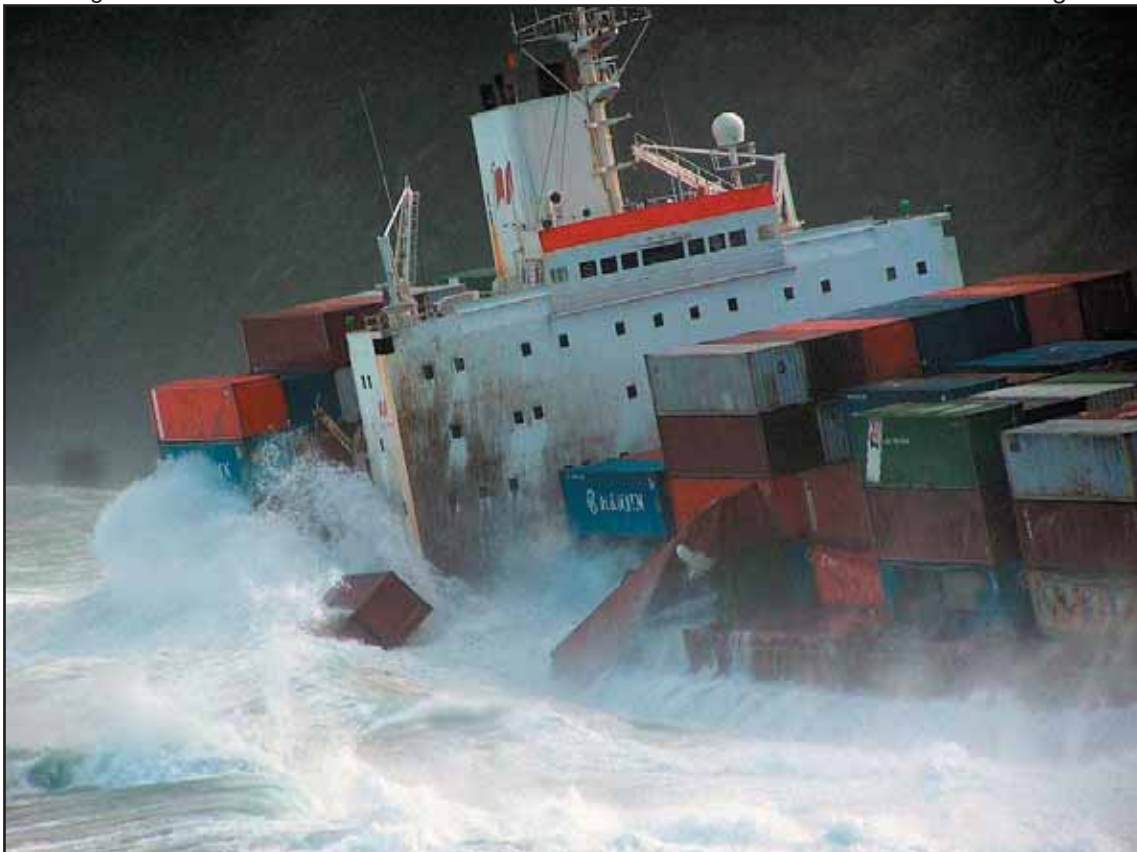
Figure 16

CP Valour had been forced further ashore, turned by currents and the sea during Friday night and Saturday morning, and was aground on rocks below the sand. Many of the vessel's tanks were holed prior to the salvage tug's initial salvage attempt to connect a tow, and oil was leaking to the sea.

Vessel still aground 24th January 2006
