Report on the investigation into the grounding of
ro-ro passenger ferry

Dieppe

on the approaches to Newhaven

Report No 18/2006
July 2006

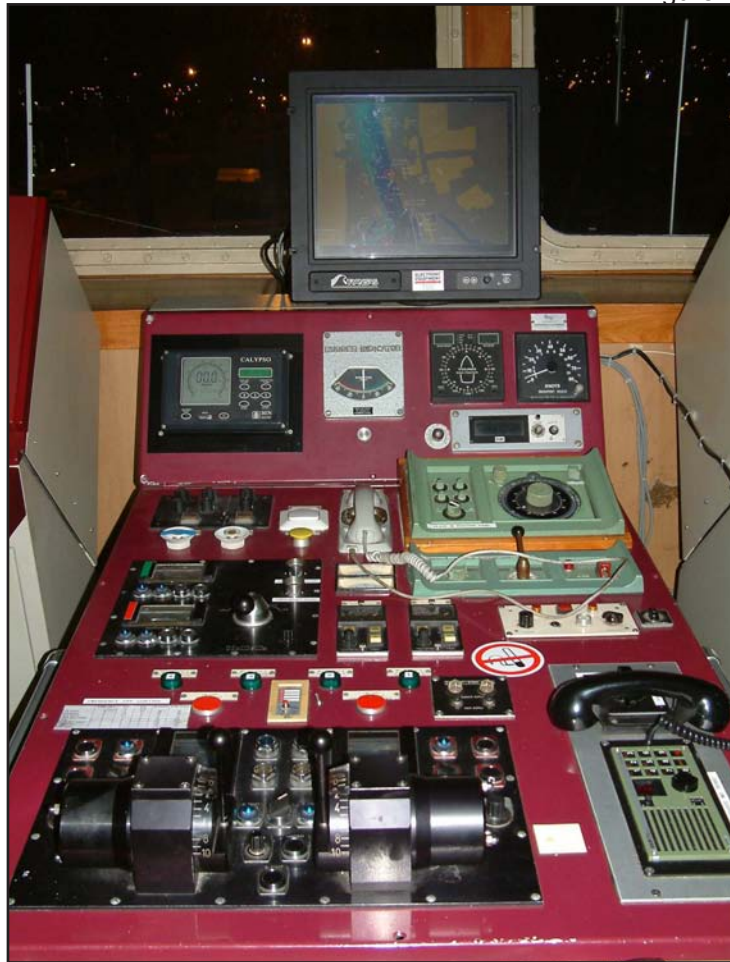
Figure 1

At 0648½ the West Breakwater light was bearing due west. The bridge was on the centre line of the channel, however, the ship's heading was 020 and the vessel was making good 023. The master continued turning *Dieppe* to port, and at 0650 completed the turn to 348, making good a course over the ground of 349 – the same direction as the approach channel. Observation of the two red lights on west pier, with a slightly open aspect, gave the master an indication that he was right of his planned track, but not how far. Observation of the electronic chart showed that *Dieppe* was approximately 20m right of track. In an attempt to regain position in the centre of the channel, 15° of port helm was applied and a new course of 345 ordered. Speed over the ground had reduced to 3.8 knots. Because the master was unable to accurately monitor the vessel's position by visual means, he used the DGPS position displayed on the electronic chart system.

Transas ECS positioned on the centreline

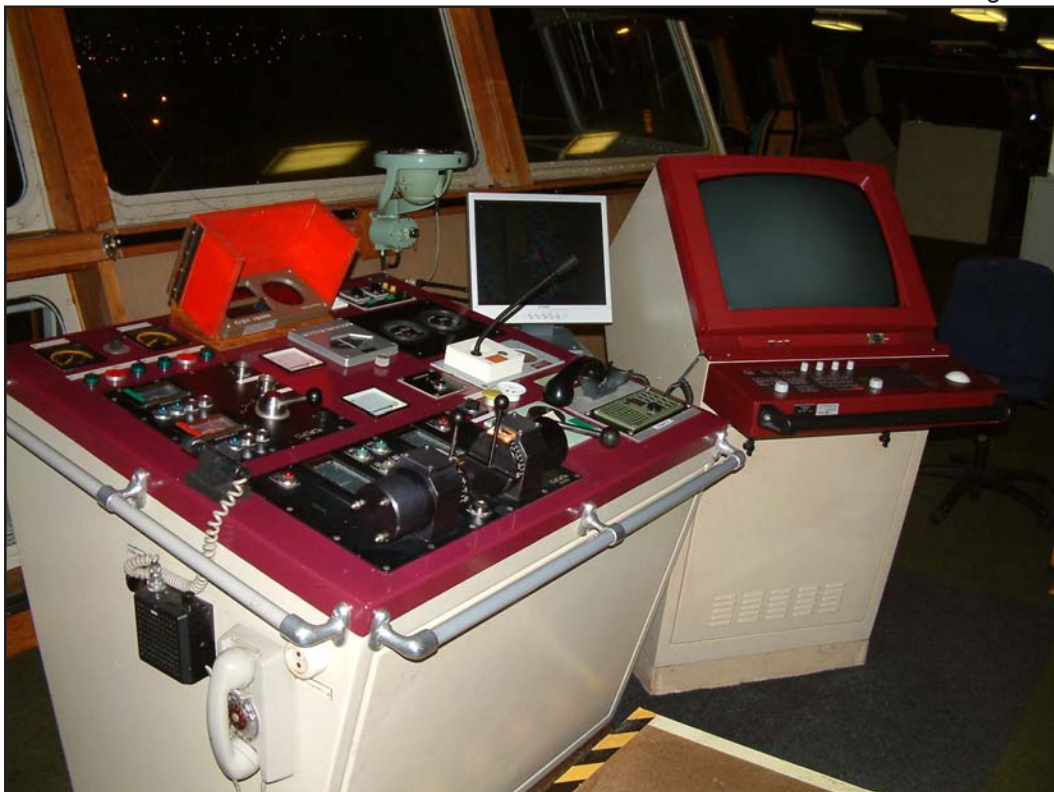
Figure 2

Transas ECS bridge wing repeat

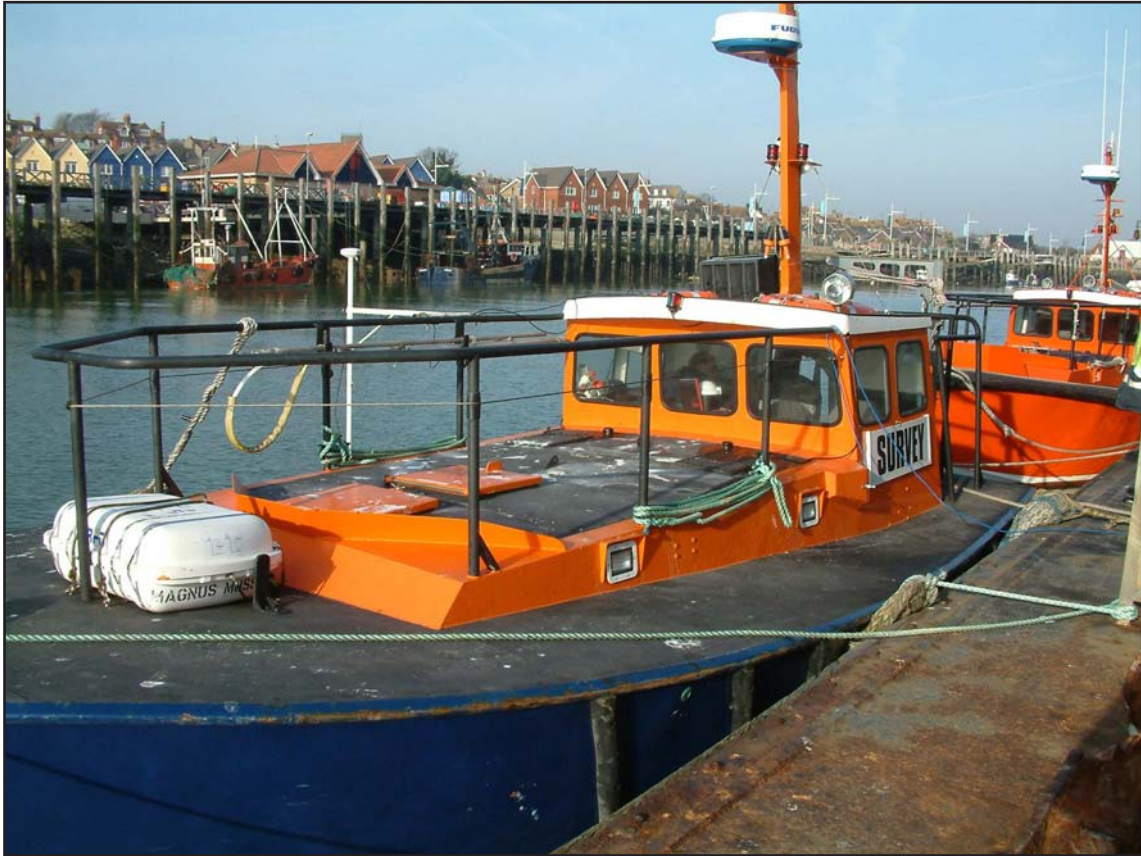
Figure 4

A dedicated survey launch fitted with portable survey equipment was available to the harbourmaster, and at the time of the accident, both the launch and the survey equipment were fully operational (**Figures 4 & 5**).

Refurbished survey launch

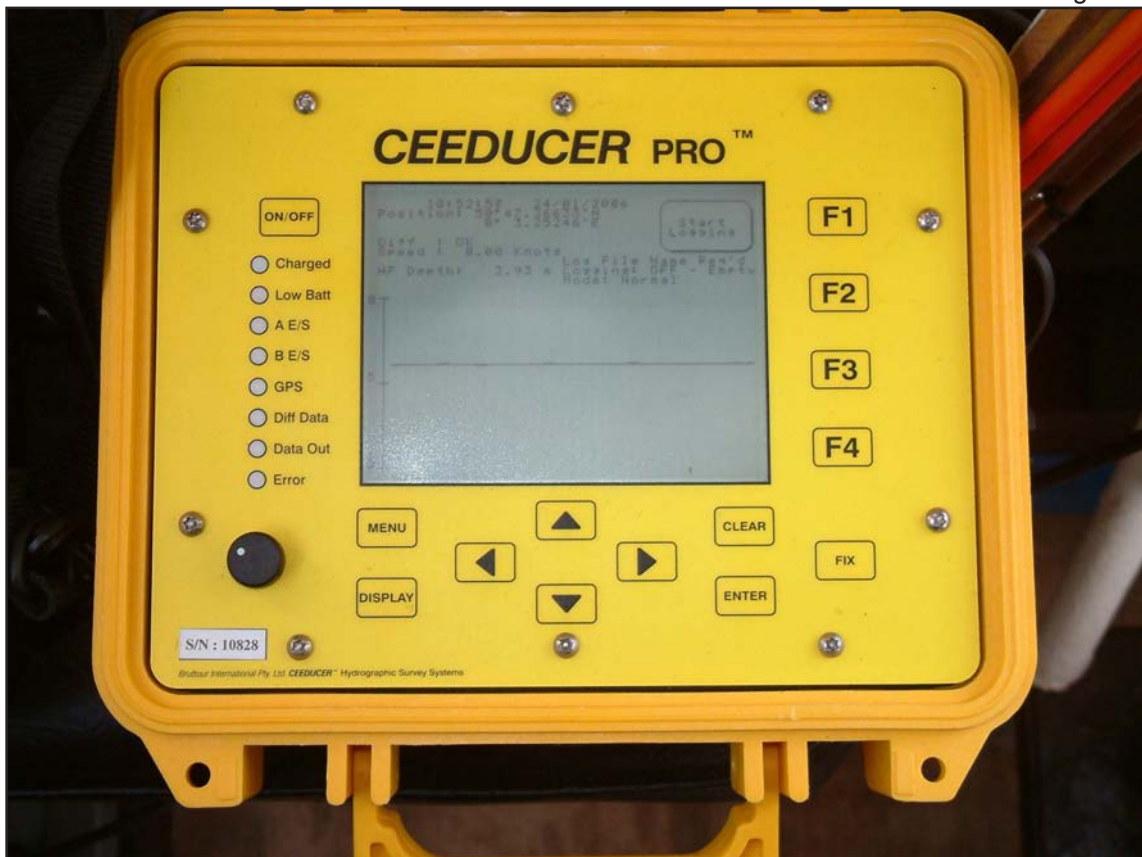
Figure 5

Portable surveying equipment

- f. Hydrographic surveying is the principal method of identifying reduction in depth, and the reliability and availability of the port's surveying equipment is key to maintaining this risk monitoring capability. No duplicate set of equipment exists, and NPP has no contract in place to either repair defective equipment or bring in alternative equipment.

- NPP has decided to arrange for the provision of a rapid response repair service for its Hydrographic survey equipment.
- To satisfy the MCA that the new measures would be enforced, the managing director of NPP provided them with written confirmation that the harbourmaster:

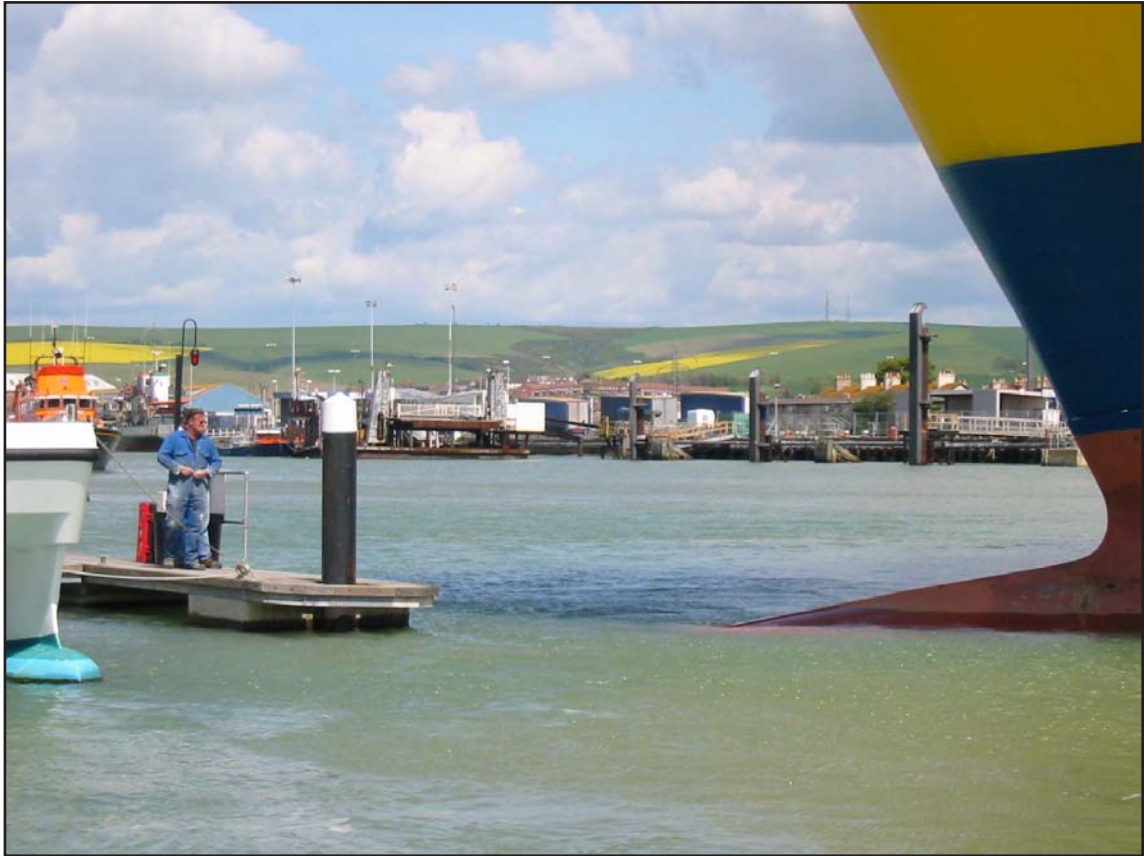
Enlargement of the turning basin remains an outstanding issue, restricting *Dieppe* from turning prior to departure (**Figure 6**).

Dieppe turning trail. Closest point of approach

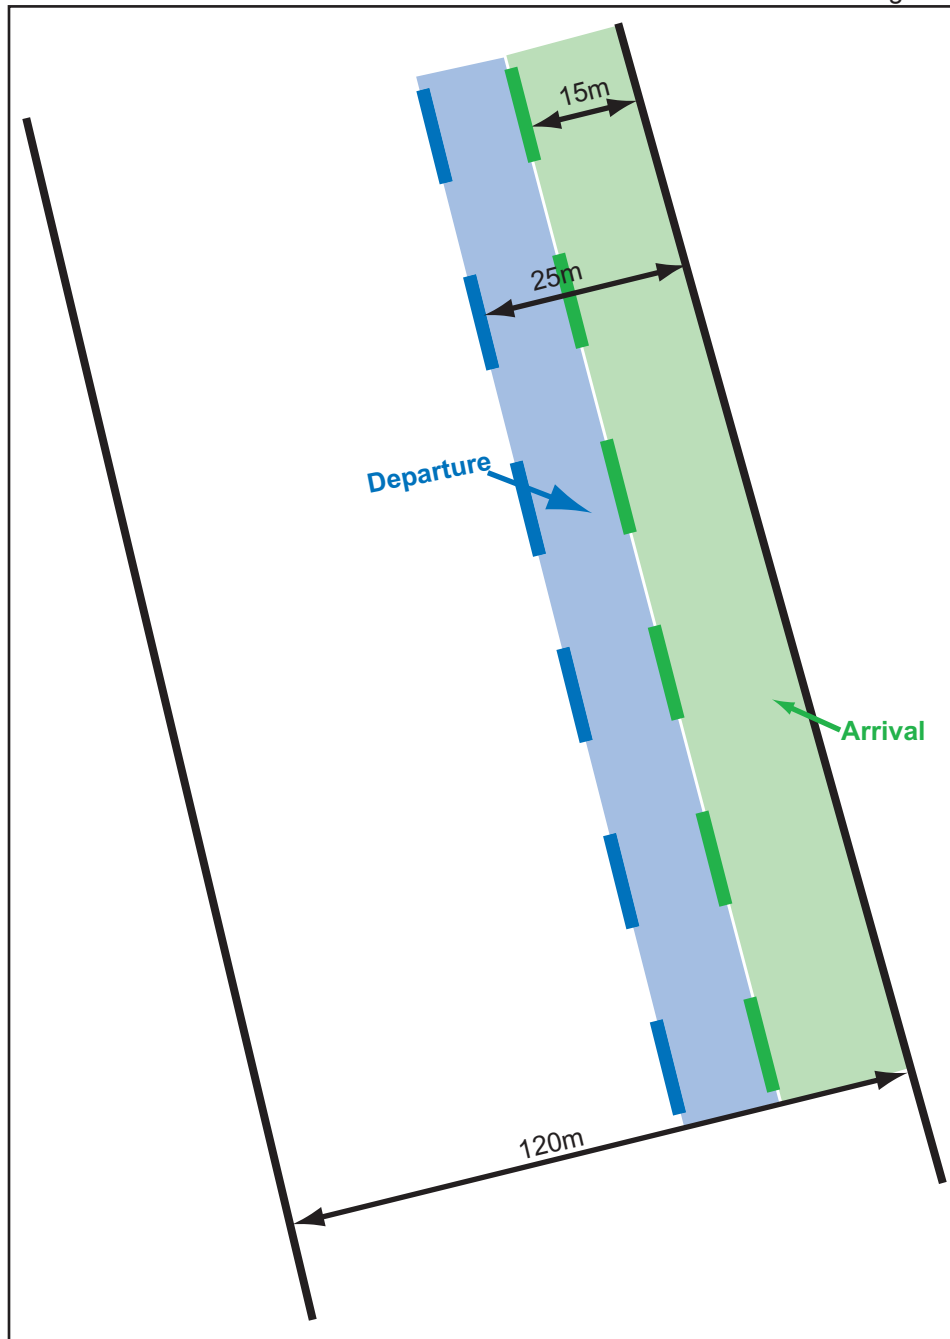
Figure 7

Newhaven approach channel - minimum permissible depth diagram
