Report on the investigation of
the collision between
fv *Harvester* and mv *Strilmøy*
North Sea
4 November 2005

Marine Accident Investigation Branch
Carlton House
Carlton Place
Southampton
United Kingdom
SO15 2DZ

Report No 15/2006
June 2006

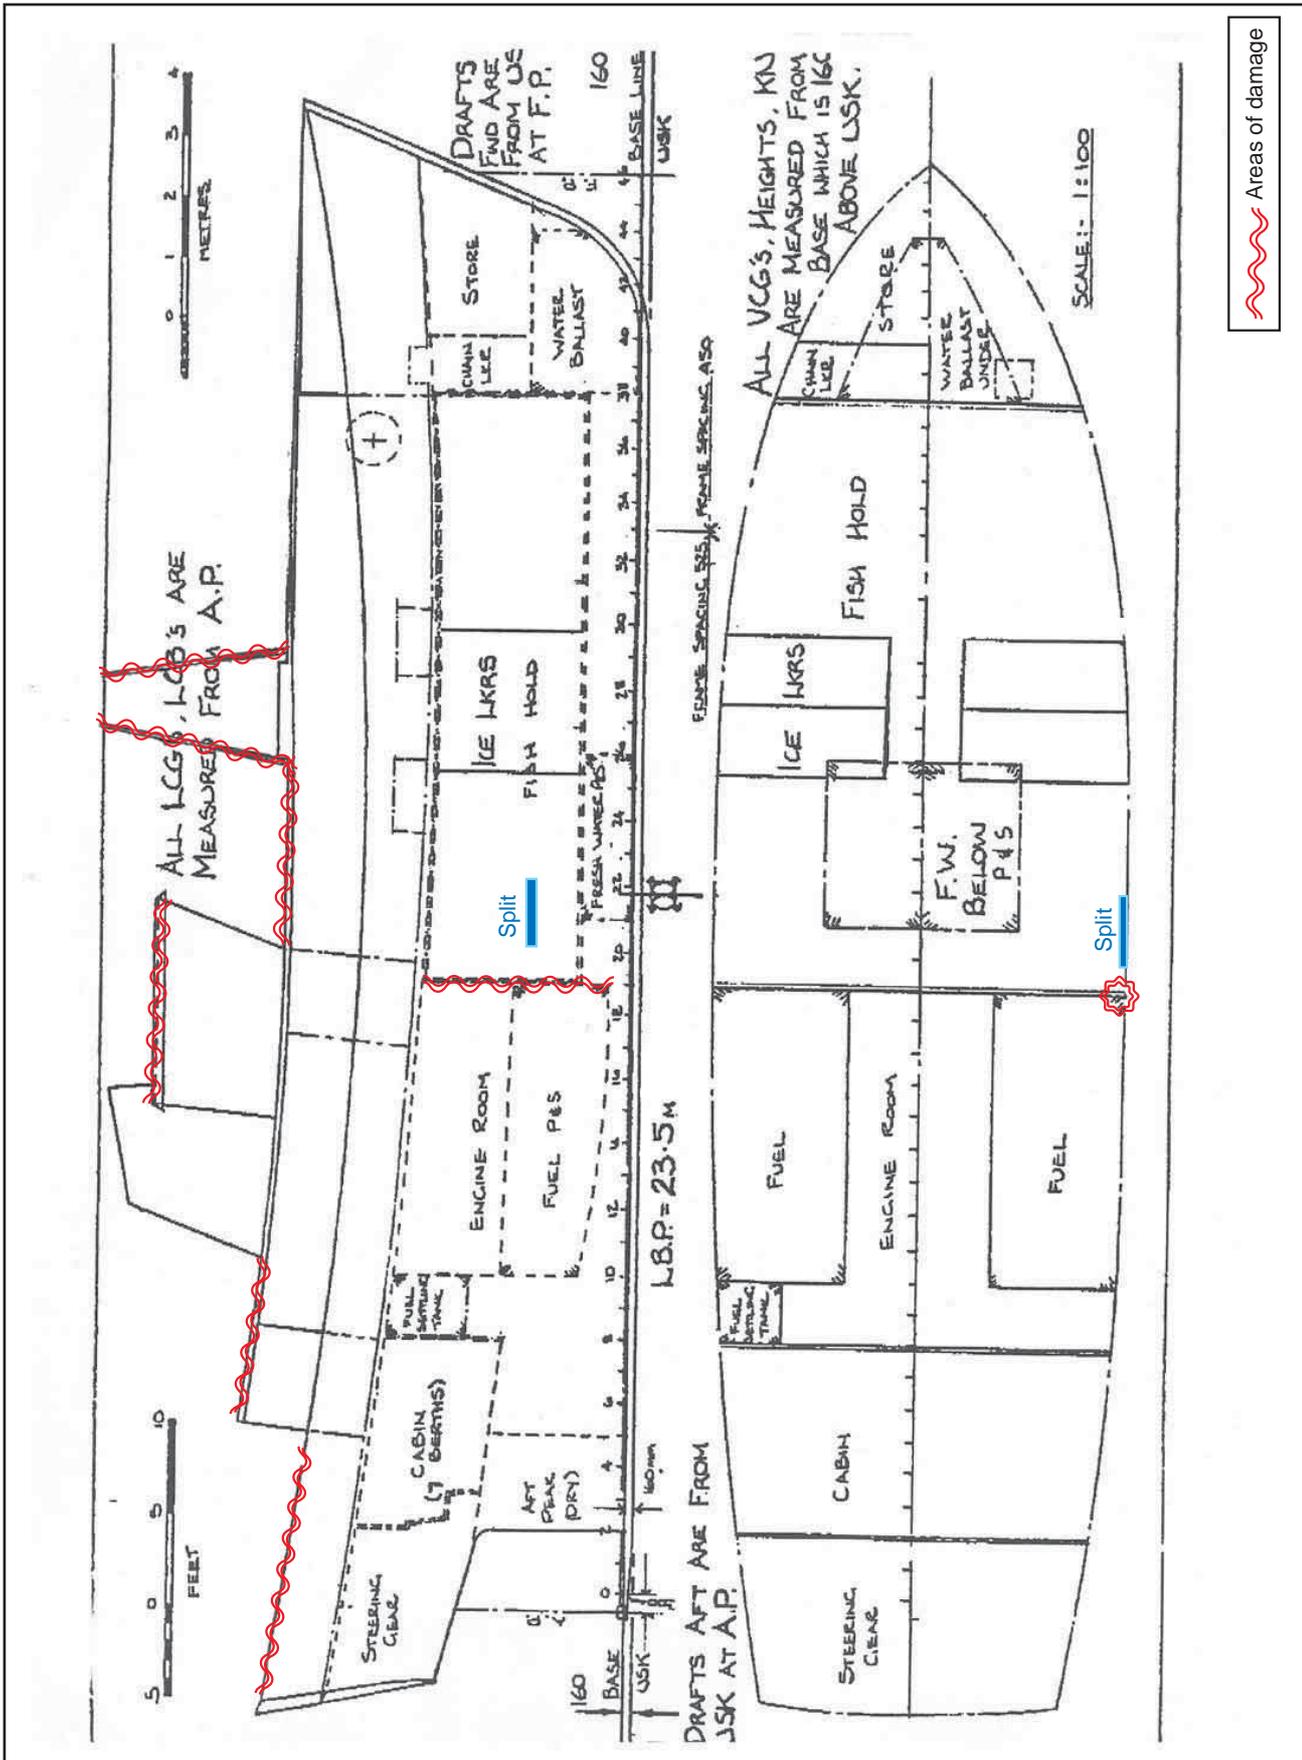
Figure 4

Harvester sustained a split in her side, approximately 25cm long and 2.5cm wide, at the after end of the fish hold below the waterline. The starboard side of the bulkhead was also damaged between the engine room and fish hold, at the junction with the vessel's side. Further damage was sustained to the superstructure around the wheelhouse, 'A'-frame and side railings (**see Figure 4**).

The split in the vessel's side caused flooding of the fish hold, and the split in the bulkhead allowed the seawater to flood between the fish hold and the engine room. The progressive flooding into the engine room was controlled by the bilge pumps, and these pumps remained running until just before the vessel finally sank. The flooding into the fish hold could not be controlled by the available pumps, so the fish hold filled with water. This caused *Harvester* to sink bow-first, about 1 hour and 40 minutes after the collision (**see Figure 7**).

Damage to Harvester PD98

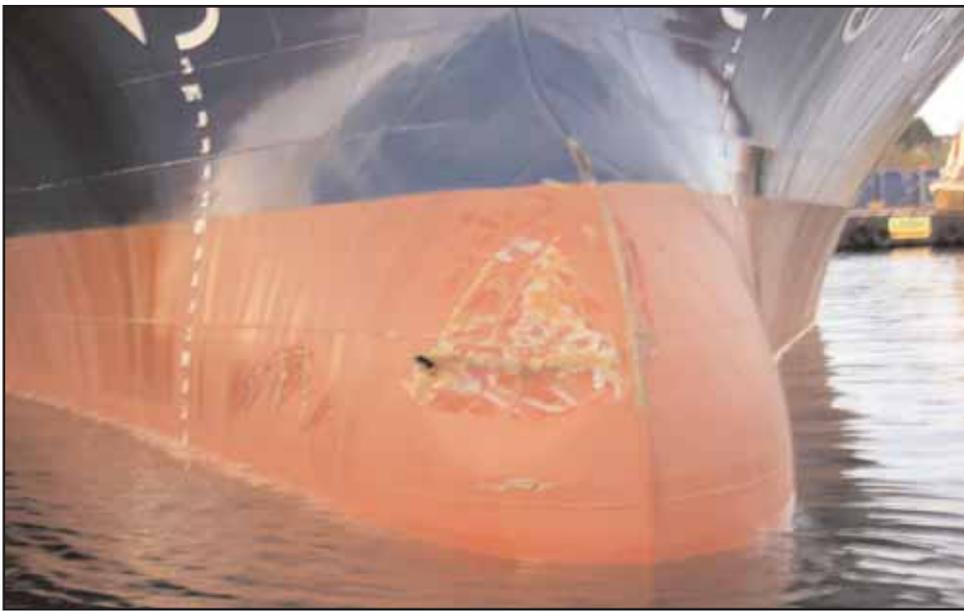
A damage survey was carried out on 5 November 2005 at Stavanger. The surveyor's report observed that there was an indented area of plating on the starboard side of the bulbous bow from the stem aft and including frame 13, at a height of between 4600mm and 5200mm. A hole measuring approximately 50mm x 120mm penetrated the hull at frame 133. Internally, the stringer at 'tween deck level at the bow, and the stringer below it, were slightly dented. Frame 134 was also found to be distorted. Scraping to the boot-topping along the starboard side of the vessel to the stern was cosmetic and did not require repair (**see Figures 5a, 5b and 5c**).

Figure 5a
Damage to *Strilmøy's*
bulbous bow

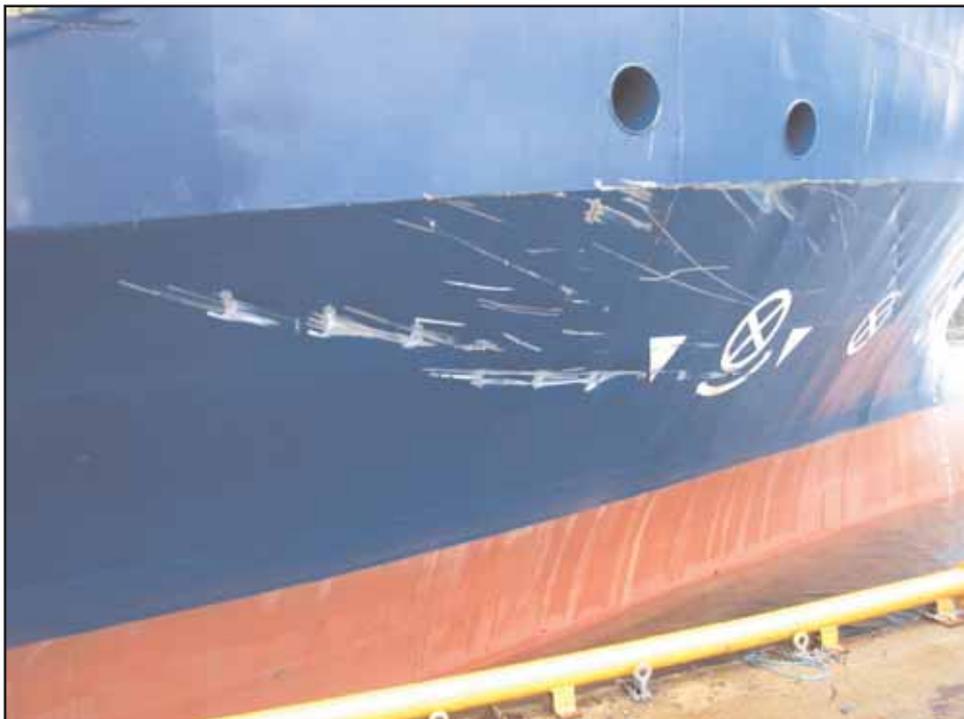
Figure 5b
Damage to *Strilmøy* (bow)

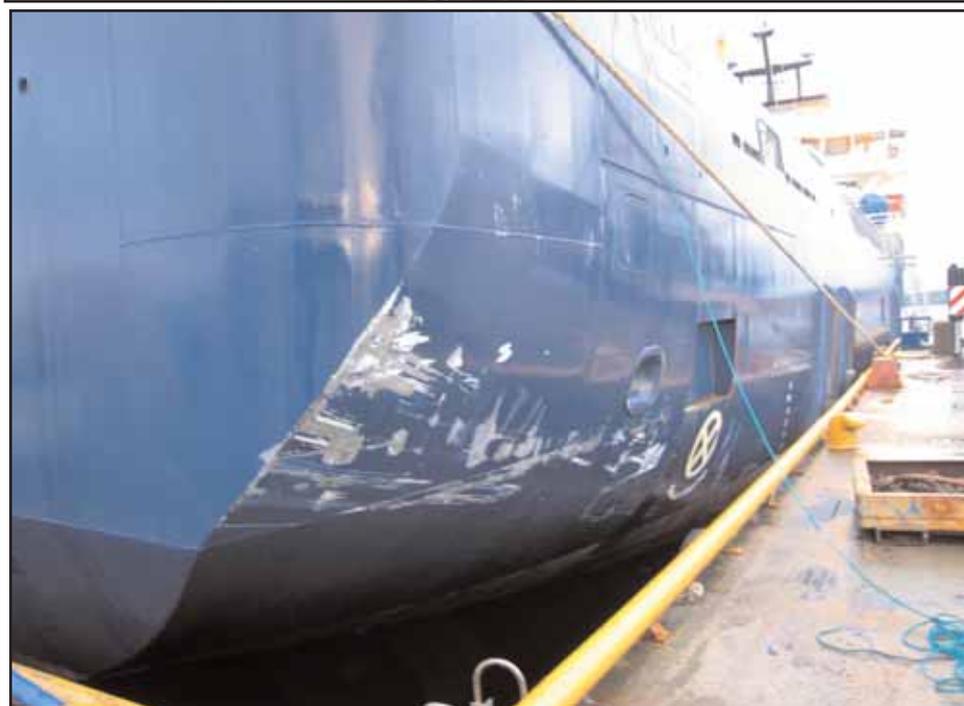
Figure 5c
Damage to *Strilmøy* (stern)

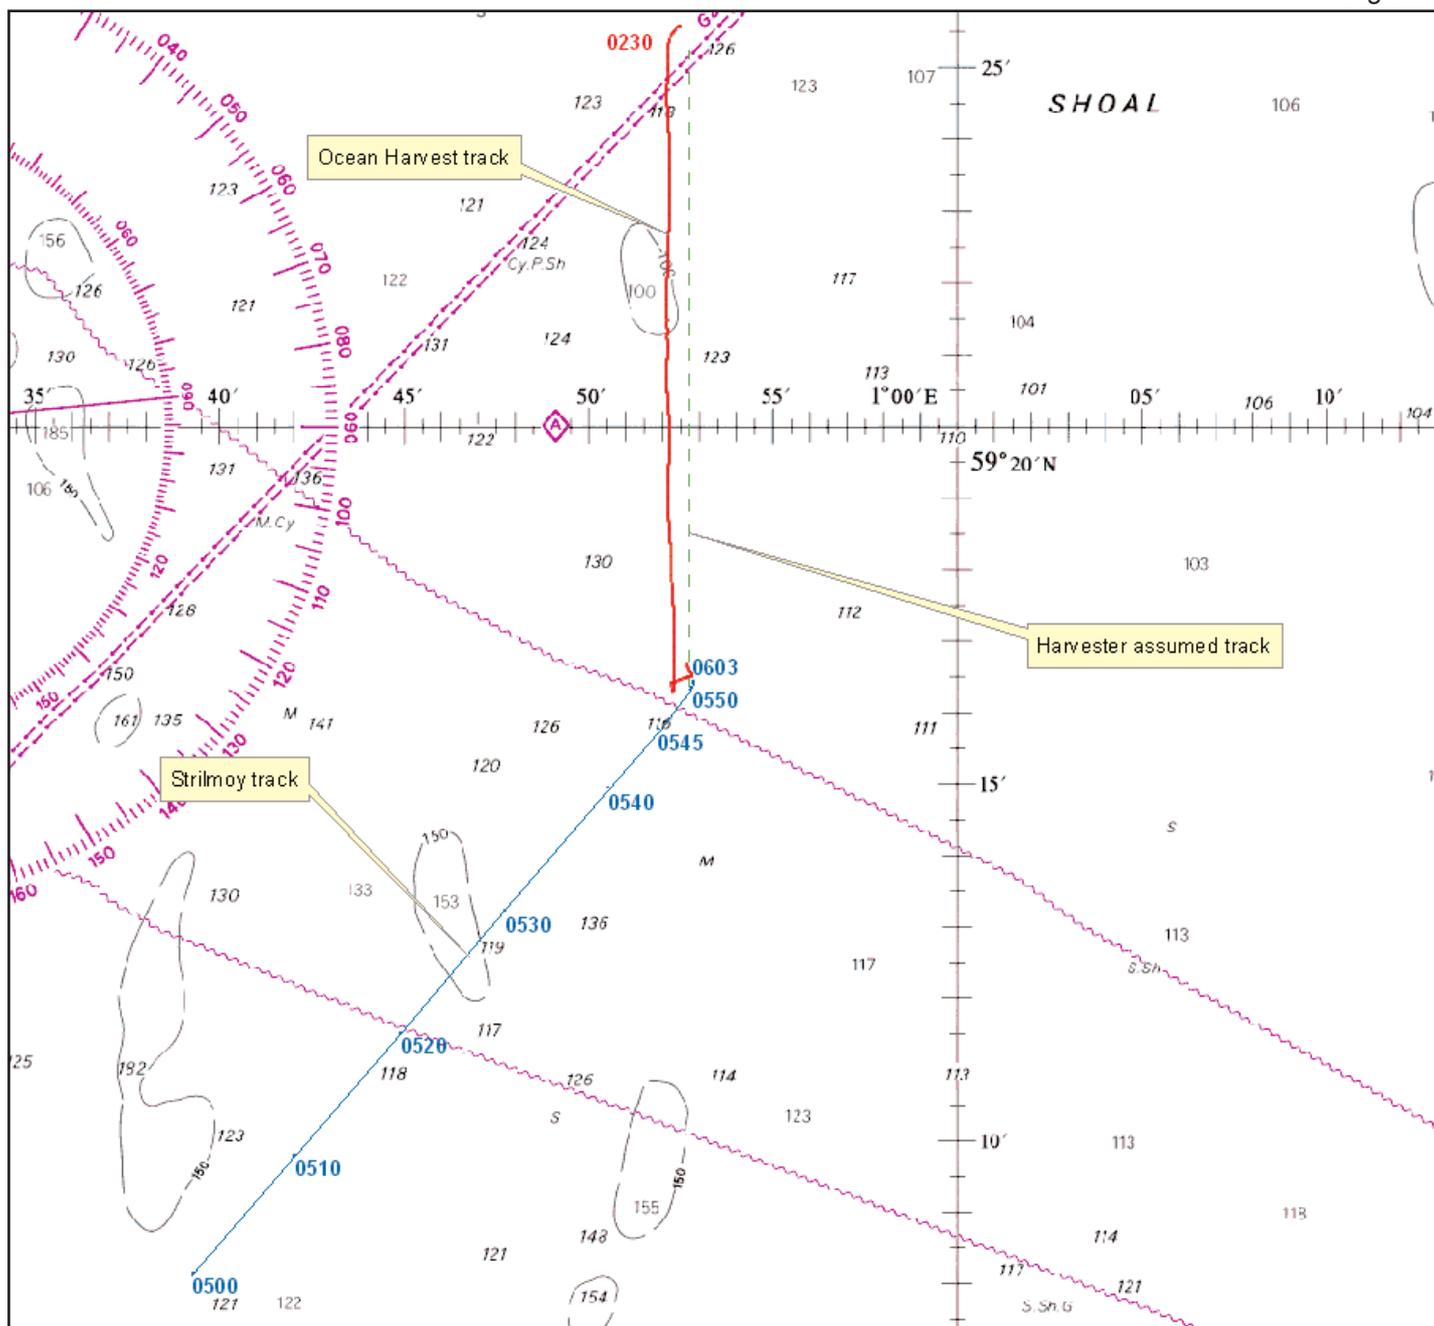
Figure 6

The tracks obtained from *Ocean Harvest's* fishfinder and *Strilmøy's* VDR have been extracted and combined for display on a Geographic Information System chart (**see Figure 6**).

Tracks of *Ocean Harvest* and *Strilmøy*, and assumed track of *Harvester*

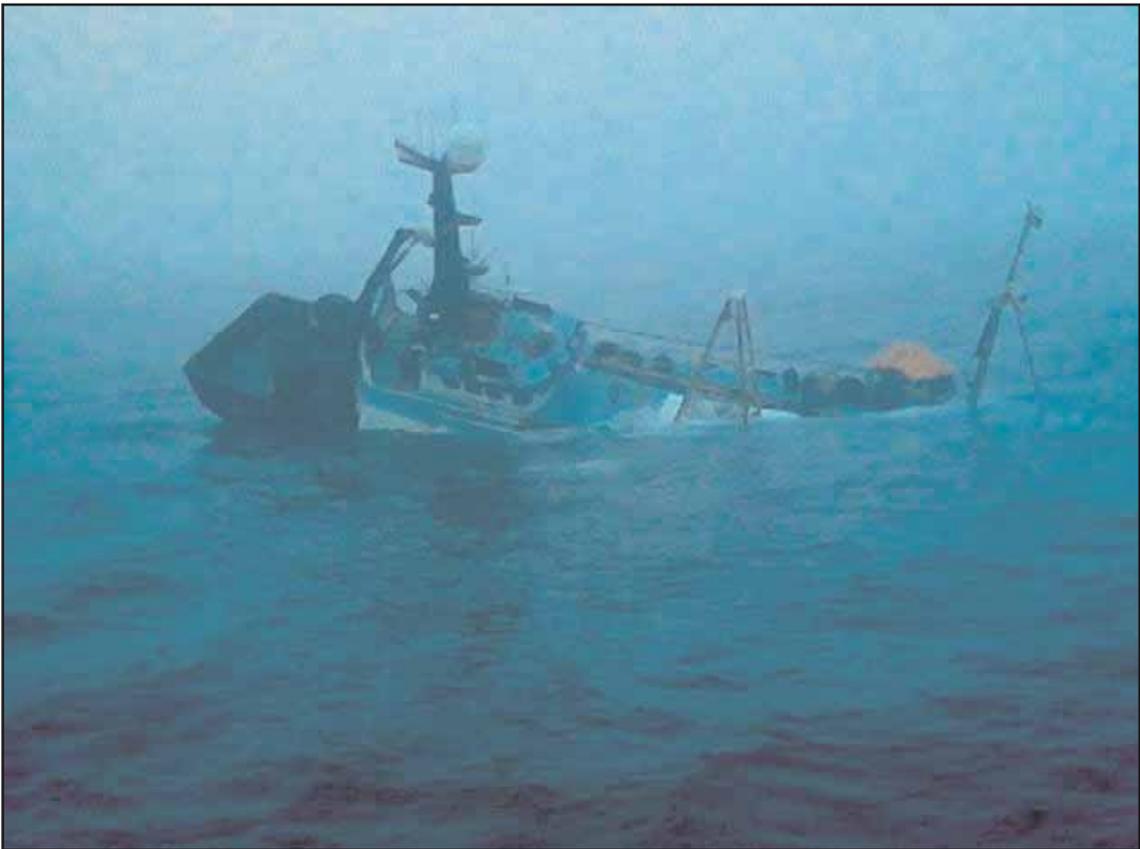
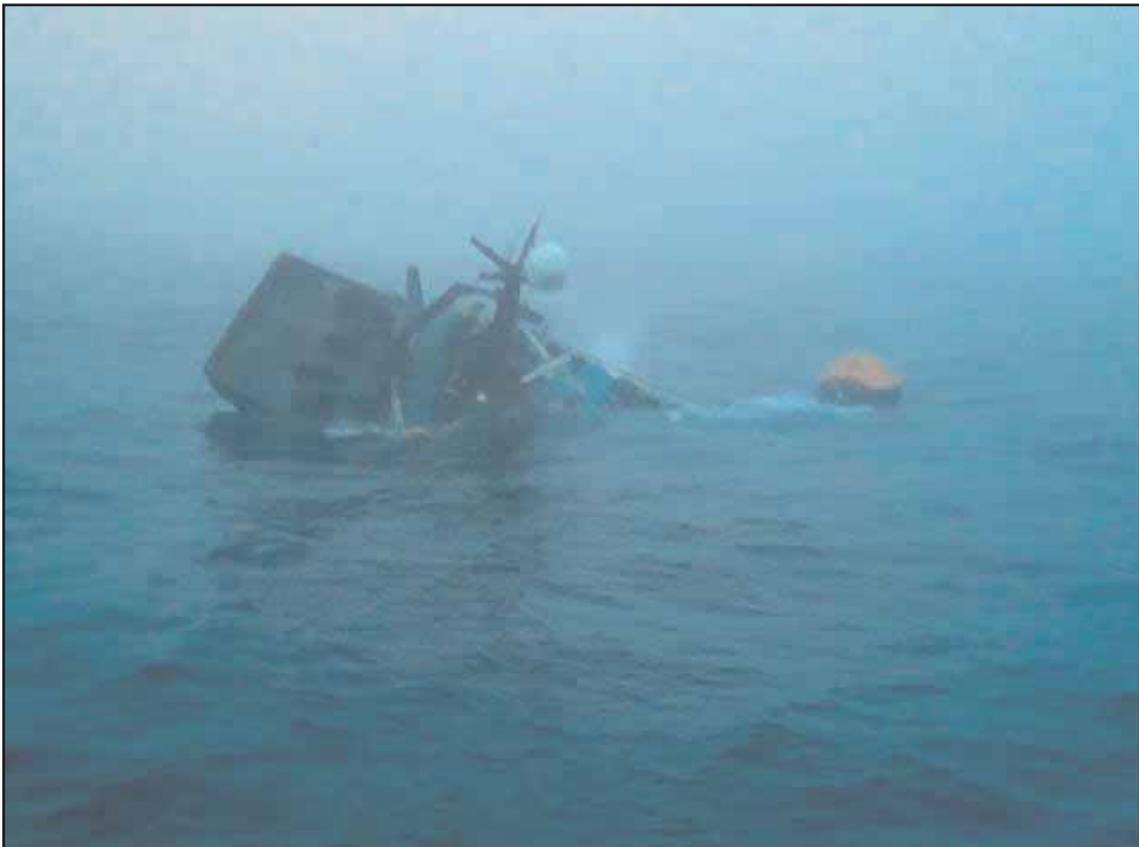
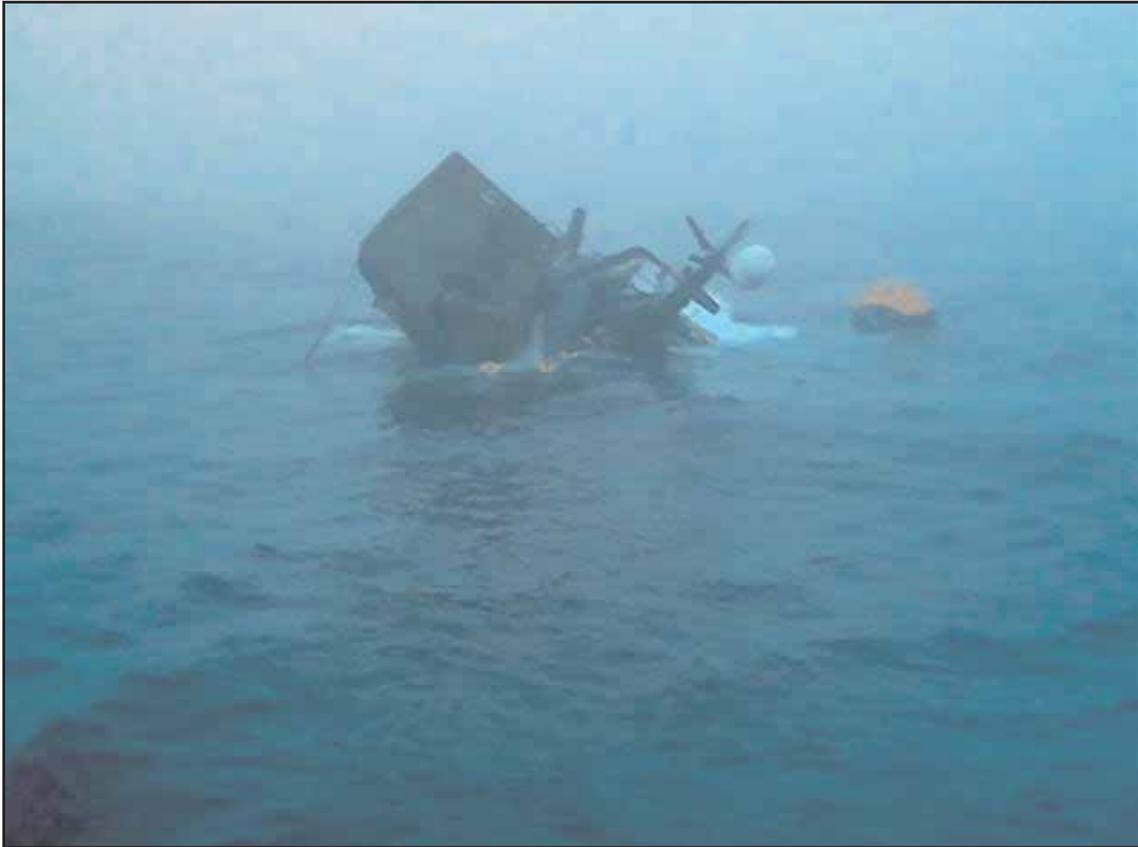
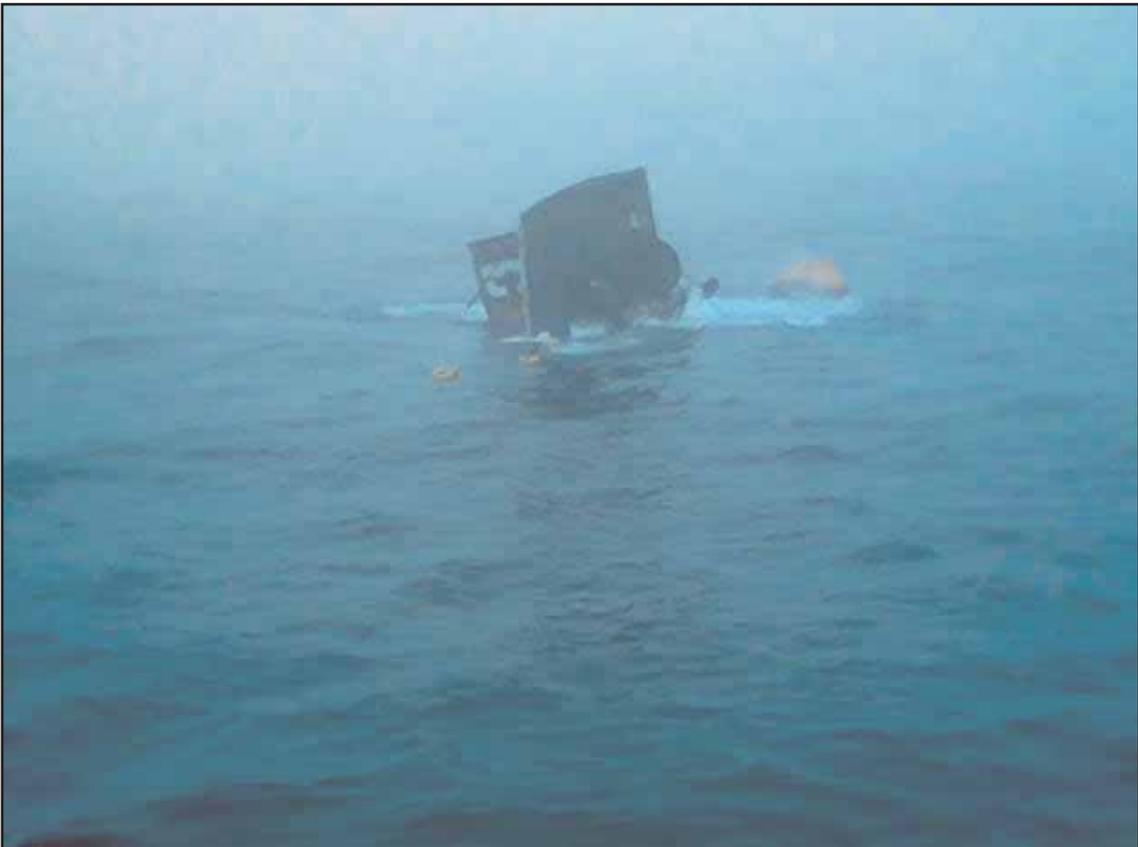
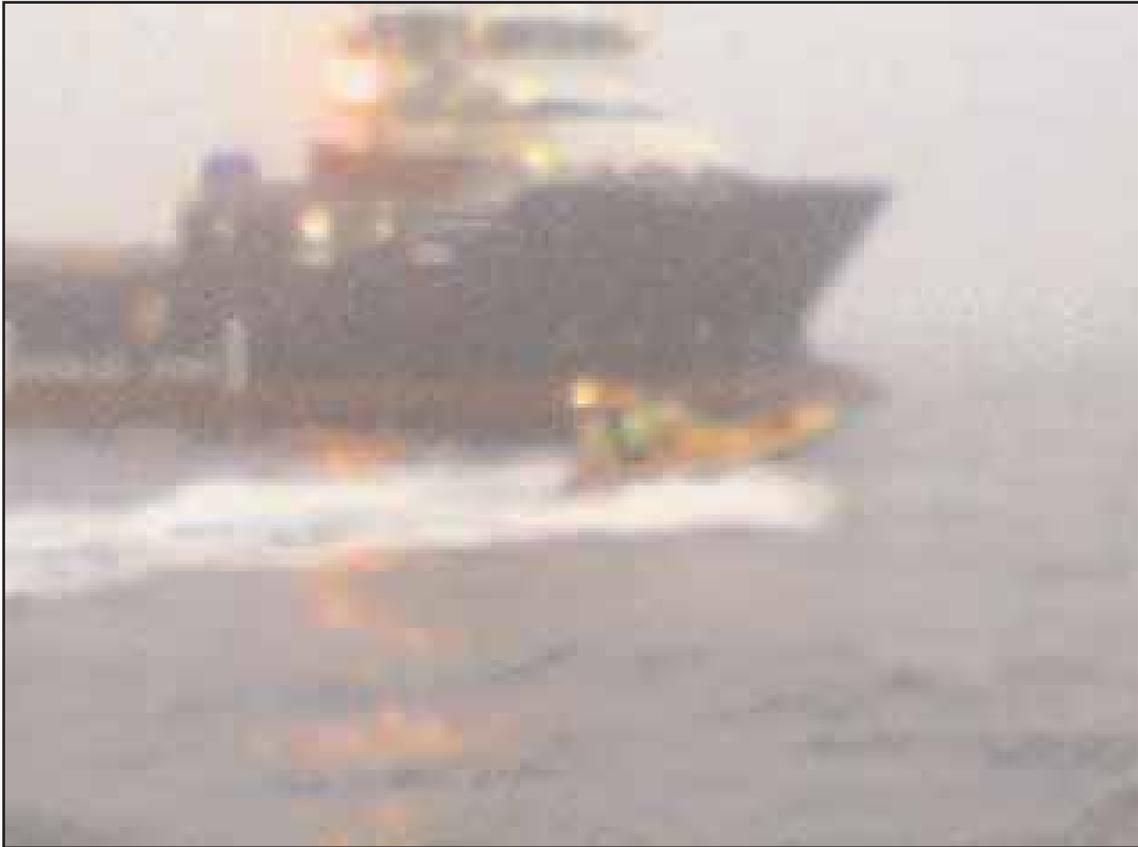
Further information was available from the scene of the collision because a number of the trawlers' crews took photographs and video images using their mobile telephones (**see Figures 7a, 7b, 7c, 7d, 7e and 7f**).

Pictures taken with mobile phone cameras
