Report on the investigation into the grounding of

MV Lerrix

off the Darss peninsular, Baltic Sea

Report No 14/2006
April 2006

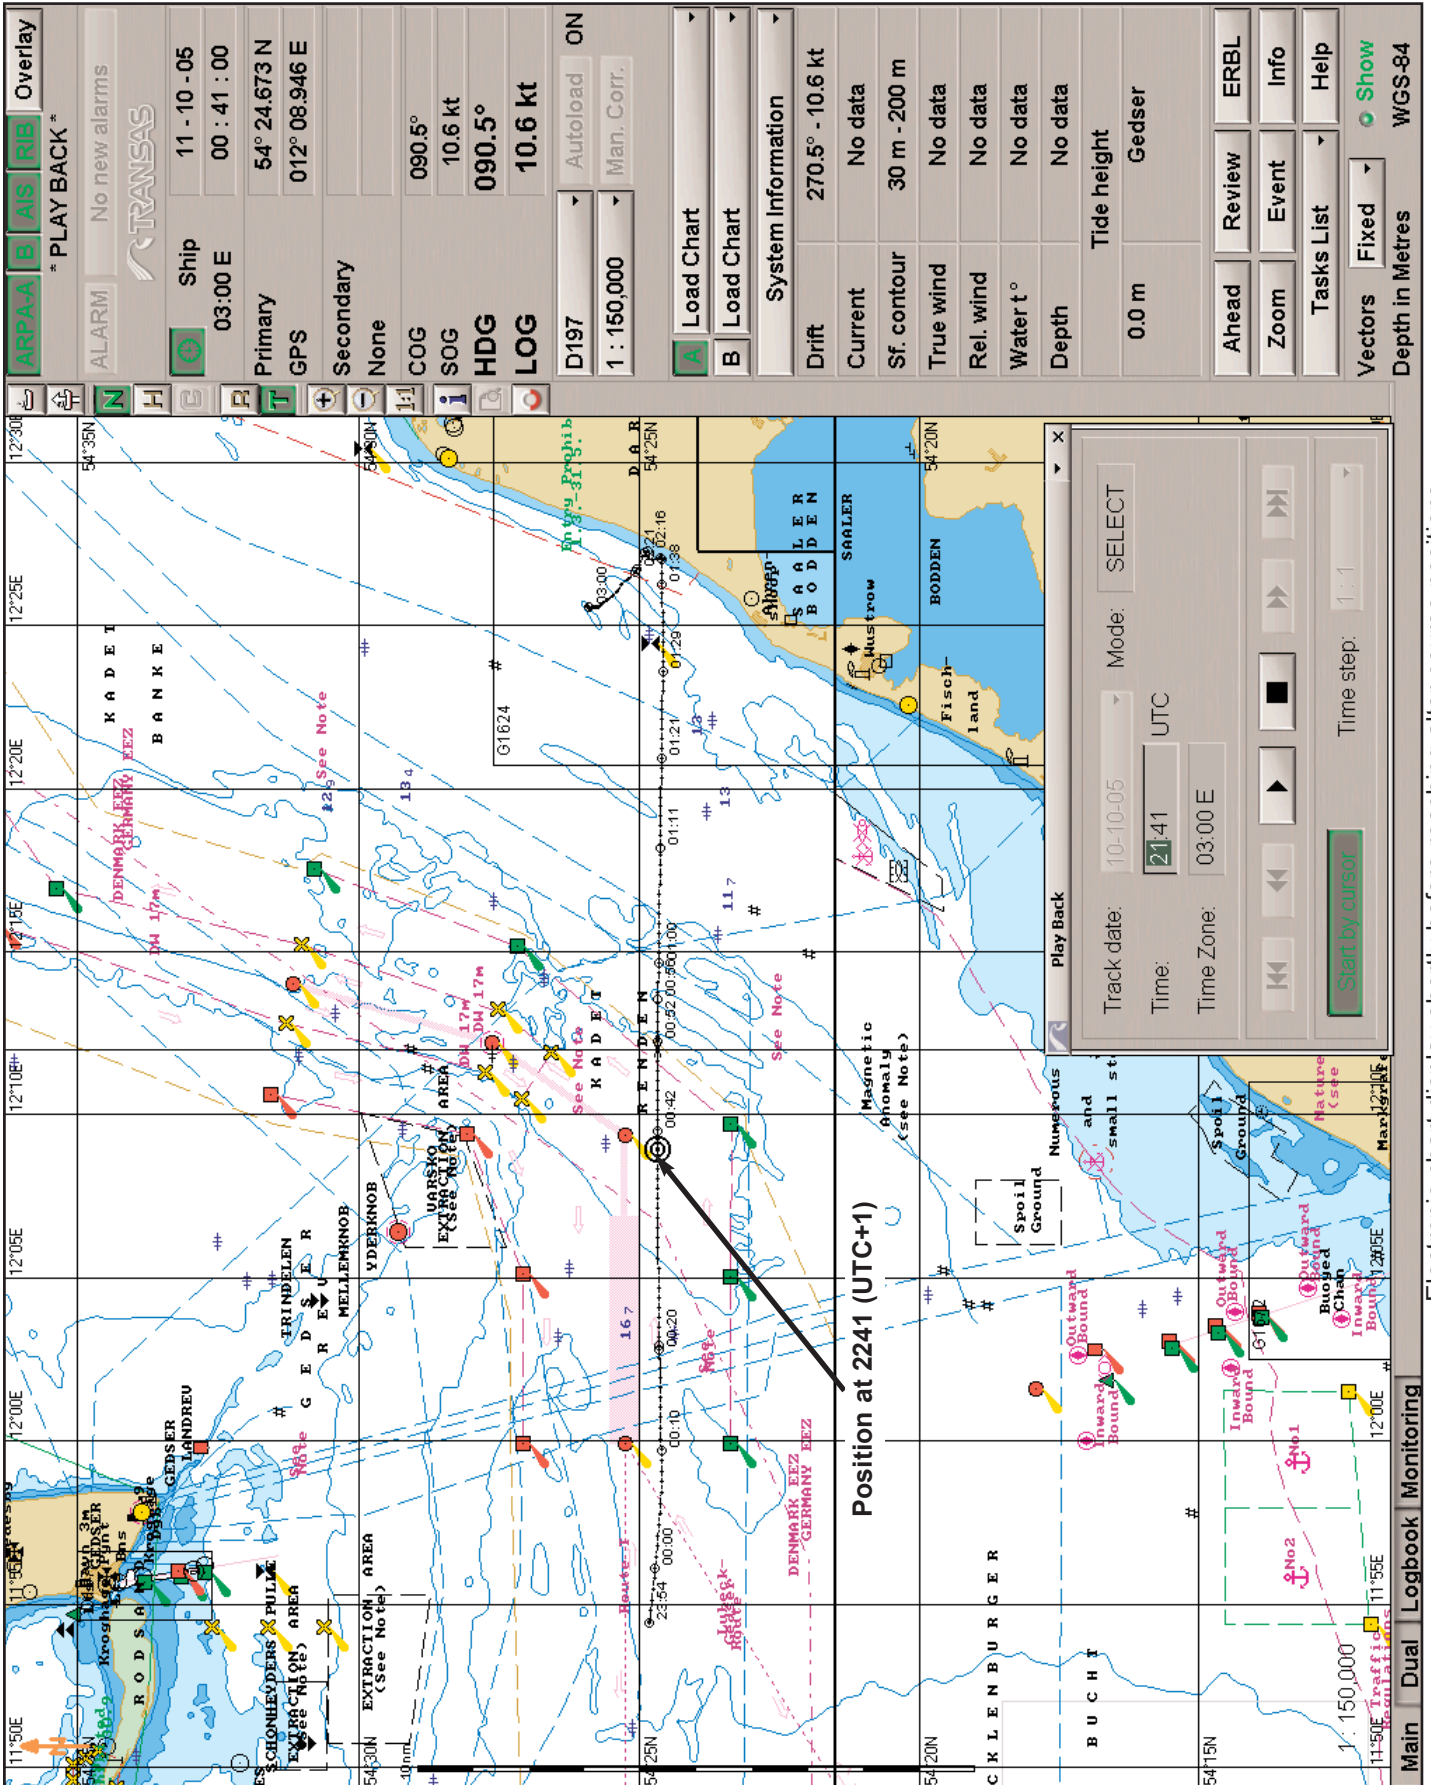
Figure 2

Electronic chart display shortly before reaching alter course positions

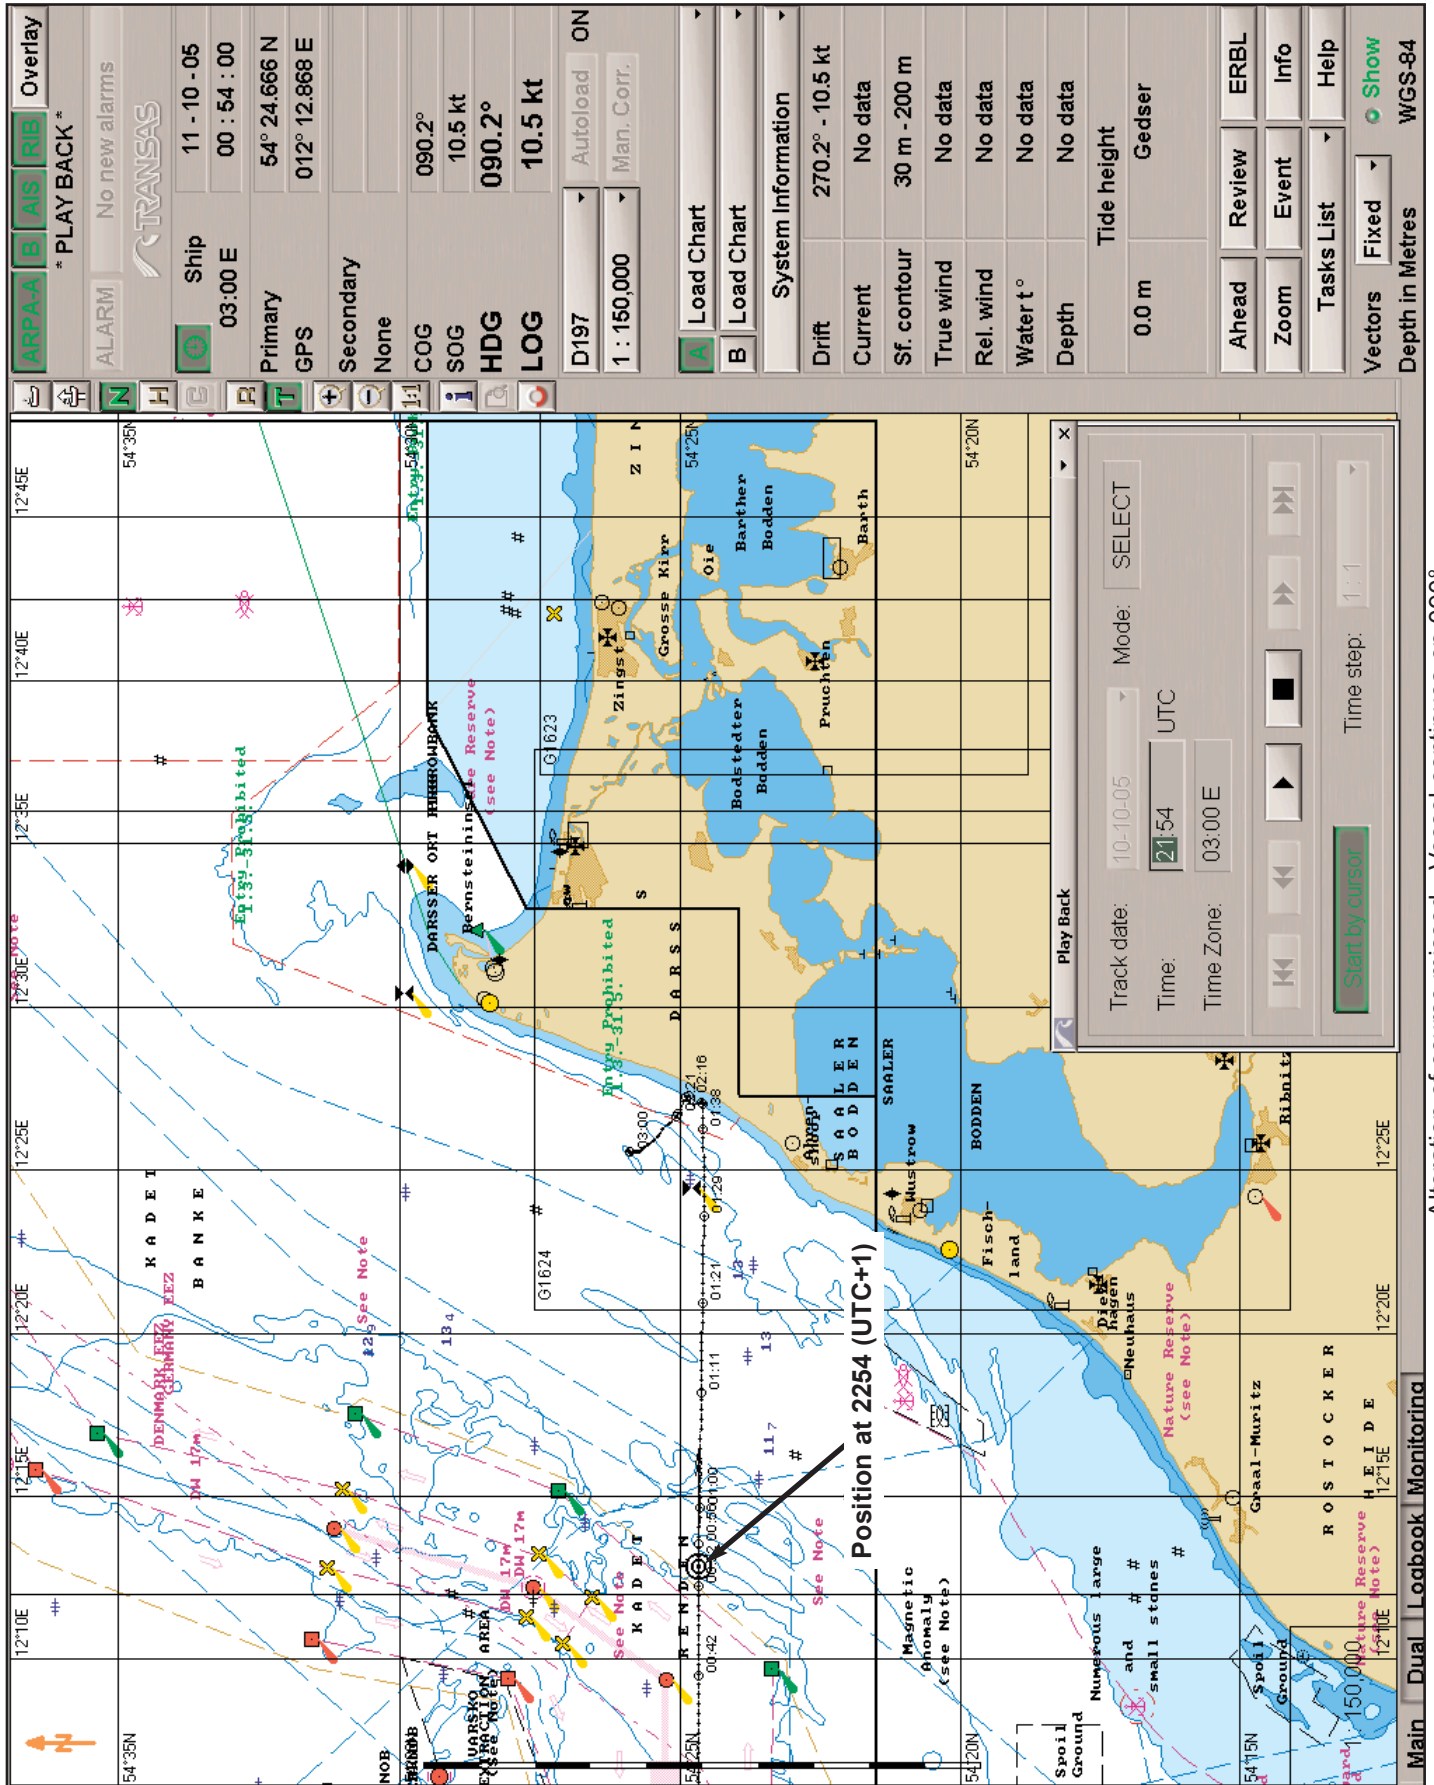
Figure 3

Alteration of course missed. Vessel continues on 090°

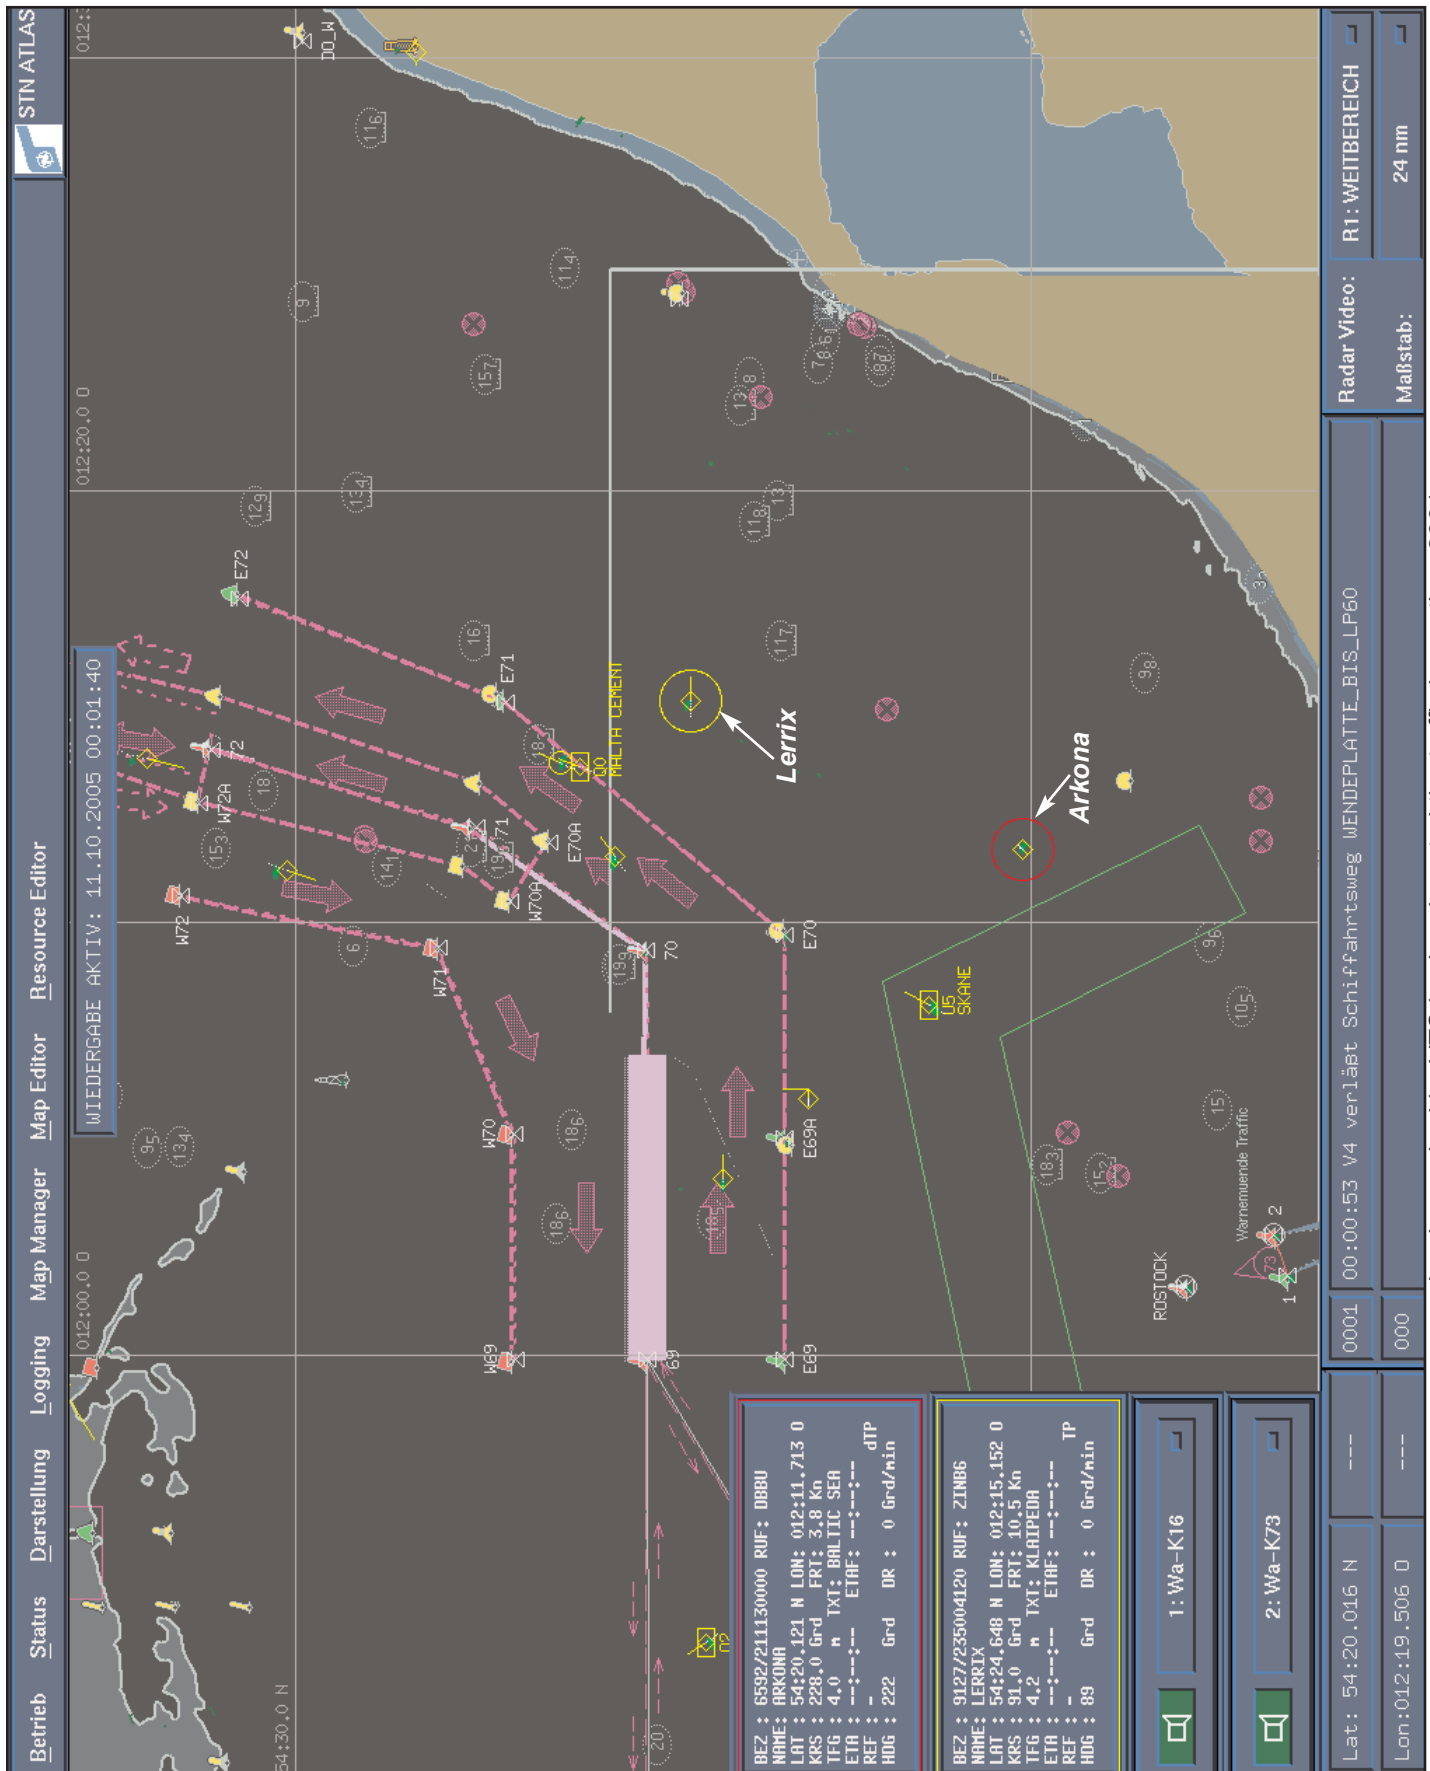
Figure 4a

Lerrix acquired by VTS having departed the traffic lane - time 2301

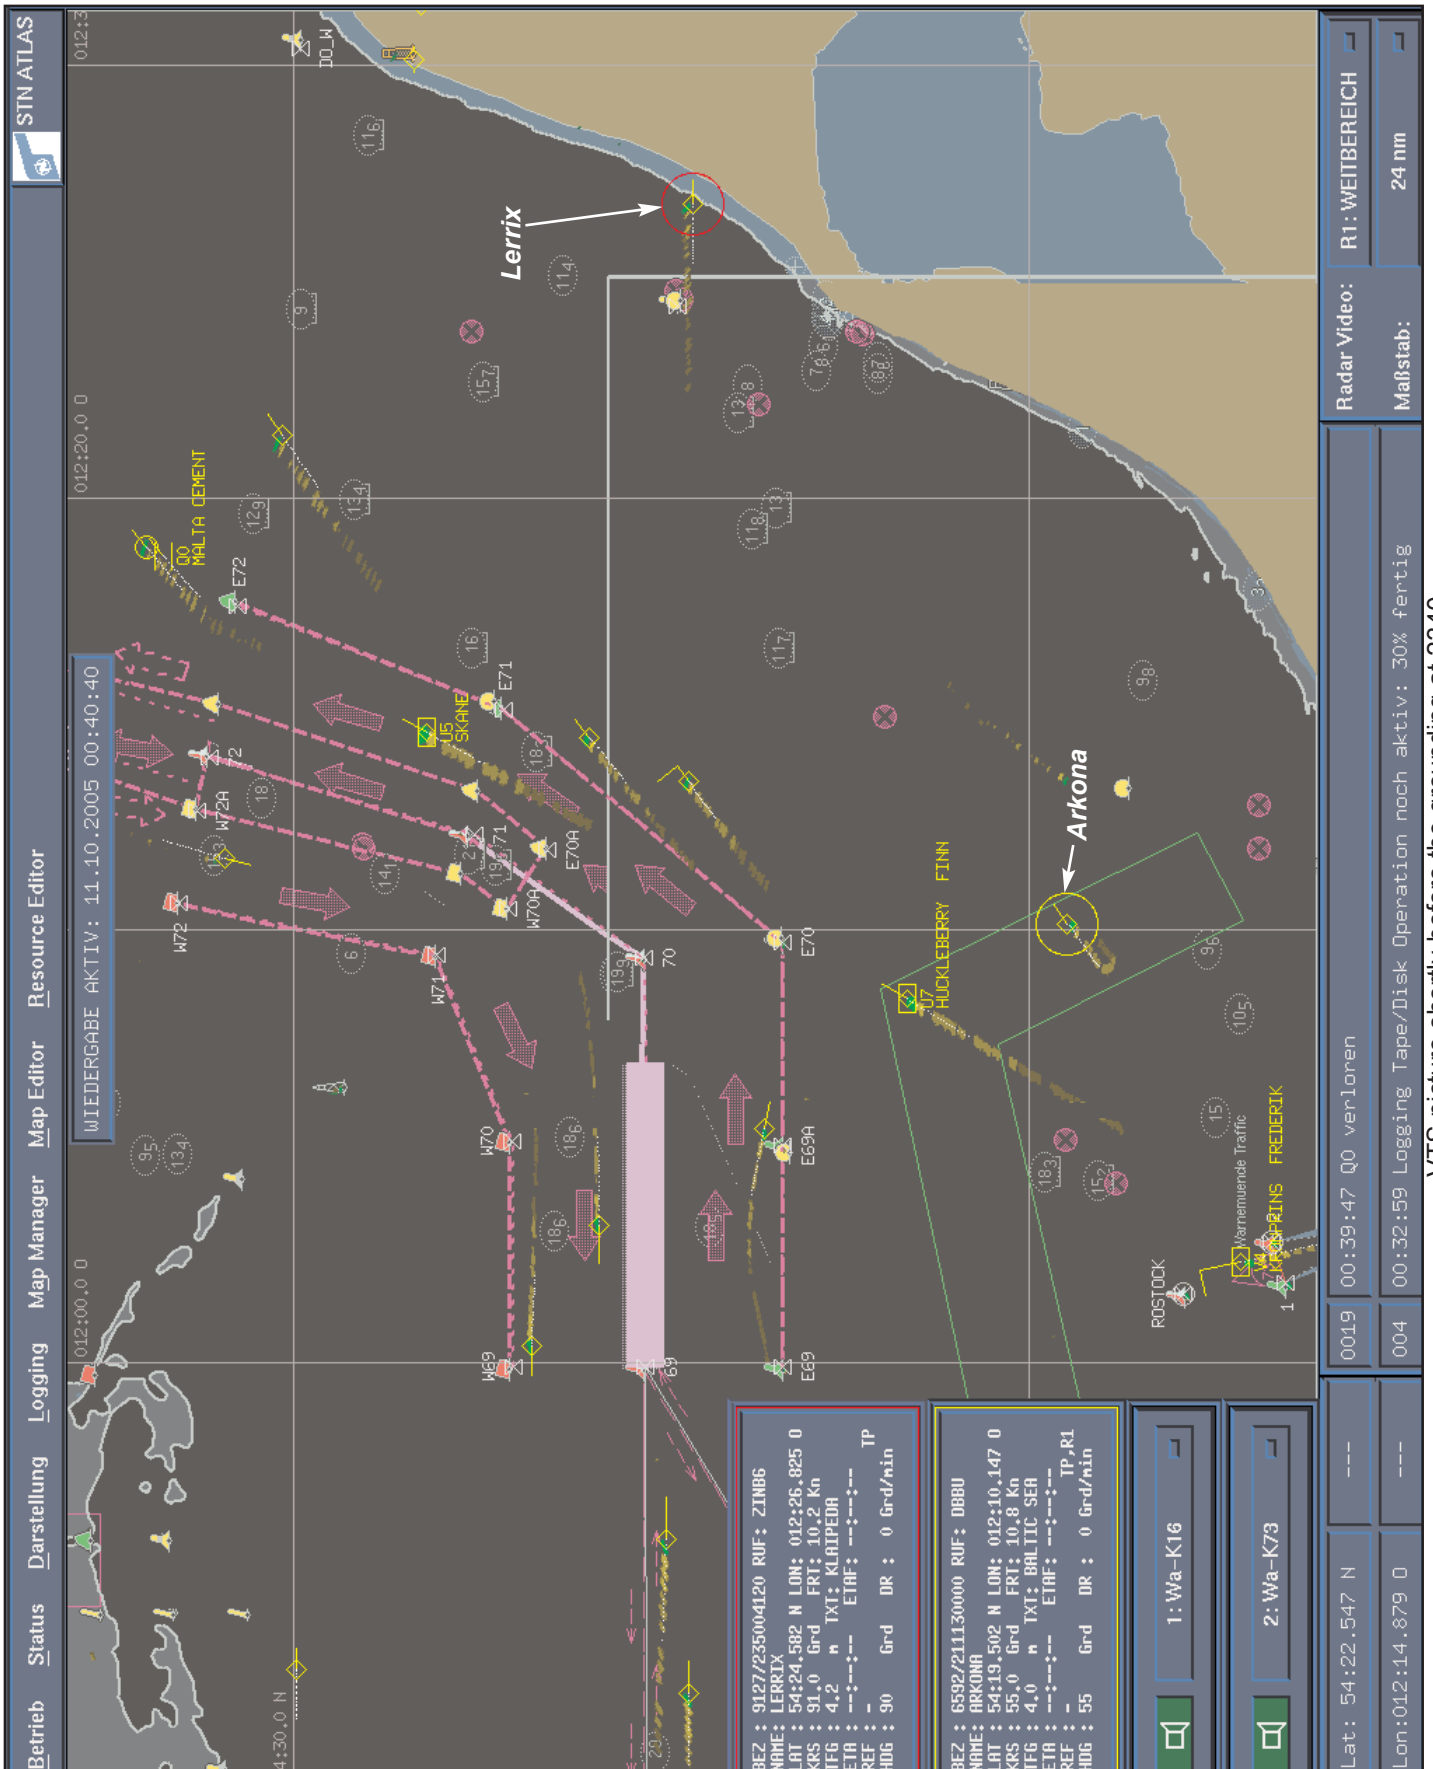
Figure 4b

VTS picture shortly before the grounding at 2340

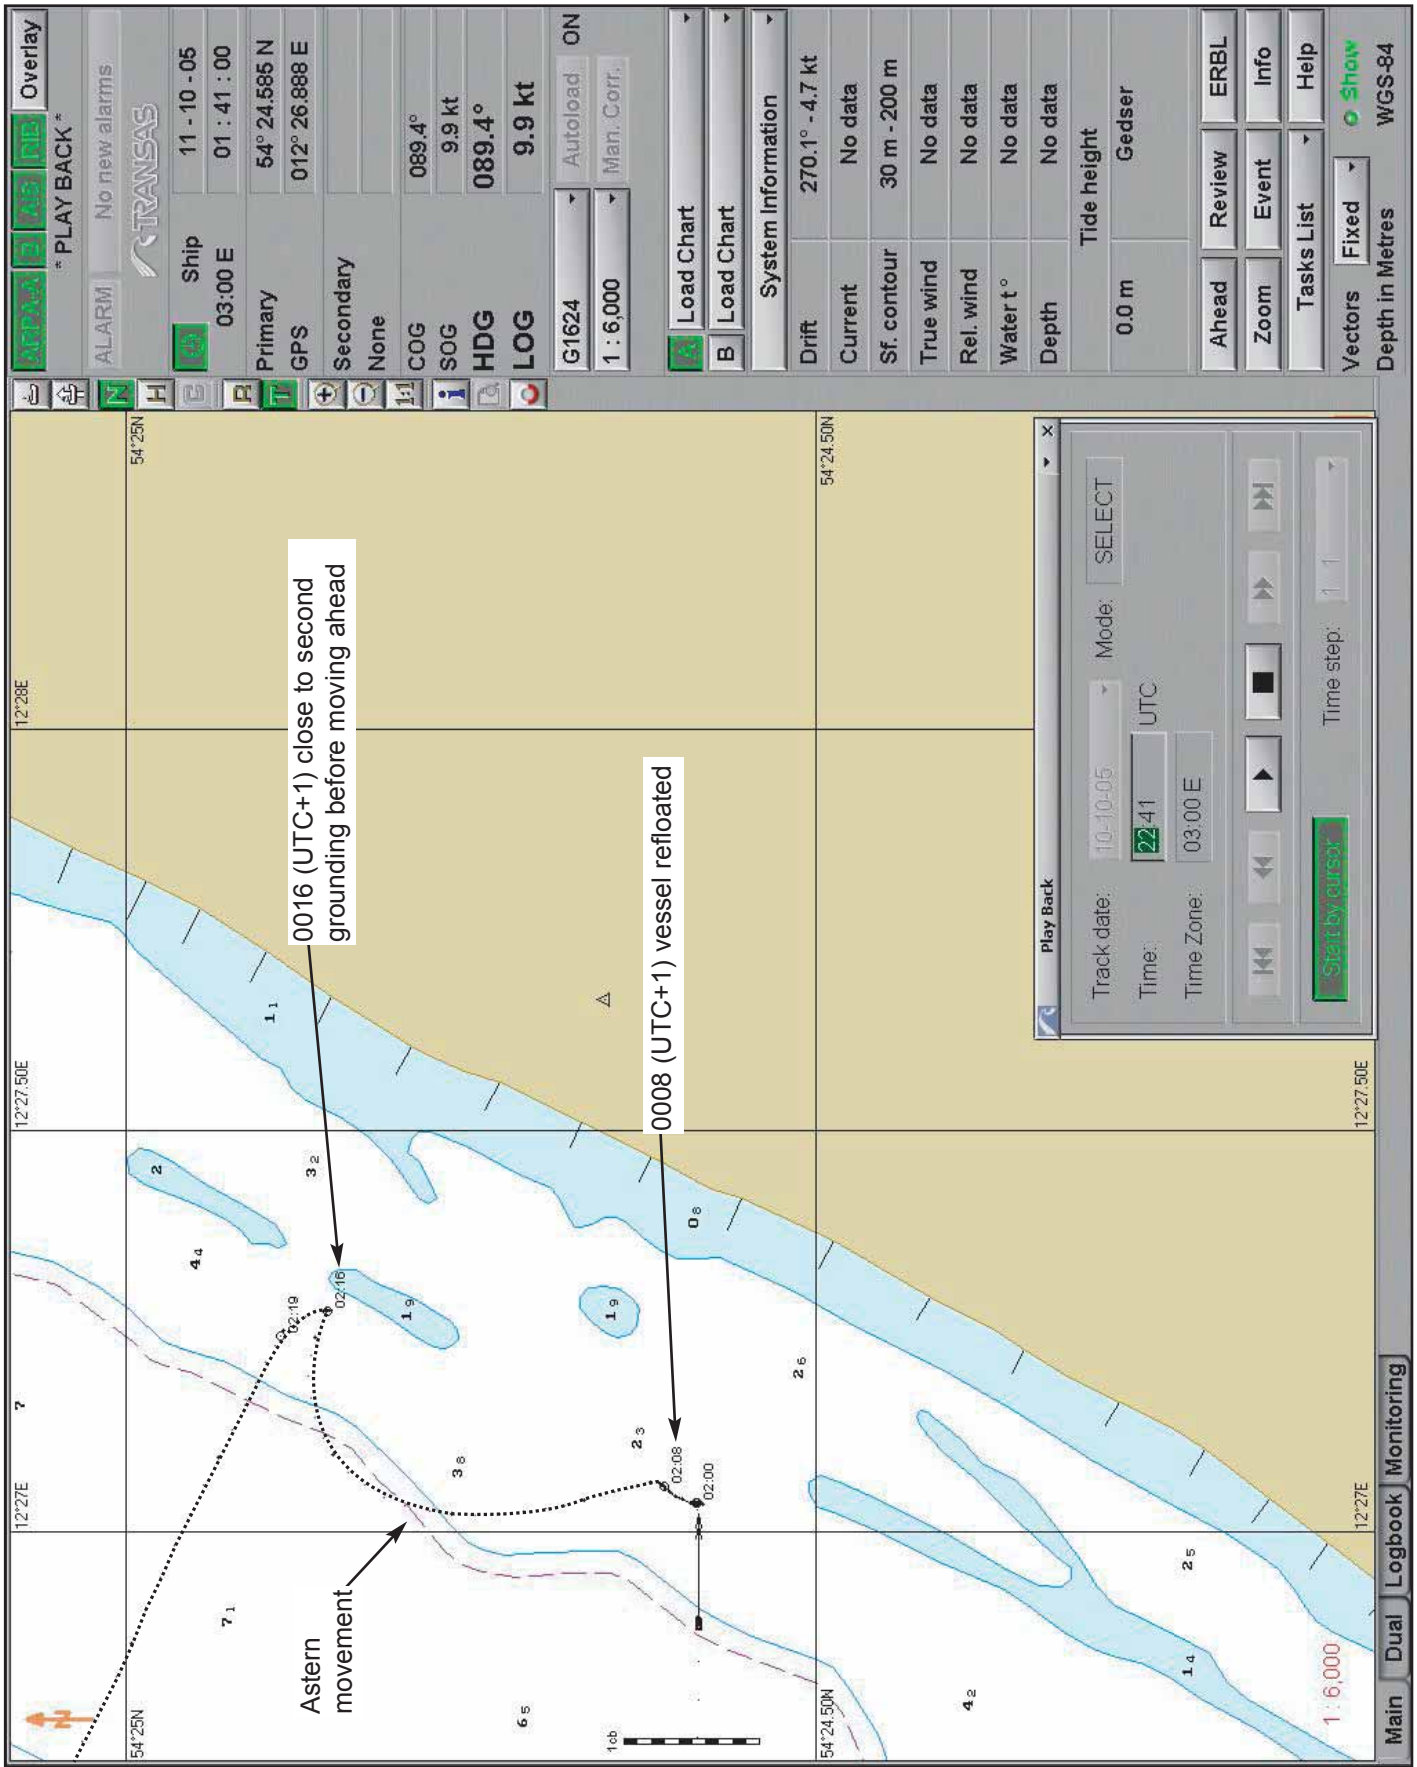
Figure 5

Track followed by Lerrix when refloated

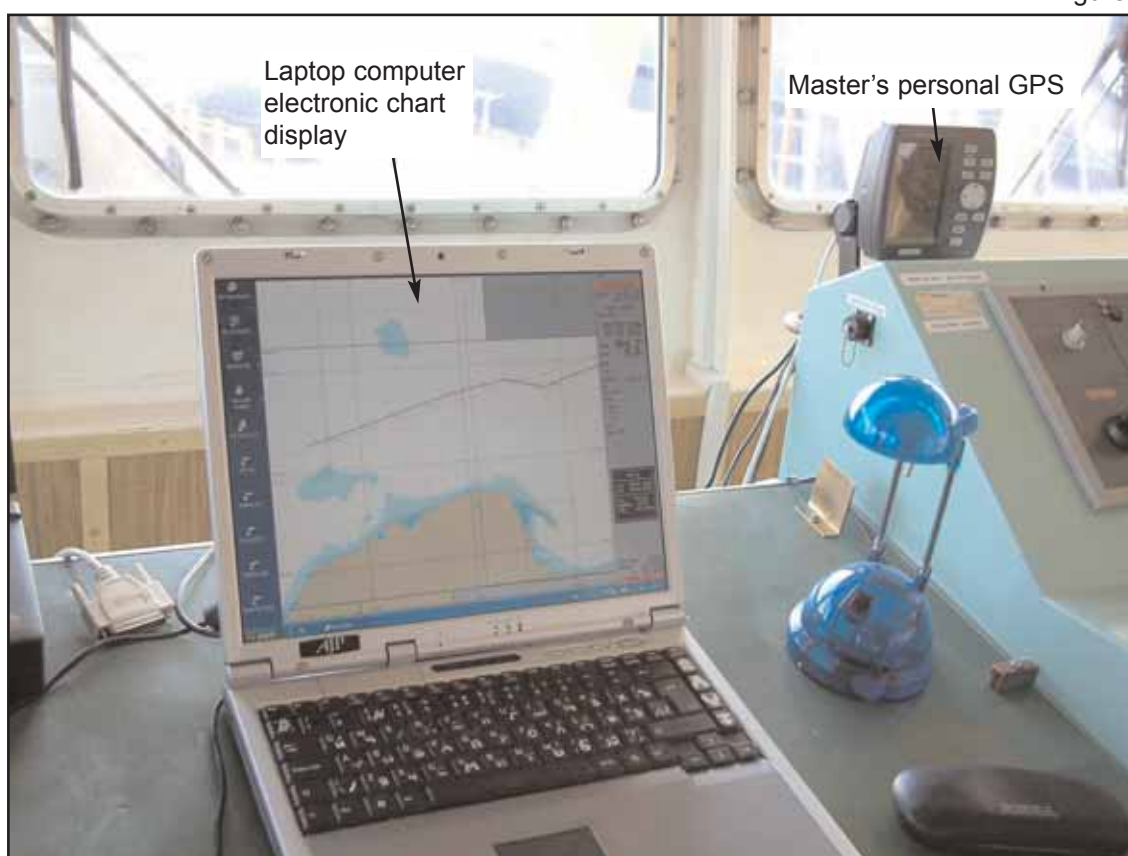
Figure 6

During the investigation, it was noted that the master carried his own laptop computer from ship to ship, complete with a hand-held GPS. Loaded onto the laptop was a pirated programme of Transas electronic charting, which he had downloaded from the internet in 1999. The hand-held GPS, which the master had secured to the bridge console, provided the positional information for the laptop's electronic chart (**Figure 6**). Examination of the programme showed that it had not been updated since 1999, and the charts on the system were based upon 1999 data. The downloaded software did not provide any of the optional operator functions, such as warnings and alarms.

Master's personal electronic navigation equipment

In this case, the master was positioned in a comfortable seat, with the computer screen placed where it best suited him. The programme had never been updated, and did not possess alarms, alerts or guards, and did not incorporate radar or AIS data. In the absence of other barriers, the lack of alarms, alerts or other interaction allowed the master to sink to a low state of alertness. By allowing himself to monitor a virtually passive display, with no other distractions, the master's comfortable, warm, dark environment provided the ideal conditions for sleep. In his fatigued state, the master succumbed, falling asleep shortly after the lookout had left the bridge.

An additional hazard of personal navigation systems is that often they are not updated with the latest navigational information. The system onboard *Lerrix* had not been updated since it was downloaded in 1999. In the vicinity of this grounding, only minor chart corrections had occurred in the intervening period. However, the risks of navigating using information over 6 years old are obvious, and it is for this reason that companies produce comprehensive instructions on the updating of navigation data.

- Establish a policy to guard against the inappropriate use of personal navigational aids carried by crew members.

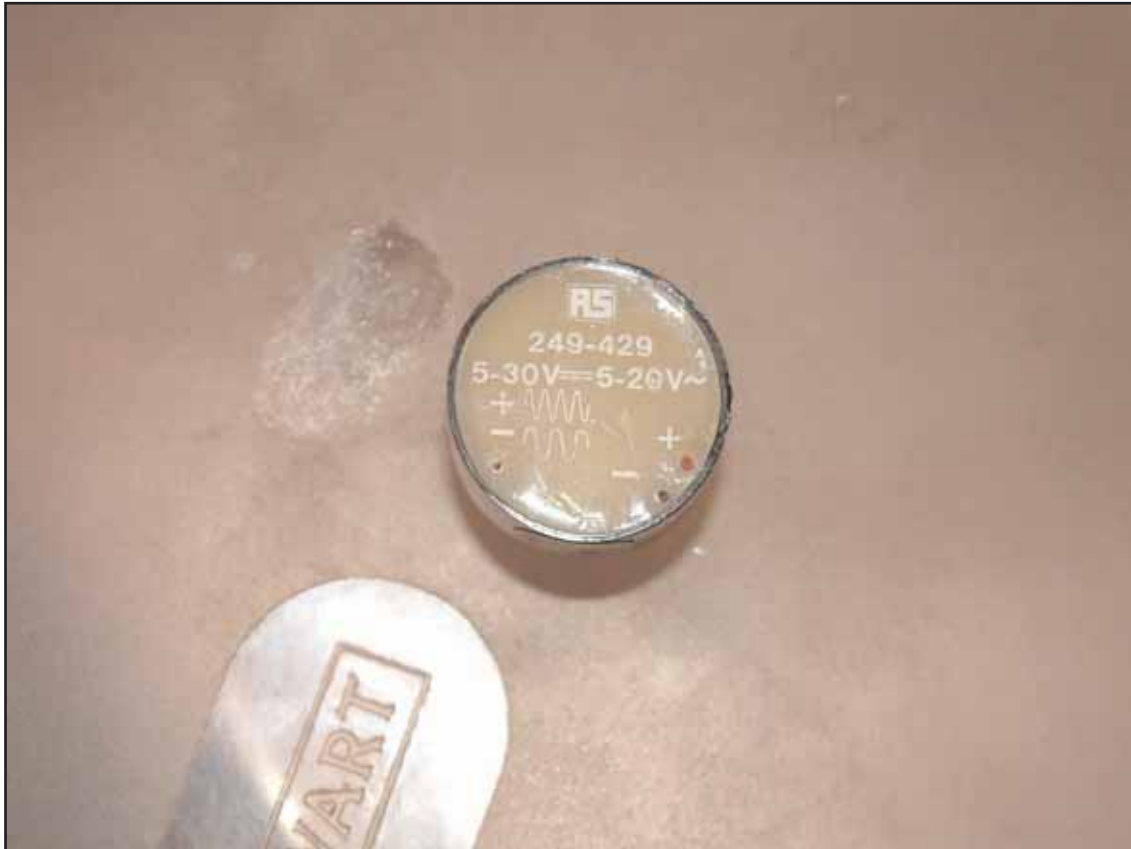
Figure 7

Examination of the alarm showed that both wires connected to the bridge alarm buzzer were disconnected (**Figures 7 & 8**). Because the crew was unaware the equipment was fitted, the defect had not been reported in accordance with the company's ISM procedures.

Watch alarm. Buzzer found disconnected.

Although there was no legal requirement for a watch alarm to be fitted, had the master been aware of its existence, and reported the defect using the appropriate procedure within the ISM system, the alarm could have been repaired and available for use.

Three days after the *Lerrix* incident, Rix Shipping Limited issued an ISM fleet instruction to all vessels instructing that watch alarms, if fitted, must be used. Masters were instructed to report any faults with watch alarms through its defect reporting procedures as soon as possible.

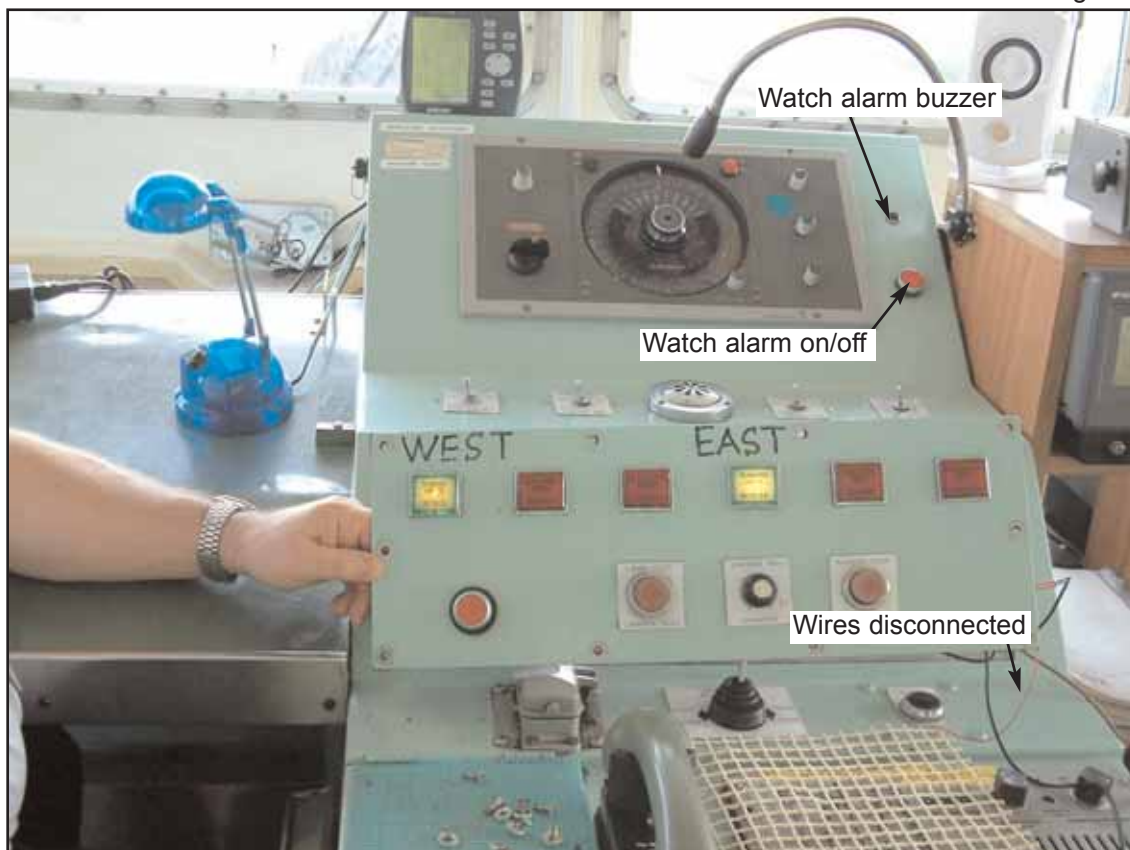
Figure 8

Steering console complete with watch alarm
