Report on the investigation into the grounding of

MV Lerrix

off the Darss peninsular, Baltic Sea

Report No 14/2006
April 2006

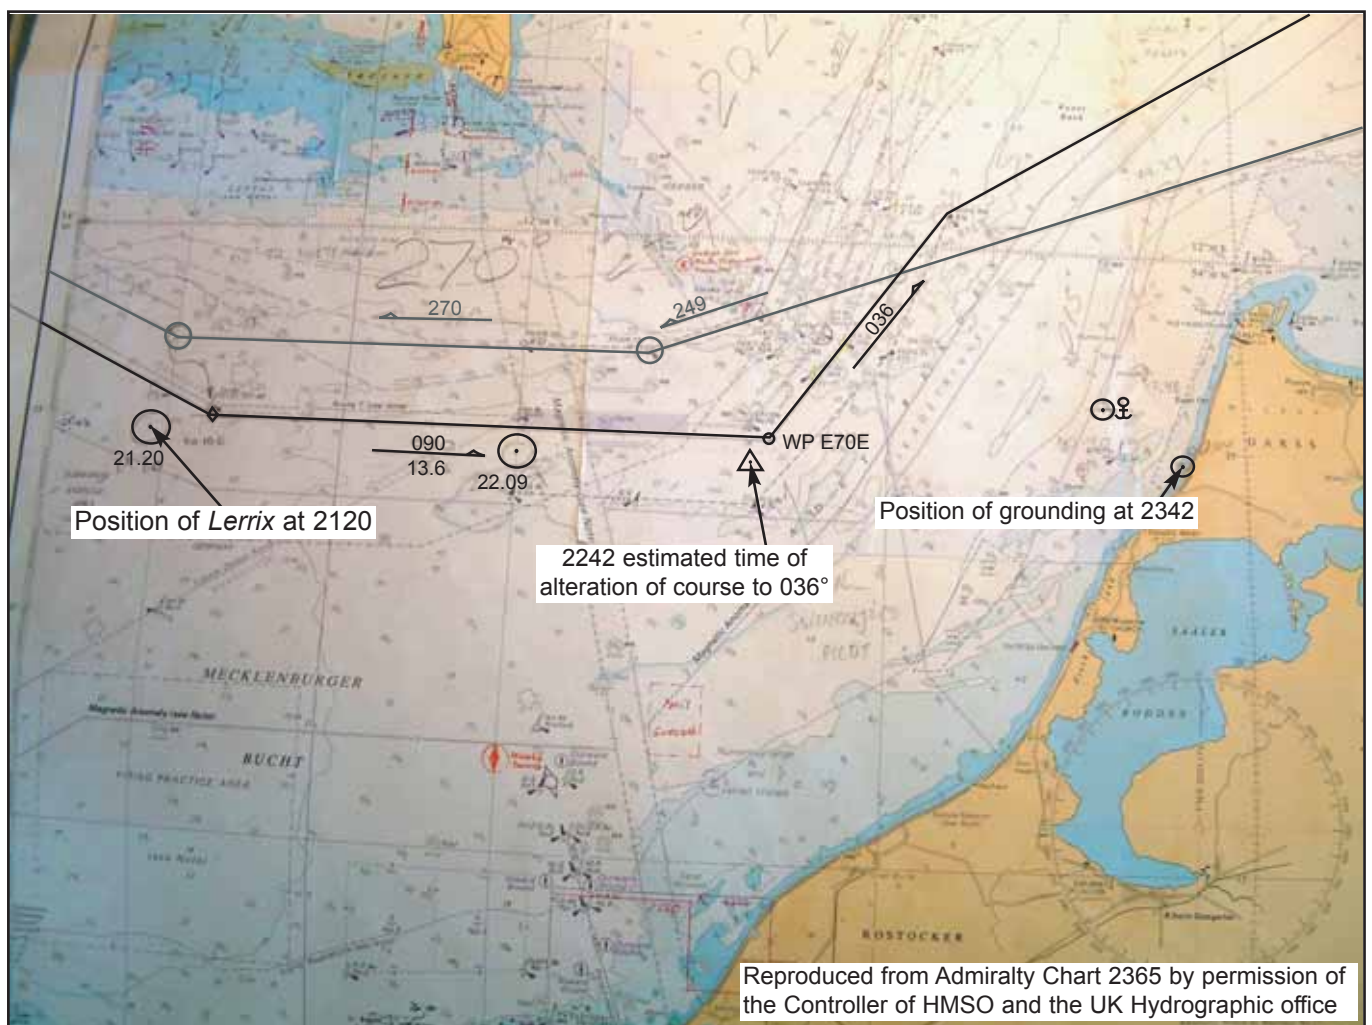
Figure 1

Chart BA2365 in use at the time of grounding

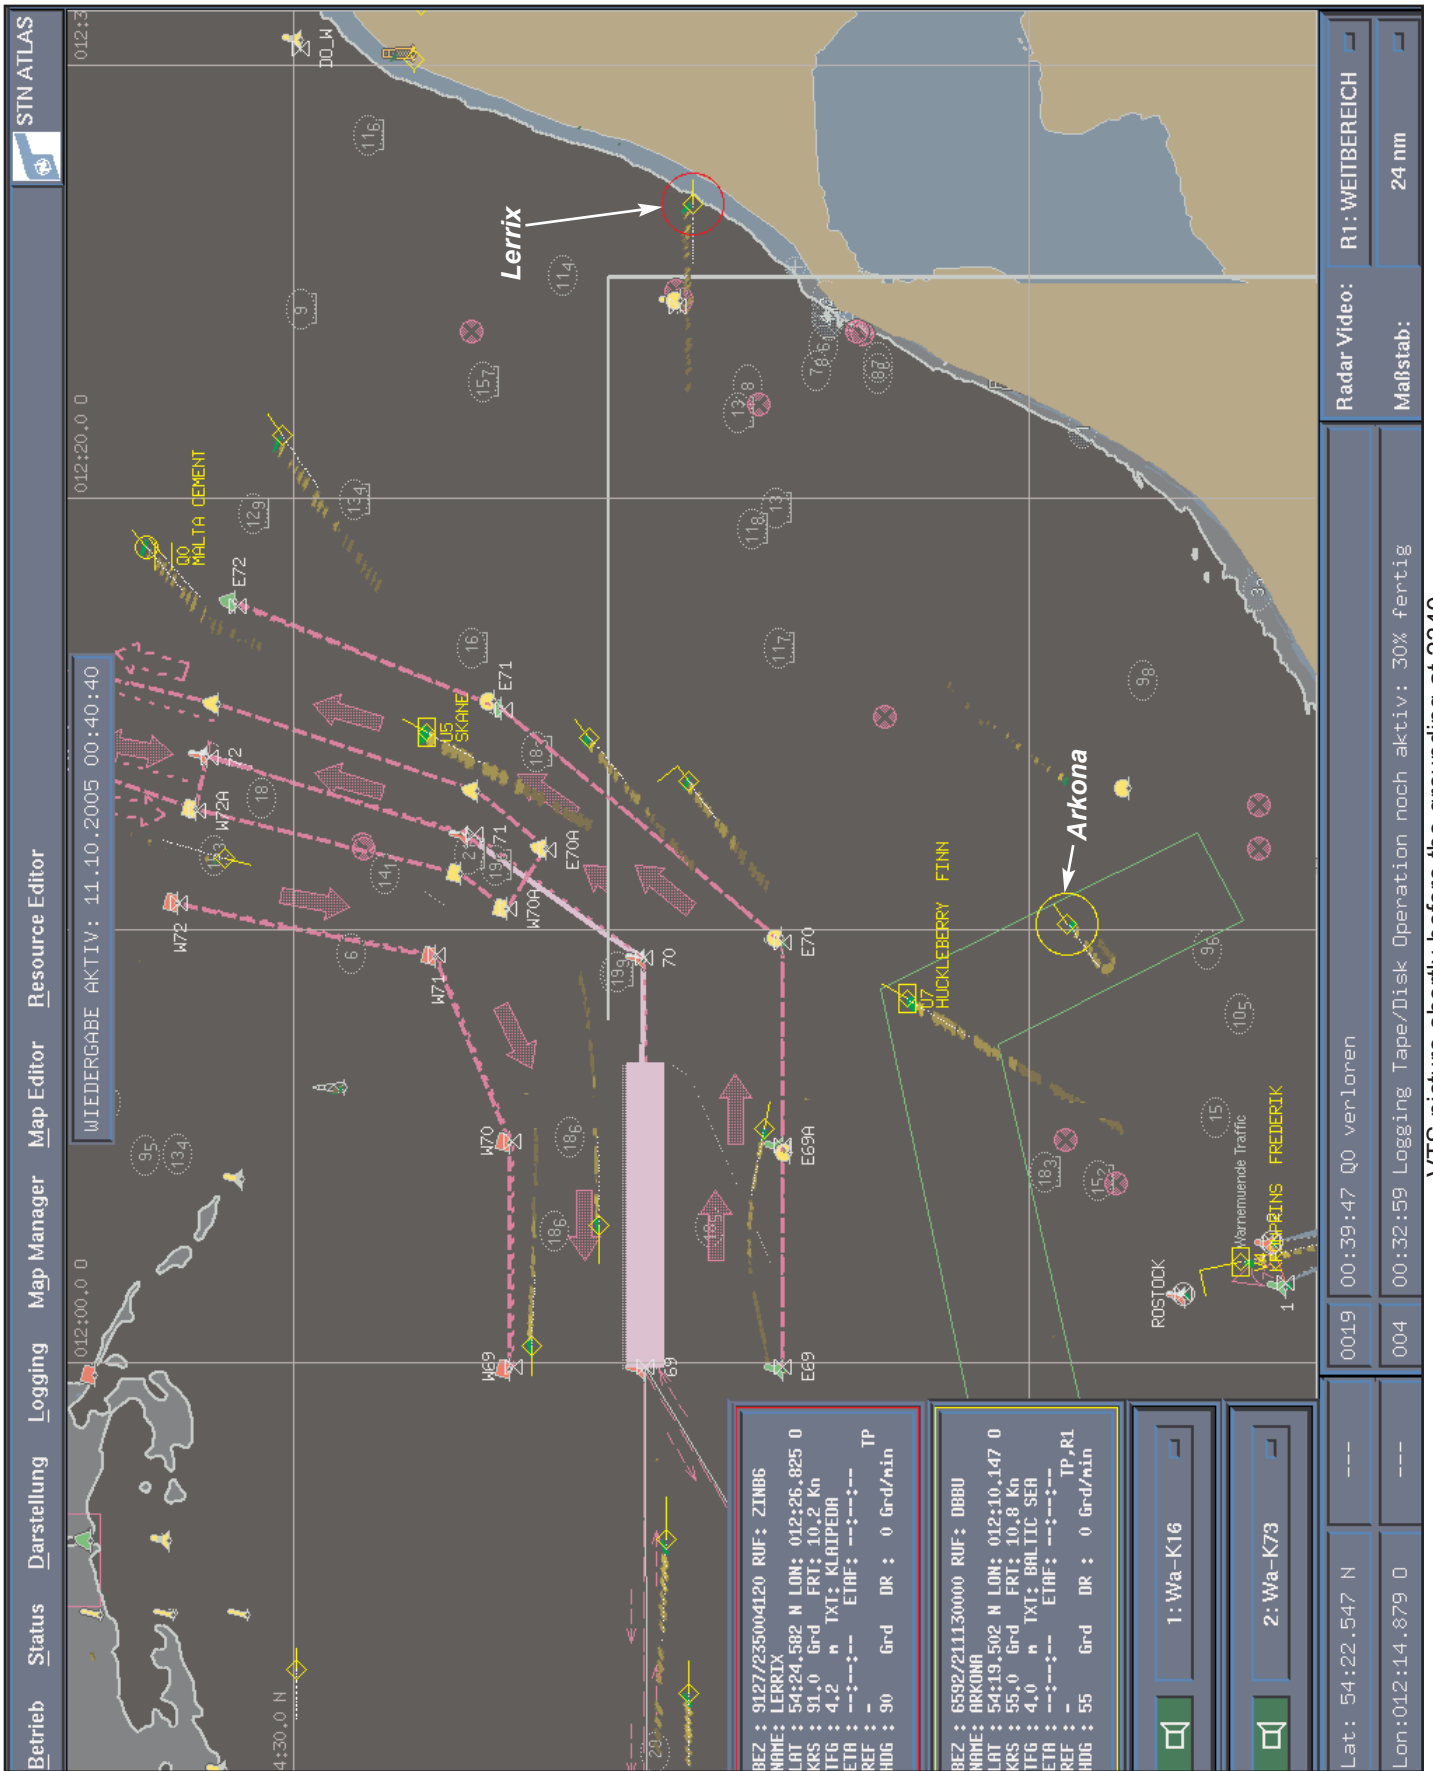
Figure 4b

VTS picture shortly before the grounding at 2340

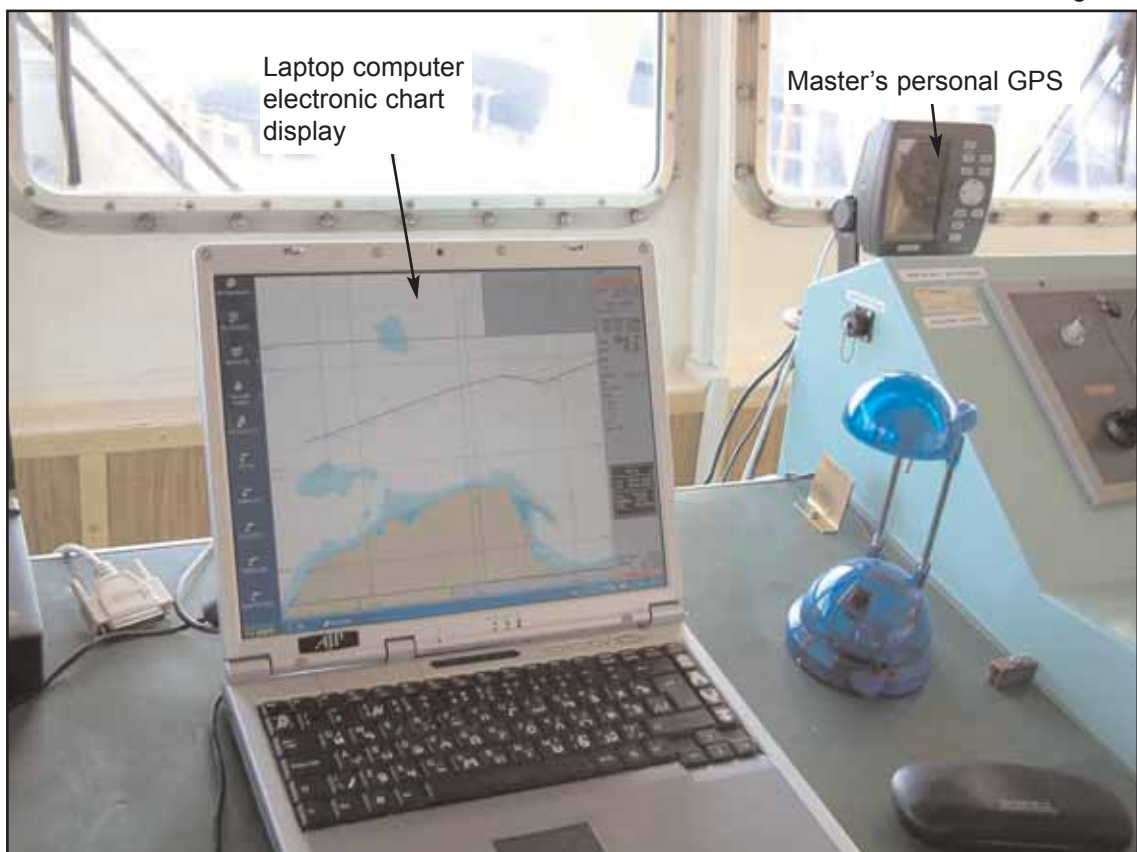
Figure 6

During the investigation, it was noted that the master carried his own laptop computer from ship to ship, complete with a hand-held GPS. Loaded onto the laptop was a pirated programme of Transas electronic charting, which he had downloaded from the internet in 1999. The hand-held GPS, which the master had secured to the bridge console, provided the positional information for the laptop's electronic chart (**Figure 6**). Examination of the programme showed that it had not been updated since 1999, and the charts on the system were based upon 1999 data. The downloaded software did not provide any of the optional operator functions, such as warnings and alarms.

Master's personal electronic navigation equipment

An additional hazard of personal navigation systems is that often they are not updated with the latest navigational information. The system onboard *Lerrix* had not been updated since it was downloaded in 1999. In the vicinity of this grounding, only minor chart corrections had occurred in the intervening period. However, the risks of navigating using information over 6 years old are obvious, and it is for this reason that companies produce comprehensive instructions on the updating of navigation data.
