Report on the investigation of the  
foundering of the fishing vessel

***Blue Sinata***

in Weymouth Bay  
on 8 September 2005  
with the loss of one life

**Report No 7/2006**  
**March 2006**

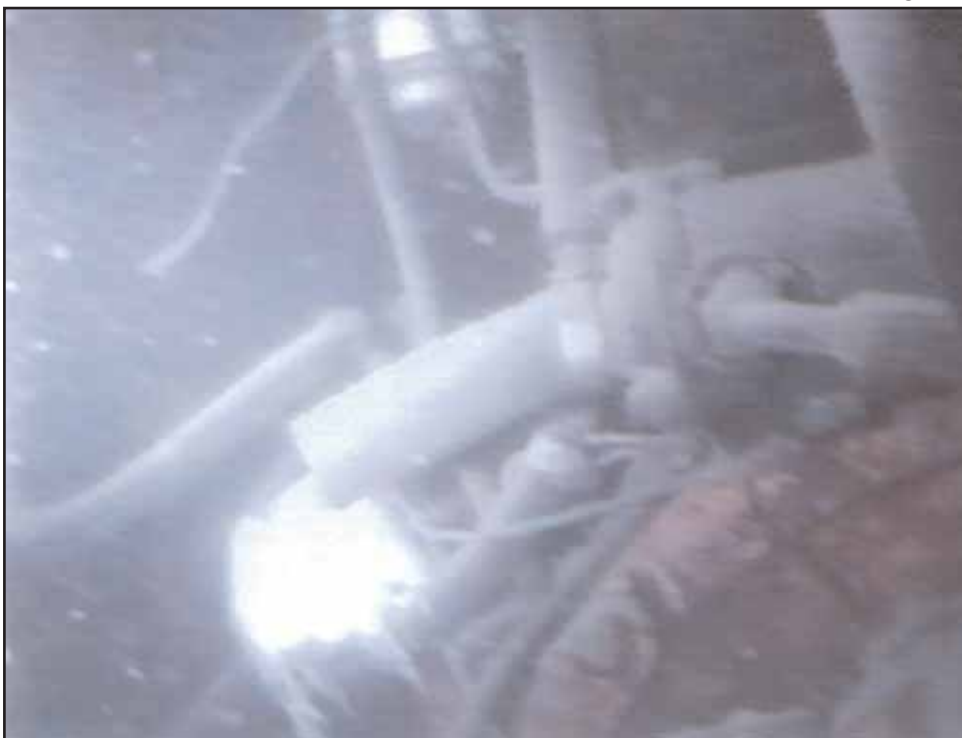
Figure 8

Cut hose in engine sea water system at gearbox oil cooler

With the vessel floating at a freeboard aft of 230mm, assessed as being the Weymouth departure condition, no water leaked into the hull through the cut water pipe in the engine's seawater system at the outlet of the gearbox oil cooler.

However, as weights were added to represent the weight of water in the circular tanks on deck, the freeboard reduced sufficiently for water to leak into the hull through this pipe. The rate of ingress increased as weights were added. This check was made with the sea inlet valve closed as far as possible.

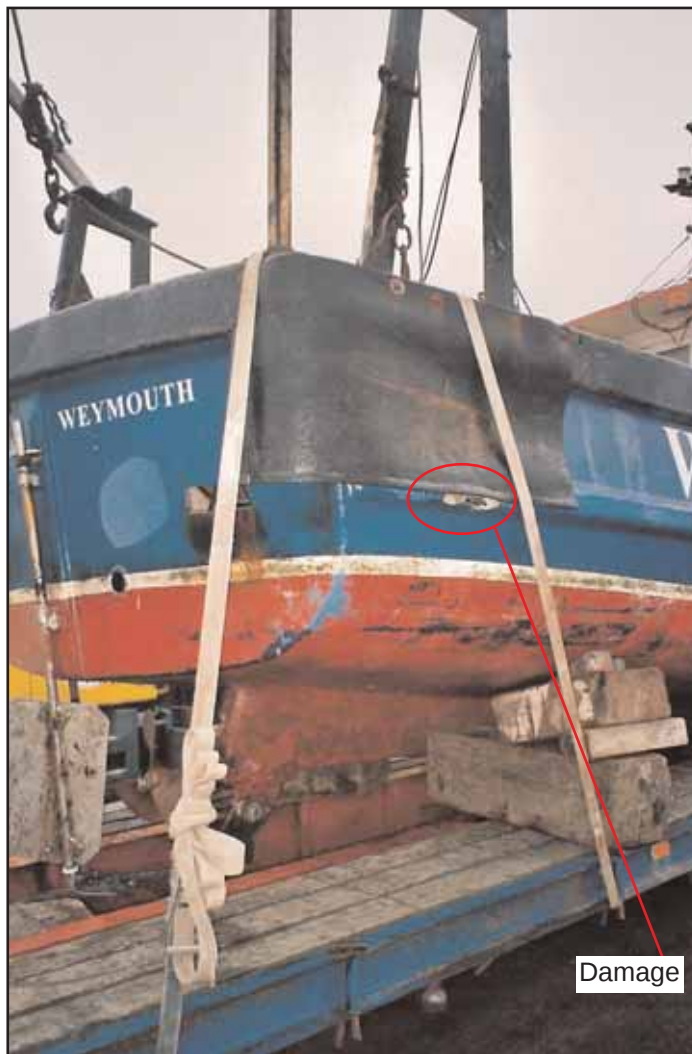
Figure 10

On the starboard quarter of the hull, level with the deck edge and largely covered by a protective rubber sheet, was an area of damage (**Figure 10**). The damage was centred on a moulded GRP rubbing strip running along the hull at deck level and had dimensions of 180mm long x 90mm high (**Figures 11 & 12**). After lifting the rubber sheet, a hose test was performed on this damage (**Figure 13**).

In view of the limited freeboard measured during the tests, the damage to the starboard quarter at deck level is significant. This damage, coupled with the poor freeboard which brought the damage close to sea level, produced a potential flooding mechanism, as demonstrated by the hose tests. However, the event that caused this damage, and its timing, are uncertain.

Whenever this damage was caused, the protective rubber mats on the vessel's two aft quarters effectively shielded the damage from a casual observer. It was necessary to lift the mat aside to see the damage clearly. An observer on the deck of the vessel, and thus looking from above, would be unable to see this damage with the mat in its normal position. An observer on a pontoon or quay adjacent to her berth would be in a similar position. Thus, unless he was deliberately looking for damage in this area of his vessel, the skipper was unlikely to have noticed its presence.

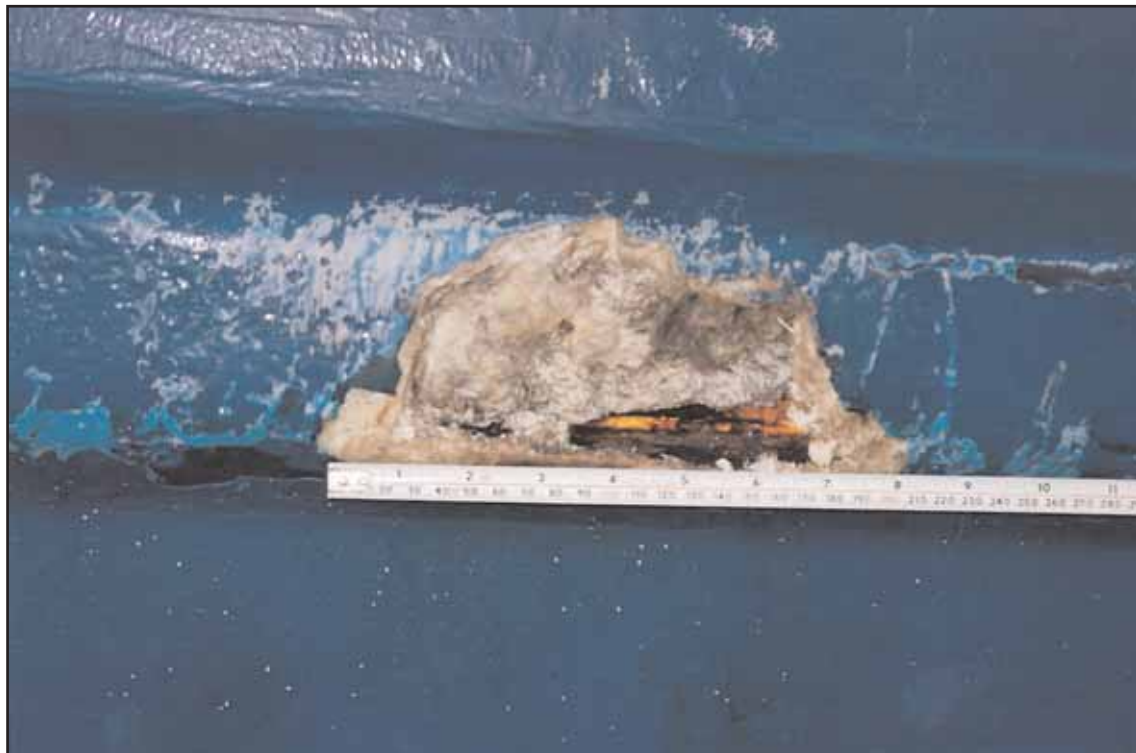
Figure 11

Damaged area

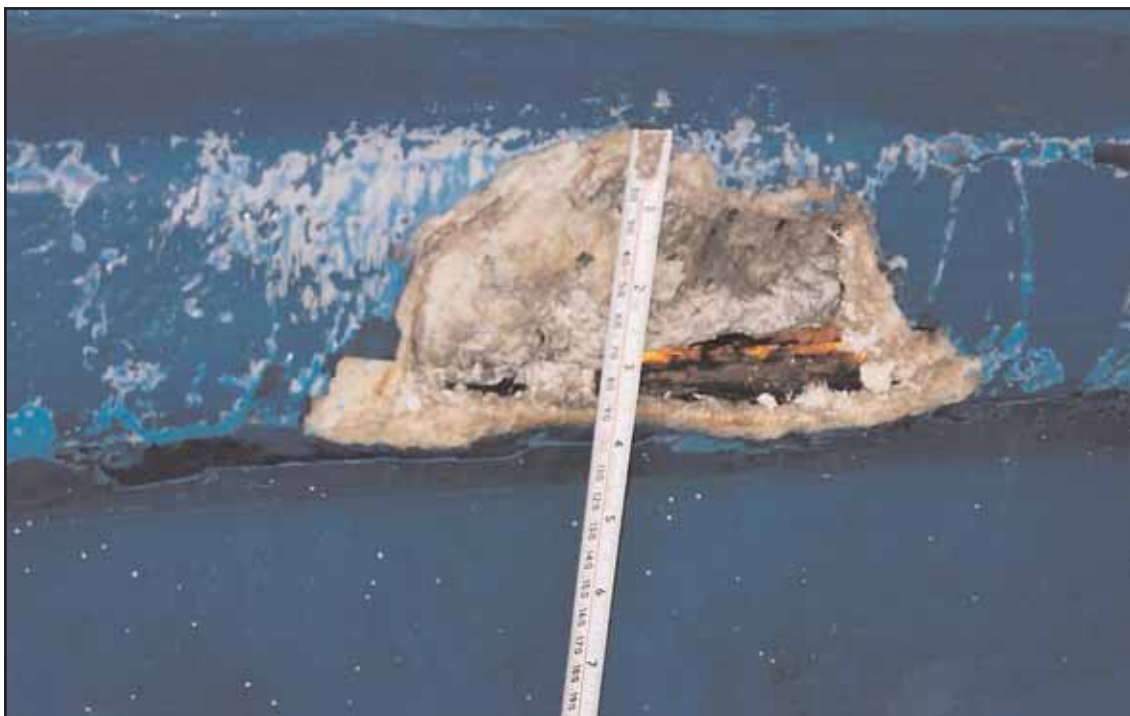
Figure 12

Damaged area

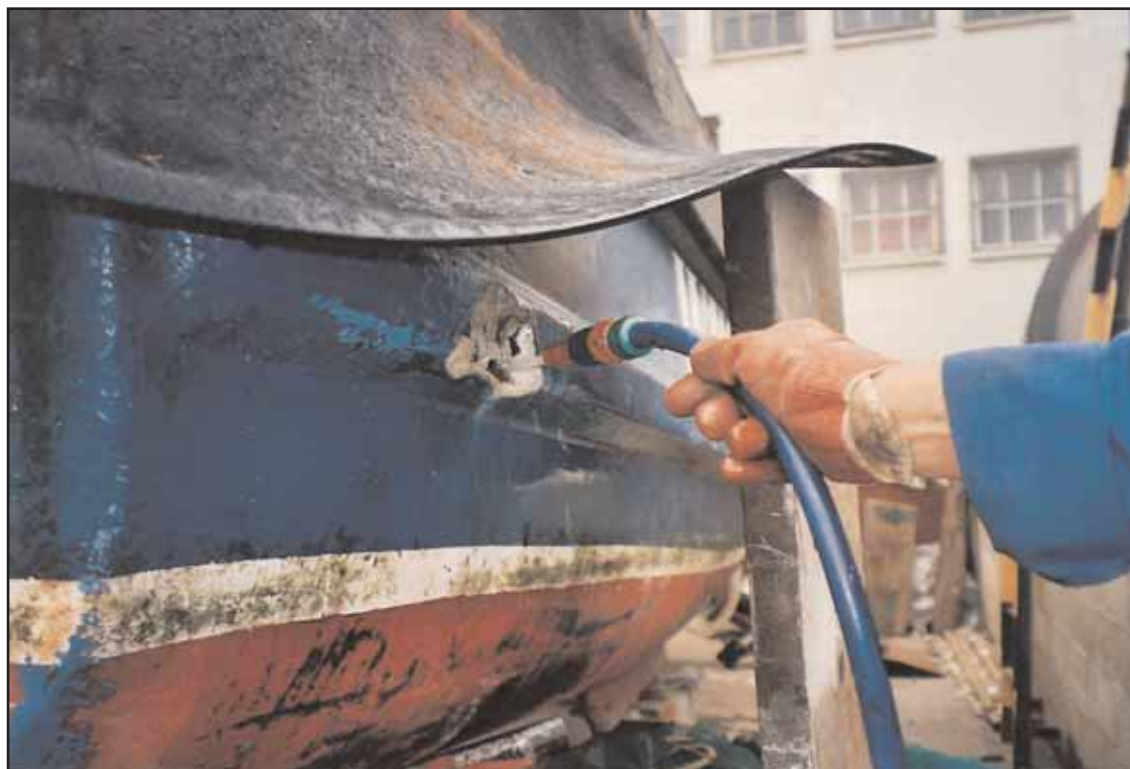
Figure 13

Hose test on damage

With a hose directed forwards and playing on the damage, water entered the engine space. A small quantity of water also migrated forward, within the moulded rubbing strip, to exit outboard at a small penetration.

When the hose was directed aft, or square on to the damage, water entered the void space at the stern.

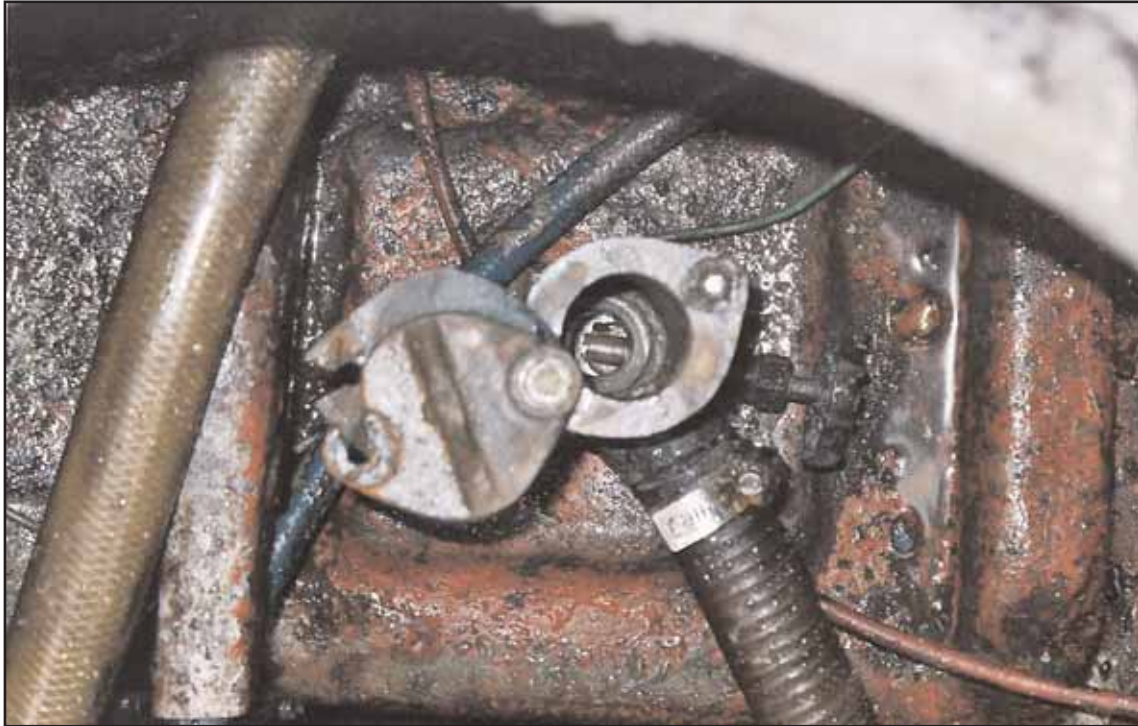
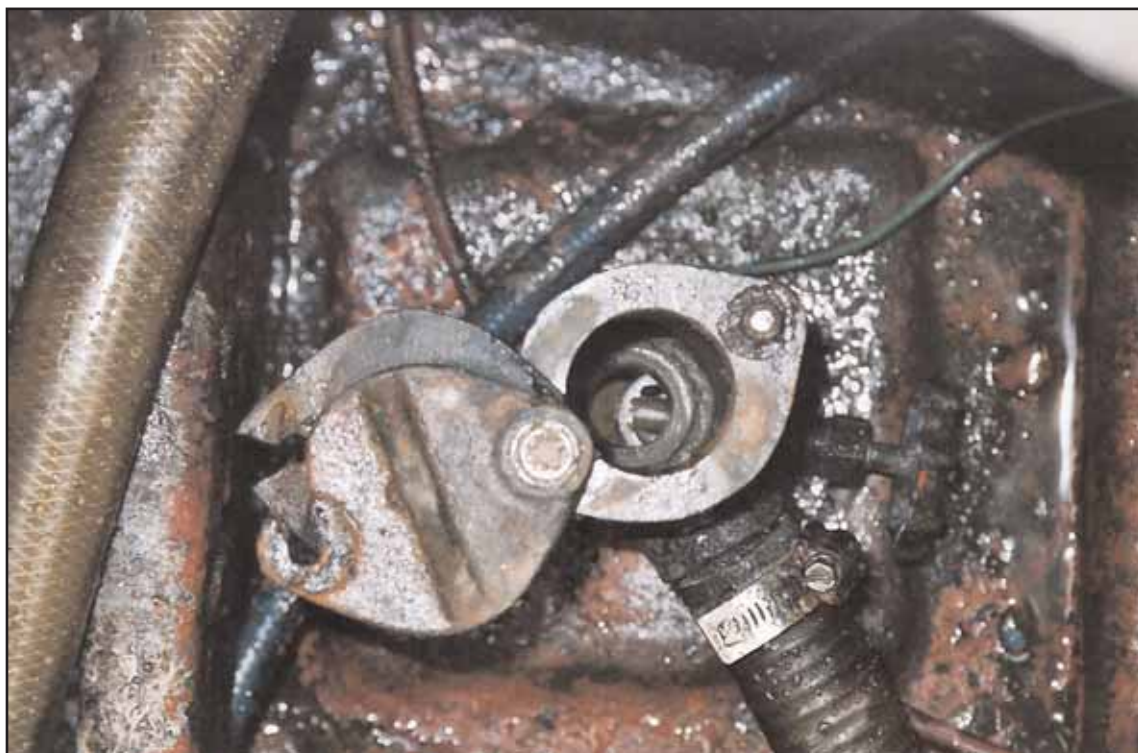
The sea inlet strainer supplying the engine cooling system was opened, the filter removed and valve on the skin fitting sighted. The filter was clear of obstruction. The valve was found in the partly open position. Attempts to close the valve, by turning the handwheel, moved the valve disc no further closed than about one quarter open. Similarly, attempting to fully open the valve moved the valve no further than one third open (**Figures 14 & 15**). Any attempt to move the valve beyond these limits resulted in the spindle turning freely, with no corresponding movement of the valve disc.

Sea inlet valve, limit of closing

Sea inlet valve, limit of opening

Once the skipper had cut the engine's seawater inlet hose, water was able to flow into the engine space through the defective sea inlet valve, which could not be properly closed. This added to the rate at which water entered the vessel.

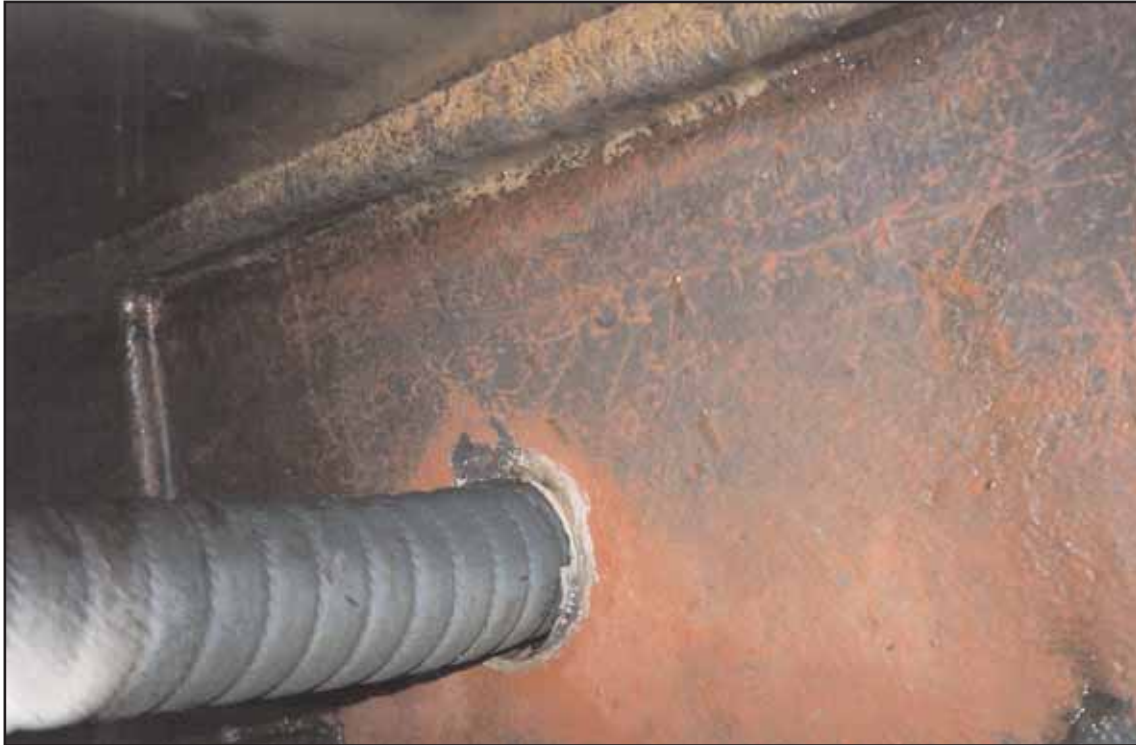
Figure 16

The engine exhaust hose passed through the aft bulkhead without being sealed, so losing the watertight integrity of the bulkhead (**Figure 16**). This hose was inspected visually and tested with water, but showed no sign of damage or leakage.

Penetration of aft bulkhead by exhaust hose

Had the aft bulkhead been made watertight, by properly sealing the penetration of the exhaust hose, most flooding would have been confined to the aft void. Comparatively small quantities of water might still have entered the engine space through the damaged area of the hull, but this could probably have been handled by the electric bilge pump in that space.

*Blue Sinata's* aftermost bulkhead lost its watertight properties when it was penetrated by the engine's exhaust hose. Had this bulkhead been maintained watertight, flooding might not have spread at a rate and degree sufficient to cause the loss of the vessel.

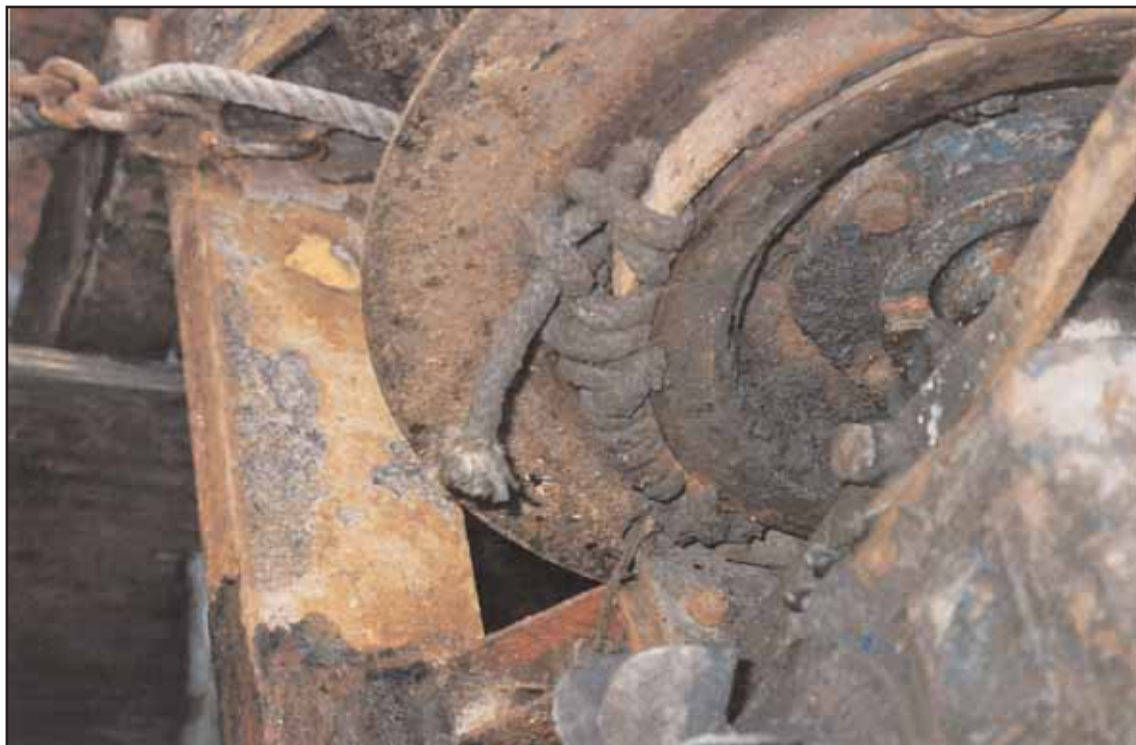
Figure 17

During initial inspection of the wreck a number of observations were made including: the winch brake-linings were missing and had been replaced with rope (**Figure 17**); the guard on the winch cooling fan was missing; there were no screws securing the control valve block to the winch; the hydraulic oil return hose from the winch was unsecured and of an incorrect type; there were no securing arrangements for the LPG bottle; the flare box contained flares with an expiry date of 12/94; there were four lifejackets in the cabin (in addition to the one used by survivors).

Brake band of winch
