Report on the investigation of
the grounding of UK registered
emergency towing vessel

Anglian Sovereign

near the island of Oxna, in the Shetland Islands

**Report No 16/2006
June 2006**

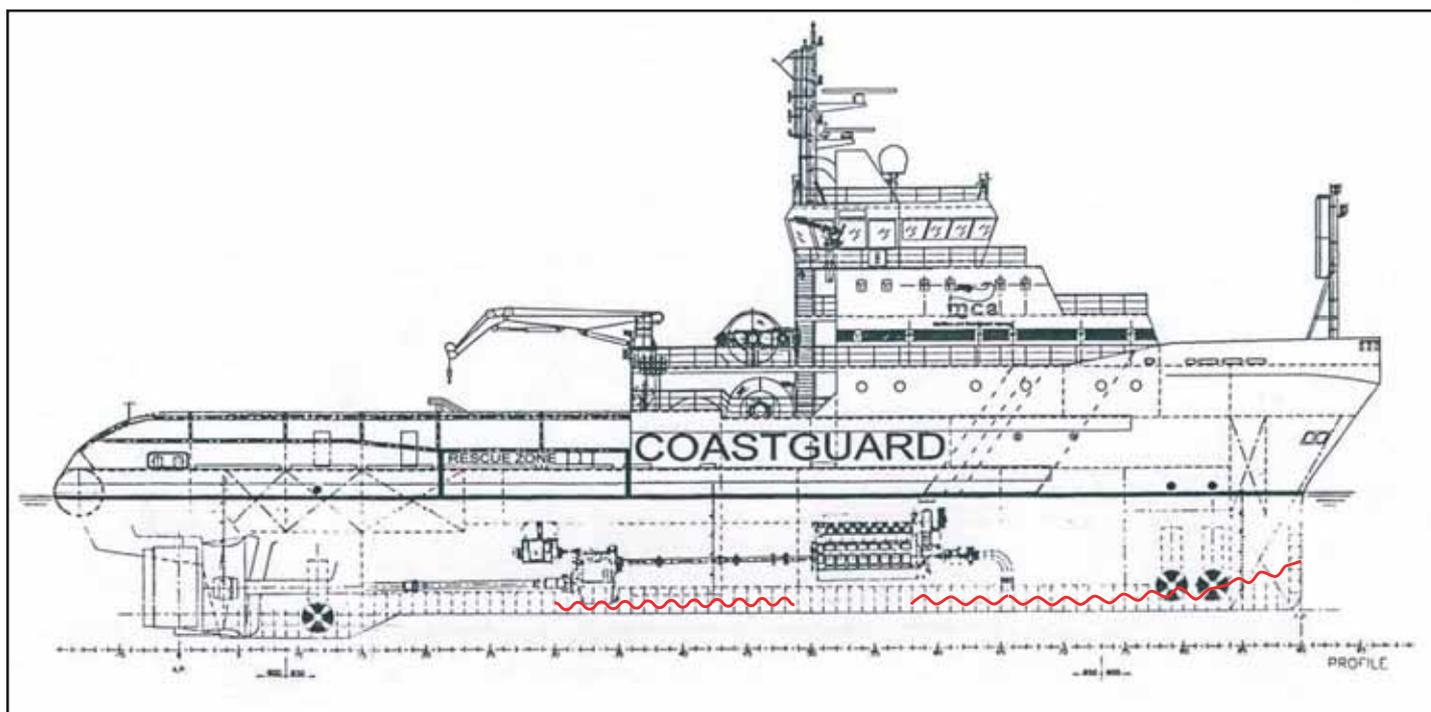
Profile of *Anglian Sovereign* showing extent of penetration damage on starboard side

During the grounding, *Anglian Sovereign* sustained heavy damage to her hull structure, with penetrations below the waterline, resulting in serious flooding to various tanks and compartments. As a result of this forward flooding, the vessel developed a list of about 15° to starboard, and trim by the head. However, the tank top structure remained intact, which prevented flooding to the engine and pump rooms (**see Figures 5a & 5b**).

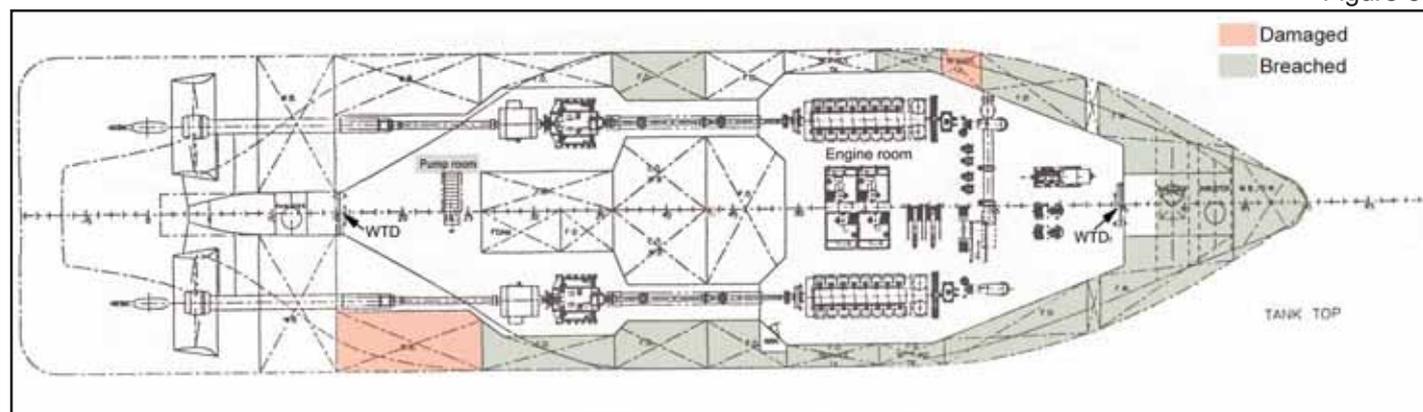
Plan of tank top showing breached and damaged tanks including the intact engine room and pump room

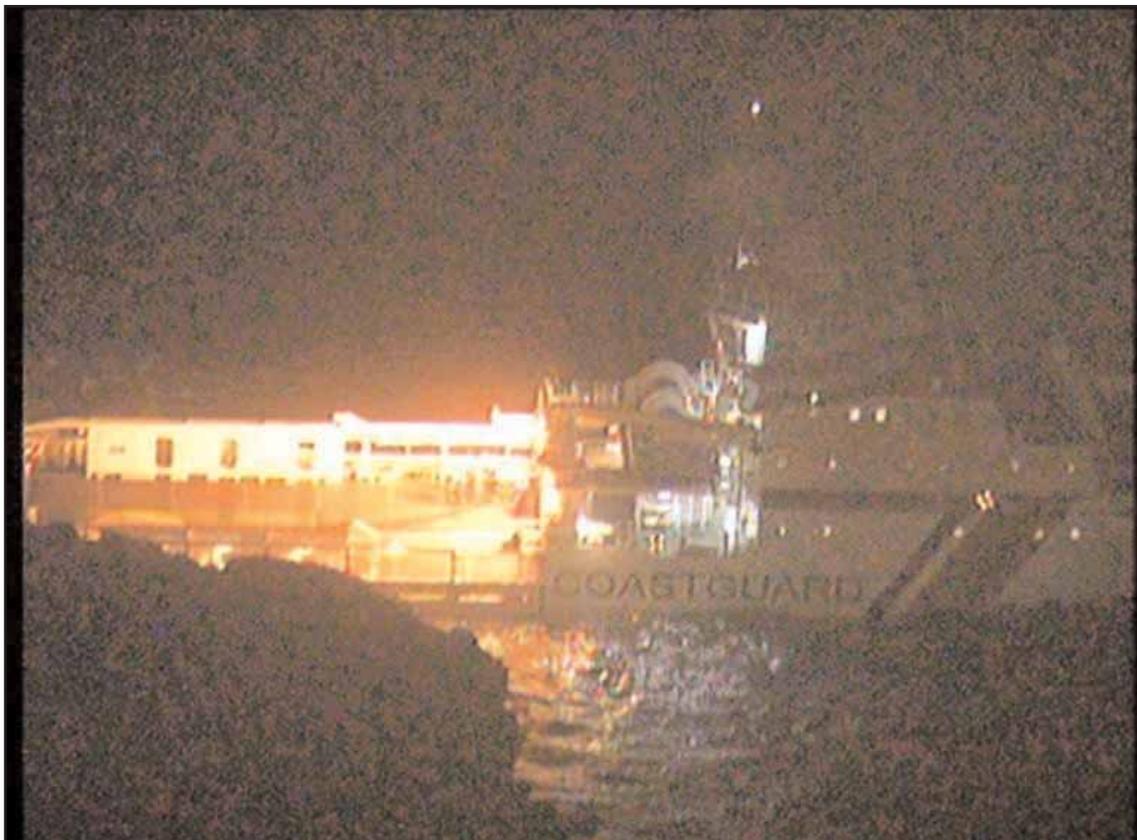
Photograph 4

Video still from rescue helicopter OC, showing *Anglian Sovereign* in the second grounding position and the vessel listing to starboard

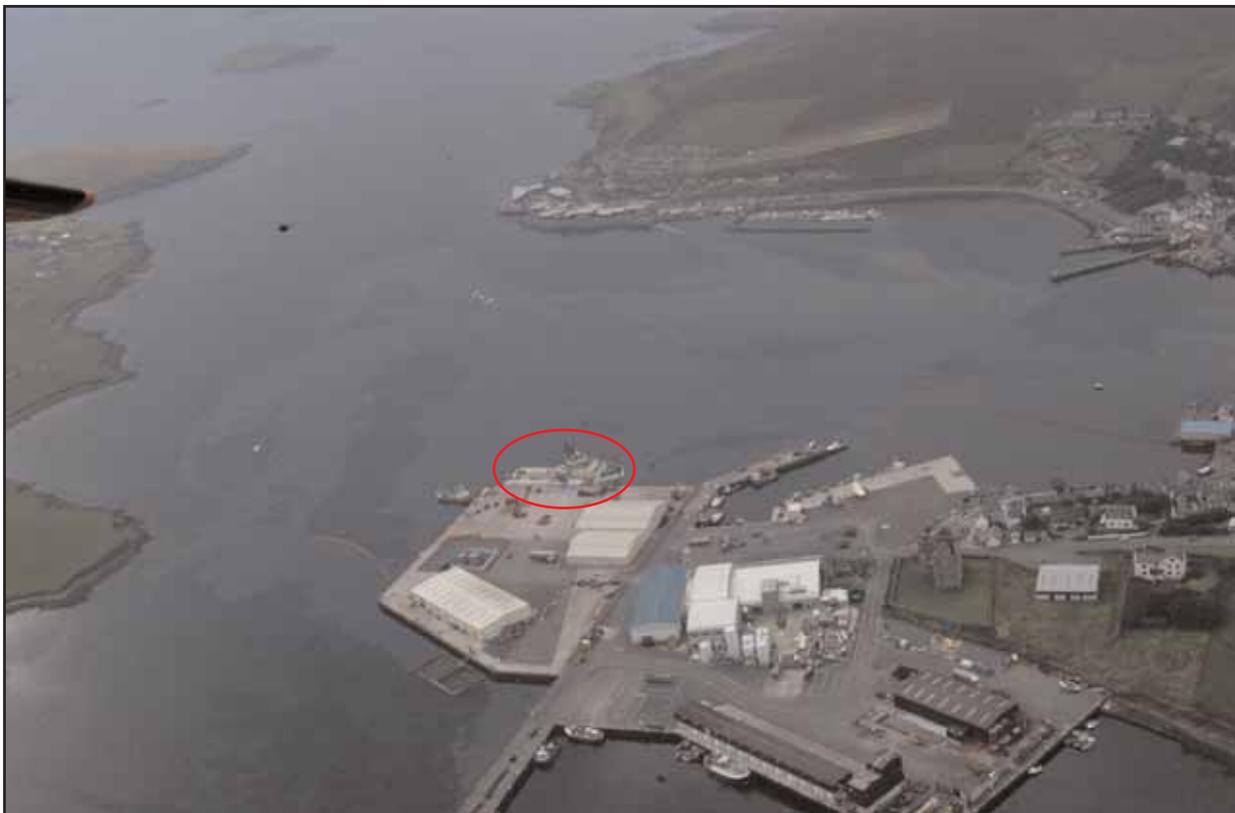
Note the oil sheen in the harbour

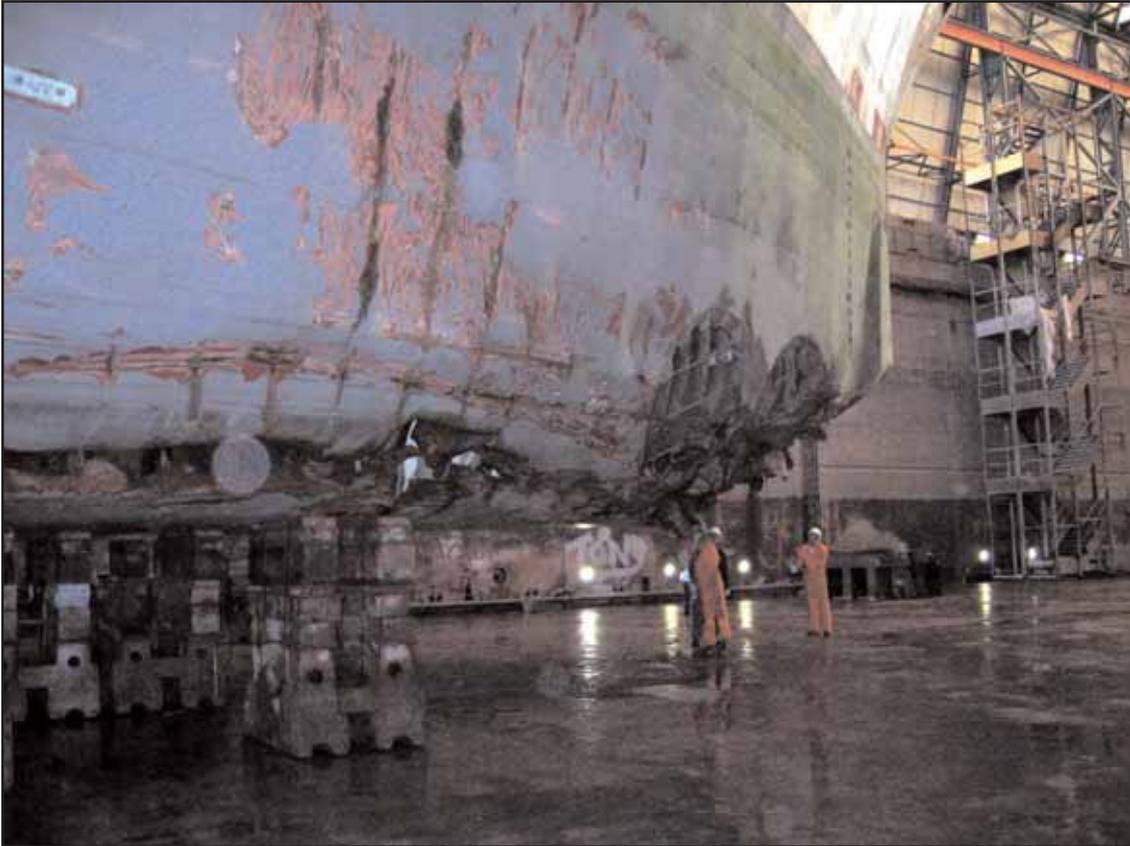
Photograph 8

The penetration damage extended over half the length of the starboard side, and about one third of the length on the port side. The penetrations damaged the hull and breached the (**Photographs 8, 9 and 10**) following tanks and compartments:

A view of the starboard side looking forward, showing damage to the bow thruster area

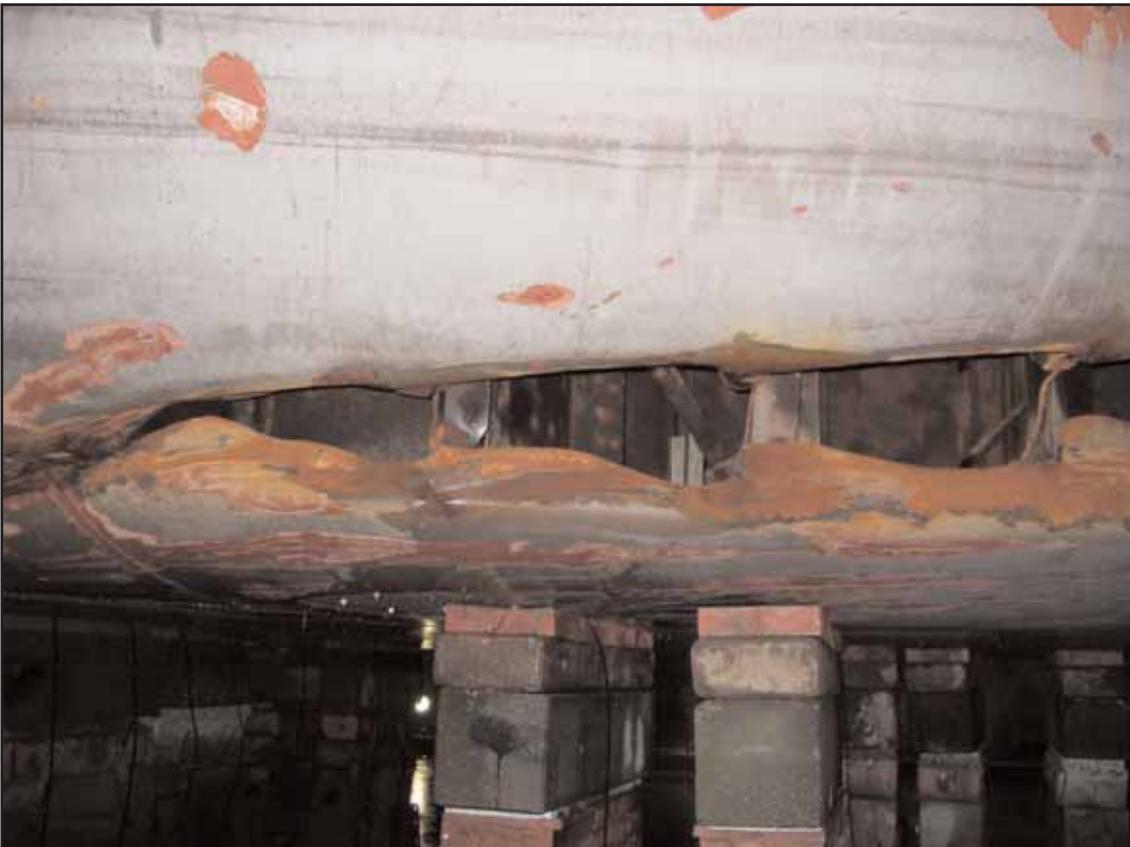
Photograph 9

A longitudinal tear in the starboard side shell plating

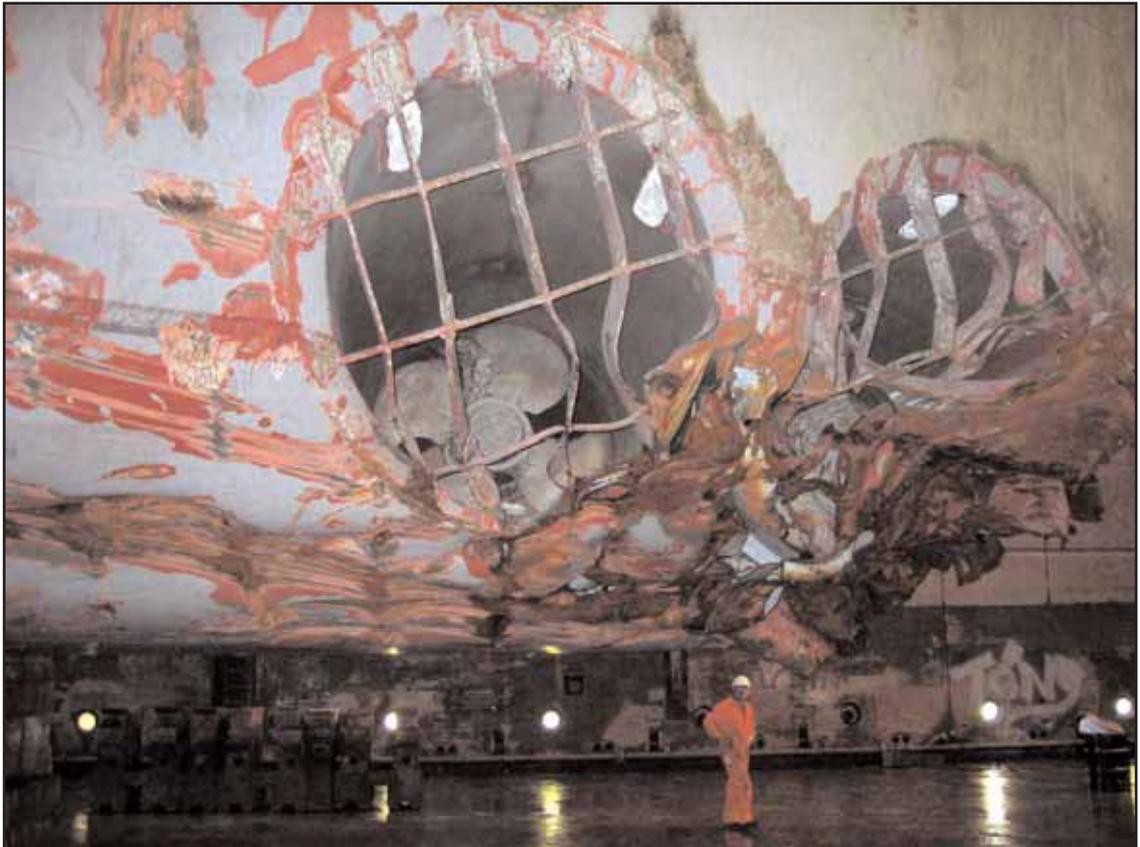
A closer view of the bow thrusters
