Report on the investigation of
the hull failure of the rigid inflatable boat

Big Yellow

Porthmeor Beach

**Report No 11/2006
March 2006**

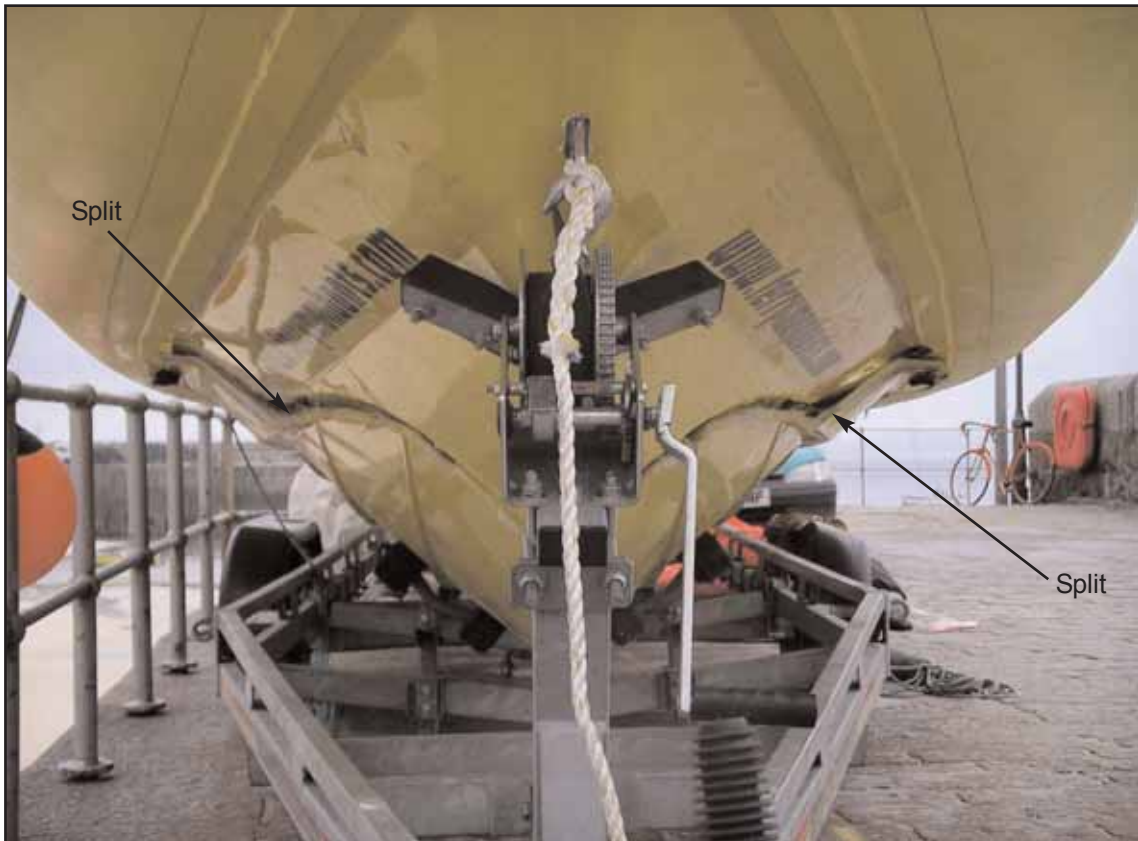
Figure 13

The hull had suffered extensive, symmetrical damage which included areas of de-lamination. A port and starboard longitudinal split had separated the hull for a total distance of approximately 4.2m from the stem reverse chine line to a point under the passenger seating area (**see Figure 13**).

Symmetrical damage from stem

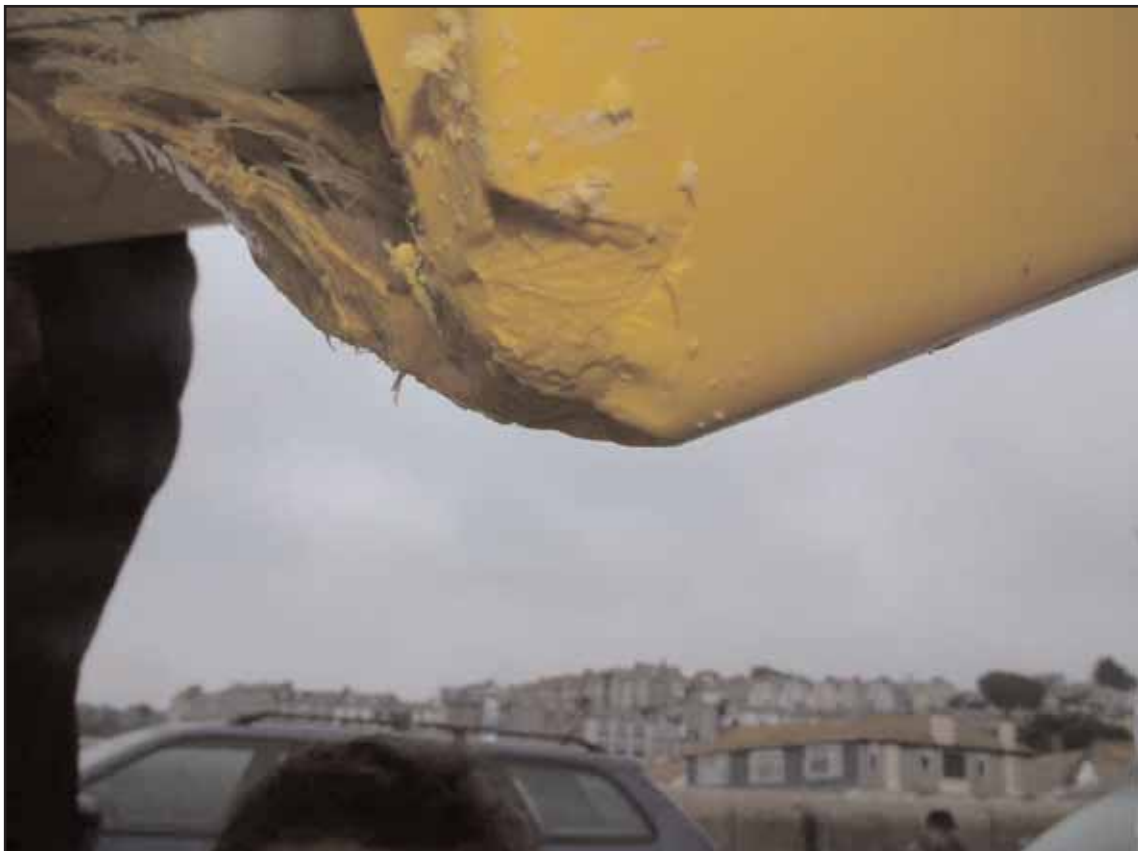
Figure 14

There was evidence of gel coat detachment at the beginning of the reverse chine, at the stem (**Figure 14**). The nature of this apparent old damage suggested that it might have been caused by the RIB touching rocks, pier steps, or during trailer loading or unloading. The area also appeared to have been "buffed" up in readiness for repair.

Gel coat detachment at start of reverse chine

The previous owner reported that, while operating in Newquay harbour the boat made contact, at high speed, with a large piece of wood. In addition, the crew of the rescue helicopter recovered a length of timber which they believed *Big Yellow* might have hit. There is supposition that either of these might have initiated the failure, and could explain the damage seen to the gel coat at the beginning of the reverse chine, located at the stem.

Passengers onboard at the time of the accident were confident the RIB did not hit anything during the trip. Examination of photographs while the RIB was at Falmouth Yacht Brokers did not reveal any damage to the stem gel coat. Discussions with the the staff from Falmouth Yacht Brokers confirmed that during their “out of water survey” they saw no damage to the vessel’s stem or in any other areas of the hull. The gel coat damage must have occurred sometime during the current ownership, and might have happened during loading or offloading from the RIB’s trailer, or during berthing operations.

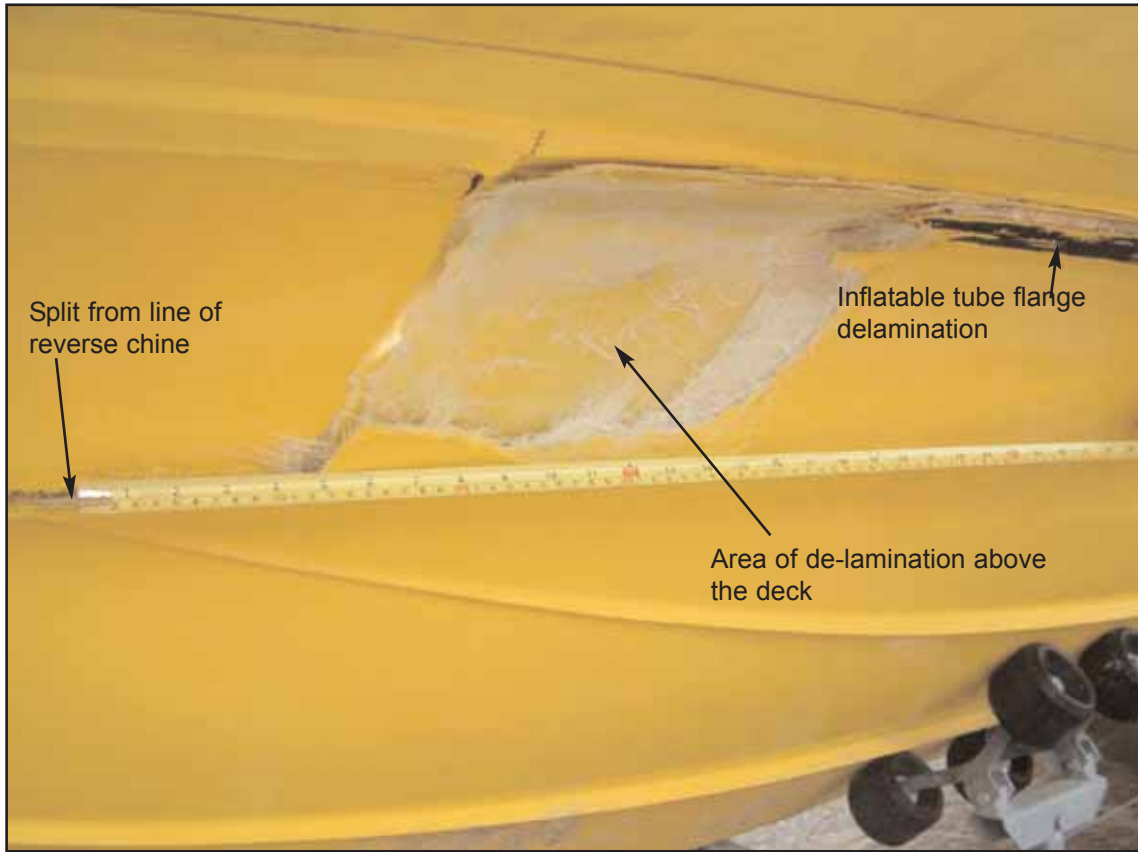
Figure 15

Extent of hull split

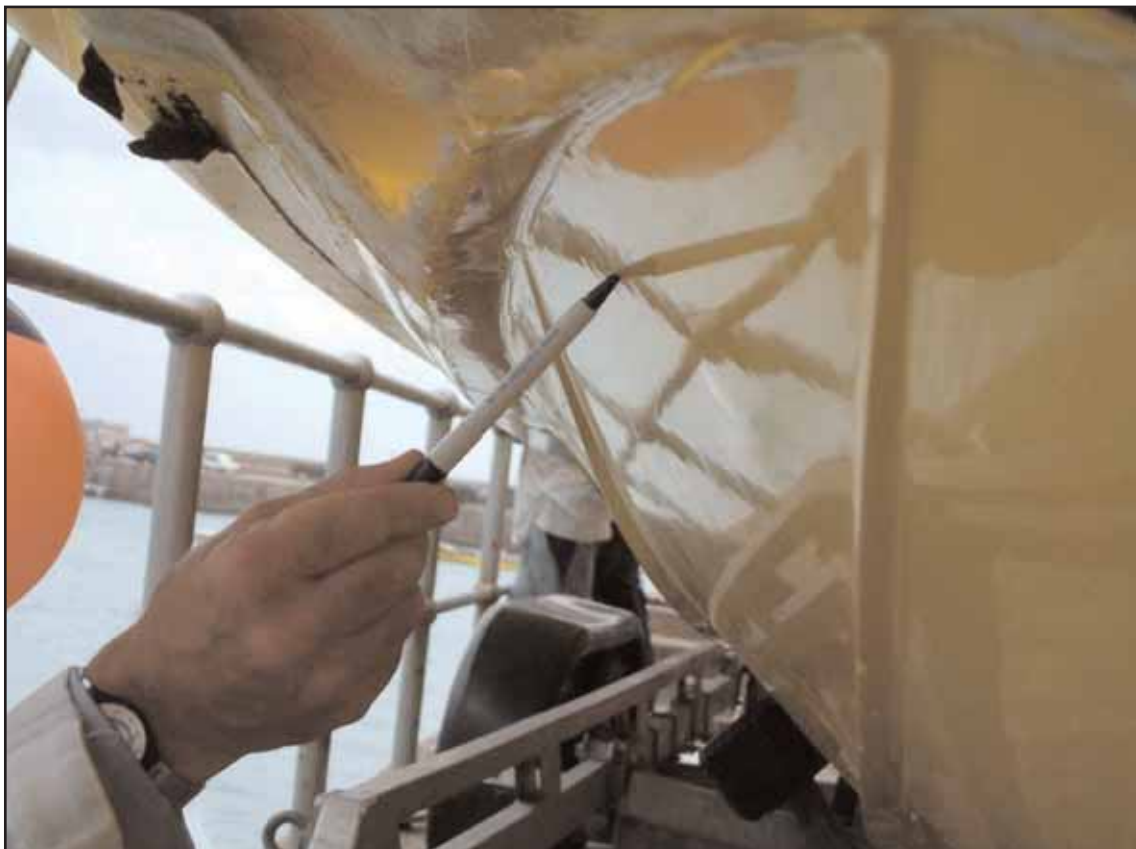
Figure 16

There was also evidence of stress cracking on the port and starboard sides just above the deck line (**Figure 16**).

Area of stress cracking

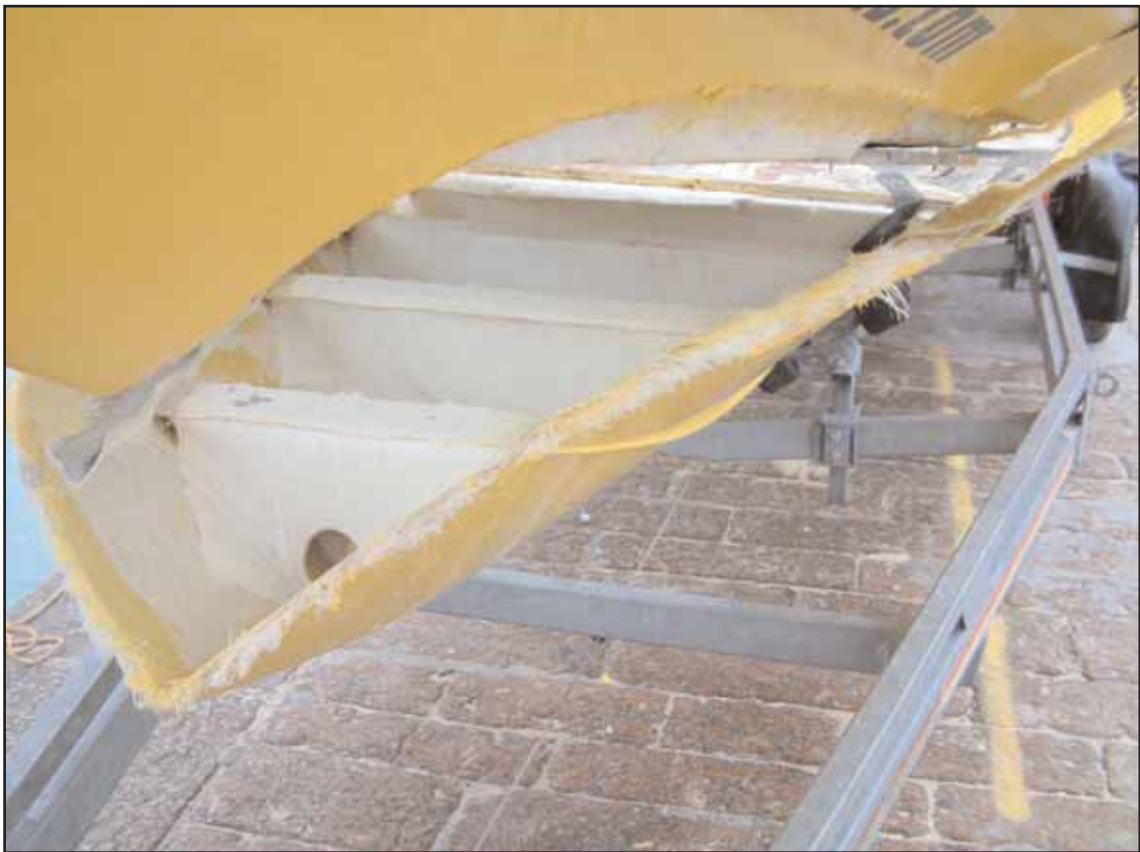
The upper part of the hull could easily be lifted to expose the under deck structure, as shown at **Figure 17**. A schematic illustrating the extent of the hull damage is at **Figure 18**.

Hull lifted to show extent of damage

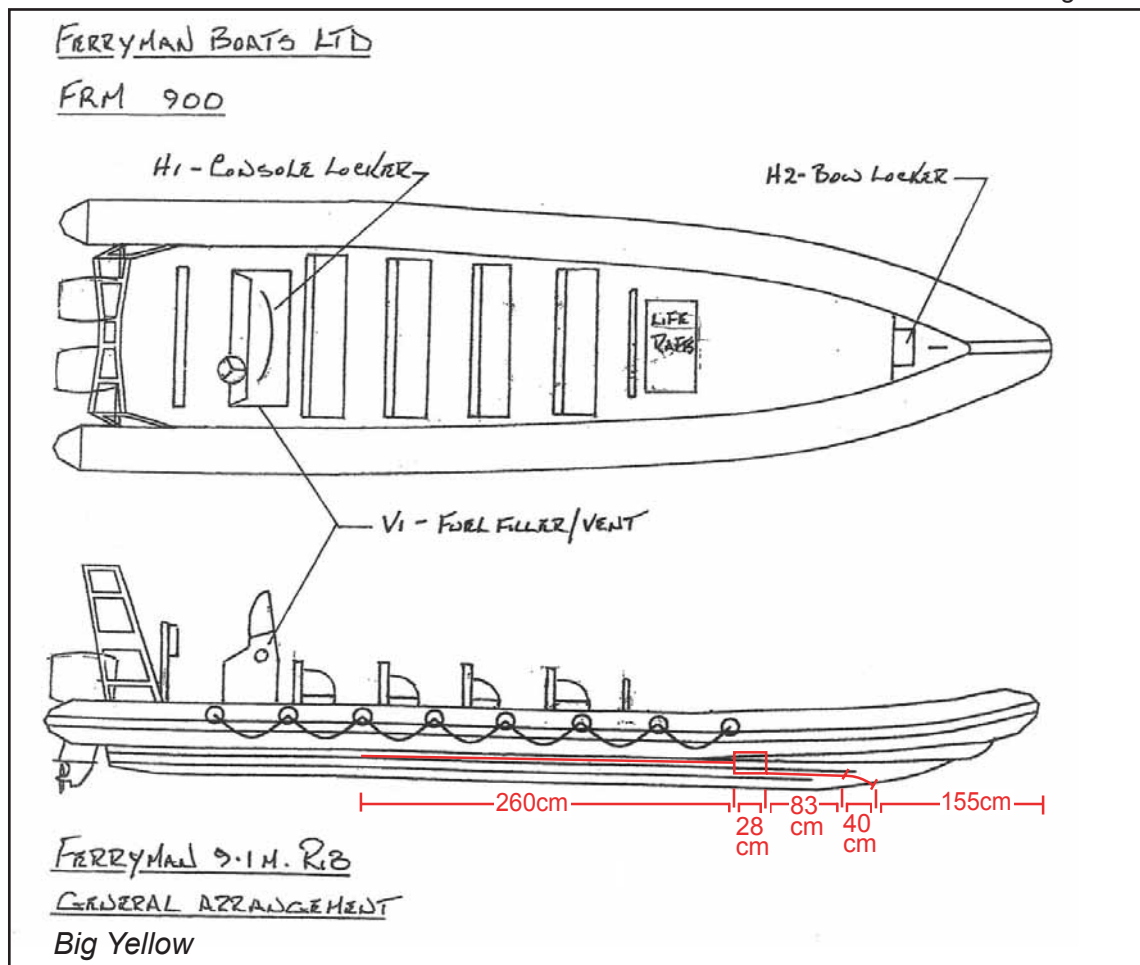
Figure 18

Schematic of hull damage

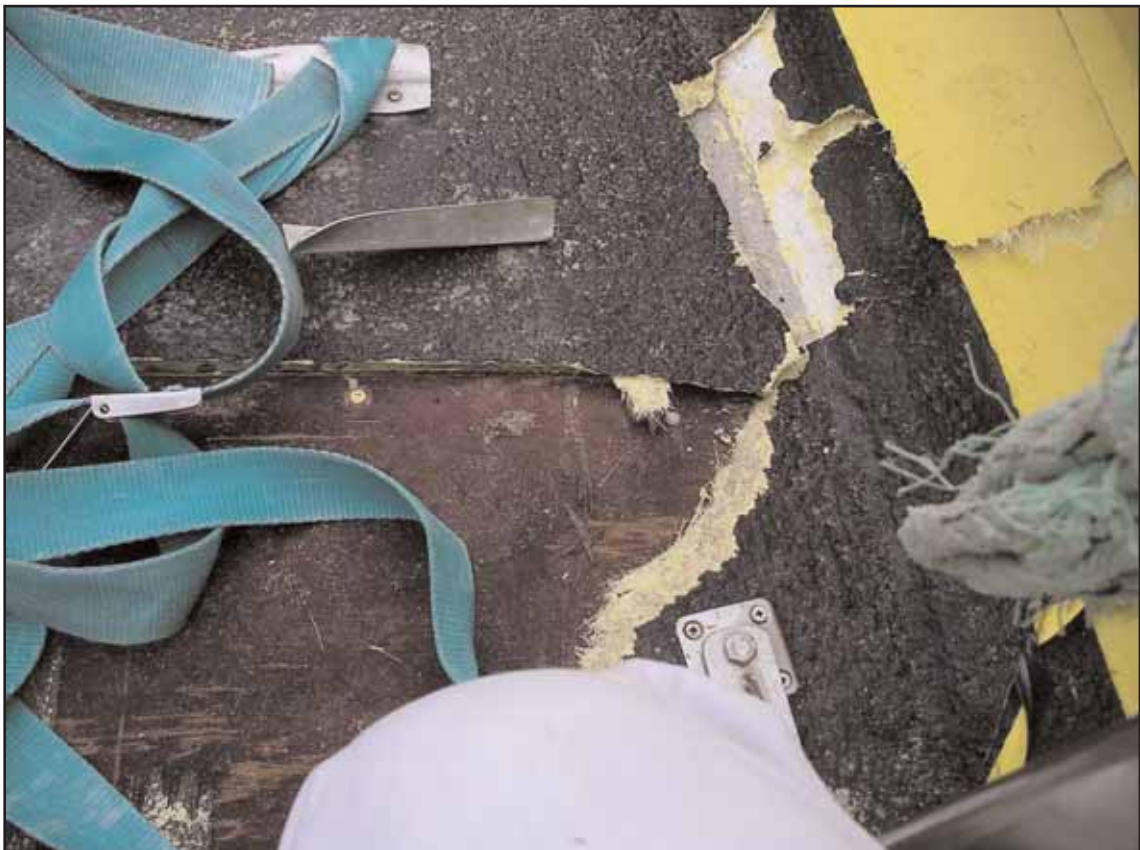
Figure 19

The marine ply sheets forming the deck were intact. The GRP layers covering the deck had failed at the marine ply butt joints coincident with the apparent area of de-lamination referred to in Section 1.9.1 above (**Figure 19**).

Failure of CSM over deck butt joints

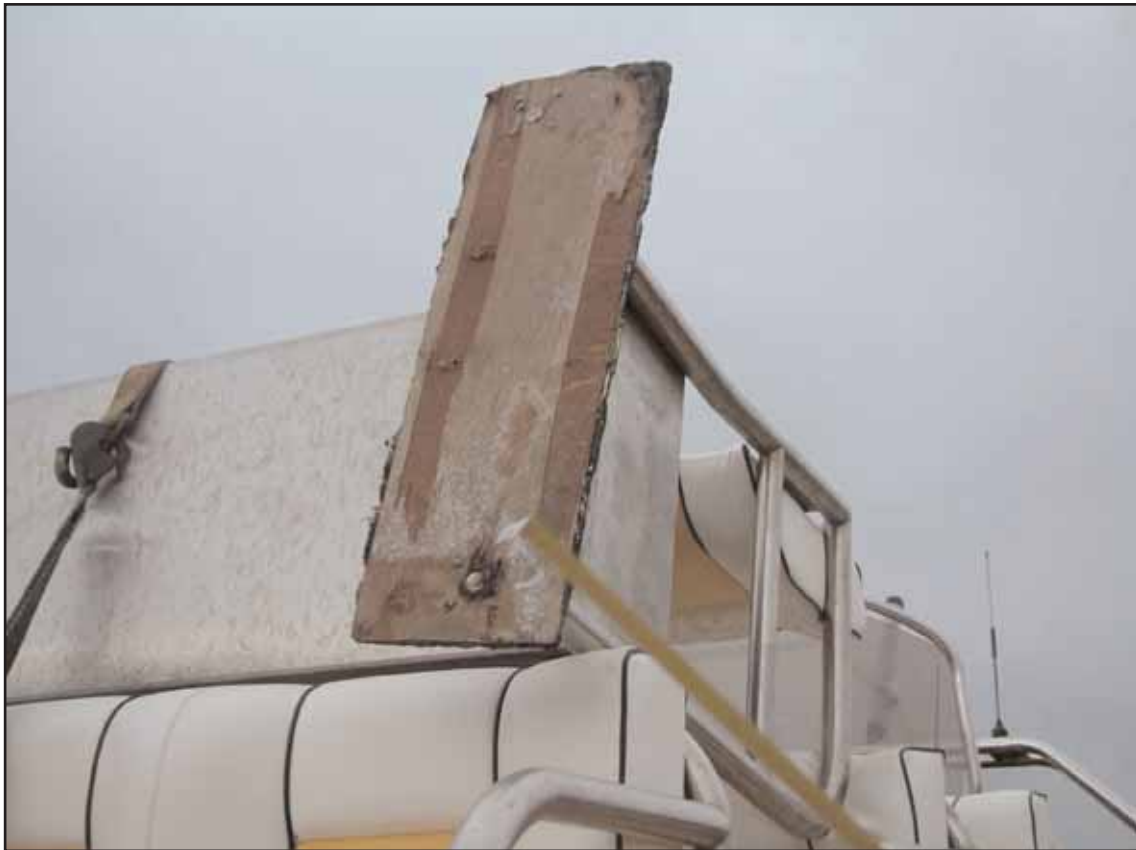
Figure 20

Front bench pad piece

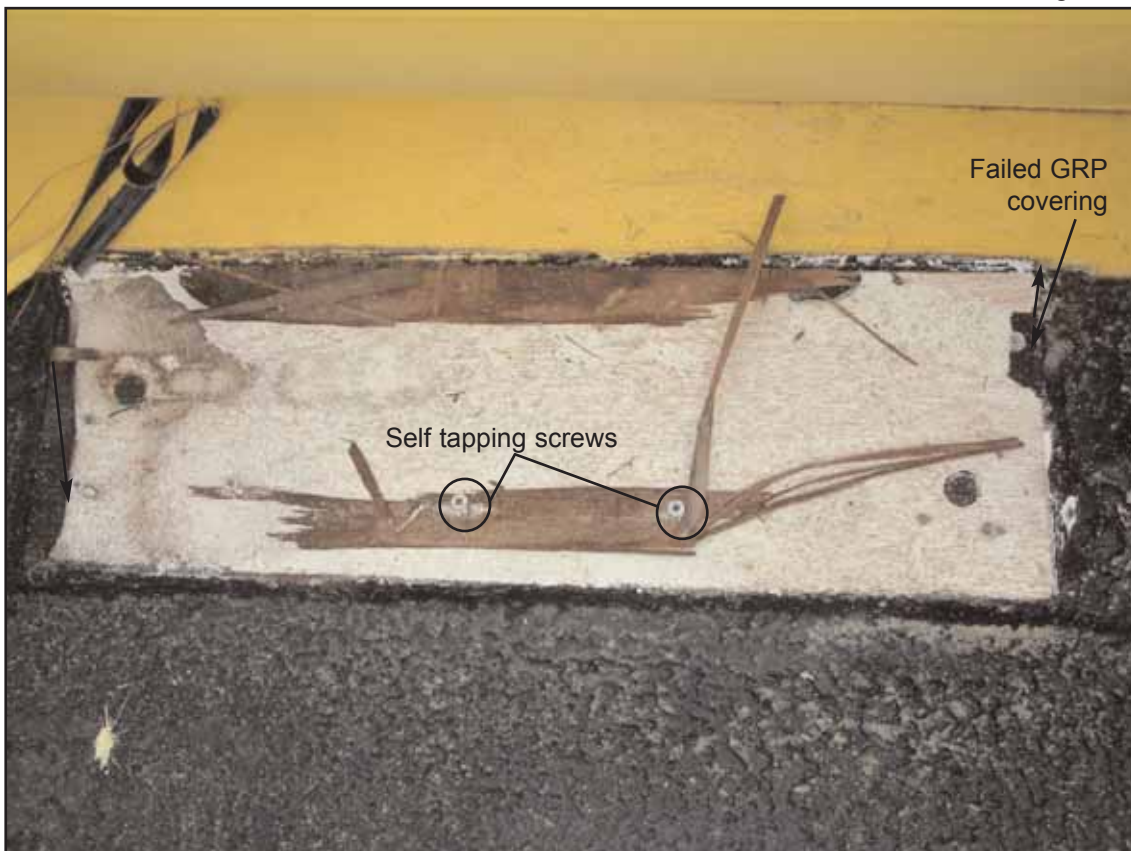
Figure 21

The front bench seat pad piece remained fastened to the stainless steel bench frame with its M10 stainless steel fastenings (**Figure 20**). However, the pad piece csm covering, and self-tapping screws, had failed, resulting in the bench being torn from the deck (**Figure 21**).

Front bench pad piece - failure of pad piece CSM covering

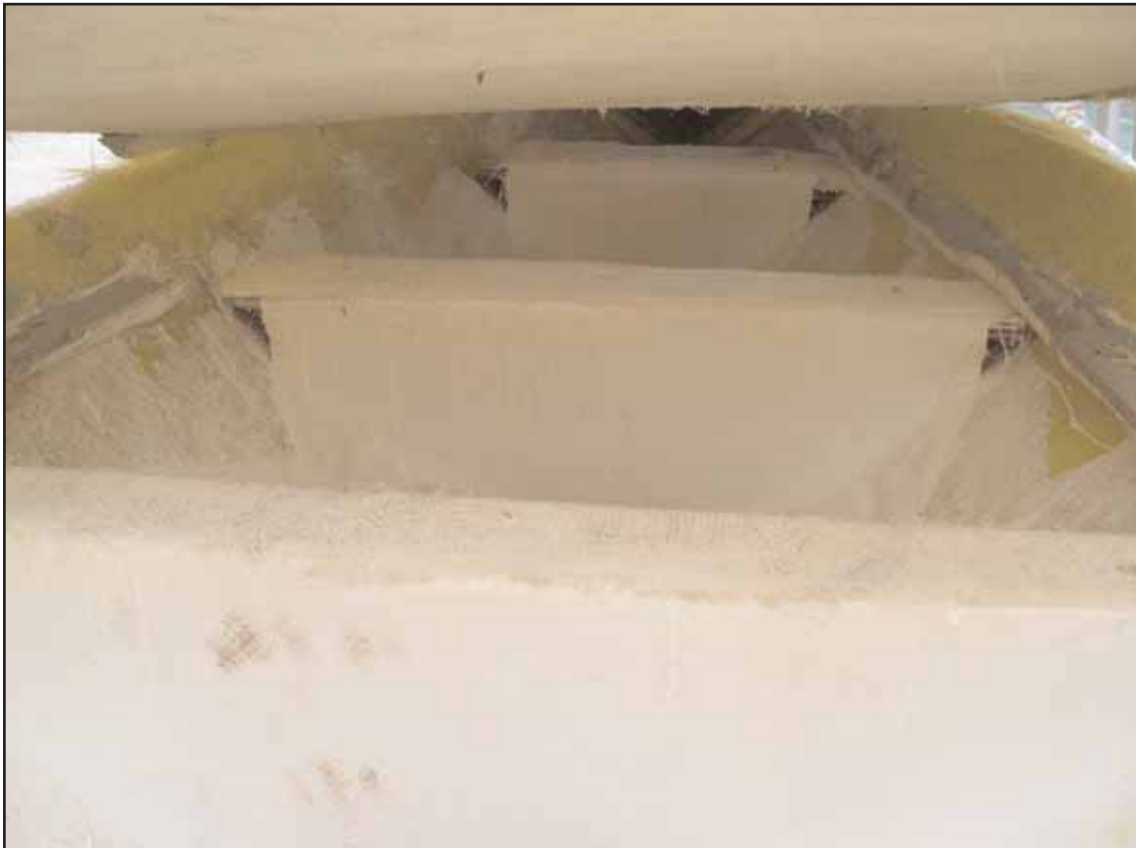
Figure 23

Transverse stiffening - FRM 900
