Report on the investigation of  
a serious injury sustained when falling overboard from a

***Ribeye Open Tender 450***

Off Abersoch beach, Wales

**Report No 12/2006**  
**March 2006**

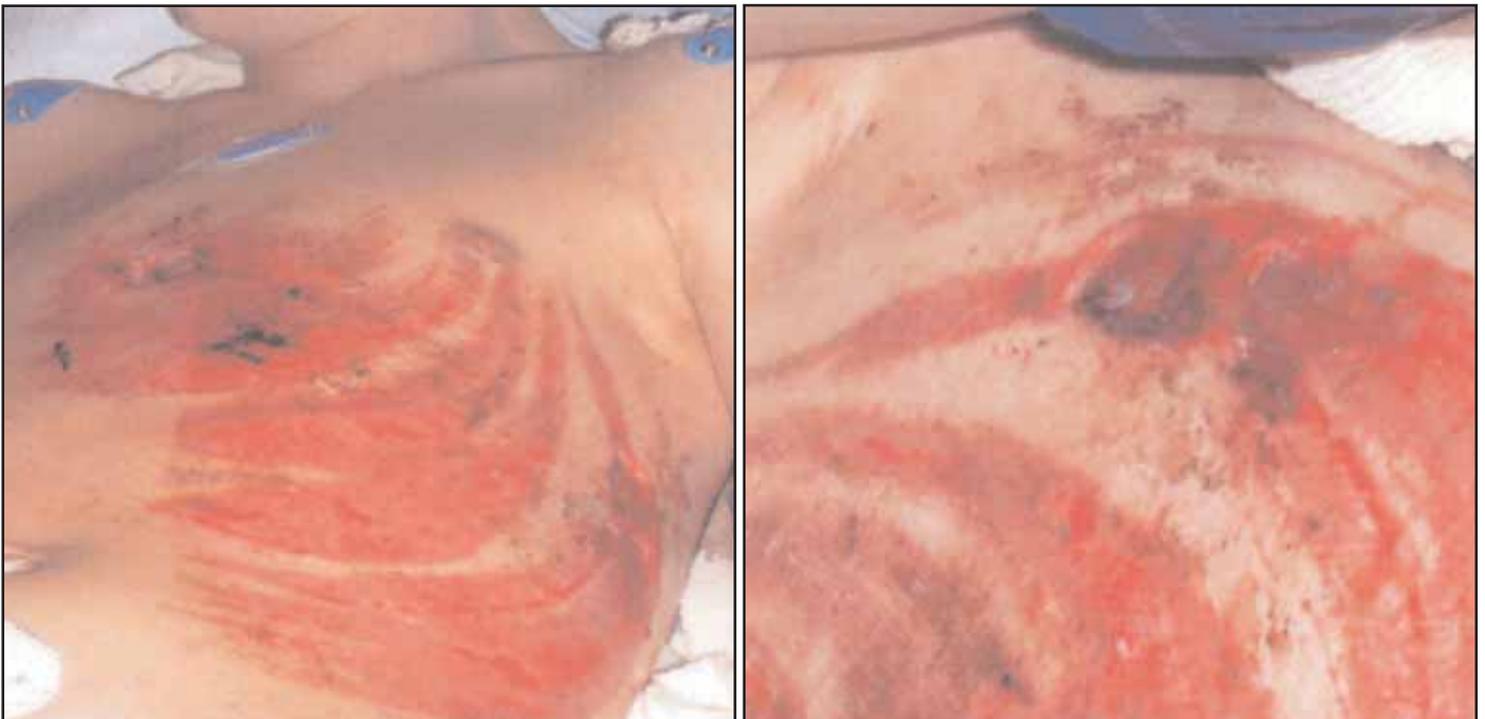
Figures 5 and 6

The injured passenger suffered deep abrasions to his chest and left side (**Figures 5 and 6**), and remained in hospital for 3 weeks.

Injuries to passenger

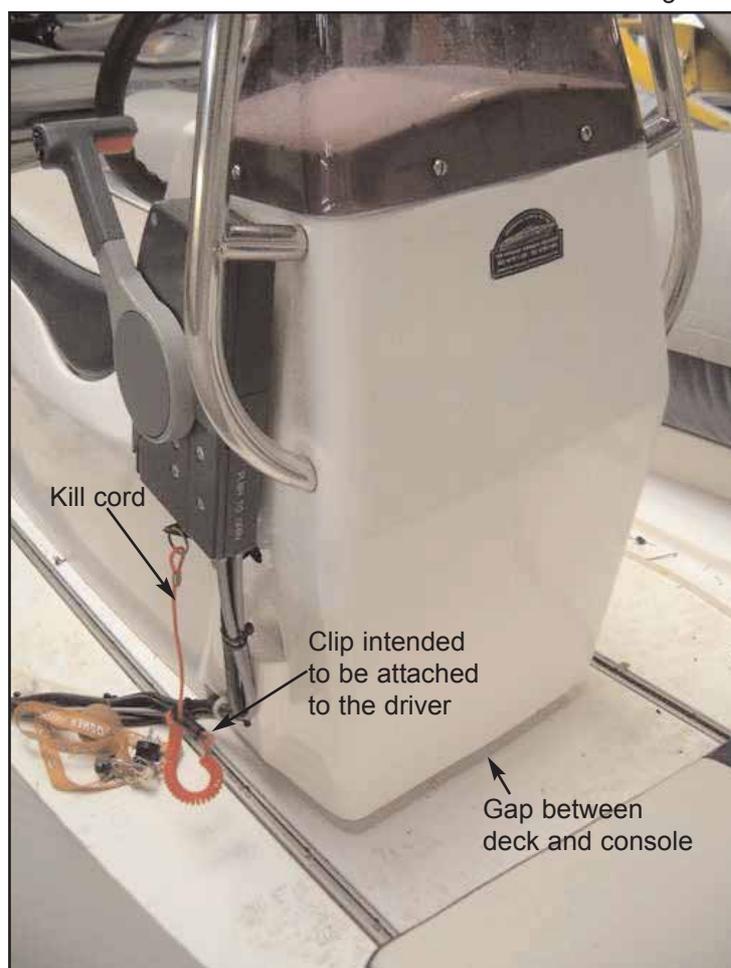
Figure 7

Kill cord and RY5030 console

was disconnected from the driving position, the kill-cord would be pulled from the console, and the engine would stop. The driver usually wore the kill-cord when driving the RIB, but forgot to do so on this occasion.

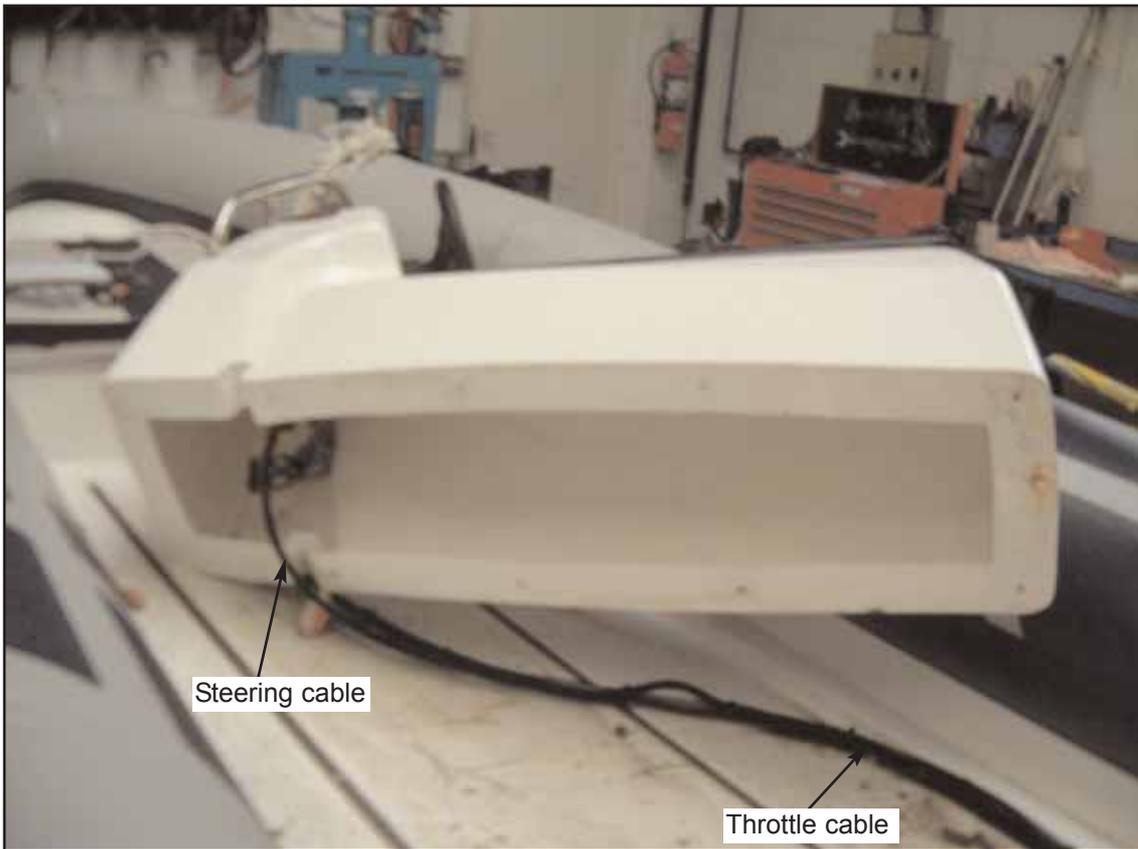
Figure 8

RY5030 console attached by control cables

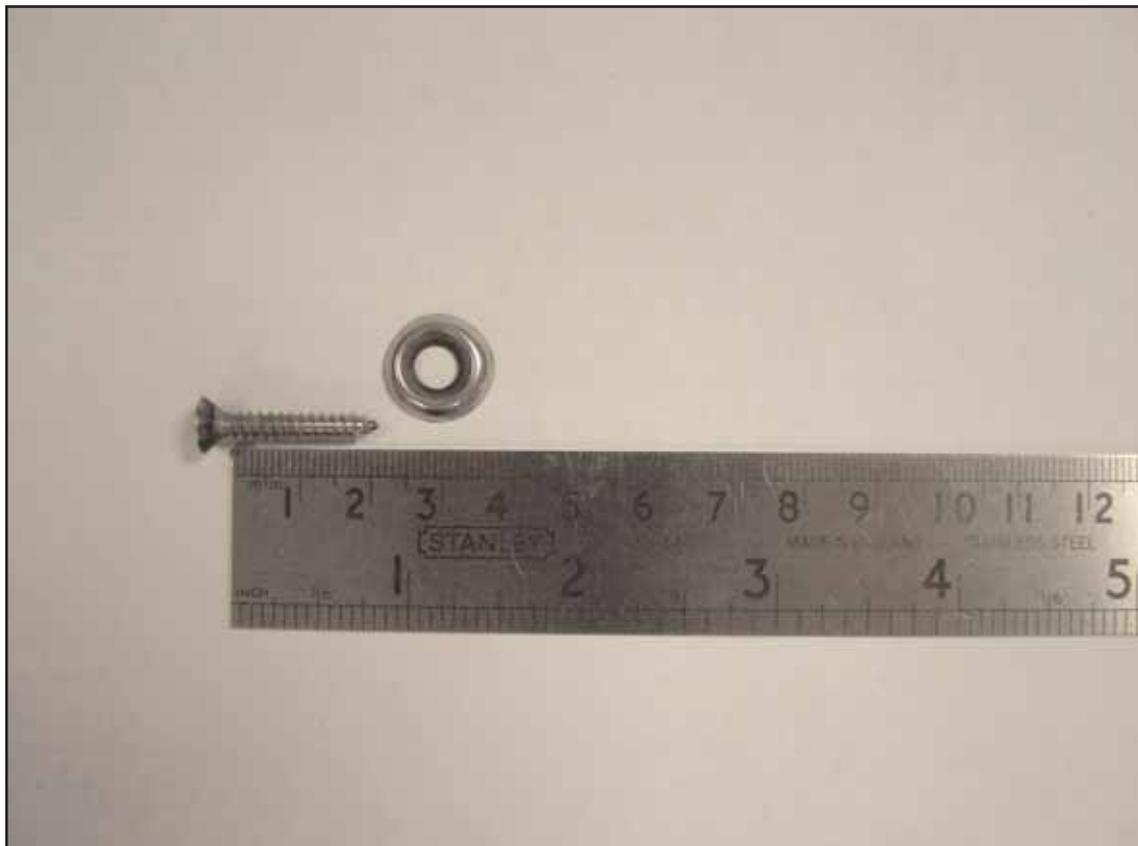
Figure 9

Self-tapping screw and cup washer

The fitter who rigged the OT450 cannot remember securing the console, and considers that it was possibly already fitted when the boat was delivered. The cup washers (**Figure 9**) used with the screws to secure the console to the deck and the 'P' clips securing the control cables (**Figure 13**), were not routinely used at Abersoch Land and Sea.

First, the console was intended to be used with the Ribeye 330, and was shaped accordingly (**Figure 14**). Therefore, it was not possible to secure the raised front section of the console to the deck. Second, as the console was secured by eight screws with an average spacing between the screws of 30cm, this was insufficient considering the area of the console in contact with the deck. Third, no fixative or bonding agent was used. Finally, it is possible that the holes in the deck were drilled oversize in relation to the size of the screws used. This is evident from the lack of damage to the deck area surrounding the holes, through which the self-tapping screws were pulled. The drilling of oversized holes would have caused the screw to act more like a bung than a fastener.

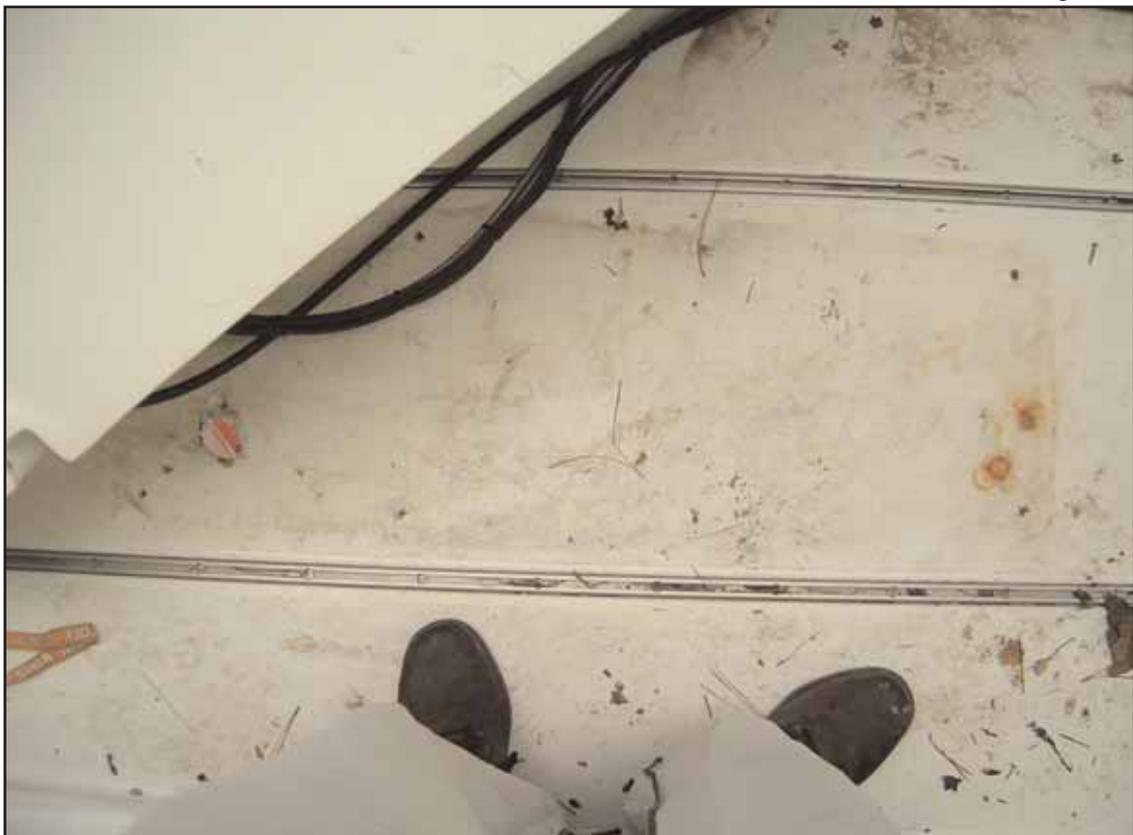
Figure 11

Following the accident, the OT450 was taken to Abersoch Land and Sea Ltd, the dealers from where the boat was purchased, and where it was routinely stored. Examination of the boat showed that its console had become detached from the deck, but was still connected to the boat by the steering cable and the engine control leads (**Figure 8**). The console had been secured to the deck by 8 x 20mm self-tapping screws (**Figure 9**) into the GRP composite deck, which was constructed using balsa as a core material, and had an average thickness of 18mm. The screws and their associated cup washers were found in the boat. The screws had been fixed through four pre-drilled holes on either side of the console at an average spacing of 30cm (**Figure 10**), and the console had been sited between the fixed rails on the deck of the boat (**Figure 11**). Four pre-drilled holes on the front section of the console (**Figure 10**) did not have any corresponding holes on the deck. There was no evidence of any bonding agent or fixative being used. The console was identified as the RY5030, which was designed to be fitted to the Ribeye 330 Tender, not the OT450. All of the propeller blades were also found damaged.

Deck of the OT450

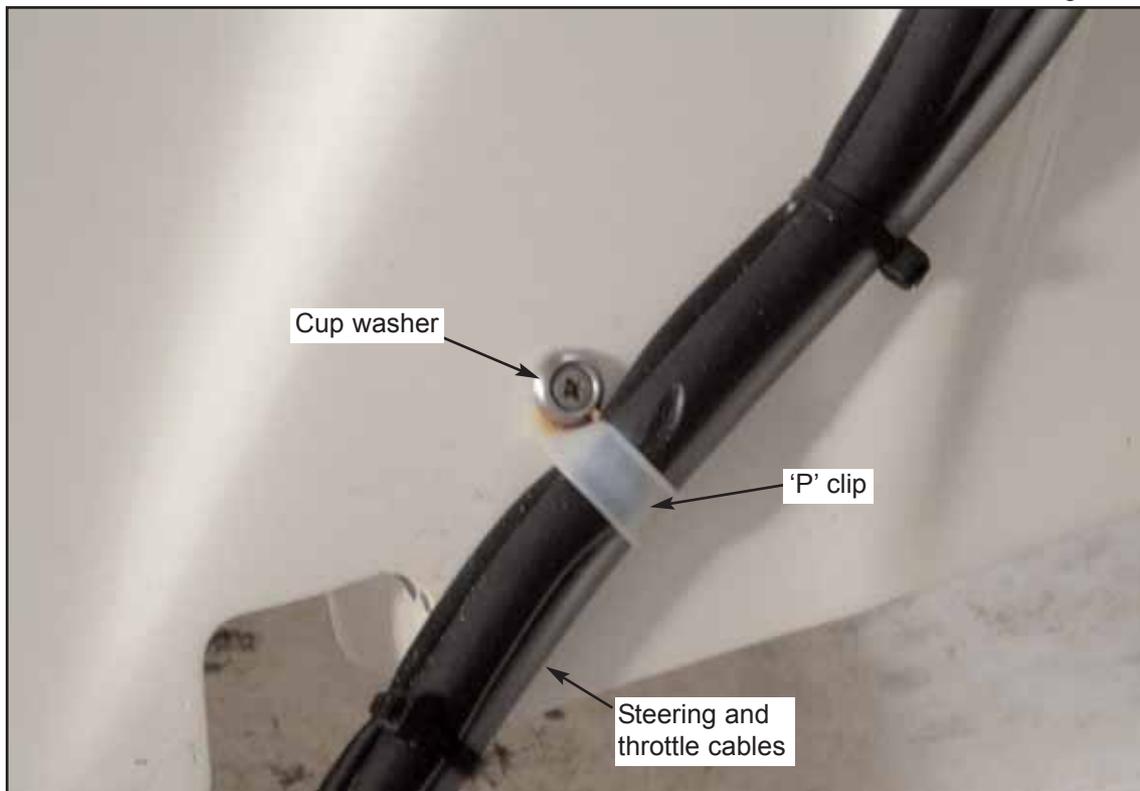
Figure 13

Control cables secured by 'P' clip

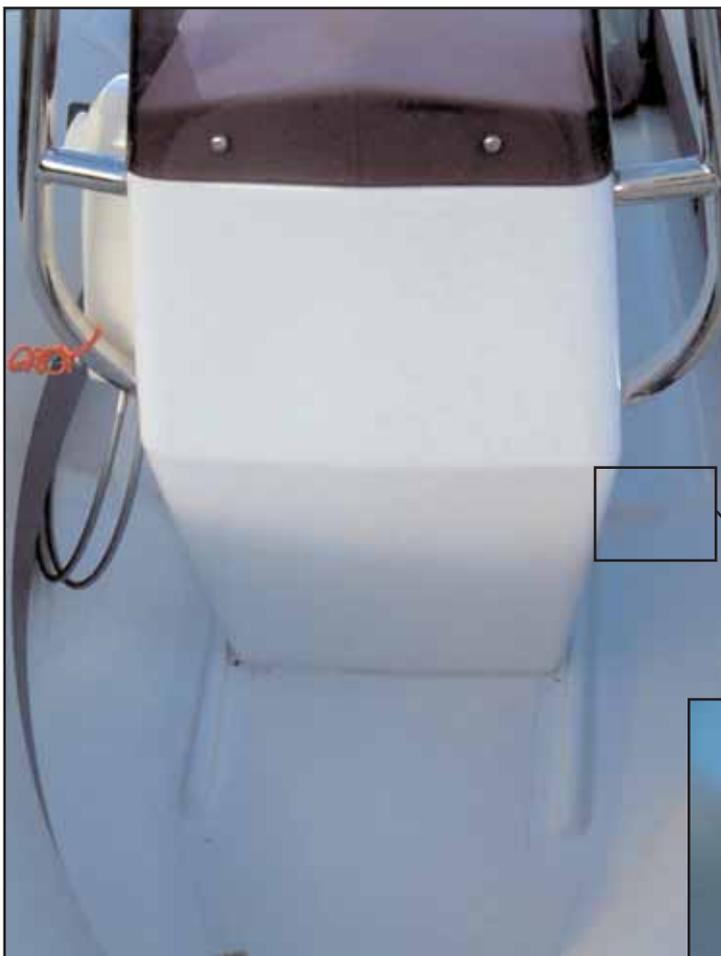
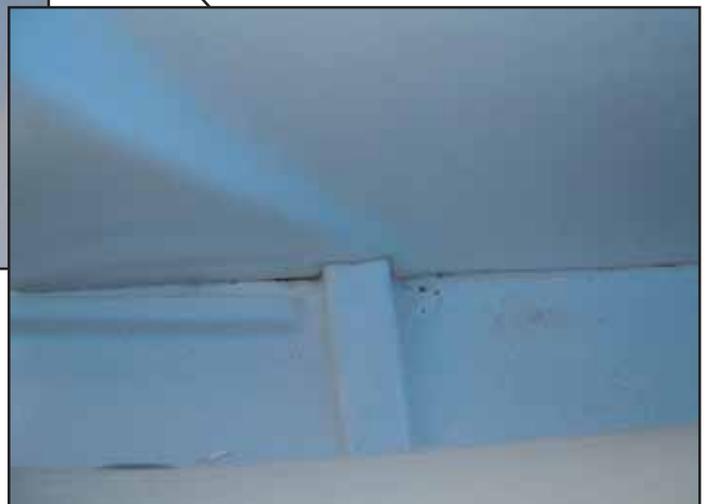
Figure 14

Note: No rail system fitted

RY5030 console fitted in a Ribeye Tender 330
