SYNOPSIS

At about 1115 on 7 August 2005, a 4.5m RIB with three teenage occupants approached the beach in Abersoch, North Wales. As the RIB passed a line of buoys marking an area in which a 4 knot speed limit had been set by Gwynedd Council, the driver of the RIB reduced to about half throttle, and commenced a slow left-hand turn. During the turn, the console on which the driver was sitting, and to which the steering wheel was mounted, detached from the deck of the RIB. The driver was unable to maintain his balance and fell over the boat's port side and into the sea.

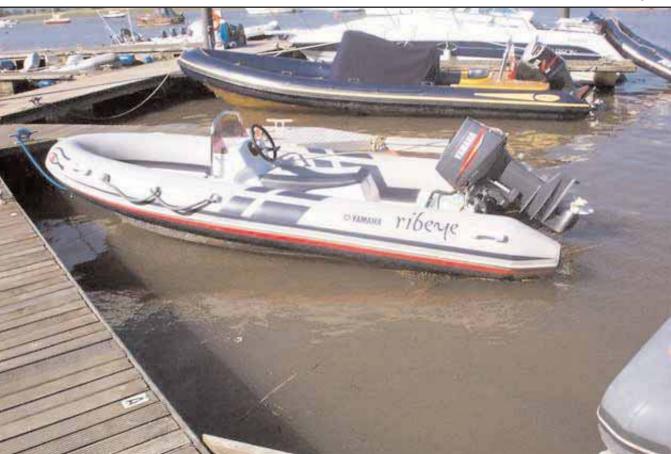
Figure 1

Ribeye Open Tender 450
