MARINE ACCIDENT INVESTIGATION BRANCH

FLYER TO SHIPPING COMPANIES

***SAVANNAH EXPRESS:* ENGINE FAILURE AND SUBSEQUENT CONTACT WITH A LINKSPAN**

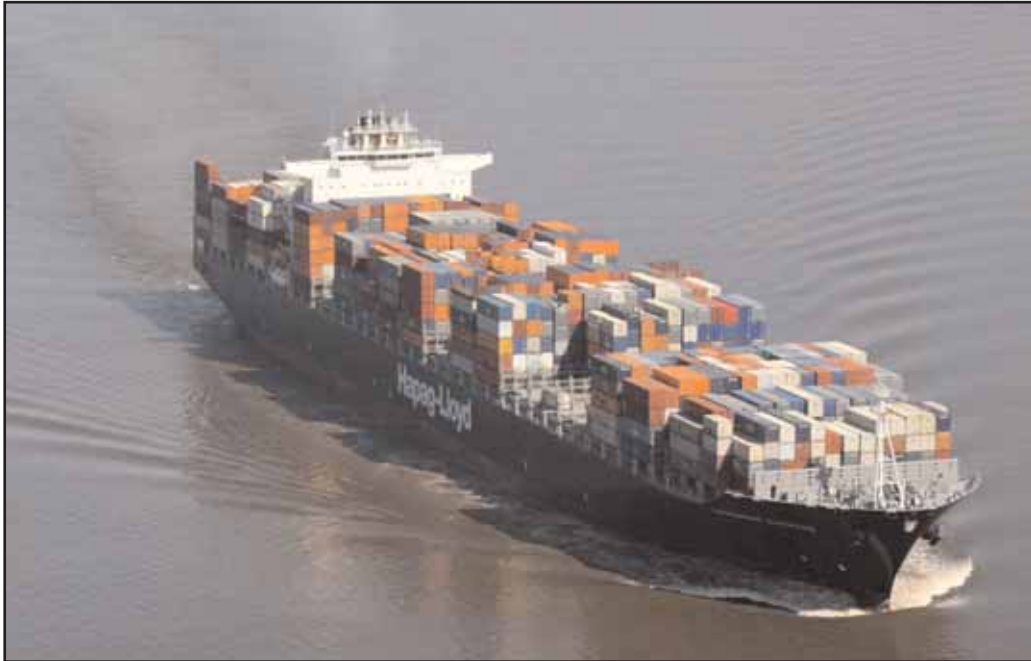
On 19 July 2005, the 8400 TEU container vessel *Savannah Express* was entering the Upper Swinging Ground, prior to berthing at Southampton Container Terminal, when her main engine failed. The engine was unable to be started astern to reduce the vessel's headway, and she made heavy contact with a linkspan, which was seriously damaged.

The engine control system had suffered a series of technical problems since the vessel had come into service. An engine failure had also occurred as *Savannah Express* approached the pilot boarding ground on arrival at Southampton. The engineers misdiagnosed the cause of this failure and, although they managed to

re-start the engine, they inadvertently disabled an integral part of the engine control system, which effectively prevented sufficient hydraulic oil pressure to be supplied for the engine to operate astern.

This led to the second failure as the vessel entered the Upper Swinging Ground. The cause of this second engine failure was also misdiagnosed by the engineers, and they resorted to repeatedly turning the engine on compressed air in an attempt to 'reset' the control system electronics instead of determining the cause of the failure. Eventually, low air reserves prevented any further attempts to re-start the engine.

The generic training undertaken by marine engineers during courses leading to professional qualifications, may be insufficient on its own to equip engineers to operate, maintain and successfully diagnose and repair faults on fully integrated, complex engine systems. Therefore, shipowners should ensure that, where appropriate, their Safety Management Systems include the need for additional measures, such as:

- effective type-specific training for engineers;
- a longer period of supervision by guarantee engineers.
