# MAIB

## FLYER TO SHIPPING COMPANIES

### ***SAVANNAH EXPRESS:* ENGINE FAILURE AND SUBSEQUENT CONTACT WITH A LINKSPAN**

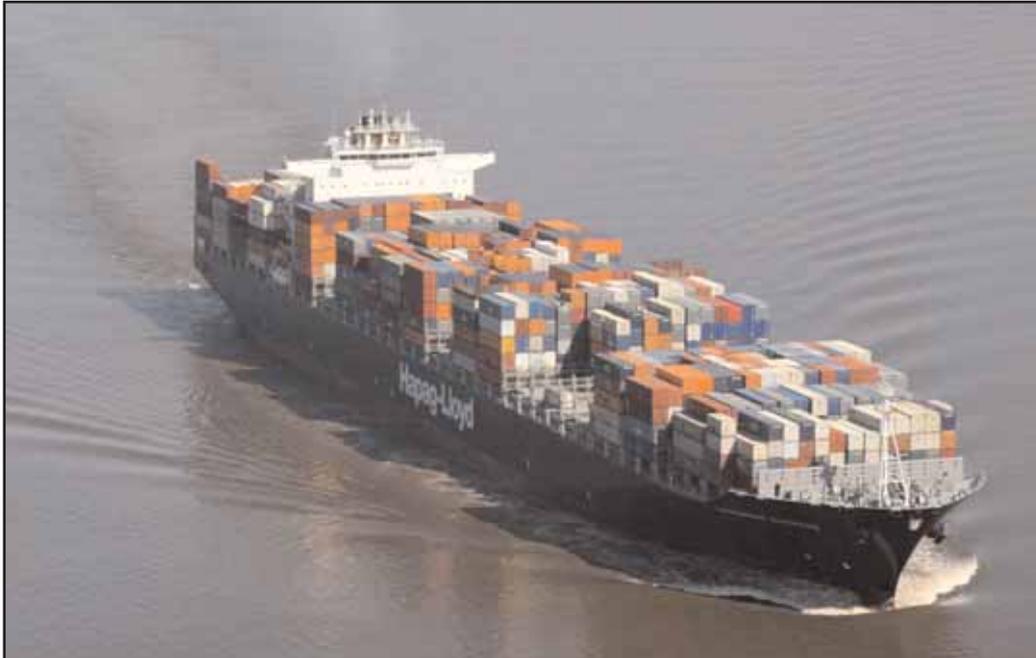
On 19 July 2005, the 8400 TEU container vessel *Savannah Express* was entering the Upper Swinging Ground, prior to berthing at Southampton Container Terminal, when her main engine failed. The engine was unable to be started astern to reduce the vessel's headway, and she made heavy contact with a linkspan, which was seriously damaged.
