Report on the investigation of  
the engine failure of  
***Savannah Express***  
and her subsequent contact with a  
linkspan at Southampton Docks  
19 July 2005

Marine Accident Investigation Branch  
Carlton House  
Carlton Place  
Southampton  
United Kingdom  
SO15 2DZ

**Report No 8/2006**  
**March 2006**

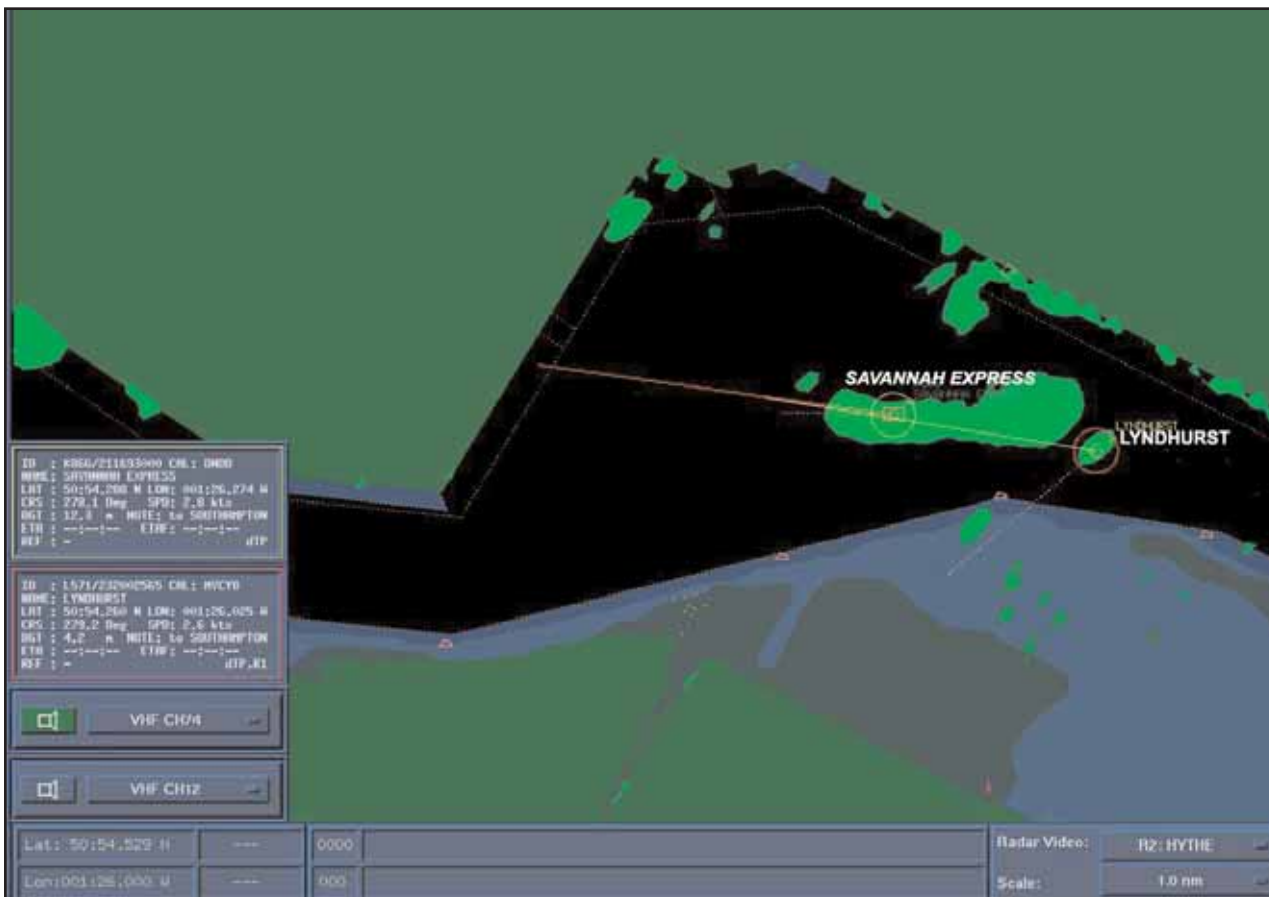
Figure 5

At 1136 the engine was set to dead slow astern. The engine briefly responded to the astern command and, although it reached 46 rpm, it failed to run and it stopped after about 18 seconds **(Figure 5)**. Further hydraulic low pressure alarms and ECU – A and B 'tacho failure' alarms occurred in the engine control room (ECR). Several attempts to re-start the engine in astern were made from the bridge wing before control was transferred to Bridge Control, and then to the ECR.

Radar recording from Southampton VTS showing *Savannah Express* beginning to swing to starboard

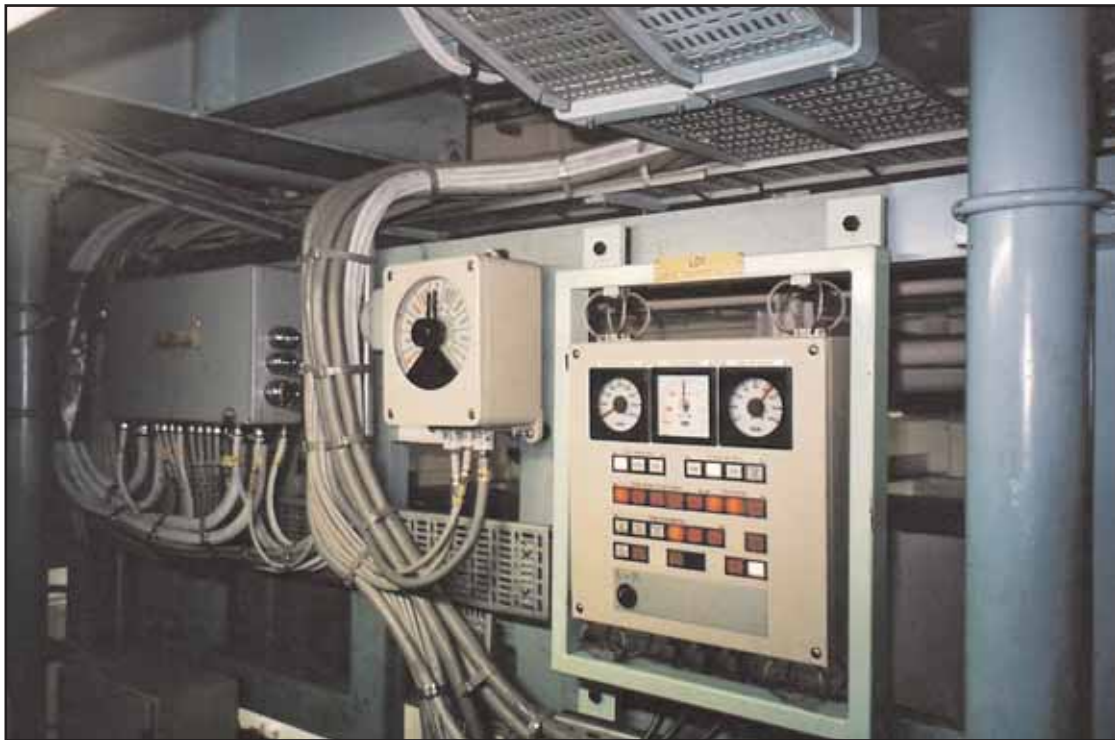
Figure 6

During the next few minutes, as the ship continued her slow swing to starboard, further attempts were made to start the main engine from the LOP (**Figure 6**), until low air pressure meant no more attempts could be made. The master informed the pilot that the main engine would not be available. At 1142, with the bow at about 20 – 30 metres off the quayside and with the vessel speed at about 2 knots, the master gave the order for the port anchor to be let go to reduce the headway. At about the same time, the pilot requested *Lyndhurst* to move right astern of *Savannah Express* and apply full power to further reduce headway.

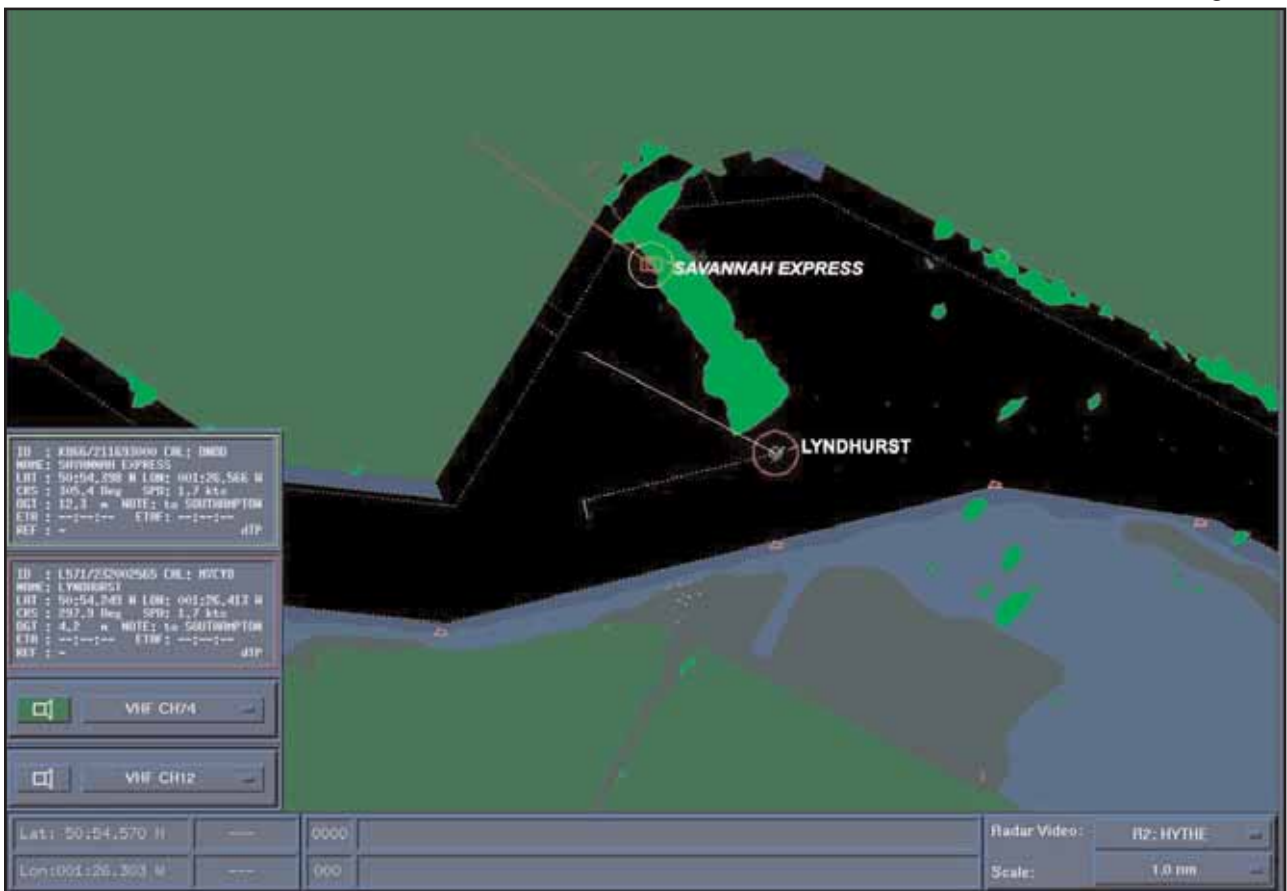
Figure 7

Radar recording from Southampton VTS showing *Savannah Express* making contact with the linkspan

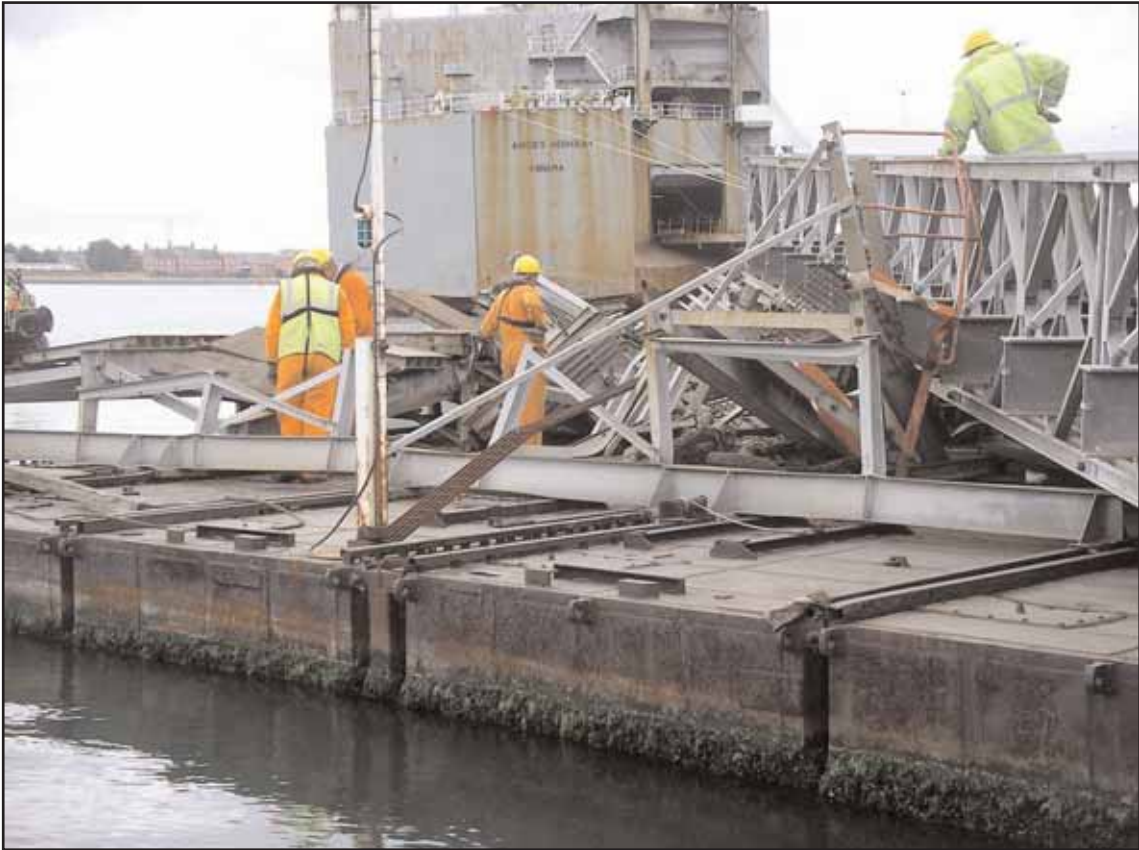
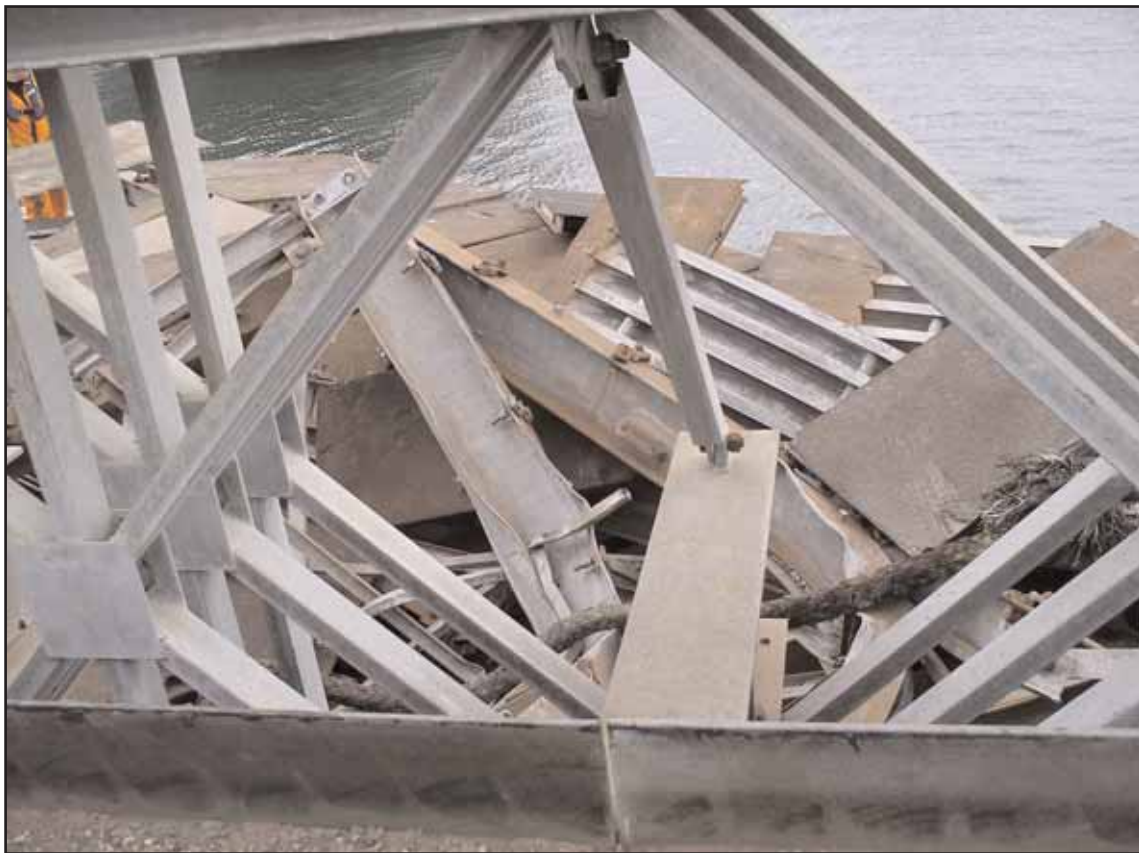
Figure 8 and 9

As she slowly continued her swing to starboard, the linkspan was severely damaged. The vessel then scraped the laid up ro-ro ferry, *Bergen Castle*, before coming to a halt (**Figures 8 and 9**).

Linkspan damage
