Report on the investigation of
the collision between
Carrie Kate and ***Kets***
resulting in one fatality
near Castle Point, St Mawes, Cornwall
16 July 2005

Marine Accident Investigation Branch
Carlton House
Carlton Place
Southampton
United Kingdom
SO15 2DZ

Report No 6/2006
February 2006

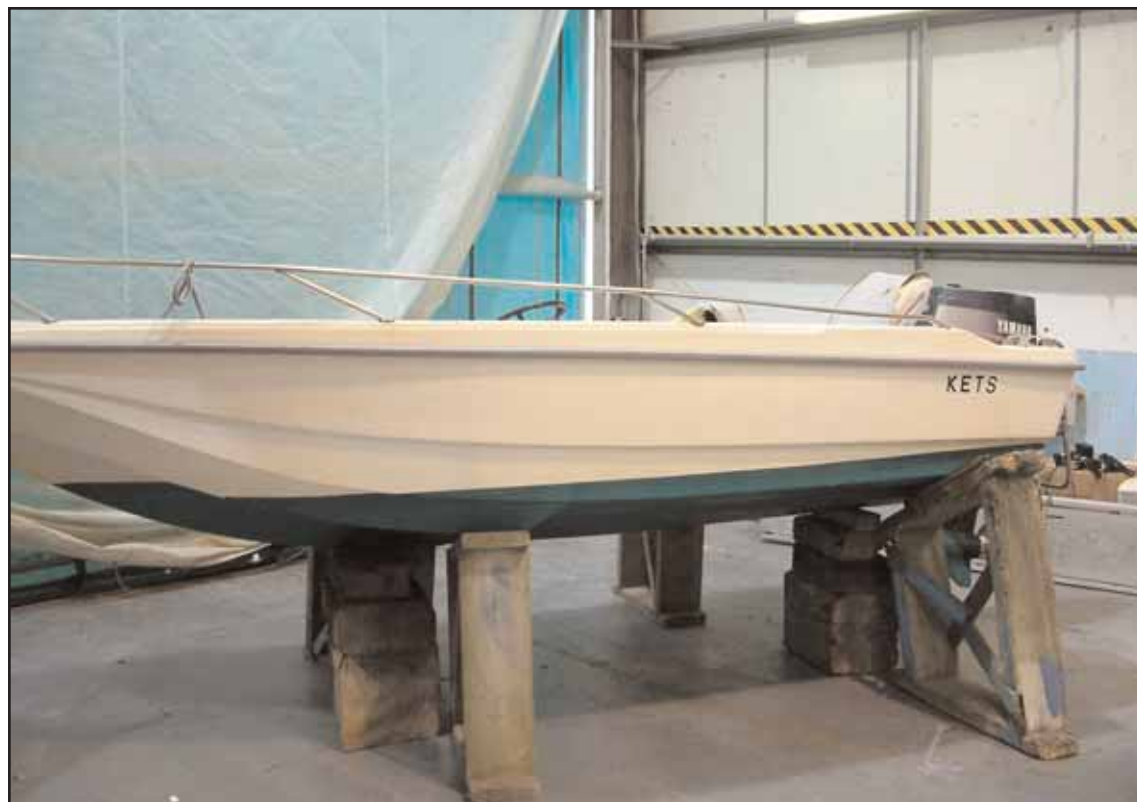
Figure 2

Kets

Kets was a 4.55m general purpose Dell Quay Dory **(Figure 2)**. Her age could not be determined, but it is known that Dell Quay stopped manufacturing this model of dory in 1970. The hull was of GRP foam sandwich construction which, the makers claimed, made the vessel unsinkable. *Kets* was powered by a 70hp Yamaha outboard engine with an electric power tilt for trimming the vessel when planing. Her top speed was not known, but was believed to be well in excess of 20 knots.

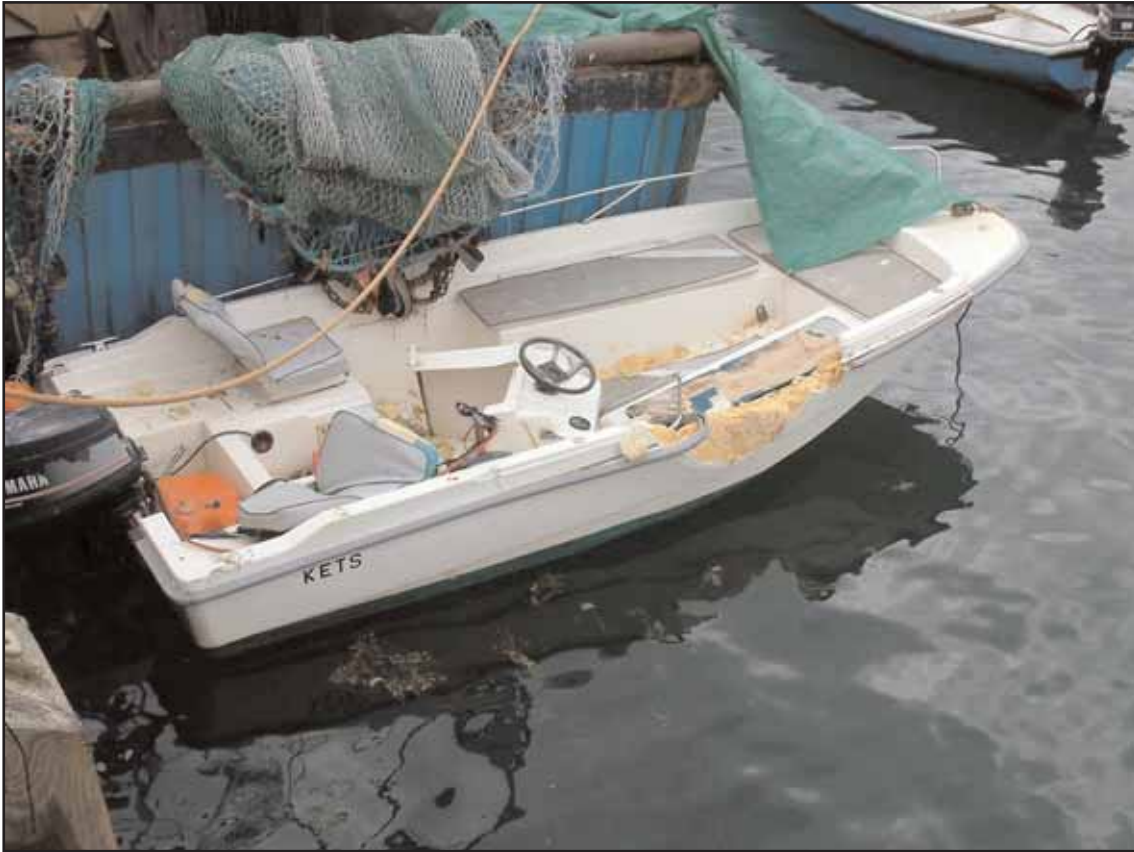
Figure 3

Carrie Kate's stern drive demolished a large section of the starboard side of *Kets* (**Figures 3 & 4**), but the vessel remained afloat. The helmsman's console in *Kets* was knocked over the starboard side and was left hanging by the engine control cables. The engine had stopped as a result of the collision, but the kill-cord was still in place. *Carrie Kate's* helmsman managed to start his vessel's engine, but he was unable to manoeuvre her to pick up the man in the water because the stern drive had been damaged in the impact and was hanging loosely from the transom (**Figure 5**).

Damage to Kets starboard side

- c) Evidence from the impact damage shows that *Carrie Kate* struck *Kets* at an acute angle on the starboard side, and crossed *Kets* at an angle of 20°-30°. This may suggest that *Kets* had *Carrie Kate* on her starboard side and that *Kets* was the give way vessel.

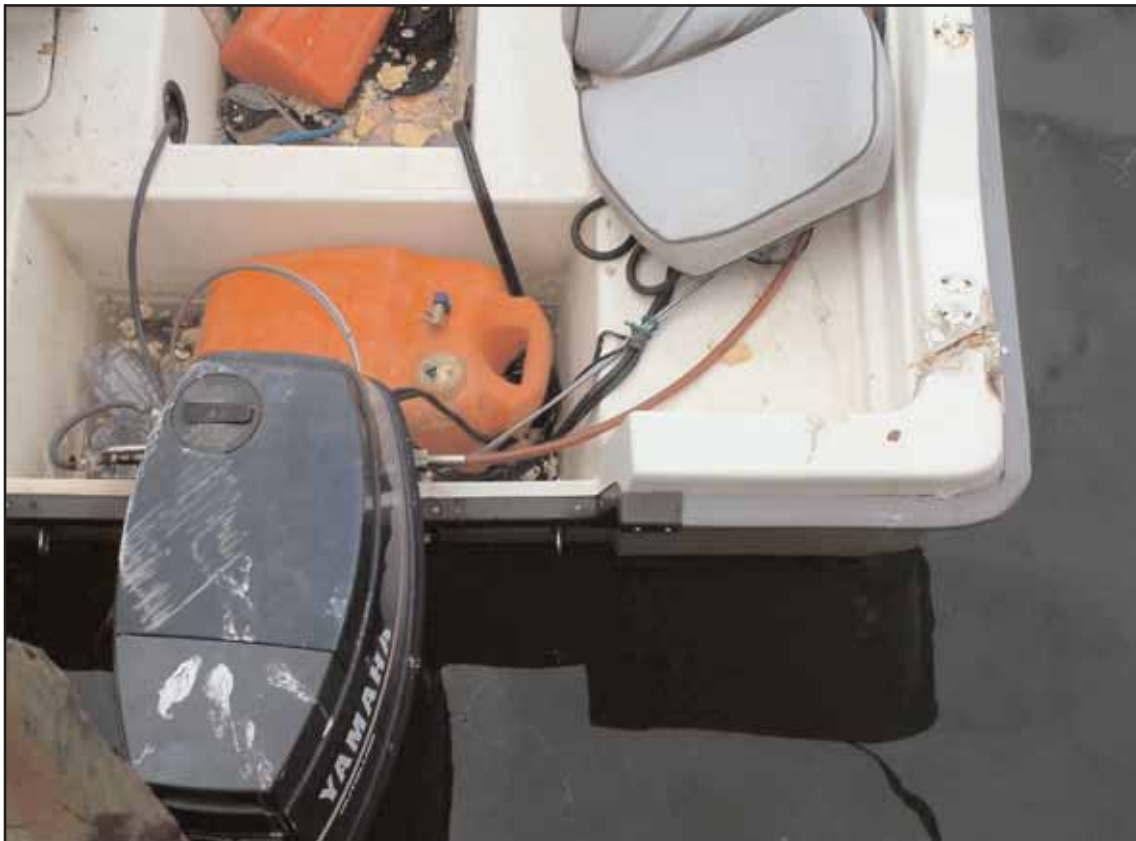
Figure 4

Kets damage aft

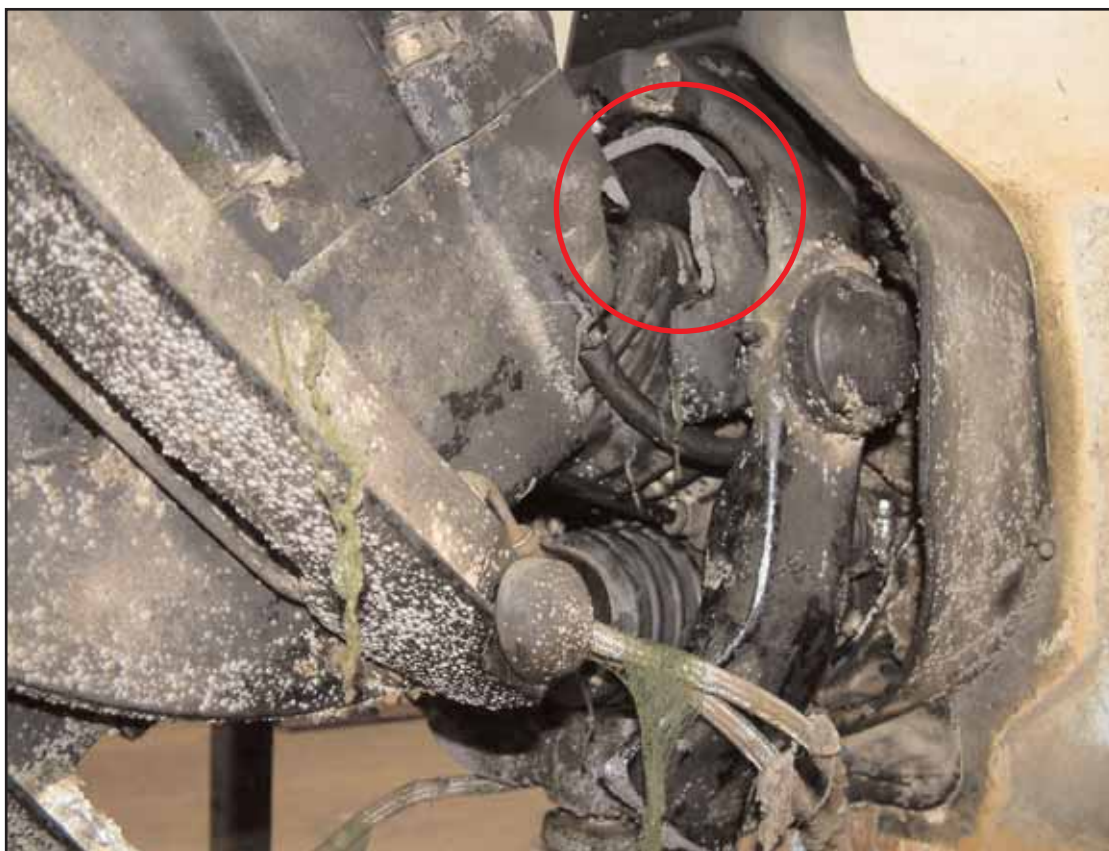
Carrie Kate stern drive damage

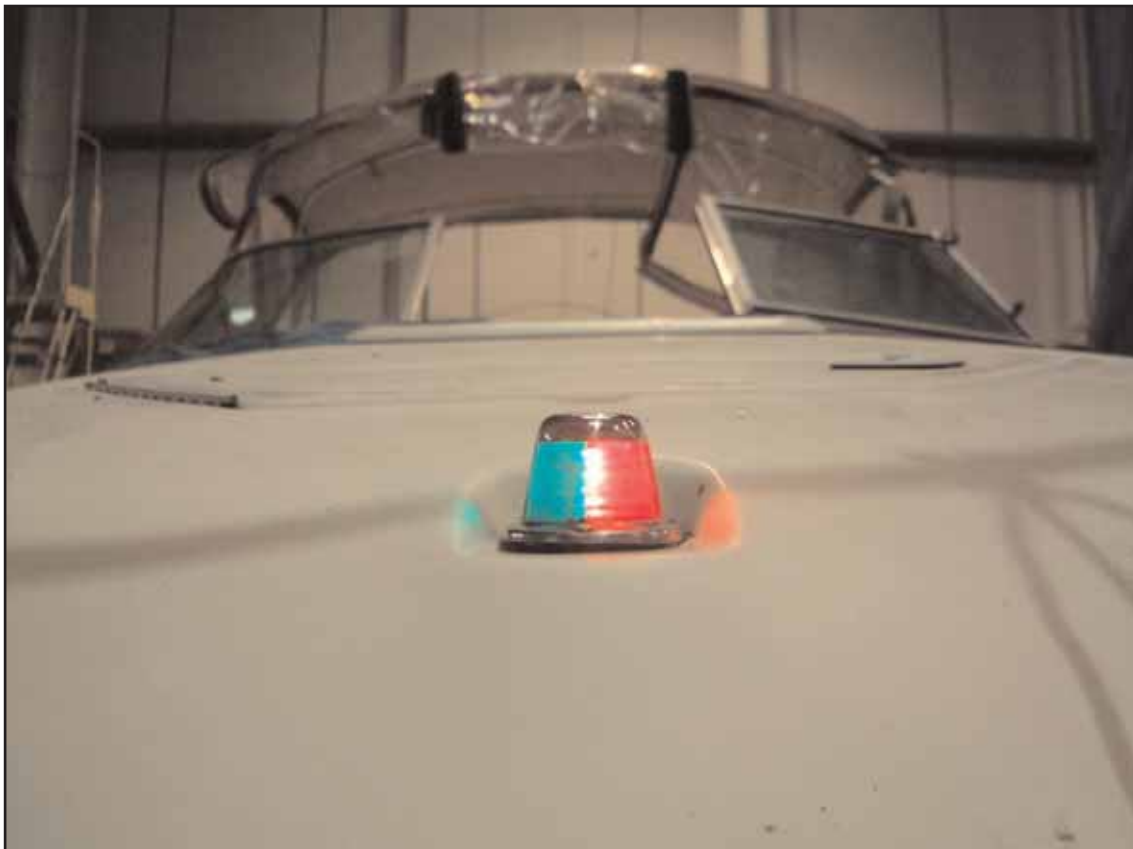
Figure 7

Carrie Kate's combined sidelight

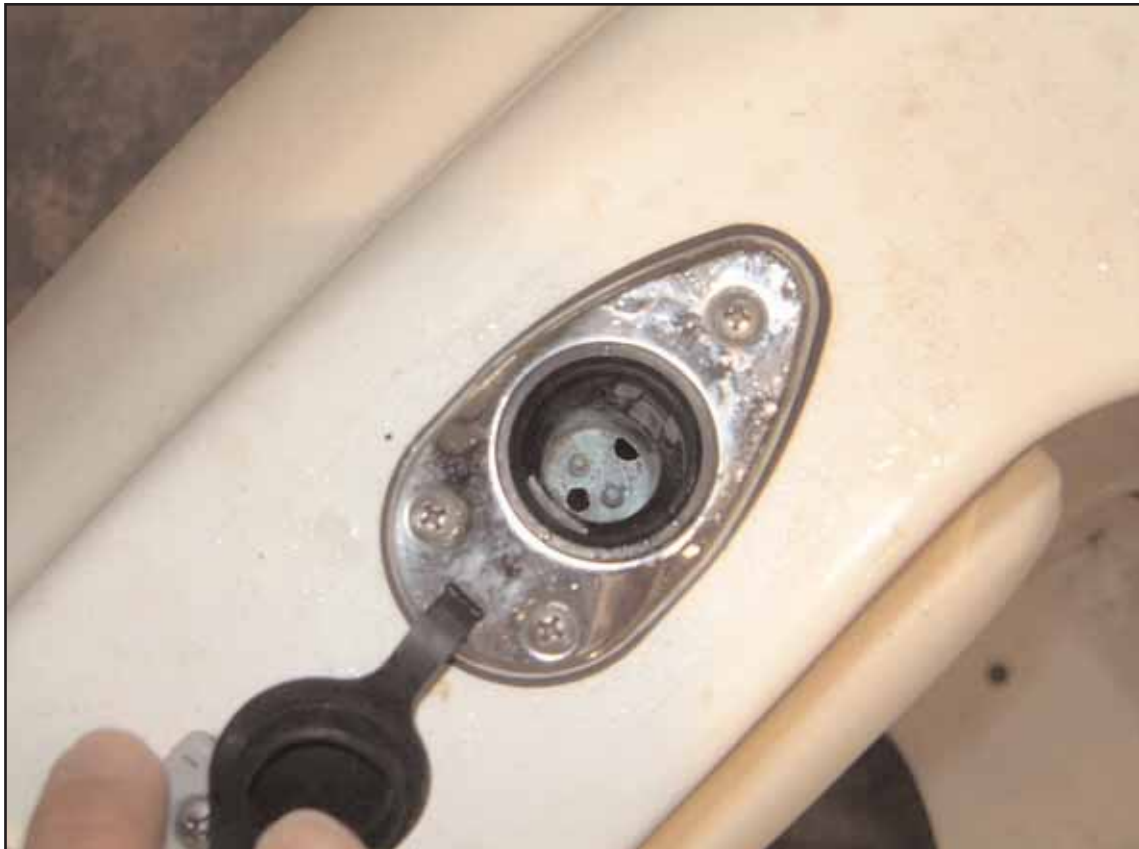
Figure 8a

Carrie Kate was a 6.5m powerboat. She was propelled by a petrol inboard engine, via a stern-drive, enabling her to reach speeds of between 38-41 knots. There were no flares, lifejackets or VHF radio carried onboard, and her only navigation light was a red and green combined sidelight on her bow. The pole-mounted all-round white light, a non-permanent fitting which plugged into the starboard quarter, was broken and not onboard the vessel at the time of the accident.

Carrie Kate's all round white light socket
