Report on the investigation of
the capsize of the sailing dinghy

Mollyanna

With two fatalities off Puffin Island, North Wales

Report No 9/2006
March 2006

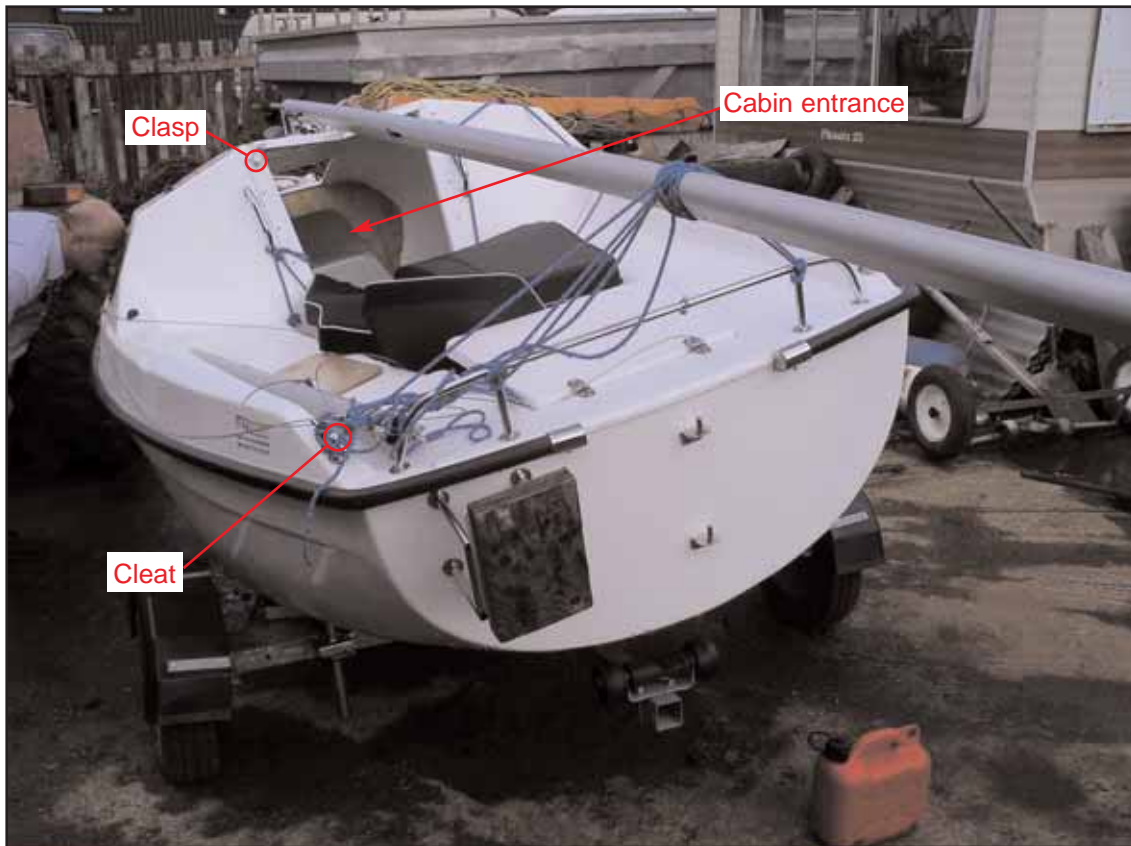
Figure 2

As *Mollyanna* approached Puffin Island, the wind increased considerably and the sea became choppy. Spray came into the boat, and the younger of the grandchildren moved to the shelter of the cabin. The drop boards to the cabin access were then replaced, and secured by a single clasp (**Figure 2**). The boat appeared to be sailing on an even keel, but the owner's son found it increasingly difficult to keep the mainsheet in hand, and took a turn around a mooring cleat adjacent to where he was sitting (**Figure 2**).

Mollyanna after recovery

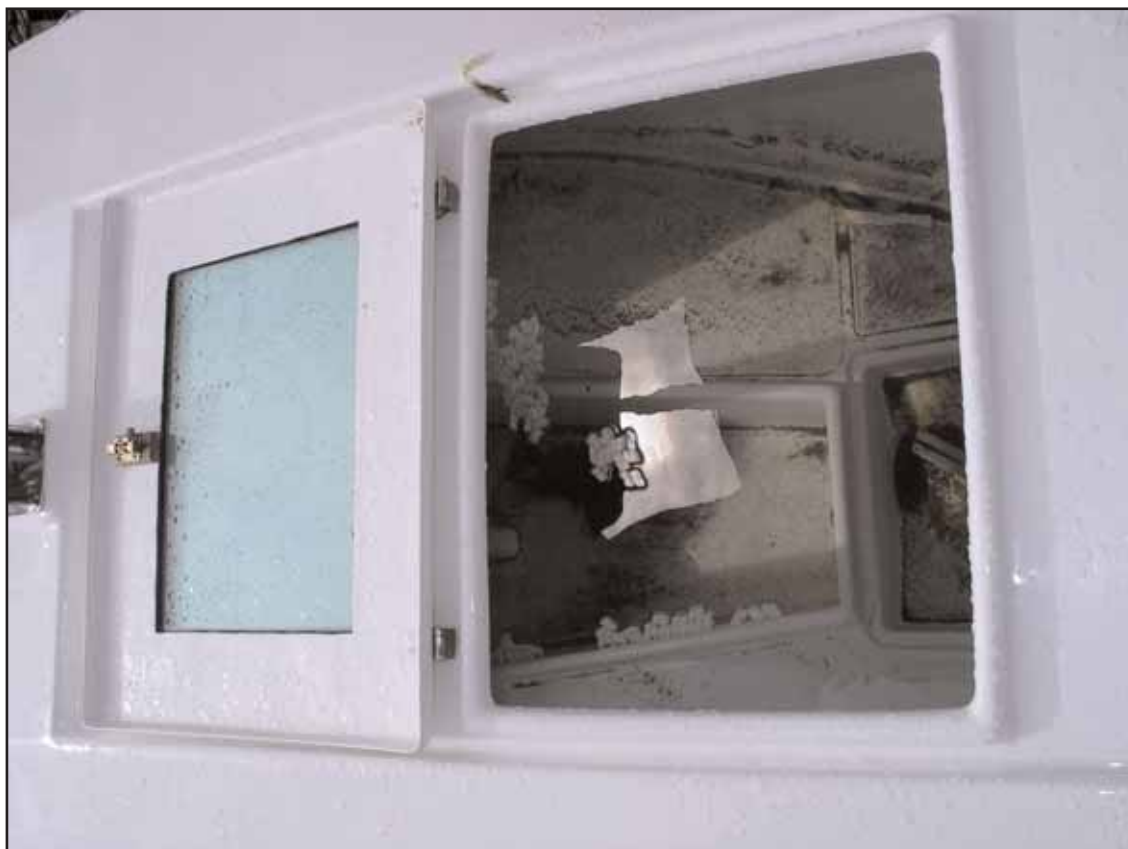
Figure 3

All of the crew successfully cleared the upturned hull, with the child in the cabin either escaping through the dinghy's forward hatch (**Figure 3**), or the access, which had been secured by drop boards. The owner's son climbed onto the upturned hull and fully extended the centre plate, which had almost completely dropped back to its stowed position. He then hung from the centre plate and pulled the boat upright. Almost immediately, the boat rolled over on top of him, and again inverted. The owner's son repeated the procedure. During the second attempt, the boat remained upright for about 15 seconds before capsizing and inverting yet again. During the short period the dinghy was upright, the owner's son saw that the cockpit was full of water, and that the drop doors to the cabin were missing. He also confirmed that the mainsail sheet was no longer secured to the mooring cleat.

Forward hatch

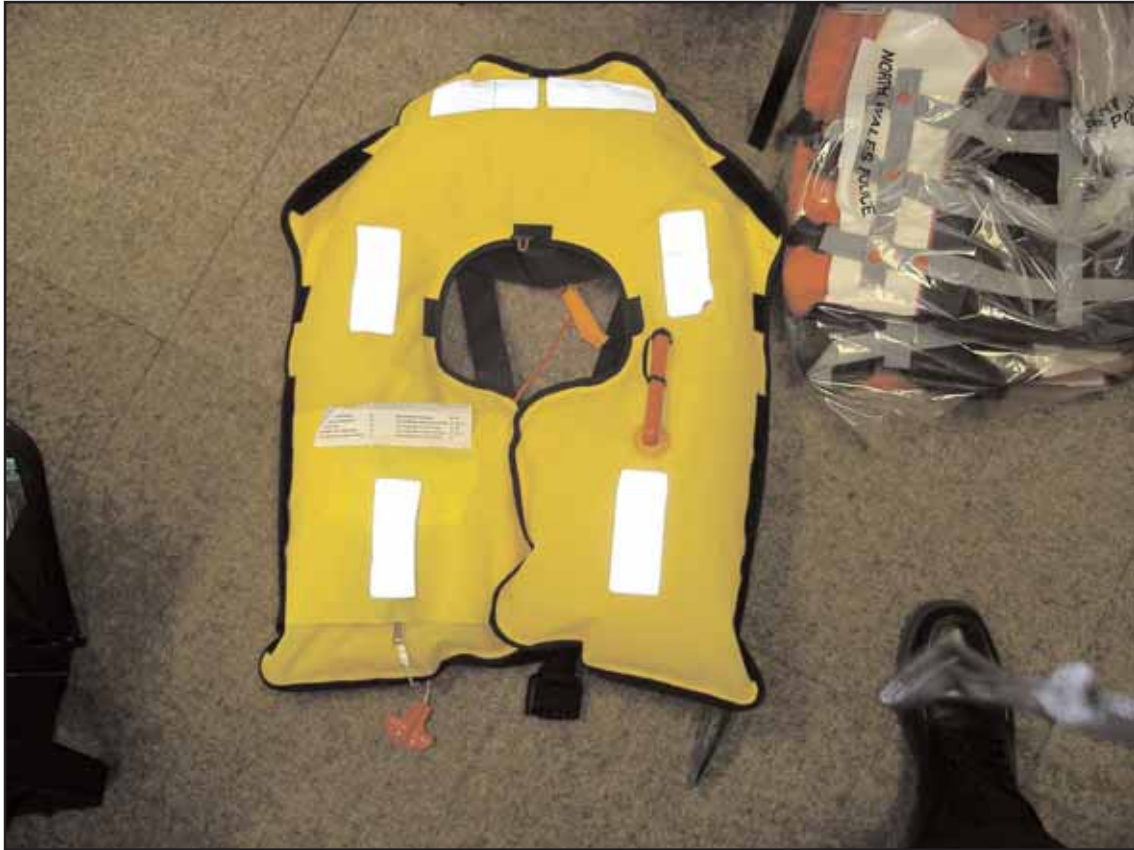
Figure 5

All of the crew in the boat were wearing 'T' shirts, shorts, and training shoes. The owner was also wearing a thin, zip-up style golfing jacket and a lifejacket (**Figure 5**). The lifejacket was manufactured in 1994, but it is not known where or when it had been purchased, and there was no record of servicing. The owner's son and his grandchildren were all wearing buoyancy aids.

Owner's lifejacket

The lifejacket worn by the owner of *Mollyanna* was examined and tested by QinetiQ³ on behalf of the MAIB. The examination and tests indicated that the lifejacket was not damaged, was airtight, and operated correctly when manually inflated. When fitted correctly, the lifejacket supported a flotation manikin representing an unconscious body, in a stable position with the head clear of the

water. When the lifejacket was fitted with the waist belt loose, it tended to ride up the torso and allow the body to slip through, with the result that the manikin floated in the water with the mouth just submerged.

Finally, the owner of *Mollyanna* encountered difficulties with his lifejacket. As the tests conducted by QinetiQ indicated that the lifejacket provided proper support when inflated, it is evident that the owner had not tightened its waist belt sufficiently. This allowed the jacket to ride up his body, causing it to be more of a hindrance than assistance, particularly as the owner was not a strong swimmer and the sea had become choppy. It is not known to what extent the owner's heart condition or medication affected his chances of survival.

6. The clothing worn by the crew would have provided very little insulation from the cold sea water. [2.5]
7. The waist belt on *Mollyanna's* owner's lifejacket was not tightened sufficiently. Consequently, the jacket rode up his body when inflated, and was more of a hindrance than assistance. [2.5]

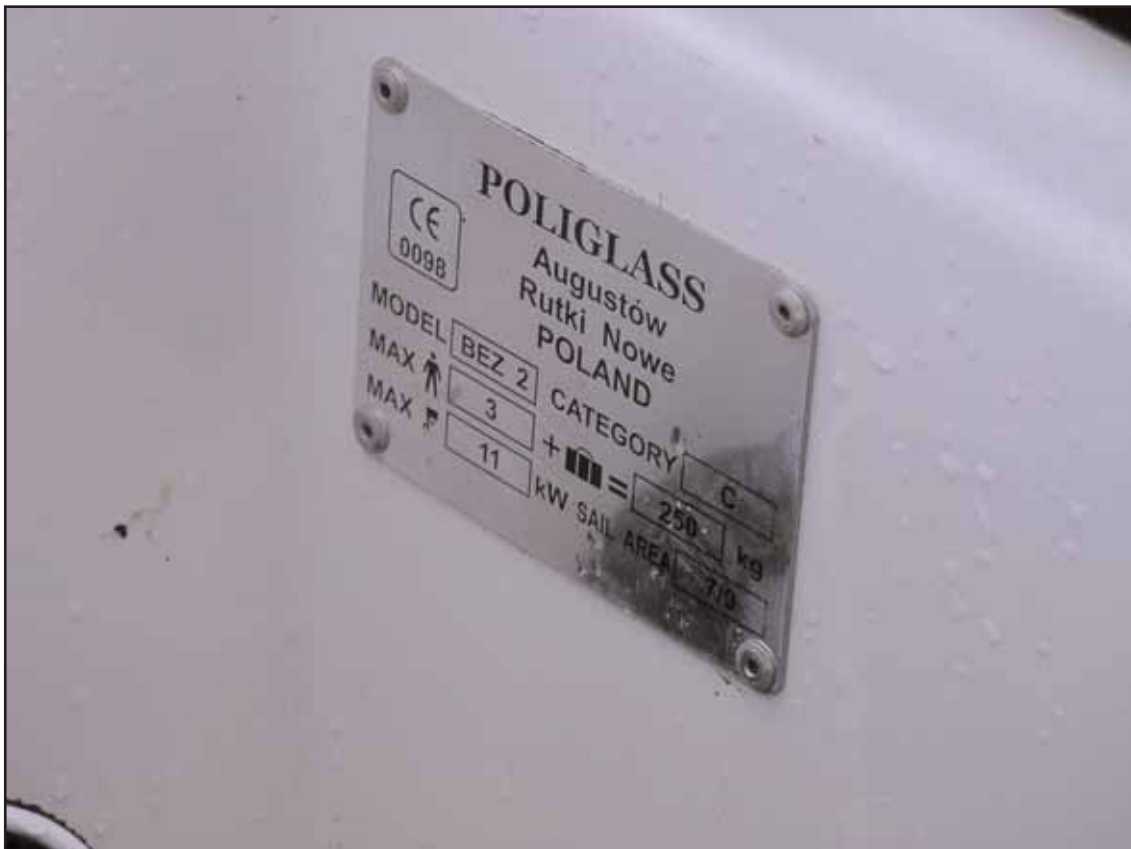
Figure 6

- the recommended maximum number of persons was three,
- the maximum recommended load was 250kg,
- the sail area was 7/9 [sic],
- the maximum recommended power rating of the outboard engine was 11kW, and
- the dinghy was intended for use in waters in Category C waters.
- It also showed the CE marking along with the notified body number of Germanischer Lloyd (0098), and the name of the manufacturer, Poliglass.

Builder's plate

Fifth, the maximum power rating noted on the certificate of conformity, issued in 2003 by the consultant, was 3.6kW; the maximum rating on the builder's plate was 11kW. Poliglass considered this to be an error, although 11kW was the rating used when the boats were sold via DarekCo.

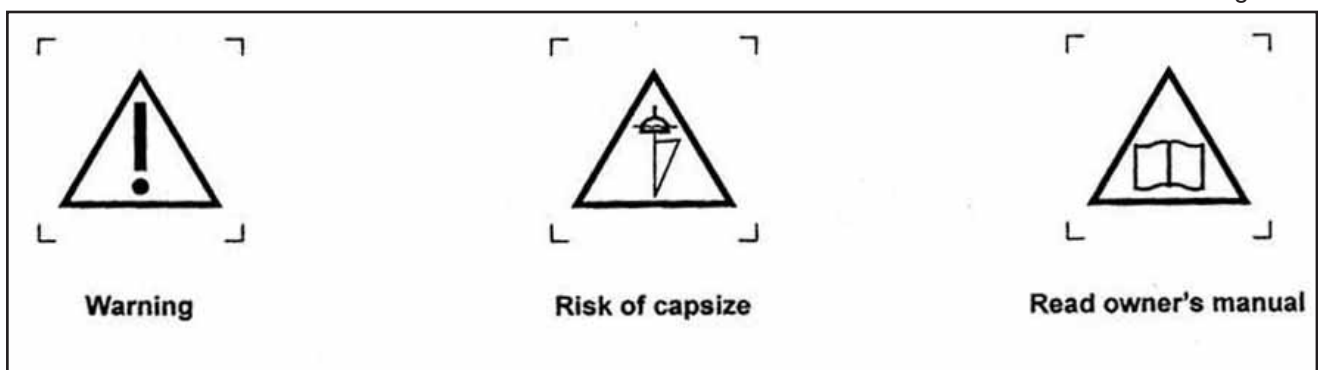
Figure 10

Warning signs

The standard requires information derived from the test completed to be included in the owner's manual. The requirement for warning signs (**Figure 10**) is similar, despite the expectation that most small dinghies are prone to capsize. Furthermore, the standard does not require attention to be drawn to the information that is available from failed tests, or tests that have not been attempted. Such information could be extremely useful in helping boat dealers to provide accurate product information, and in assisting boat owners to determine the limitations of their craft.

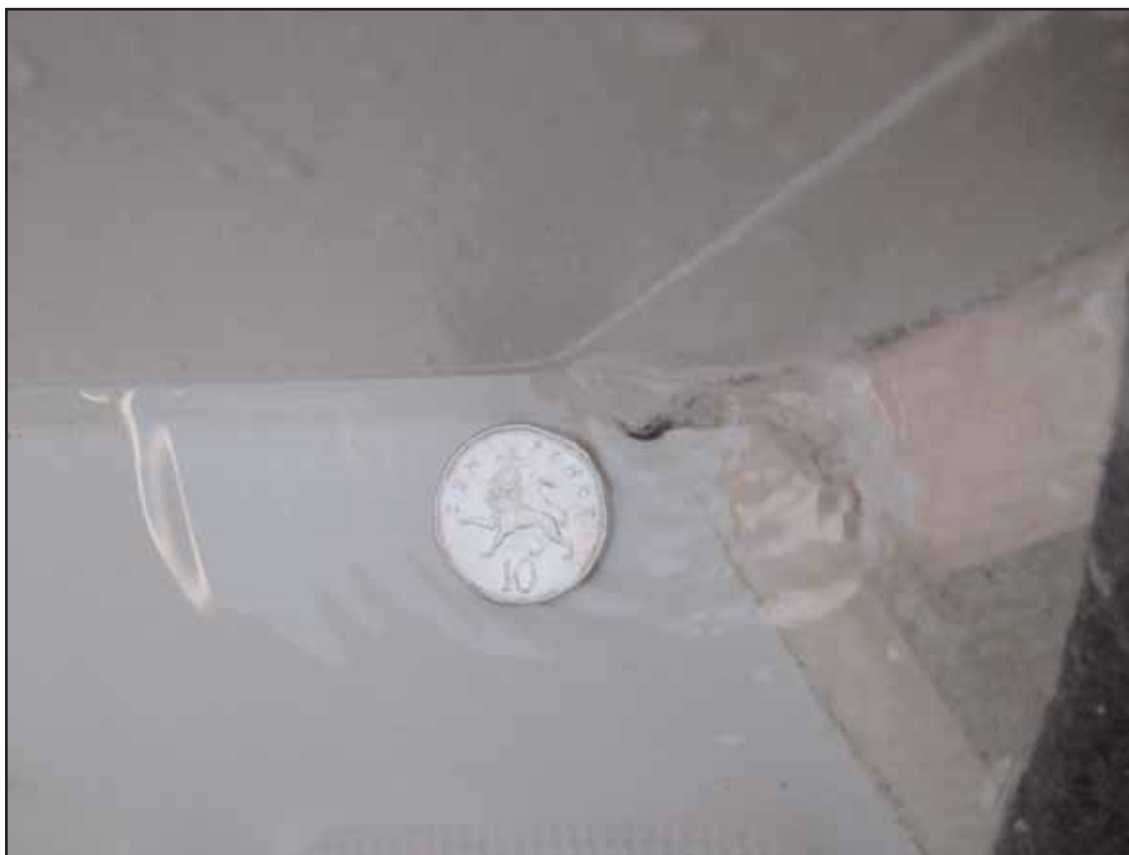
Figure 12

On completion of the capsize-recovery test, the water from the BEZ 2 could only be bailed when supported by craft on either side to prevent further capsize. When the boat was taken out of the water following the tests, it was evident that a large amount of water had entered the space between the inner mouldings and the hull. This substantially increased the weight of the boat, making it difficult to support on its trailer without damaging either the dinghy or the trailer. When the boat was tilted forward, the trapped water was seen to escape from the hull void space into the cabin via the seam joining the inner mouldings to the hull (**Figure 12**). When the dinghy was tilted aft, water escaped into the aft storage locker in a similar manner. In order to release all of the trapped water to safely transport the dinghy, it was necessary to drill a hole through an internal bulkhead into the void space. The hole was later secured with a watertight drainage plug.

Water passing through deck seam

The instability of the BEZ 2 in a swamped condition evident during the tests conducted in October 2005, and also following the capsize of both *Mollyanna*, and the dinghy off Langstone on 2 July 2005, was due to a lack of buoyancy. This was probably because the dinghy was either fitted with insufficient flotation, or because of the ingress of water into the spaces between the inner mouldings and the hull. The requirement for the fitting of additional flotation noted on the consultant's test report in 2001 was acknowledged by DarekCo, but a copy of the report was not forwarded to Poliglass, the boat's constructor. Therefore, although additional flotation was added after 2001, it is not certain whether the requirements of the test report were fully implemented.

The danger of water ingress into the spaces between the inner mouldings and hull was noted in the owner's manual (**Annex D**), which advised that care was to be taken when securing fittings to the deck and inner bulkhead because of the adjacent buoyancy spaces. However, the buoyancy spaces contained polystyrene and were not airtight; they were also not watertight (**Figure 12**). Consequently, as soon as the boat capsized, and water entered the cabin and cockpit area, it was able to penetrate into the buoyancy spaces and fill the areas not containing polystyrene. This caused a reduction in the dinghy's buoyancy, which was evident from the reduction in hull visible above the waterline while inverted during the tests in October 2005. Water trapped in the buoyancy spaces not only has a detrimental effect on the dinghy's stability, it also increases the risk of damage to the boat when stored or transported on a trailer.

13. The instability of the BEZ 2 in a swamped condition was due to a lack of buoyancy, which was probably due to the dinghy either being fitted with insufficient flotation, or because of the ingress of water into the spaces between its inner mouldings and its hull. [2.7]
