Report on the investigation of
the collision between
2 Sorcerer Powerboats
during a junior racing event at
Portland Harbour
on
19 June 2005

Marine Accident Investigation Branch
Carlton House
Carlton Place
Southampton
United Kingdom
SO15 2DZ

Report No 13/2006
March 2006

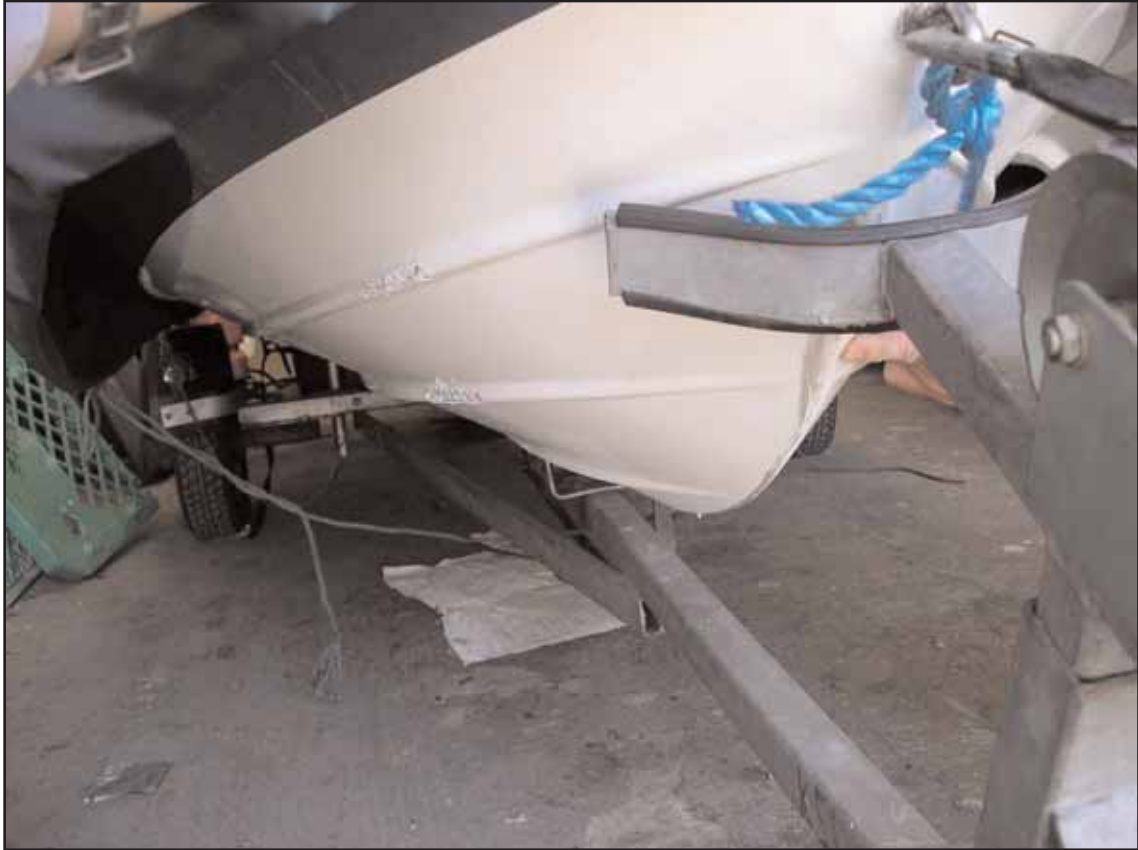
Figure 2

Description	:	Collision between two powerboats during a junior racing event
Time and date	:	1320 on 19 June 2005
Location of incident	:	Portland Harbour
Persons on board	:	2
Injuries/fatalities	:	A 13 year old child seriously injured
Damage	:	Slight hull coating damage to one boat. Major hull structural damage to the other. (Figures 2 and 3)

Hull damage to boat K51

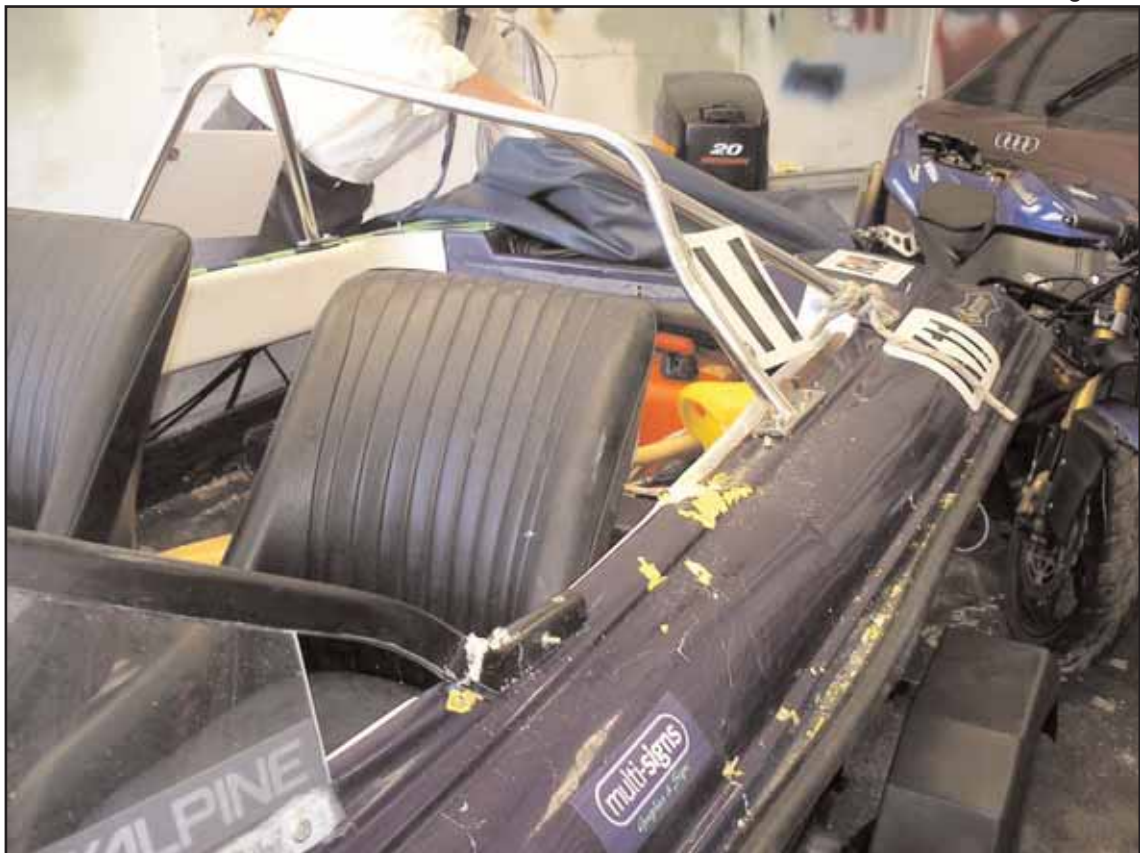
Figure 3

Impact damage to K11

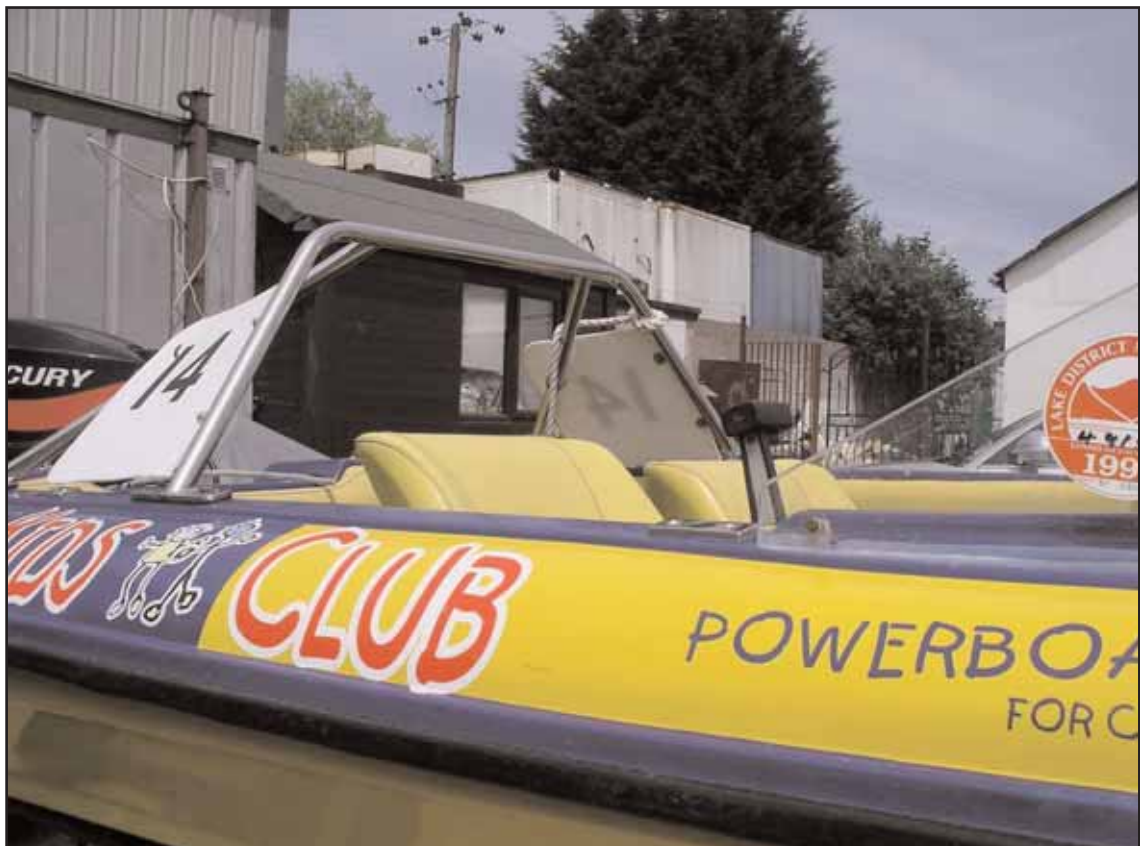
Figure 5

The anti-intrusion bar was added during the 2003 racing season to protect the crew from injury caused by boats overriding or riding up alongside each other during racing (**Figure 5**).

Anti-intrusion bar

The anti-intrusion bar onboard boat K11 was found to be severely distorted by the impact from the hull of K51. It is probable that the bar did provide some protection for the crew of K11, but it did not provide all the protection necessary.

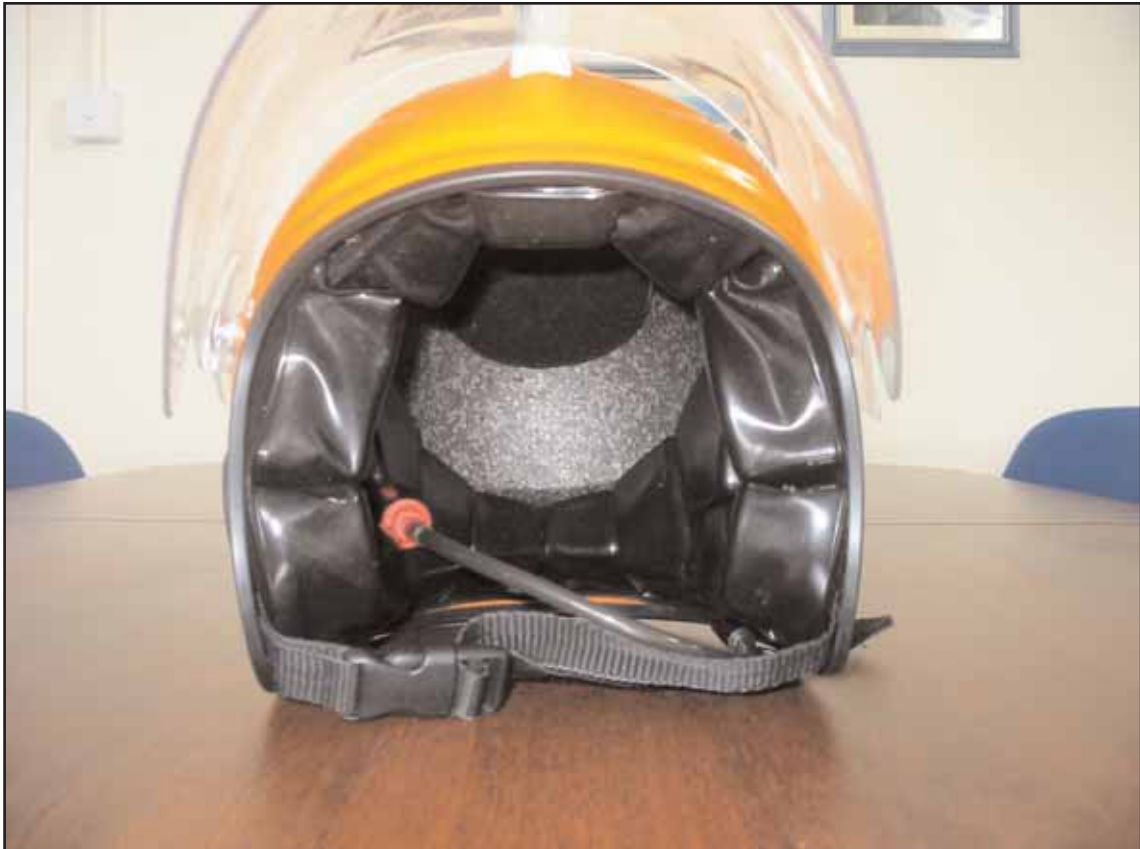
Figure 8

The injured co-driver of boat K11 was wearing a MK10 Gecko Marine Safety Helmet (GMSH), which became dislodged at some time during the accident and was found floating in the sea with the chin strap fastened and the internal bladder partially inflated. A neoprene sleeve used to assist in securing the chinstrap was missing. The visor was found to be cracked, but apart from this, there were no visible signs of impact or damage on the helmet.

Actual MK10 GMSH worn by the injured co-driver

What caused the helmet of K11's co-driver to come off during the accident may never be established. Despite careful scrutiny of the video recording, the MAIB could not determine when the helmet became dislodged. The helmet was found to be largely undamaged, the chin strap was fastened and the bladder partially inflated. Anecdotal evidence indicates that the co-driver was usually careful to ensure the helmet was donned correctly. However, the co-driver had a head circumference of 54cm and the helmet was only tested for head sizes between 57cm and 62cm. Furthermore, an important part of the helmet's securing arrangement, the sleeve on the chin strap, was found to be missing, and this could have had a bearing on the security of the fastening.

Helmet fitting and donning instructions have been extensively re-written to enable the user to determine whether the helmet supplied is a proper fit, how to wear it correctly, and determine if it is being worn correctly by use of a *roll test*.

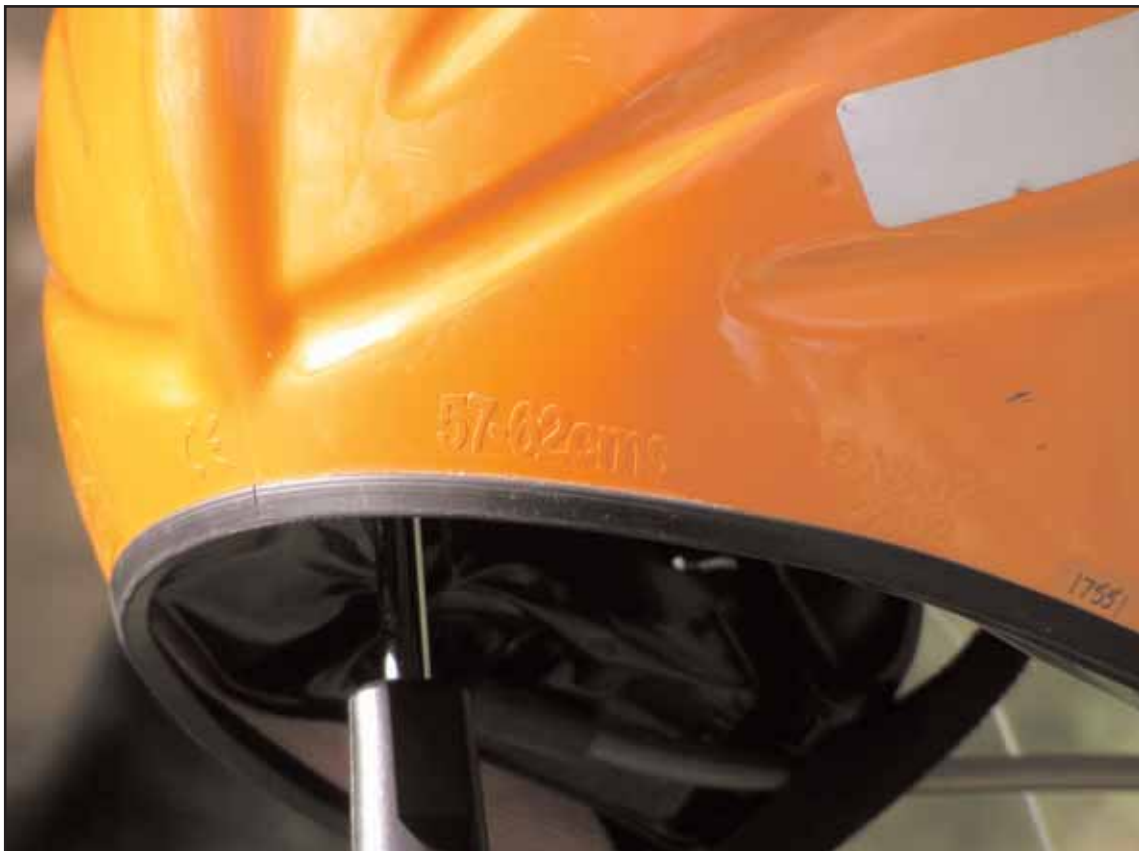
Figure 9

It was also found that, despite a widespread belief that the helmet was “one size fits all”, and therefore appropriate for use by children, the helmet had only been tested in line with the British Standards Institute specification for an adult male head size. The protection afforded by the helmet to persons with head sizes outside this range had therefore not been established.

Helmet embossed size marking

- The MK10 GMSH was only tested for sizes 57cm to 62cm. As such, it was not tested for safety for many head sizes, including most children's. [2.7.1]
- What caused the helmet of K11's co-pilot to come off during the accident may never be established. However, the boy's head was smaller and outside the range of head sizes for which the helmet had been tested, and an important part of the helmet's securing arrangement was missing. [2.7.1]

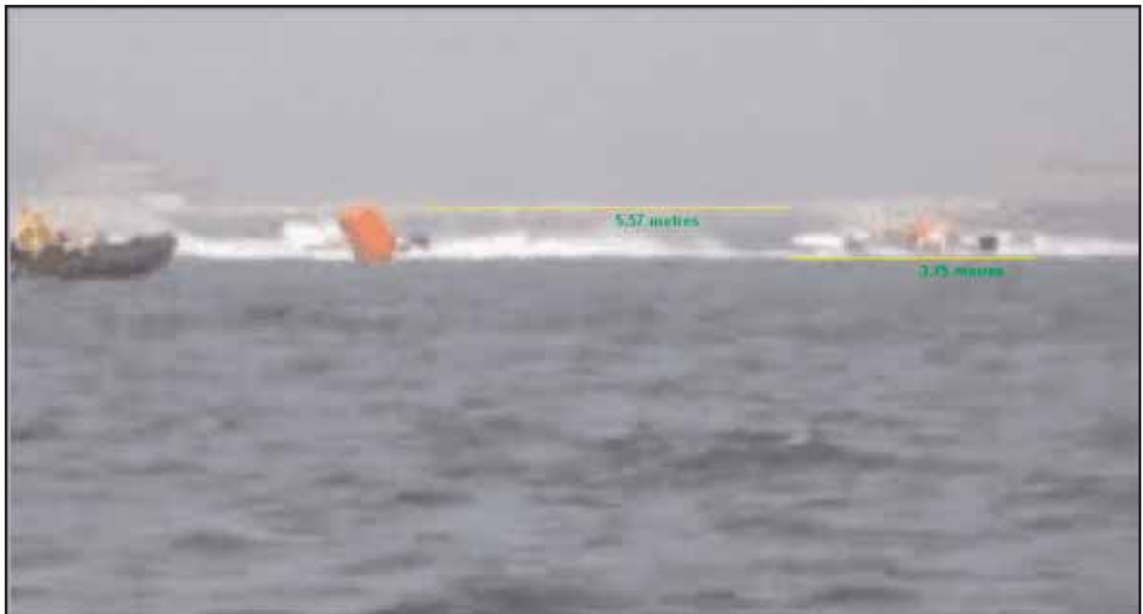
Figure 12

The precise reason that K11 hooked cannot be ascertained with any certainty. However, the three leading boats had already passed the marker buoy, and their wake, combined with the choppy seas, would have left an area of broken water at the time and location of the collision.

Position of K11 and K51 just before K11 hooked

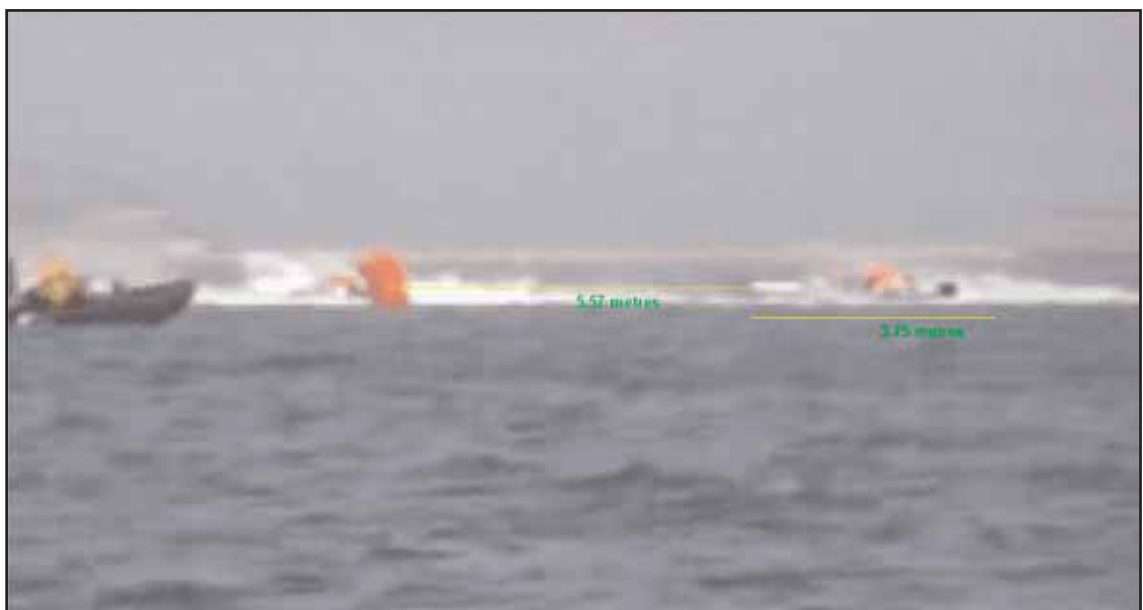
Figure 13

Hooking can be caused by broken water and the bow suddenly dropping into a trough, or by over steering where the driver tries to make too tight a turn often due to inexperience, or when the kill cord is inadvertently disconnected or the engine stops for another reason, leading to the bow suddenly dropping into the sea.

Position of both boats as K11 hooked

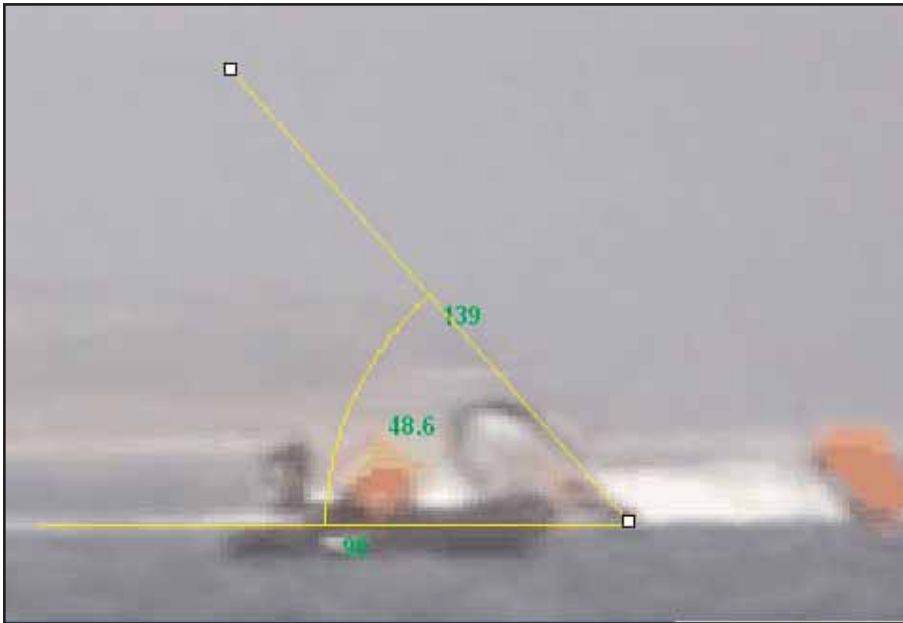
Figure 14
Maximum vertical angle of K51 after impact

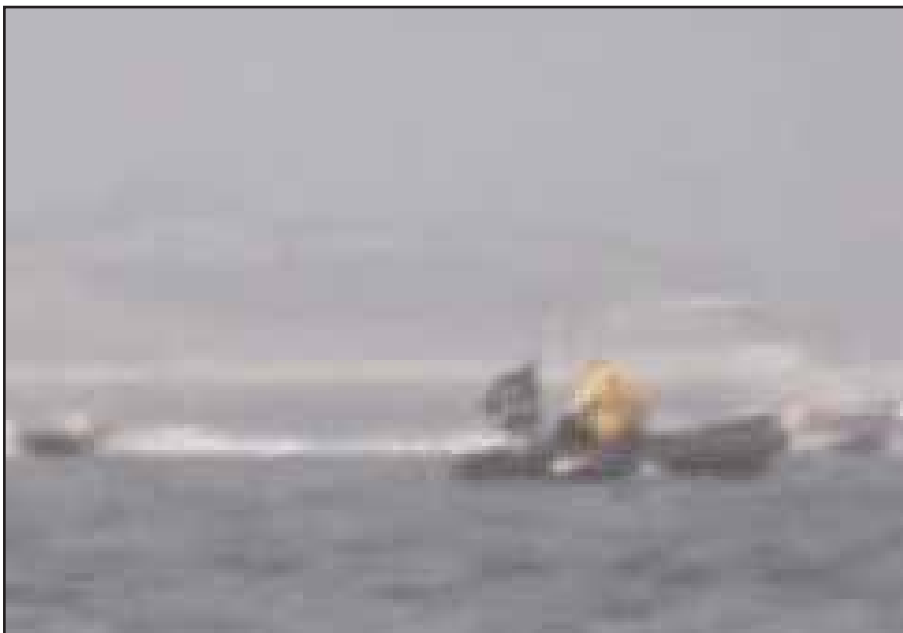
Figure 15
Initial collision and hull impact

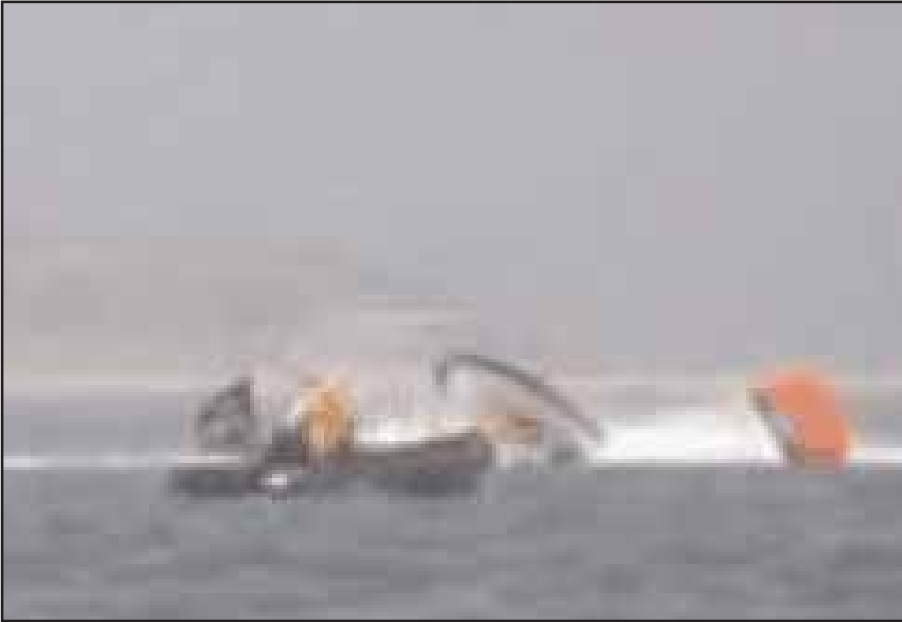
Figure 17
K51 continues to over run K11

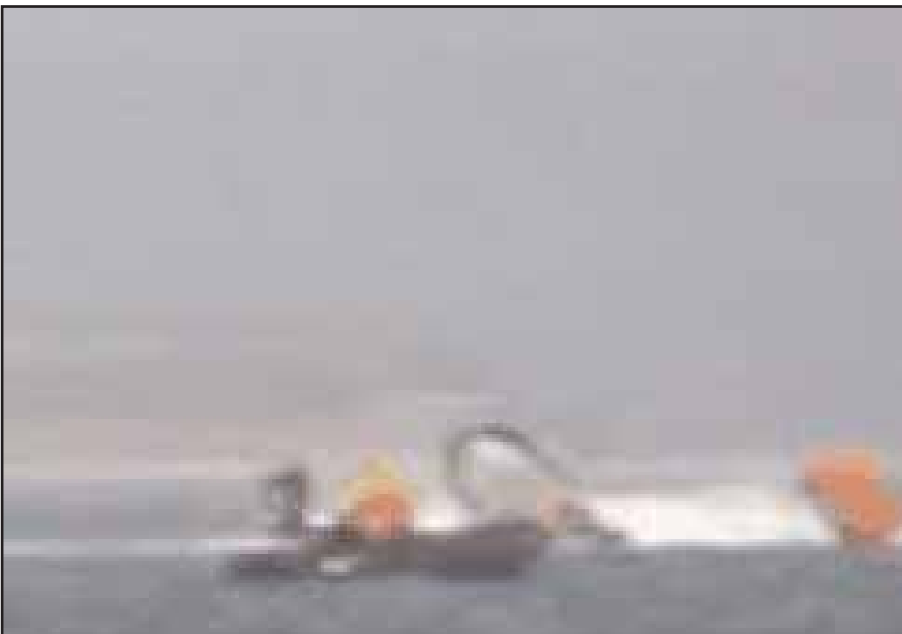
Figure 18
K51 continues to over run K11
