Report on the investigation of the capsizing  
and loss of the 9.8m stern trawler

***Bounty***

4 miles off Berry Head, South Devon  
on 23 May 2005

**Report No 2/2006  
February 2006**

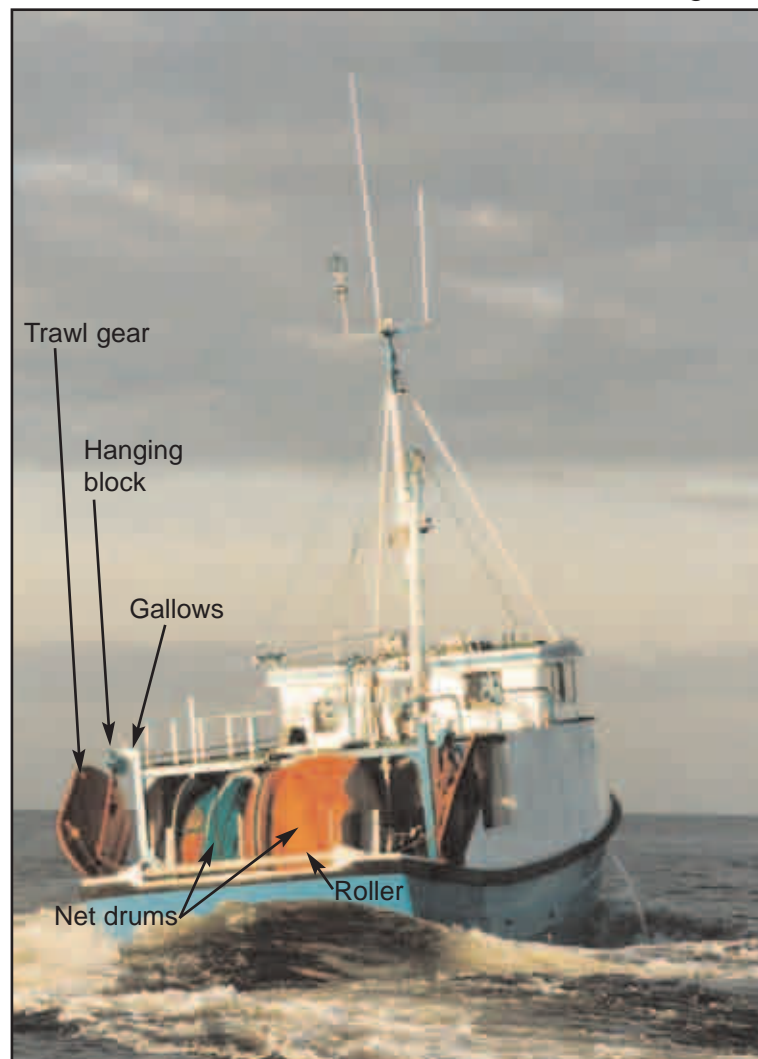
Figure 4

- Hanging blocks were suspended from gallows at the aft end (**Figure 4**). The warps/bridles/splits (**Figure 3**) were led over the hanging blocks and then down through the shelter top via two pulleys to the trawl winch (**Figure 5**).
- Two split net drums, each with a core pull of 2.1 tonnes, and a weight of 780kg; direct drive low speed/high torque motor without clutch or brake. The nets were wound onto the net drums, after being detached at the split ends, they were hauled over a roller attached to the top of the transom bulwark (**Figure 4**).

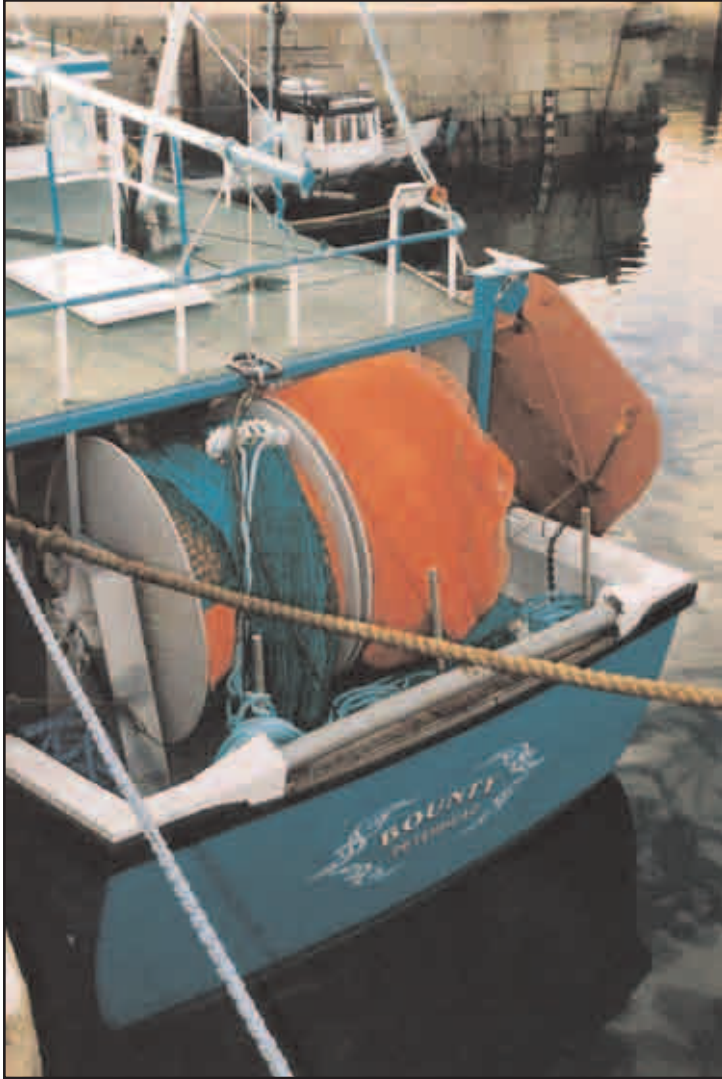
Figure 6

Photographs taken on builder's sea trials (**Figures 6 & 7**) show the position of the waterline at the fore and aft ends. This waterline was marked on the lines plan, and it was found that the minimum freeboard was about 240mm in the region of the middle freeing port (**Figure 8**). *Bounty* displaced about 20 tonnes at this waterline.

Waterline aft

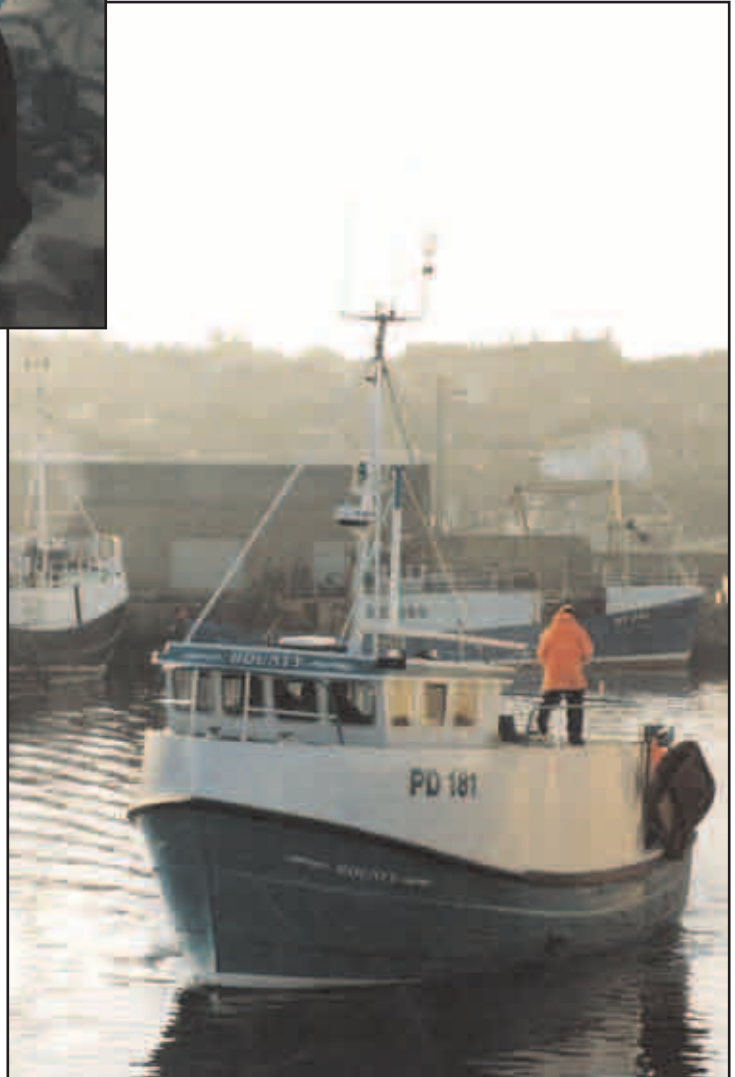
Figure 7

Waterline forward

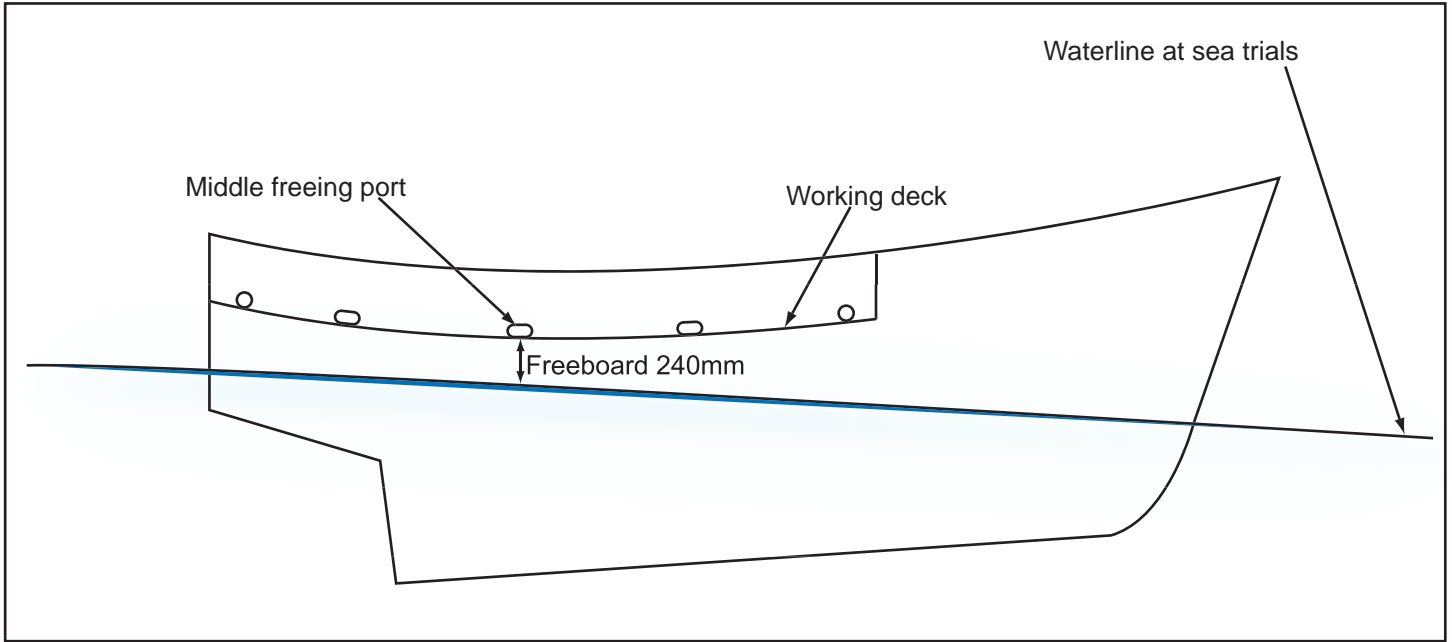
Figure 8

Freeboard diagram (not to scale)

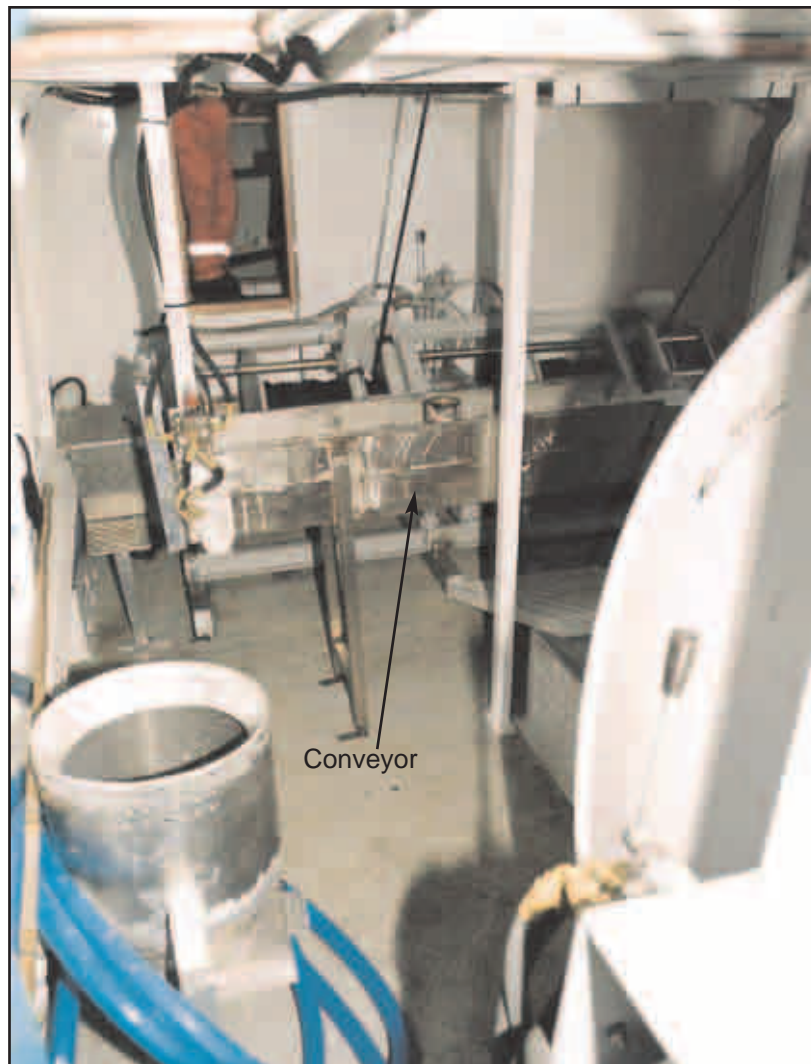
Figure 9

A stainless steel conveyor (**Figure 9**), weighing 100-200kg was fitted to *Bounty* at the time of the sea trials, but this had been removed and was not on board at the time of the accident. Ships and boats tend to increase in weight as they grow older, due to an accumulation of stores, equipment, paint etc. The skipper recalls that the freeboard was less than that shown in **Figure 8**, which indicates that the weight growth exceeded the weight loss which was caused by the removal of the conveyor.
