Report on the investigation of
the collision between
Thorngarth and Stolt Aspiration
River Mersey, Liverpool
13 April 2005

Marine Accident Investigation Branch
Carlton House
Carlton Place
Southampton
United Kingdom
SO15 2DZ

**Report No 21/2005
November 2005**

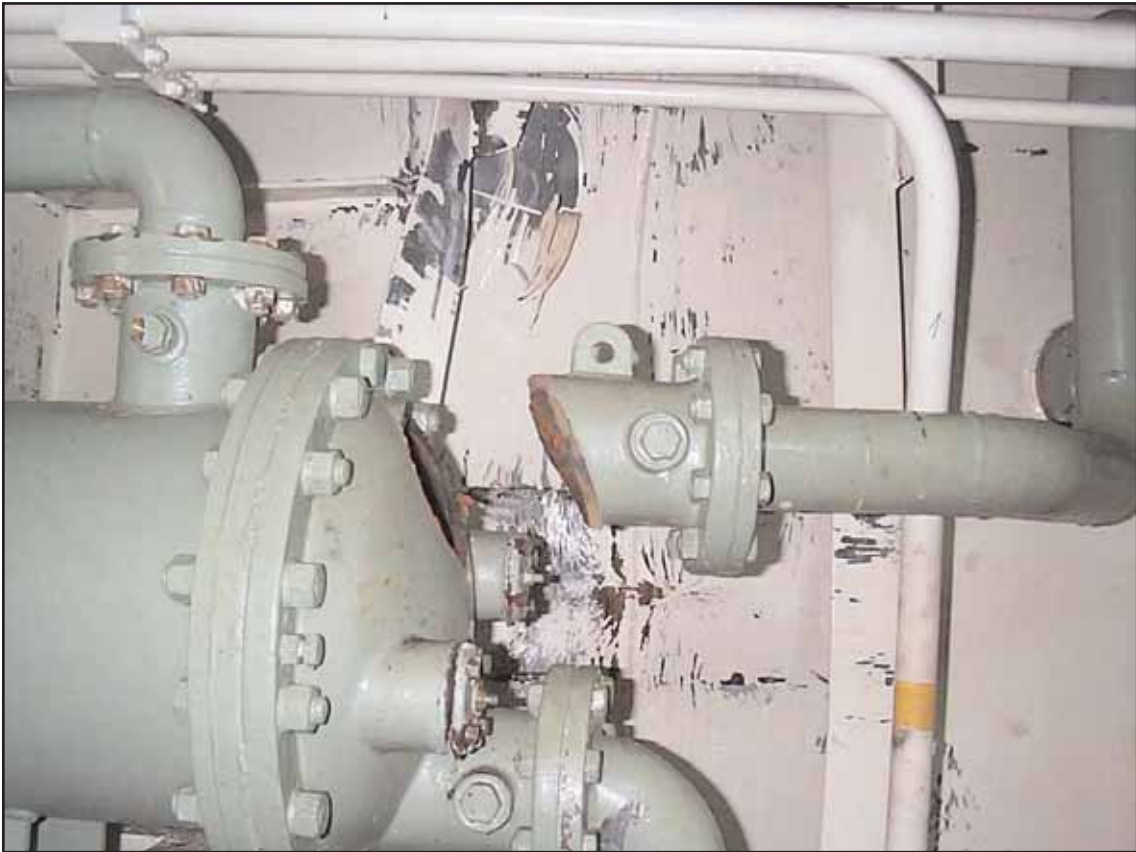
When *Thorngarth* came back upright, her mate left the bridge to check on the other crew members. Passing through the cross-alleyway, he came across the engineer, lying on the deck with his arm at an unusual angle. The engineer appeared to be in no imminent danger, so the mate went out on deck to confirm that the deckhand was unhurt. He then shouted to the master that the engineer had been injured. The deckhand and the mate then went to the engine room to assess the damage. They could see water coming in through a crack in the ship's side and from damage to the starboard main engine jacket water cooler (**Figure 4**).

Damage to the starboard main engine jacket water cooling heat exchanger and ships side

and isolated its jacket water cooler. This action stopped much of the water ingress, and the tugs' crews attempted to stem the remaining water flow into the vessel by blocking the holes in the ship's side using *Thorngarth's* damage control equipment.

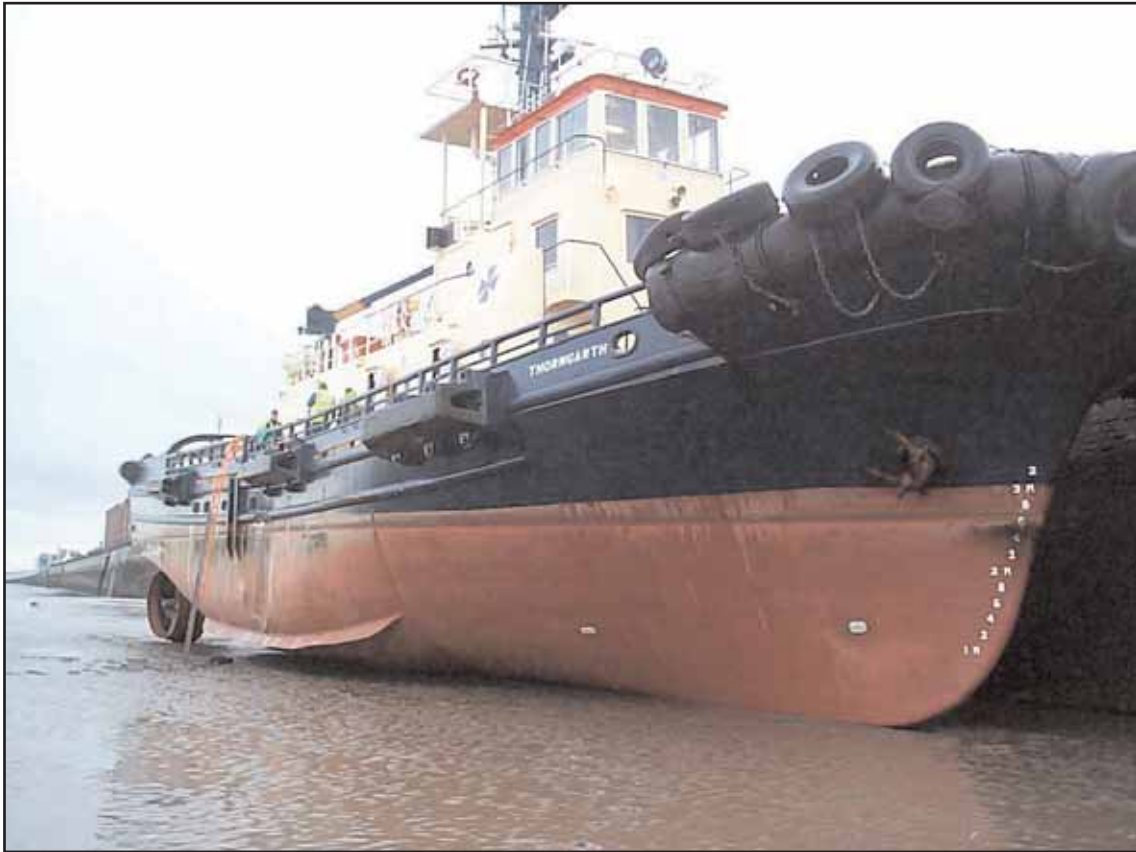
Figure 5

Thorngarth beached at Kings Dock River Wall

the damage and noted that all preparations for drying out had been made. They then sent the personnel from the other tugs back to their vessels and sent the crew of *Thorngarth* home. The tug dried out at about 0535 (**Figure 5**).

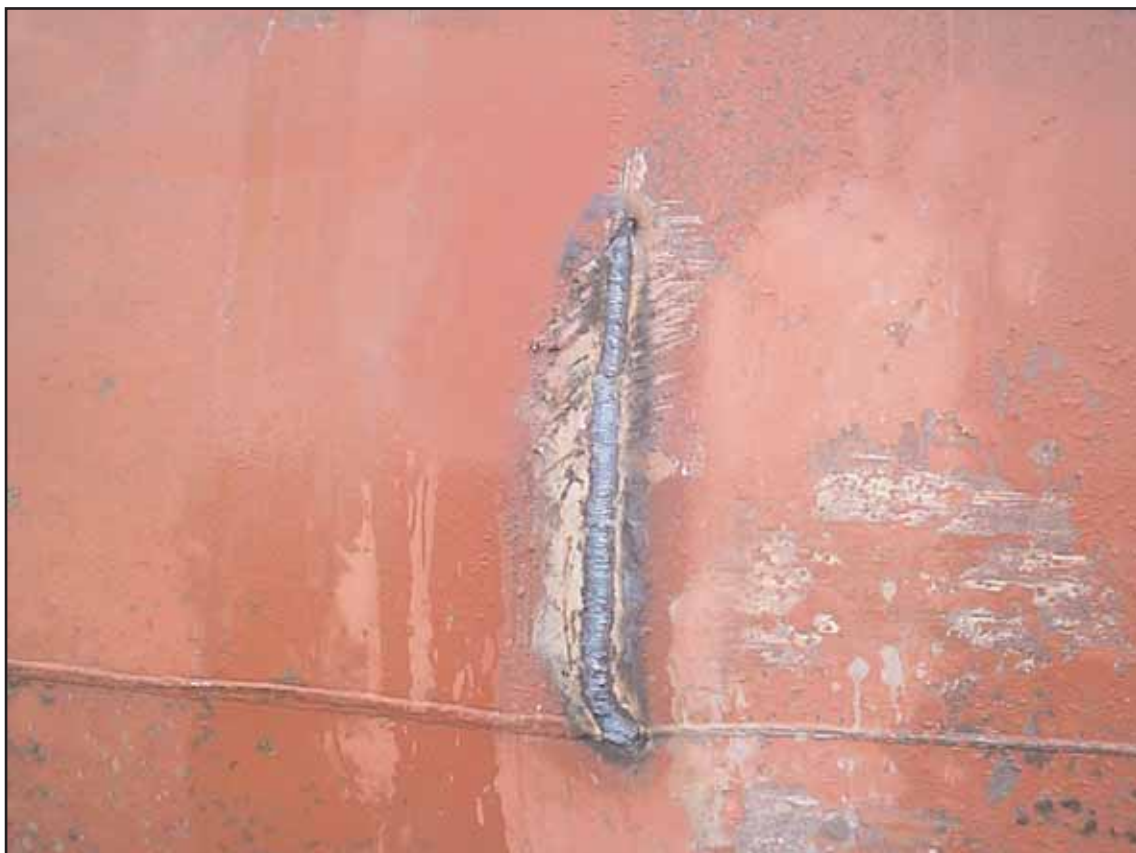
Figure 6

Weld repair to split in the hull

Following an inspection of the external hull, the area of damage was temporarily repaired before *Thorngarth* refloated at 1330. Permanent repairs were later effected in dry dock. (**Figure 6**)

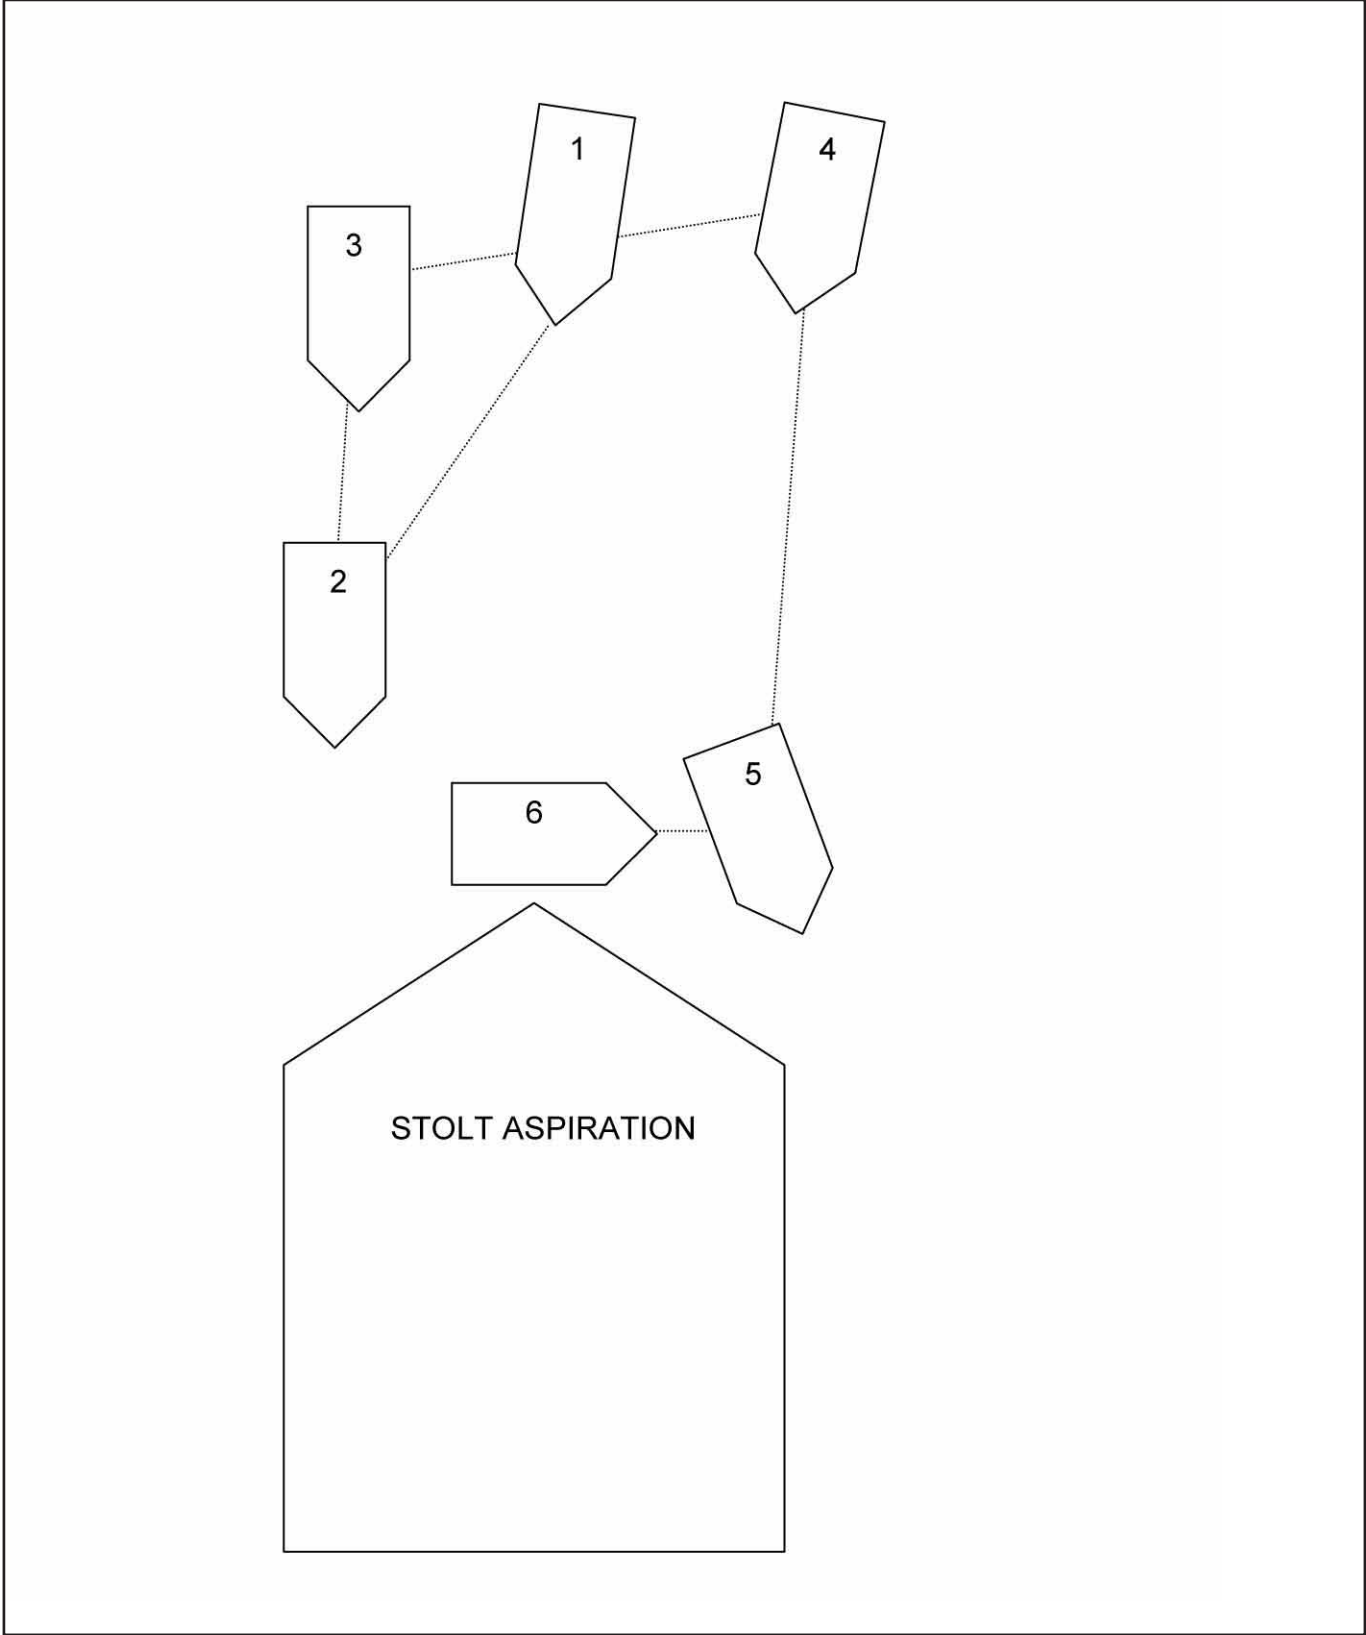
There were no mechanical failures on either vessel that could have led to the collision. The collision occurred when the tug master was re-positioning his tug ahead of the ship (**Diagram 1**). In backing away from the ship's bow, the stern of the tug began to move to port (**position 1**). To correct this, he pushed the port ahead-astern handle forward, which swung the stern back to starboard. However, this slowed the tug and it closed the ship (**position 2**). Engine speed was increased to regain position ahead of the ship (**position 3**). Once ahead of the ship, the stern again moved to port (**position 4**), and again the port ahead-astern control handle was pushed forward to correct the swing. Because *Thorngarth* was now to starboard of *Stolt Aspiration*'s bow, as speed reduced due to the change in astern power, she ended up on the starboard bow of *Stolt Aspiration* (**position 5**). In attempting to recover from this position, the tug master caused *Thorngarth* to move across the closing bow of *Stolt Aspiration* where he was hit on the starboard side (**position 6**). The tug master was unfamiliar with *Thorngarth*'s manoeuvring characteristics and the manoeuvre he was required to undertake. Due to the necessary close range at which the pickup of the tow occurred, there was no time for *Stolt Aspiration*'s bridge team to take any action to avoid the collision.

Movement of *Thorngarth* ahead of *Stolt Aspiration* (not to scale)

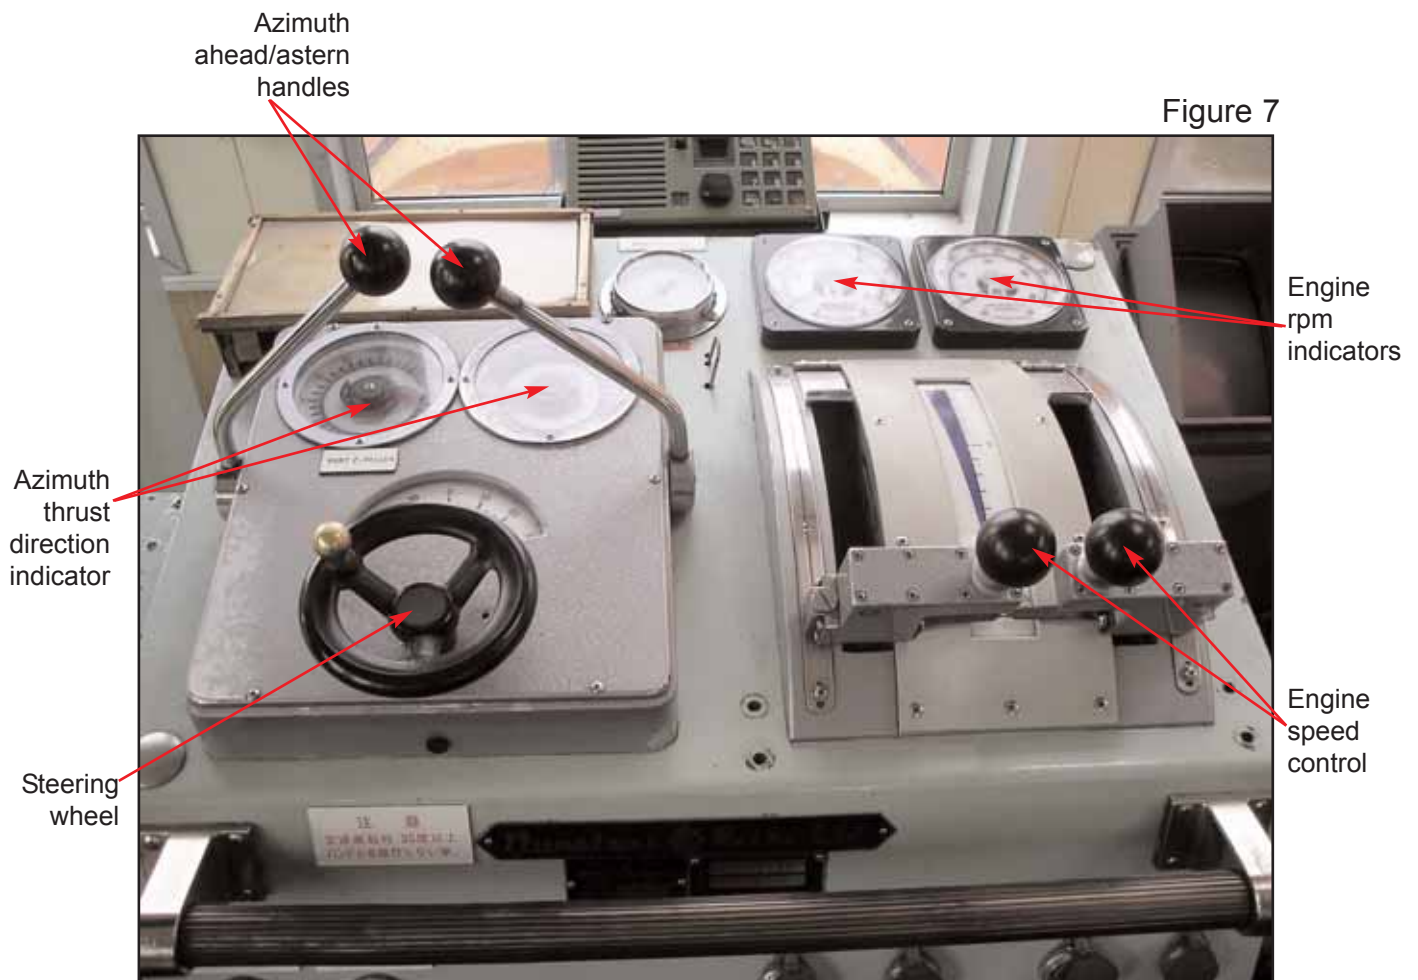
Tug manoeuvring controls and their propulsion systems cover a wide spectrum and, even among tugs of the same type, the speed of reaction of the propulsion gear to a control input will vary. As a consequence, any tug master will need to spend time familiarising himself with the controls of a new tug, even if he is familiar with the propulsion type and control system. Control of *Thorngarth* was effected by the use of three controls: the steering wheel, the ahead-astern handles and the speed control handles (Figure 7).

Thorngarth propulsion controls

A further complication is that if an operator is used to conventional tug operation (ie twin screw propulsion with rudders), when going astern to turn the stern to starboard, an increase in speed on the port engine is required. This is usually achieved by moving the port engine control lever aft. Moving the starboard lever forward would also move the stern to starboard. The required control movement is therefore opposite to the actions required on a T ASD tug. For more details about the controls of a T ASD tug see **Annex B**.
