Report on the investigation of
the collision between
Lykes Voyager
and ***Washington Senator***

Taiwan Strait

8 April 2005

Report No 4/2006
February 2006

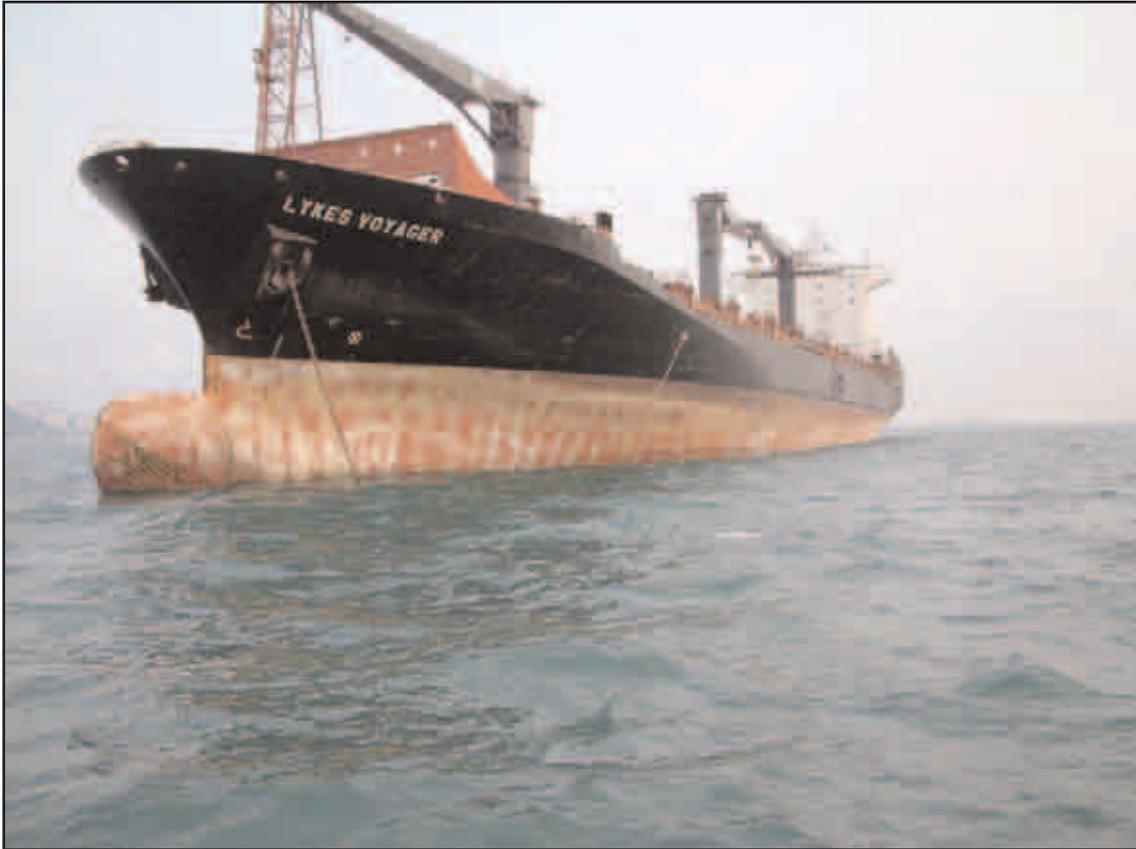
Photograph 1

Vessel details	:	<i>Lykes Voyager</i> (photograph 1)
Registered owner	:	CPS Number 1 Ltd
Manager	:	Anglo-Eastern Ship Management
Port of registry	:	London
Flag	:	United Kingdom
Type	:	Container
Built	:	1995, Stocznia Gdynia S.A. Poland
Classification society	:	American Bureau of Shipping
Construction	:	Steel
Length overall	:	187.16m
Gross tonnage	:	23540
Engine power and/or type	:	17940kW Sulzer oil engine, direct drive
Service speed	:	19.5 knots
Persons on board	:	24
Injuries	:	None
Damage	:	Extensive damage to shell plating, decks, internal frames, and container stowages in way of the port quarter.

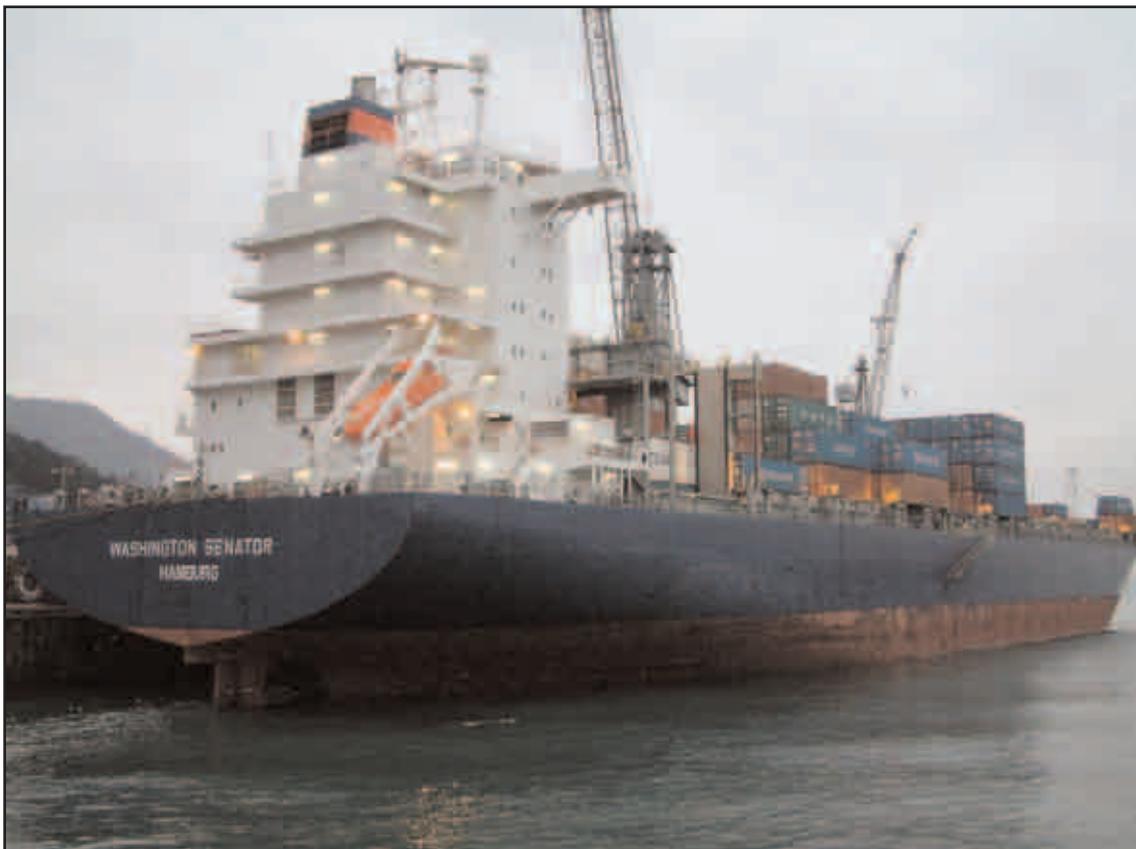
Photograph 2

Damage : Extensive damage to shell plating and internal
decks and bulkheads in way of the port quarter.

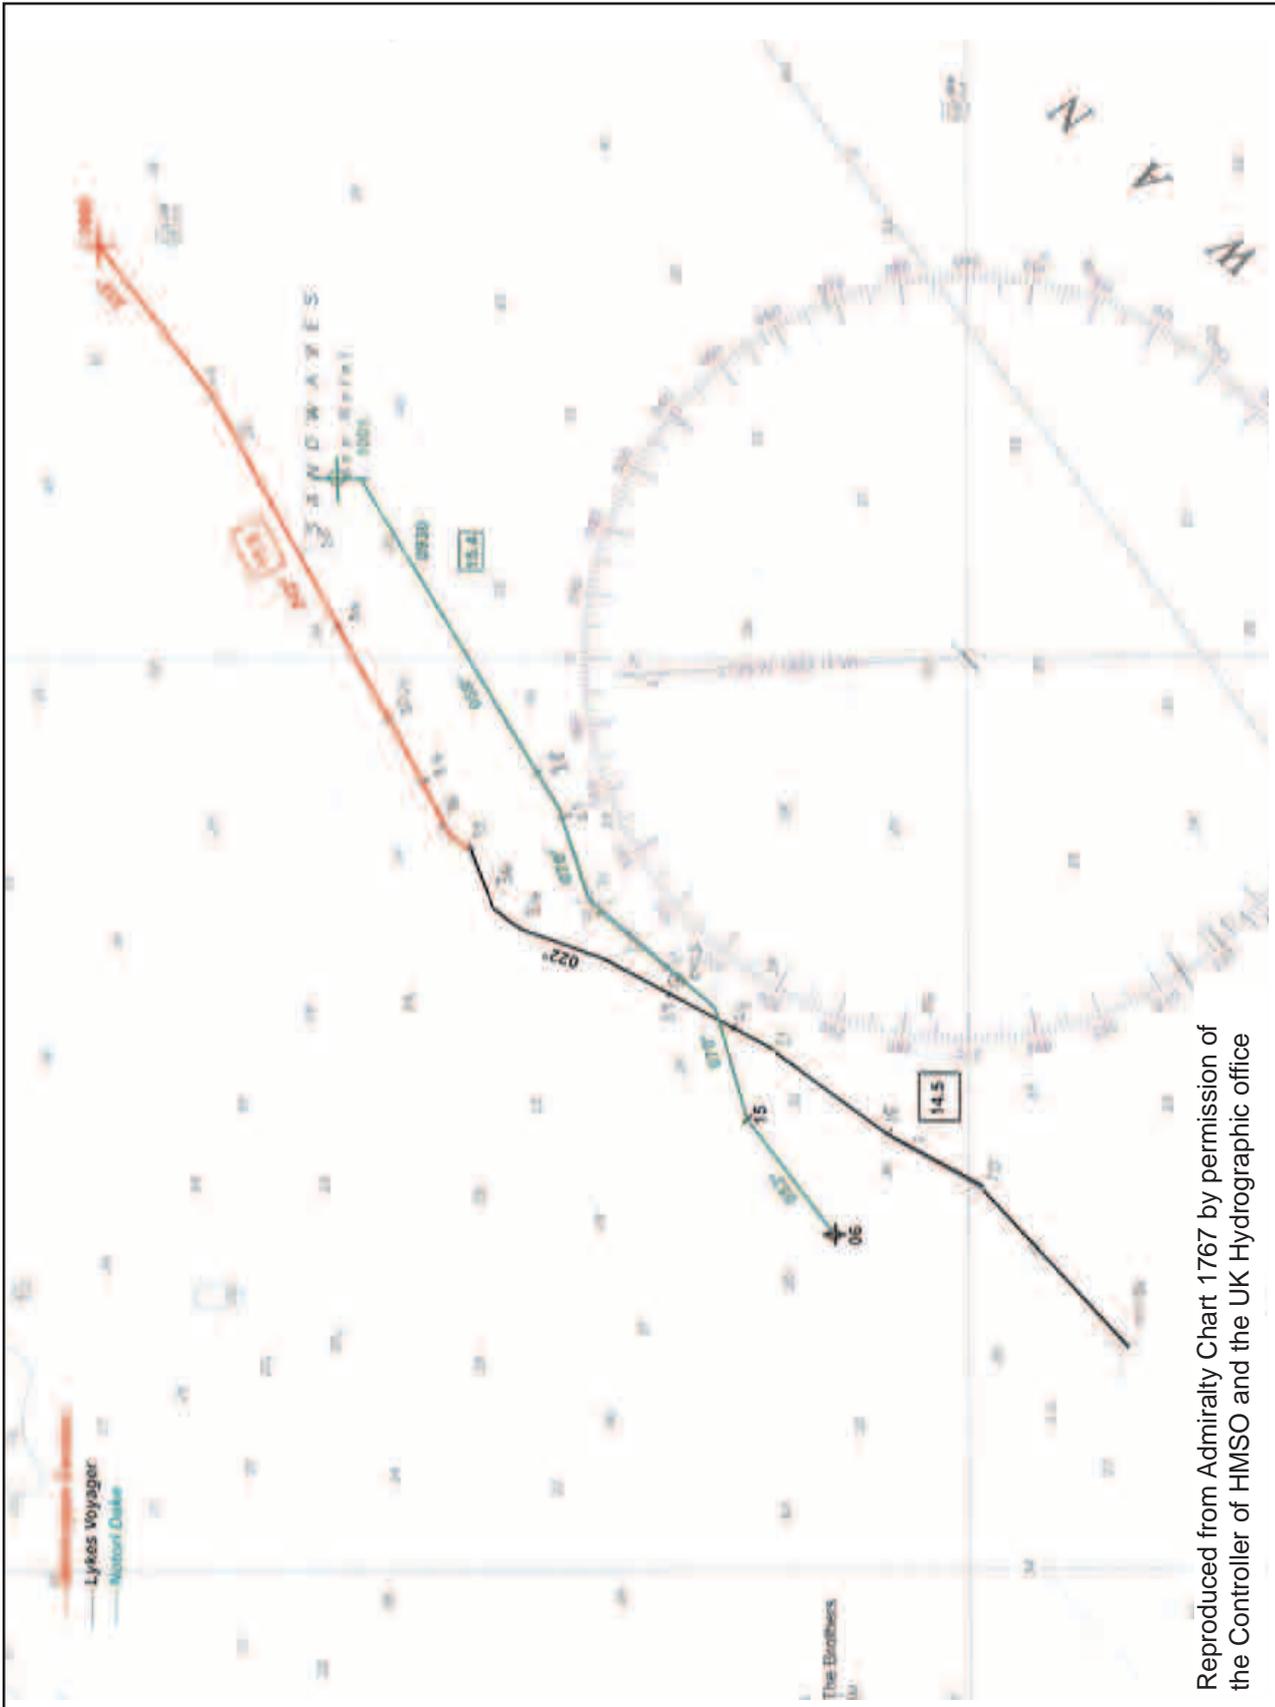
Figure 4

The reconstructed ground tracks of *Lykes Voyager*, *Washington Senator*, and *Notori Dake* are shown at **Figure 4**. This reconstruction is based on the recorded information available, GPS positions recorded on the paper charts, navigational records and accounts from witnesses. The time of the collision has been based on the time recorded by *Lykes Voyager's* engine data logger, which is within 1 minute of the time noted on board *Washington Senator*.

Extract from BA 1767 showing the reconstruction of the ground tracks
