Lykes Voyager - engineering response and damage

Lykes Voyager – Engineering Response and Damage

Washington Senator - engineering response and damage

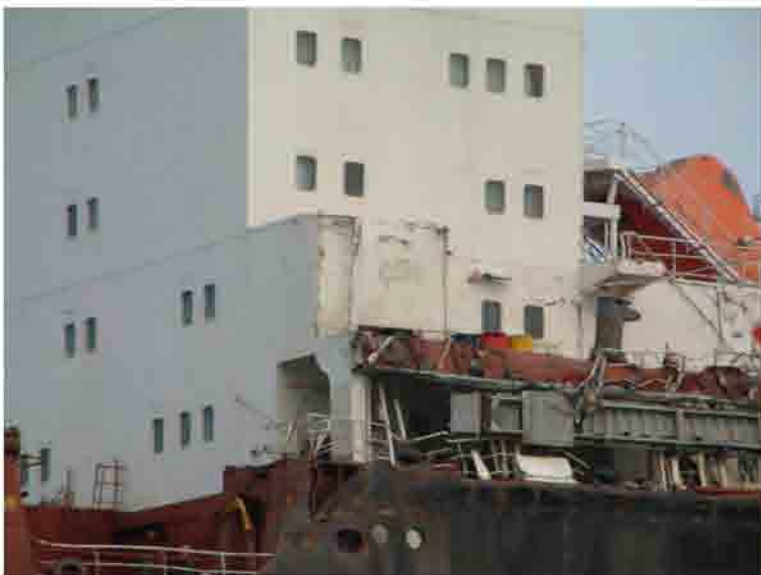
Figure 1 - Port side damage general

Lykes Voyager suffered widespread structural damage to the upperdeck, TEU supporting systems, port side shell plating and loss of upperdeck equipment. **(Figure 1)**

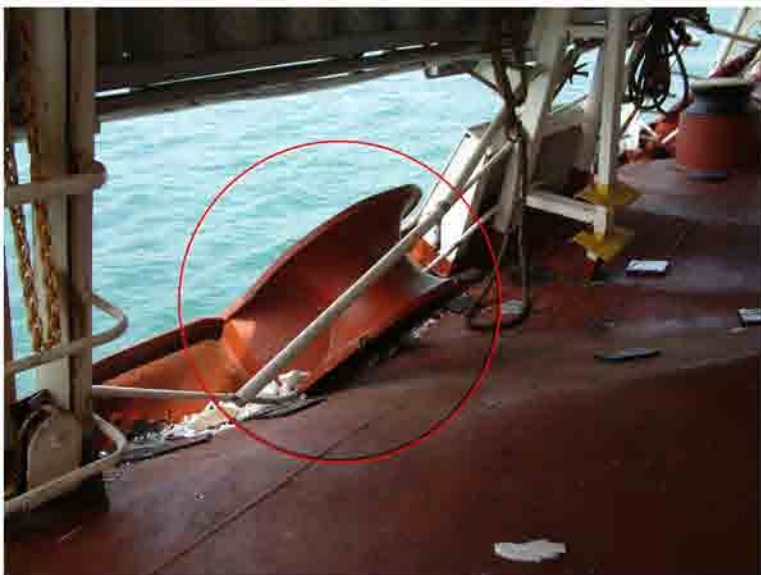
Figure 2 - Panama firlead

- Port poop deck windlass
- Port poop deck Panama fairlead **(Figure 2)**
- Port boat deck Suez crane, pedestal and motor **(Figures 3 & 4)**

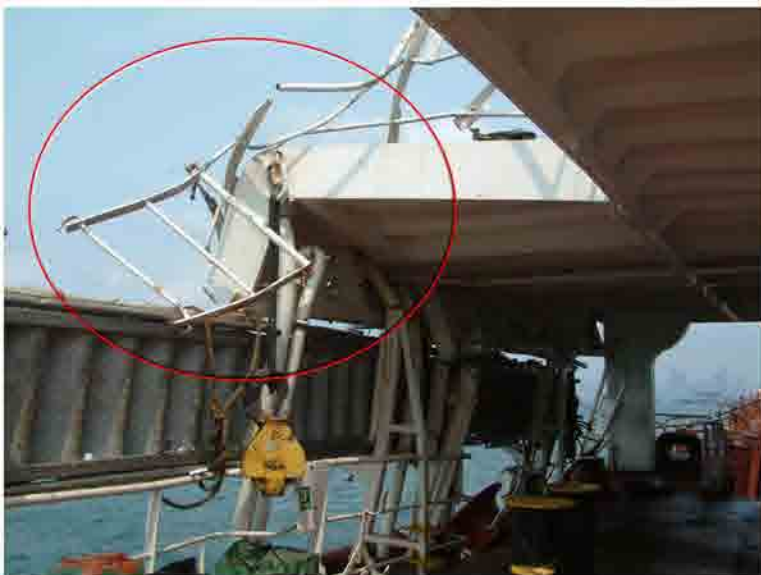
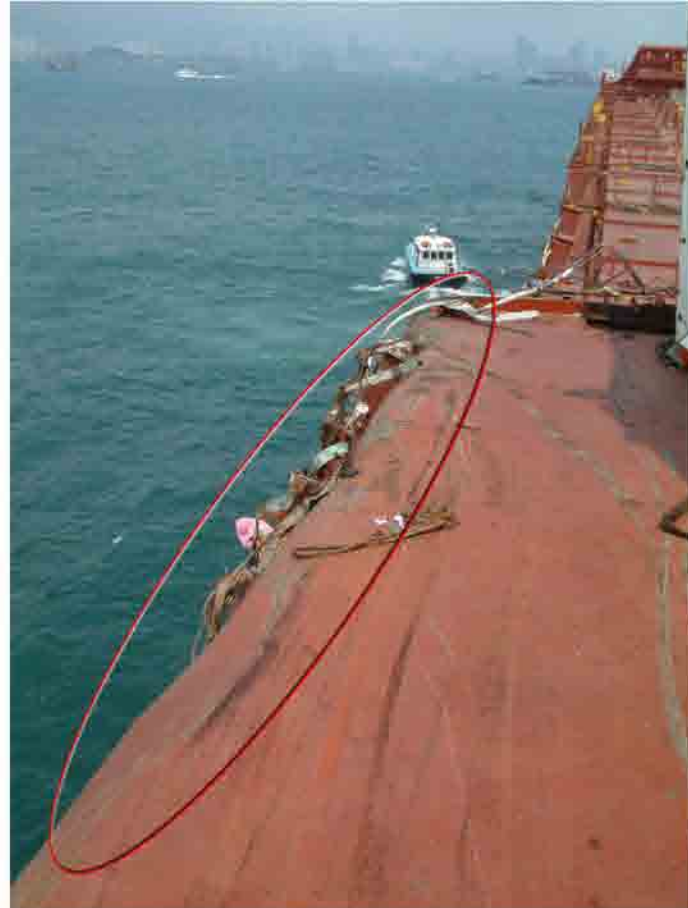
Figure 5 - Boat deck damage

- Port Boat deck
 - Refrigeration Space exhaust ventilation terminal destroyed
 - Deck edge turned over for whole of its length **(Figures 5 & 6)**
 - Severe creasing of the deck and of the access ladder supporting structure

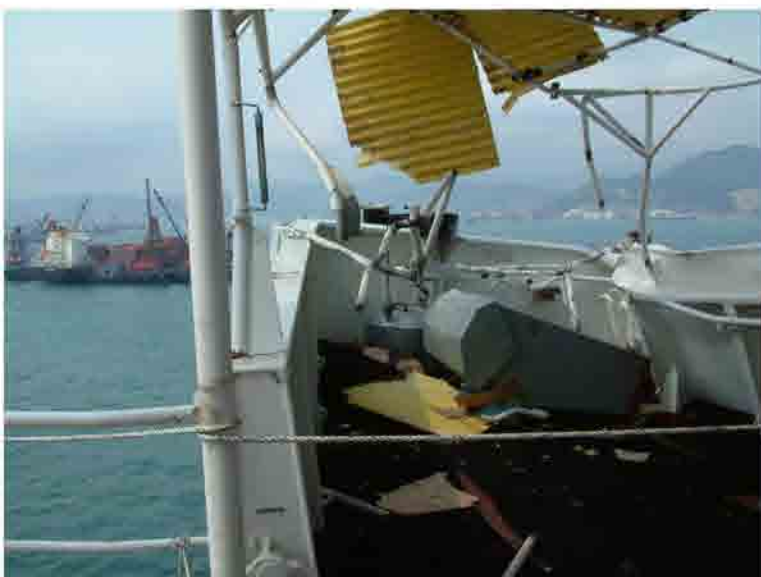
Figure 7 - Port bridge wing

- Port Bridge Wing
 - Deck severely creased
 - Guardrail damaged throughout their length
 - Roofing destroyed **(Figure 7)**
 - Floodlight destroyed
 - Front of bridge wing severely distorted

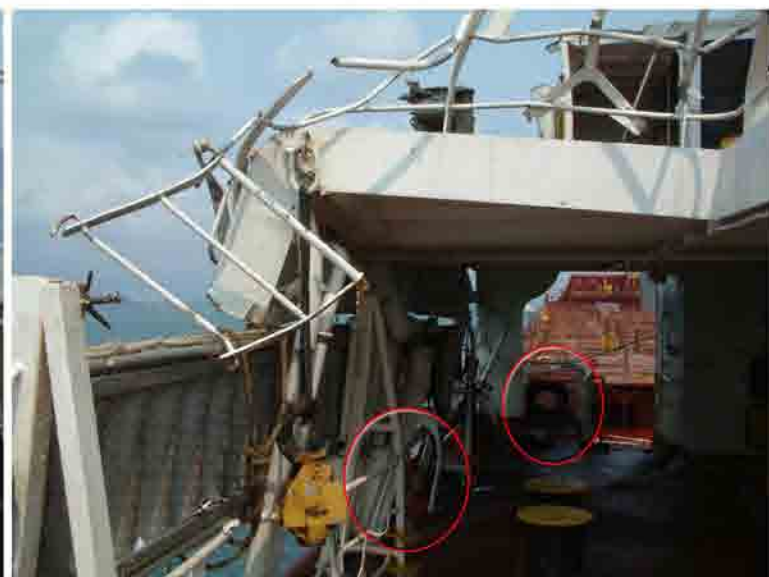
Figure 8 - Poop deck

- Port poop deck
 - Two Panama fairleads badly damaged **(Figure 8)**
 - Severe deck edge creasing extending to access ladder **(Figure 9)**
- Port side main deck walkway

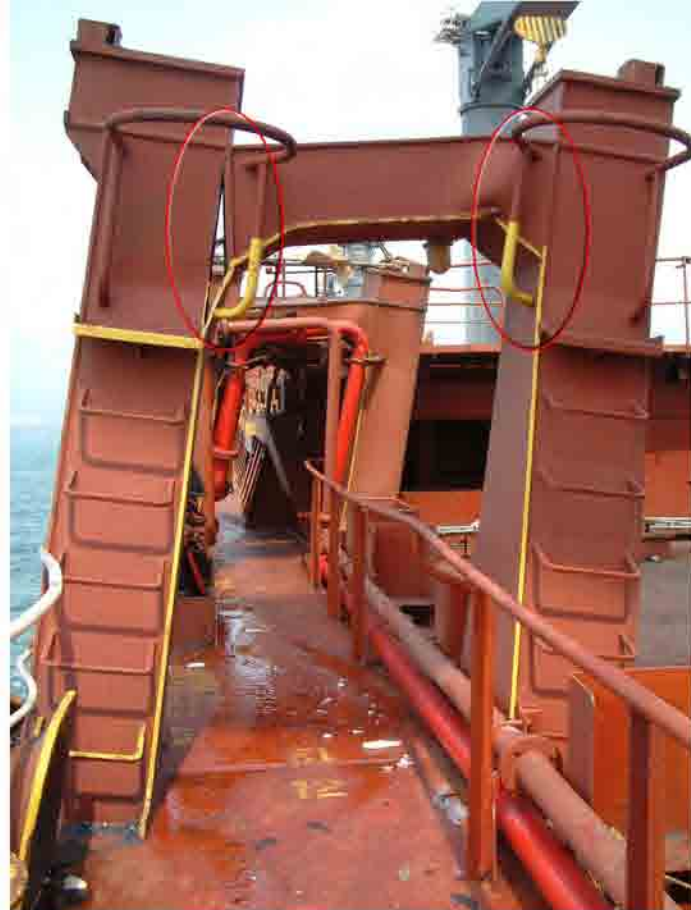
Figure 10 - TEU Supports

- Nine containers supports (crutches) severely damaged **(Figure 10)**
 - Other support suffered impact damage and weld failure **(Figure 11)**
 - Guardrails destroyed

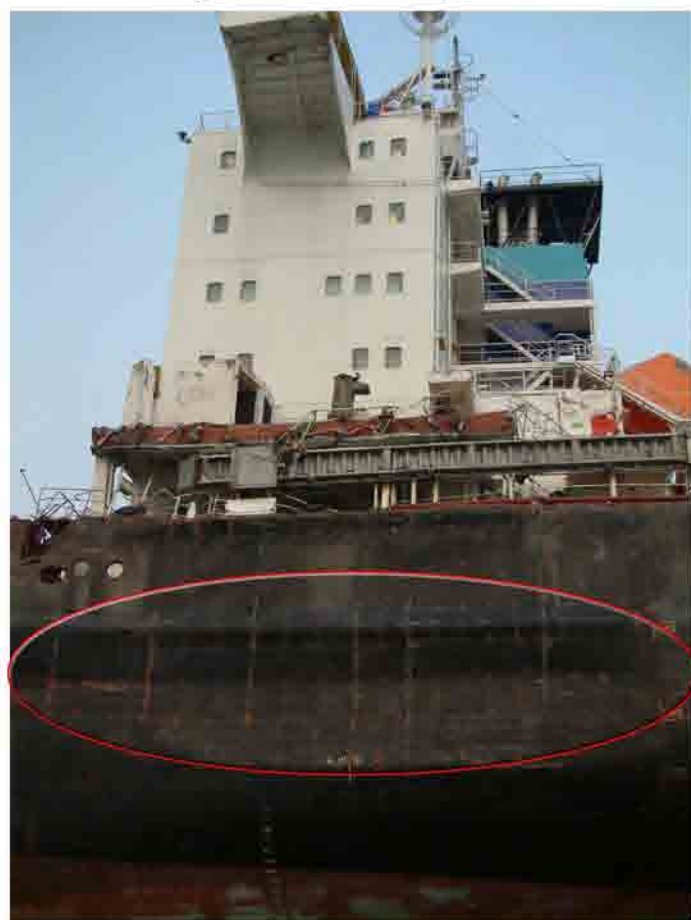
Figure 12 - Shell plating damage

- Deck damage – various levels
- Hull damage
 - The shell plating was severely set back for approximately one third of her length to the stern. **(Figure 12)**

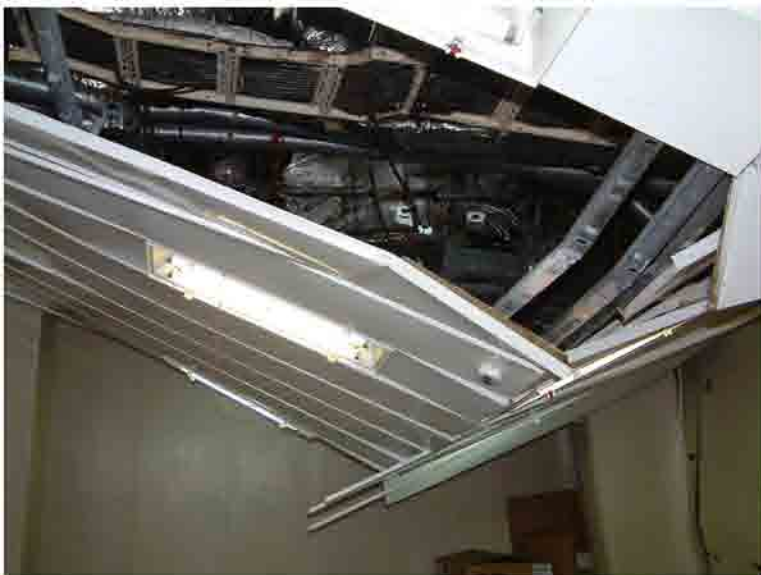
Figure 13 - Gym deckhead

- Between deck damage
 - **Gymnasium** - extensive deck head creasing and compartment lining displacement **(Figure 13)**

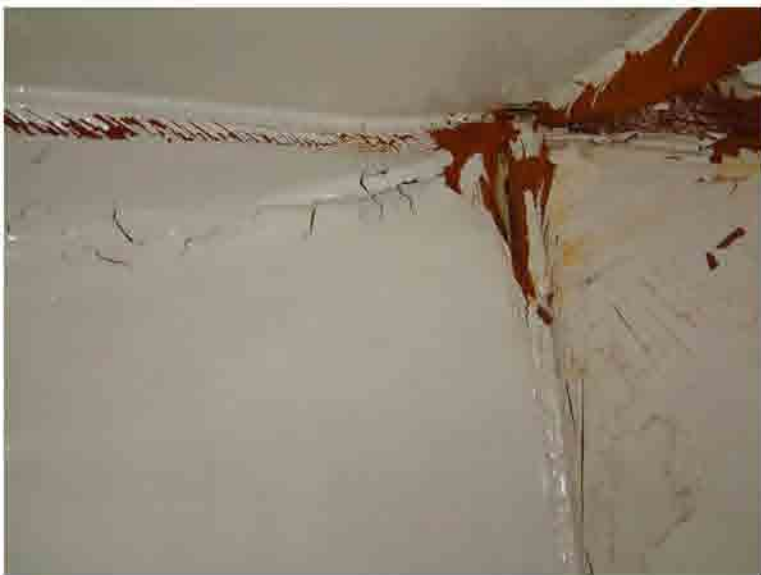
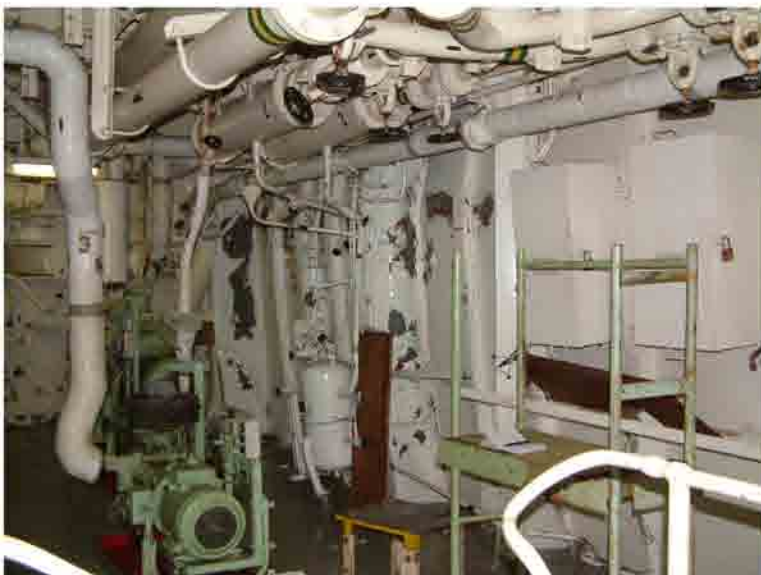
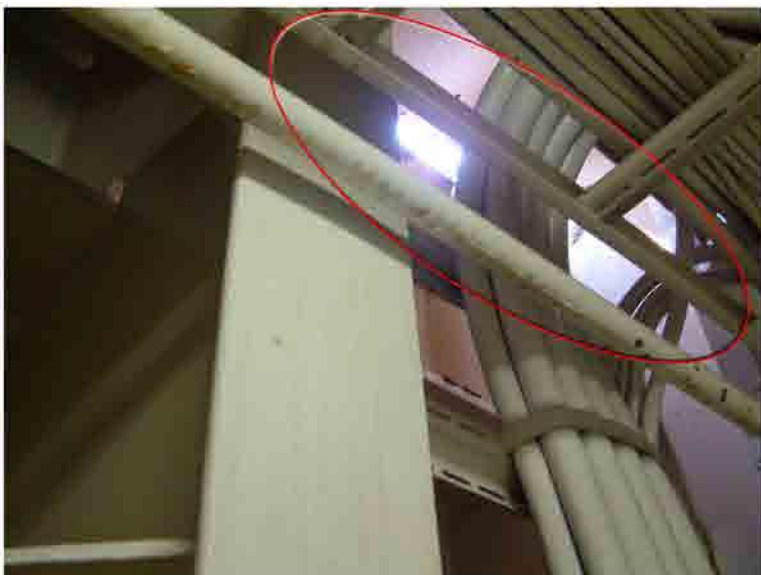
- **Refrigeration, air conditioning and air compressor space** – pipe work systems damaged, beams and girders displaced and bulkhead distortion. Split adjacent to 607 fresh water tank at frame No 5 (**Figure 14**). Numerous frames set back throughout the full length of the space. (**Figure 15**)
- **Passage to Electrical Distribution Suite** – frames severely distorted.
- **Port Pipe Passage** – (Engine room forward bulkhead at frame 47) deckhead fractured opening onto the upper deck (**Fig 16**). Extensive frame distortion.

Figure 14 - FW tank damage

Figure 15 - Fridge space damage

Figure 16 - Split to deckhead opening to UD

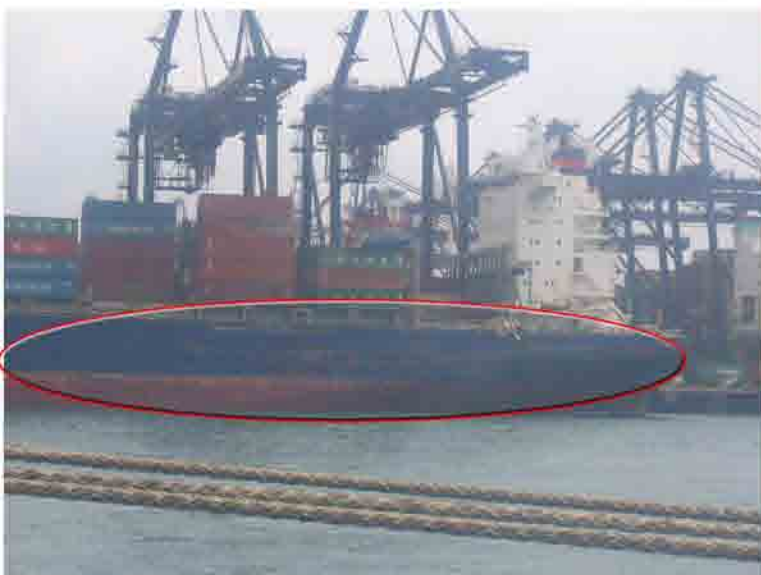
Figure 1 - General view of damage

Washington Senator suffered widespread structural damage to the upperdeck, TEU supporting systems, the port side shell plating, and internal decks, longitudinals and frames. A general view showing the extent of the shell plating damage is at **Figure 1**.

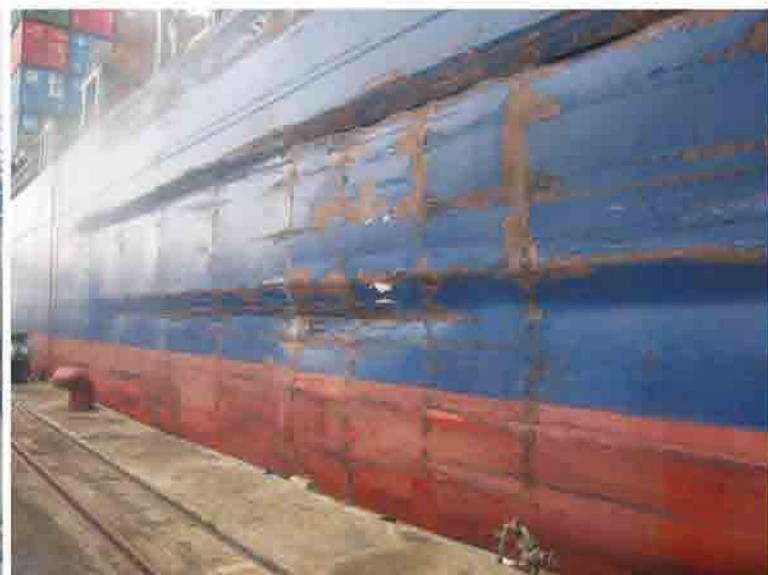
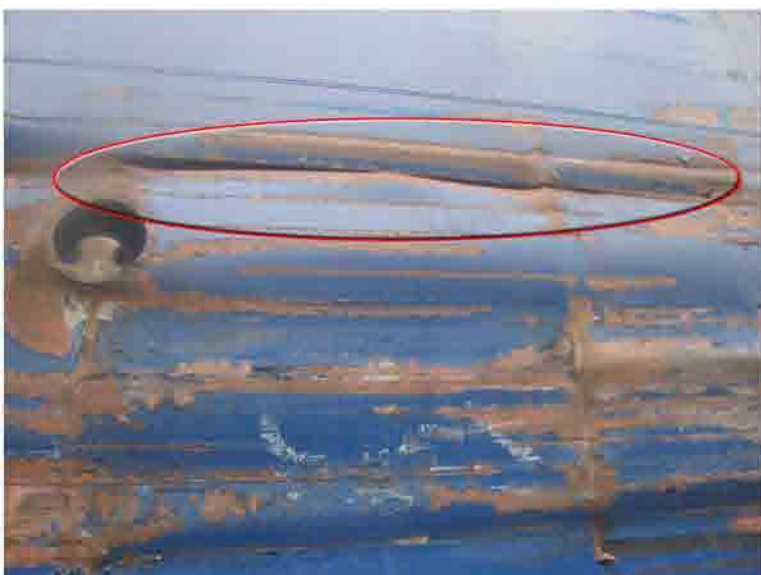
The damage to the port side shell plating was extensive (**Figures 2 & 3**). There were large areas of shell plating that were set back causing pronounced dishing of the plating. There were also several splits throughout the external damaged area (**Figures 4 & 5**).

Figure 2 - General view outer shellplate

Figure 3 - Mid ships outer shellplate

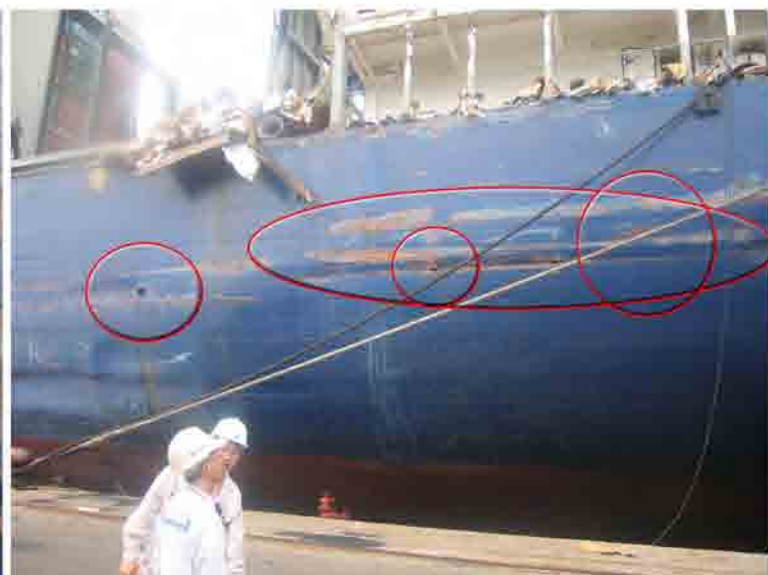
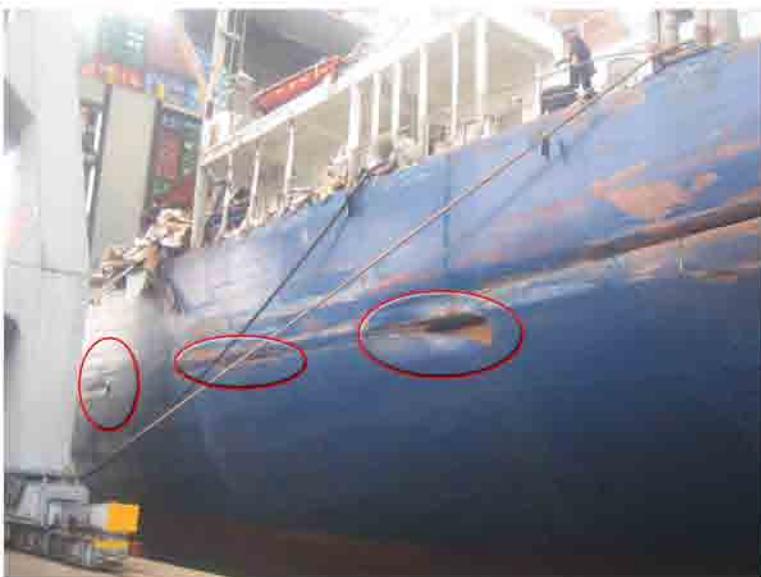
Figure 4 - Port aft outer shellplate

Figure 5 - Aft outer shellplate

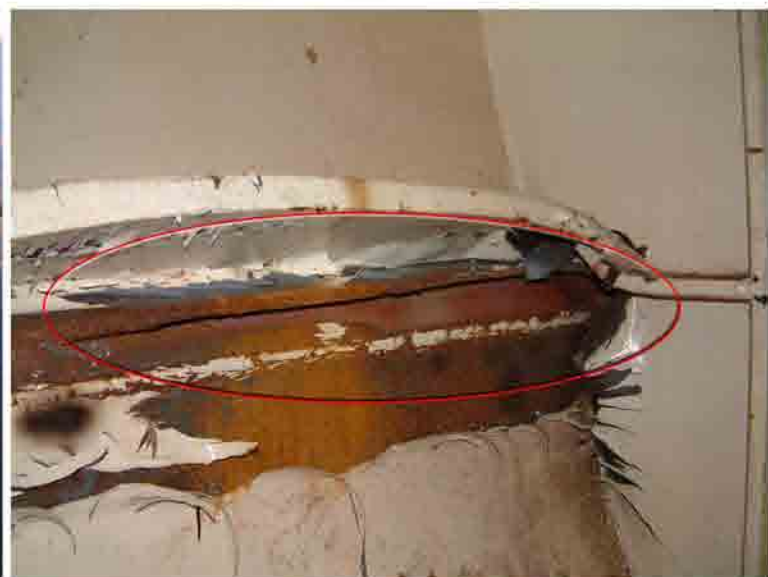
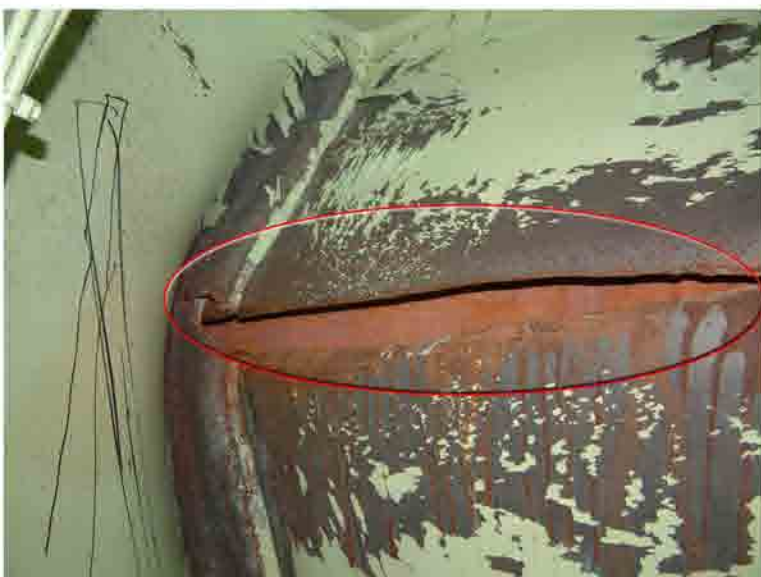
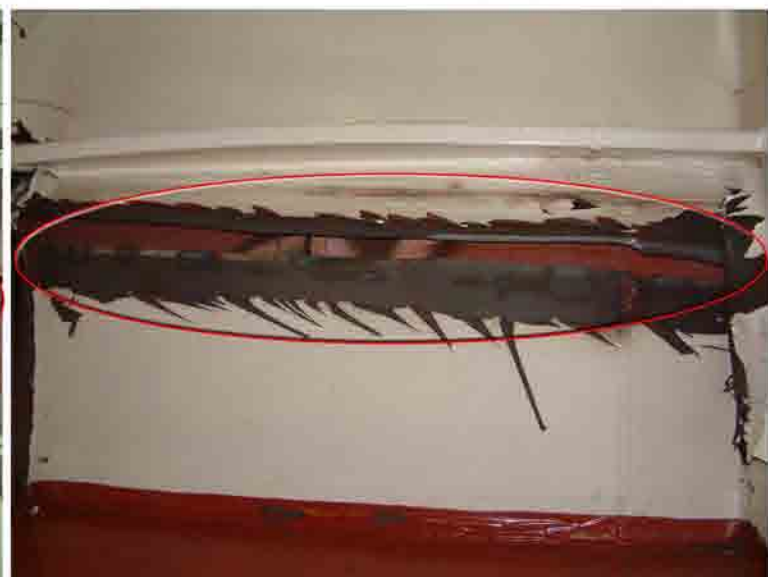
The damage sustained by the shell plating was more easily discernible from inside the vessel where the splits were clearly visible. At the time of the inspection, some doubler plates had already been welded in place to provide water integrity. (**Figures 6,7& 8**).

Figure 6 - Inboard shell plating split

Figure 7 - Shell plate split

Figure 8 - Shell plate split with doubler

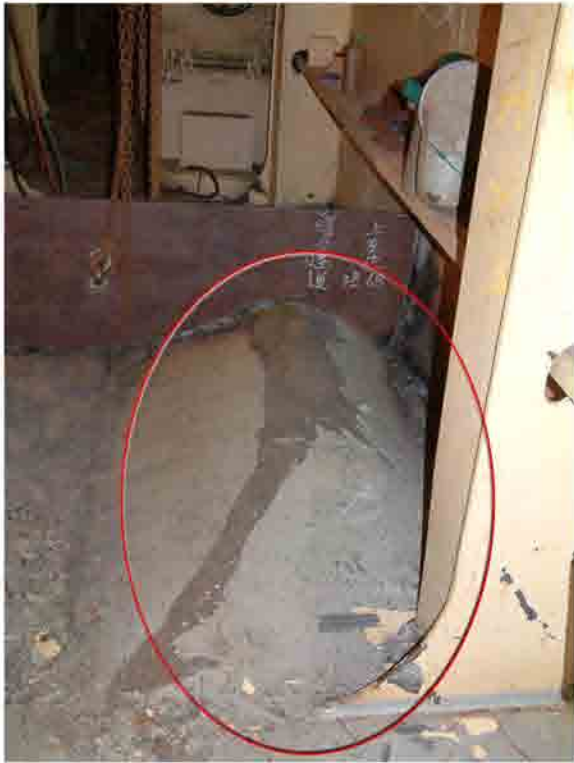
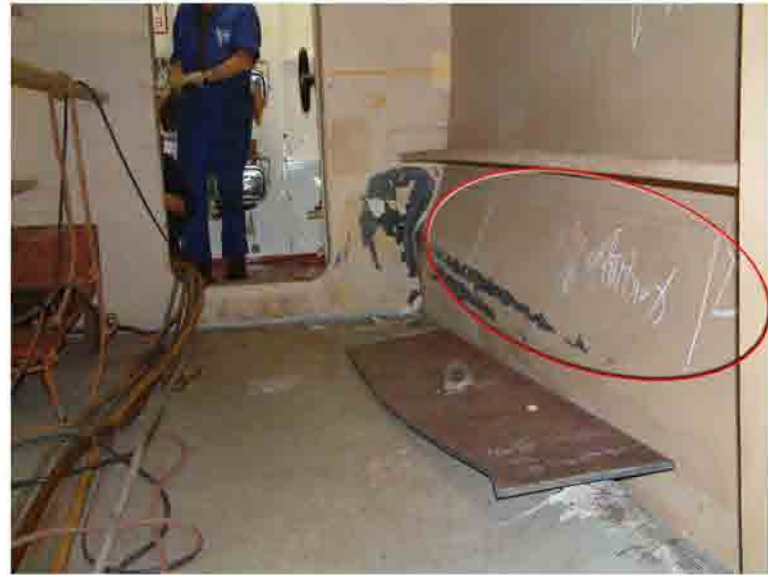
The deformation of the shell plating caused severe creasing of the internal decks and under deck stiffeners. The creases in some areas deformed the deck by as much as 200 mm (**Figures 9 & 10**).

Figure 9 - Example of deck creasing

Figure 10 - Shell plate and deck creasing

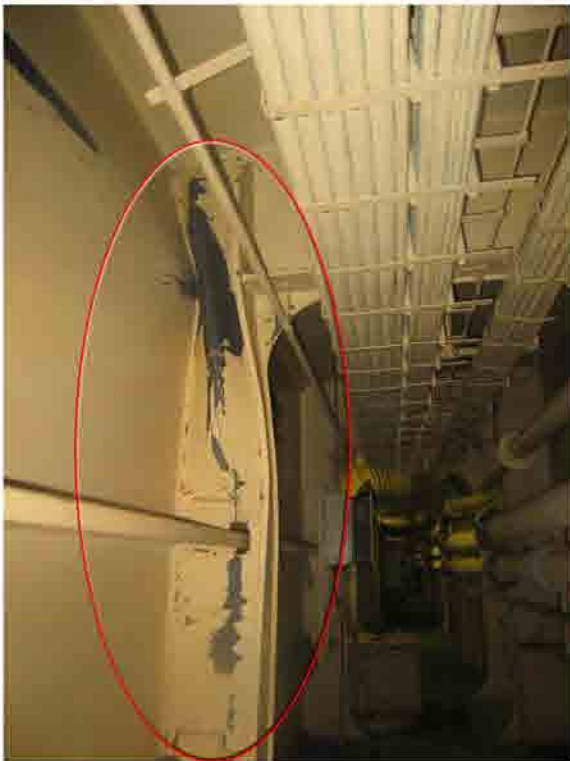
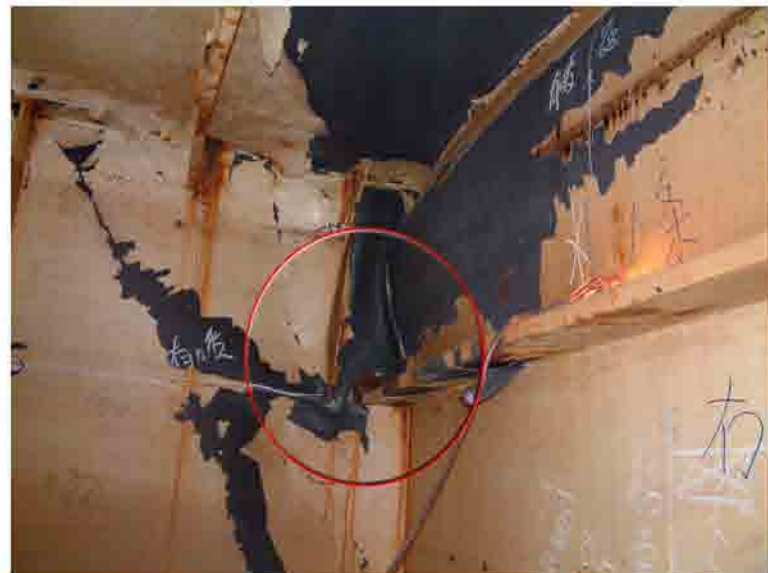
There was significant damage caused to internal fore and aft bulkheads particularly within the port pipe passage caused by the deformation of the shell plating, longitudinals and bulkhead stiffeners. (**Figures 11 & 12**).

Figure 11 - Passageway 1st strake buckled

Figure 12 - Shell plate and stiffener damage

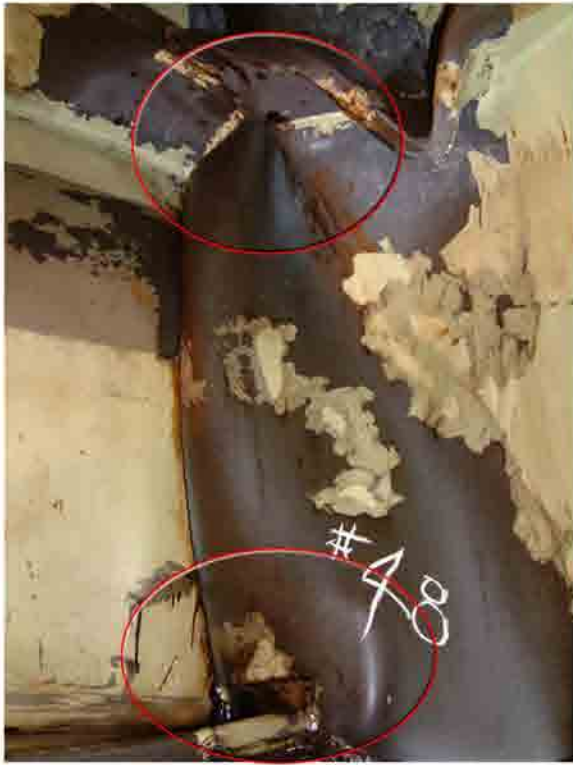
The oil leak was found to have come from No 2 settling tank, which was holding 110 m³ of heavy fuel oil at 80° C. Other fuel tanks were checked, but were found to be undamaged. The chief engineer opened the run down

valve from the settling tank to No 5 bunker tank. His prompt action enabled 80 m³ of hot oil to be saved and reduced the fire risk. However, 30 m³ flooded into the engine room bilge.

Damage was also caused to No 2 settling tank outboard juncture with the shell plating that caused severe structural failure and spilling of the contents into the workshop area of the engine room. (**Figure 13**).

Figure 13 - No 2 settling tank damage
