Report on the investigation of
two people being thrown from a
high-speed rigid inflatable boat
with the loss of their lives
in Milarrochy Bay, Loch Lomond, UK
on 13 March 2005

**Report No 24/2005
December 2005**

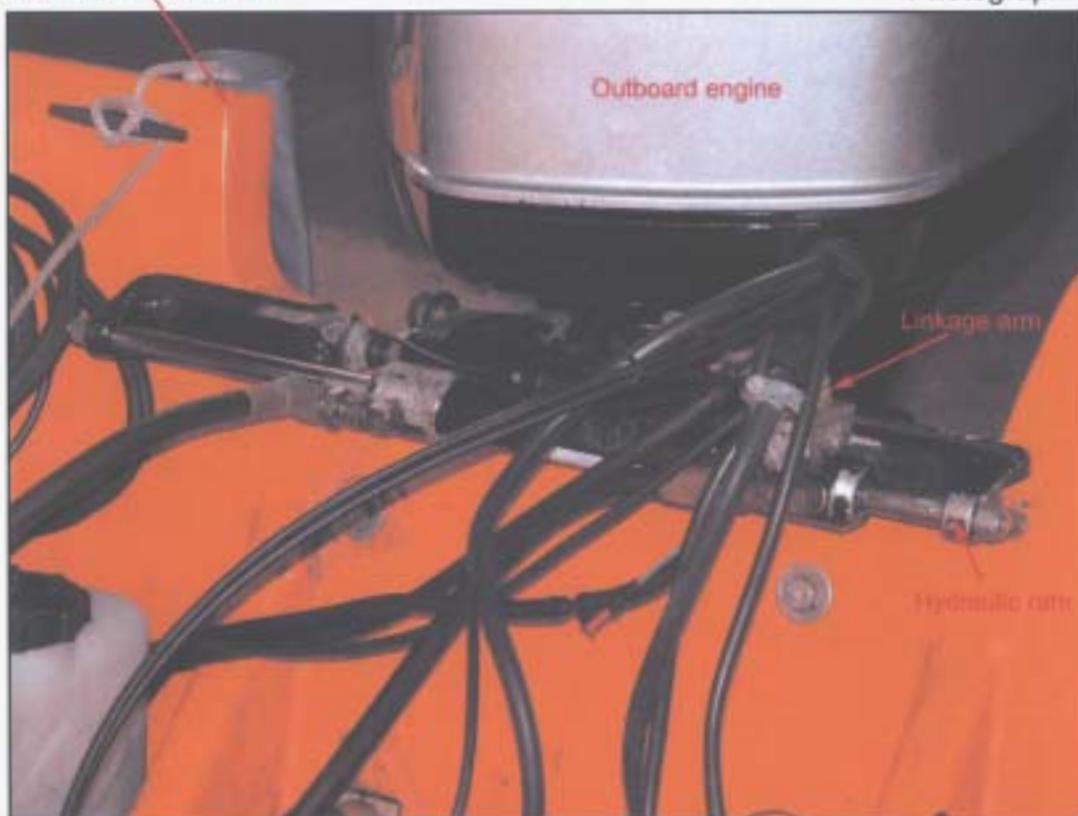
Photograph 6

The representative also noted that the cut-away section of the transom stern had been deepened at some time in the past. However, the edges of the transom stern were cracked, showing that it was beginning to de-laminate (**see Photograph 6**).

Evidence of de-lamination

A closer view of the hydraulic ram

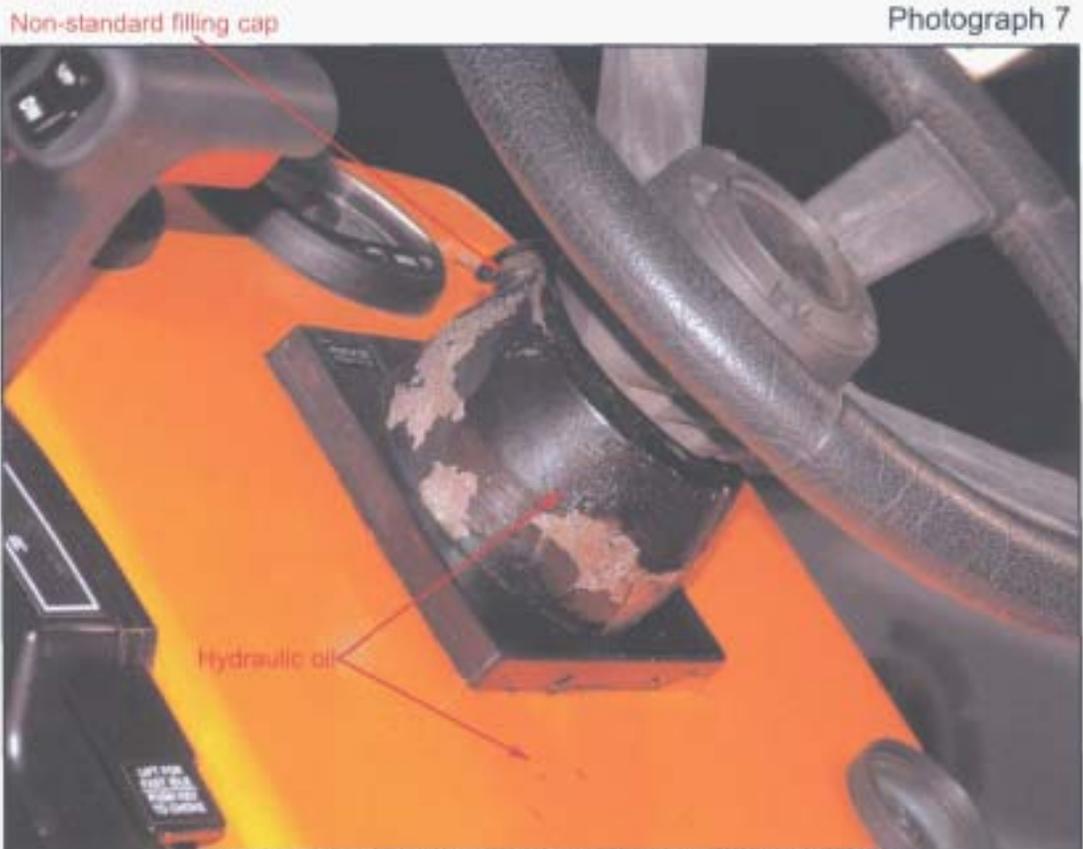
The inspections conducted on 17 March and 5 April 2005 (see 1.5.2 above), found the steering system to be old, with paint missing from the helm pump boss and from the ram to the engine. There was evidence of hydraulic oil leakage from between the steering wheel shaft and the pump boss, and this had produced a film of oil extending down the console in front of the driver's seat (**see Photograph 7**).

The refilling plug used in the top of the pump boss was not original (**see** Photograph 7). It appeared that the original nylon or metal plug had been substituted by a rubber grommet which was neither watertight nor airtight. Inspection of the inside of the pump boss filler hole revealed no sign of hydraulic oil, and when the wheel was turned it made noises consistent with the pump continually drawing in air. This would have been a direct result of there being insufficient fluid in the system.

A view looking up from underneath the helm pump boss, showing leakage of hydraulic oil

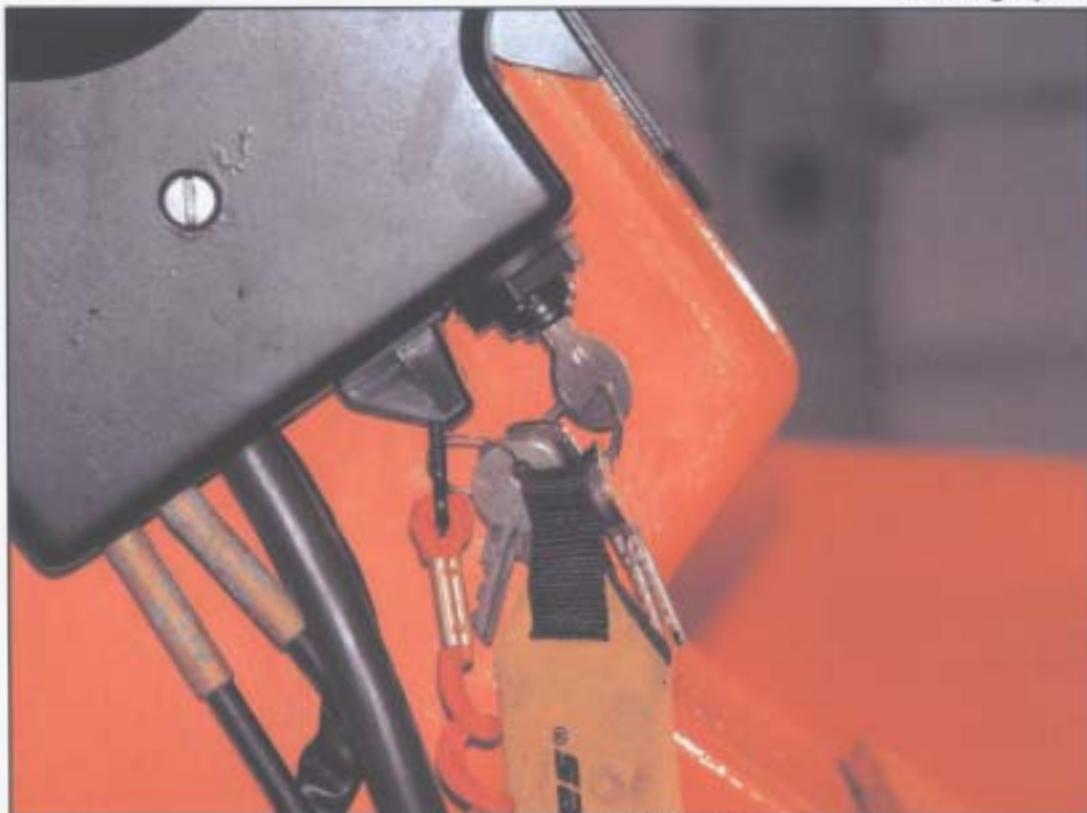
Photograph 9

1. The RIB's kill cord was not properly in place on the return passage from the island. Although the elder daughter had seen it in place on the outward-bound passage, for some reason, the father had not attached the free end of the cord to himself on the return passage. The National Park Authority's rangers had found the cord attached to the ignition cut off switch after the accident, but the free end was hanging loose (there was no defect with the cord's attachments) (**see Photograph 8**). Because the kill cord was not in place, the RIB carried on travelling away from the area in which the father and his daughter were thrown into the water. This caused a significant delay because it took time for the elder daughter to recover from the violent lurch, struggle to reach the controls, stop the RIB, and then return the RIB to her father and sister.

The kill-cord in place in the ignition
