Report on the investigation of
the collision of the general cargo vessel

Orade

with the Apex Beacon, River Ouse

**Report No 23/2005
December 2005**

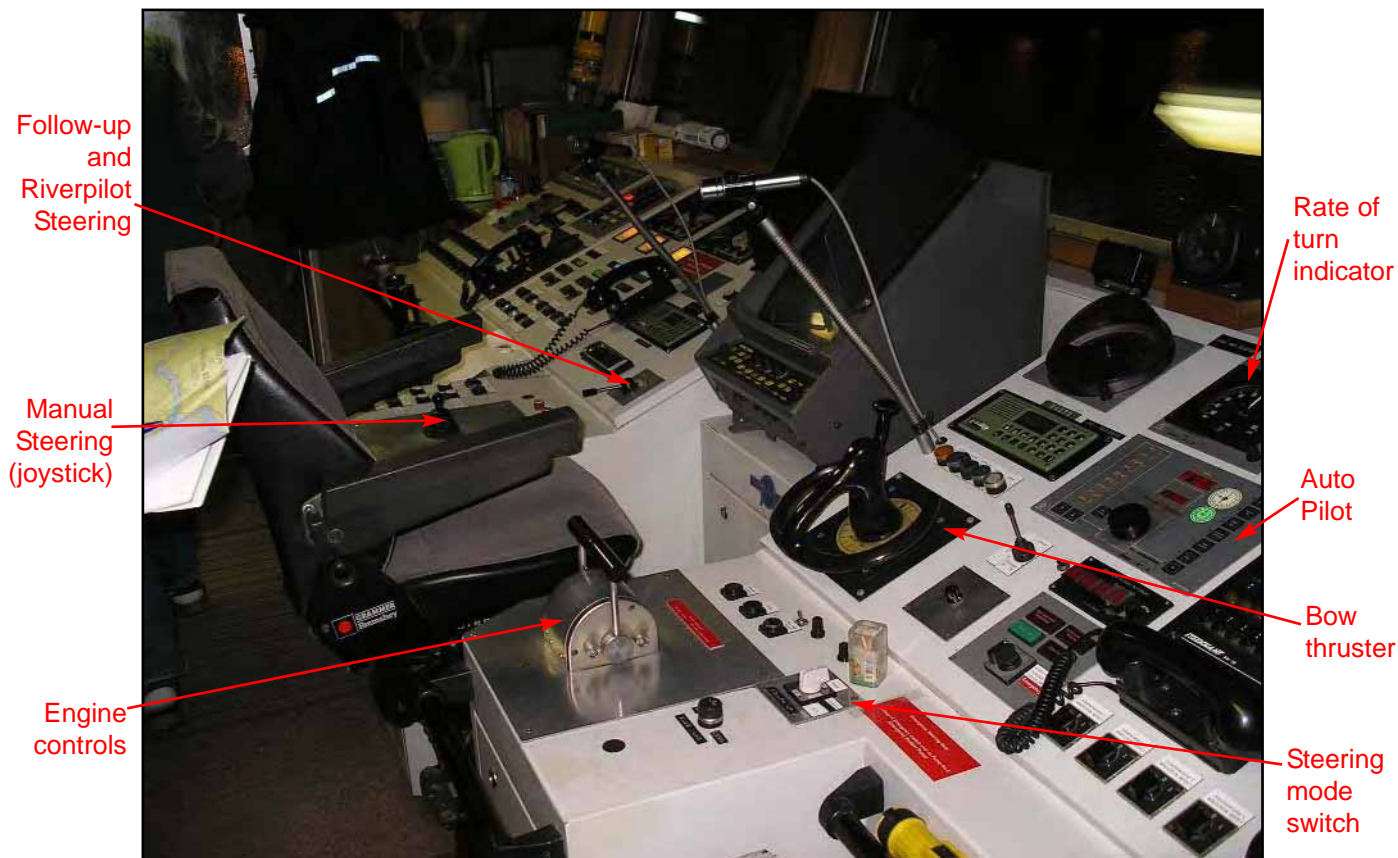
Figure 2

The bridge layout and equipment was of conventional design, and included a central steering position from where the engines, bow thruster, steering and communications could be controlled from a seated position. A Kelvin Hughes radar, which provided ship's head-up mode only, was sited in front of the control position. Rate-of-turn indication was provided at the top of the radar screen when the autopilot was switched to riverpilot mode. Sited on the deckhead, above the chair, was the rudder angle indicator (RAI), which provided direct angular feedback from the rudder stock.

Bridge layout and controls

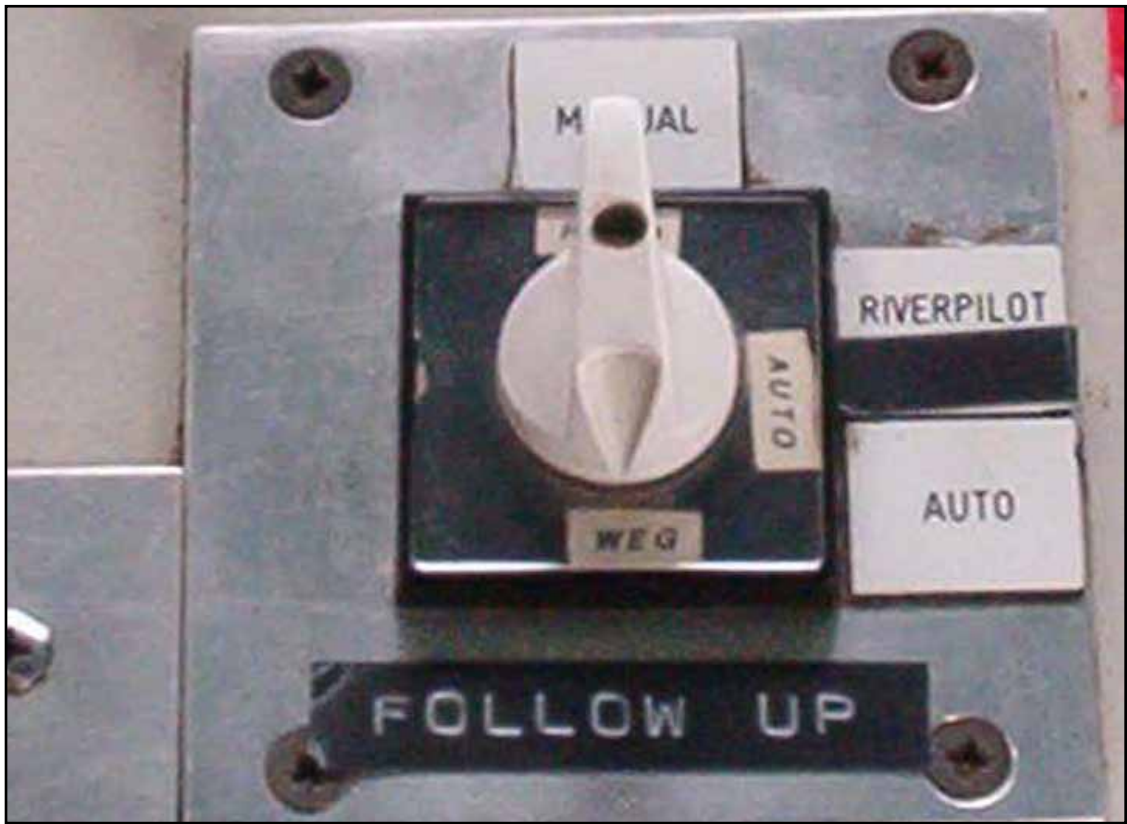
Figure 3

The mode of steering was controlled by a three way position switch (**Figure 3**). The steering mode switch, which could not be illuminated, enabled manual, follow-up and autopilot steering modes to be selected.

Steering mode selector switch

The switch labelling indicated both riverpilot and autopilot in the horizontal switch position when, in fact, it only connected to the autopilot. A further selection needed to be made on the autopilot console for riverpilot mode to be active. This is misleading and could, in some circumstances, cause confusion or a misunderstanding.

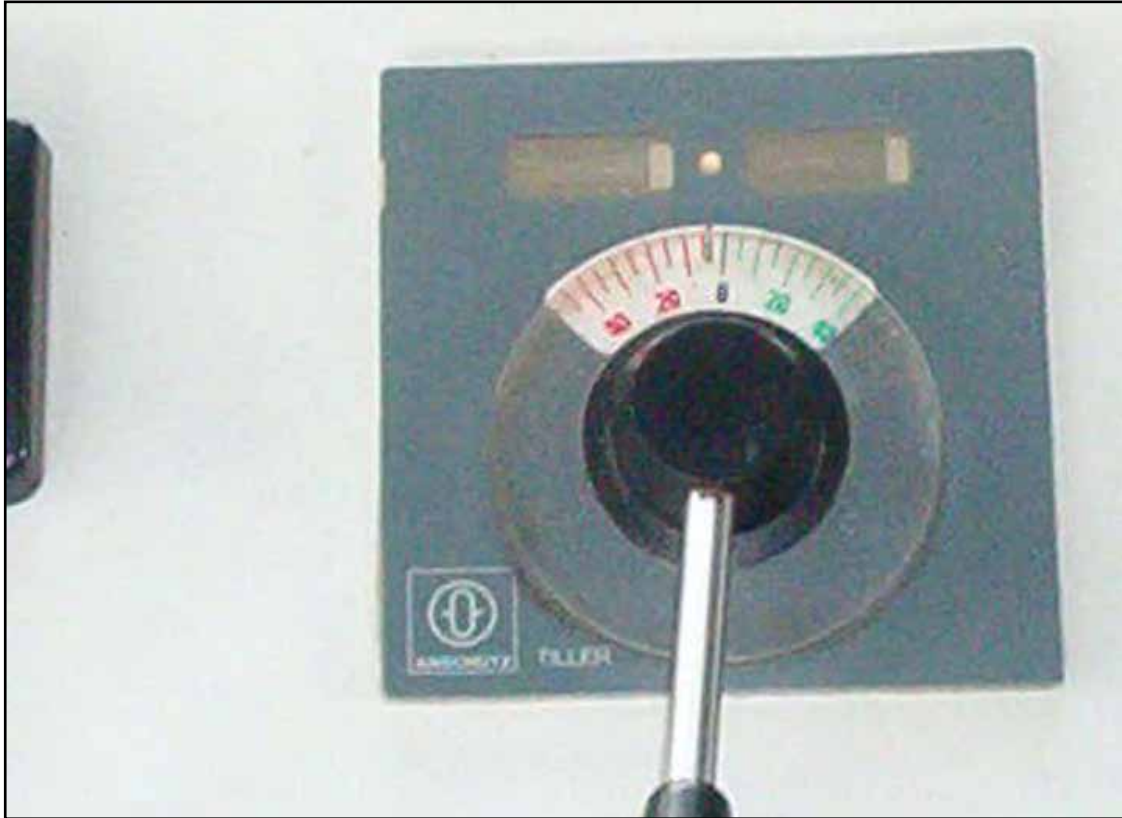
Figure 4

When the switch was turned to point down, manual steering in follow-up mode was selected. In this mode, steering was accomplished with the follow-up lever (**Figure 4**) which was not spring loaded. The rudder would move to a helm order until it reached the selected angle, where it remained until the lever was moved again.

Follow-up / Riverpilot lever

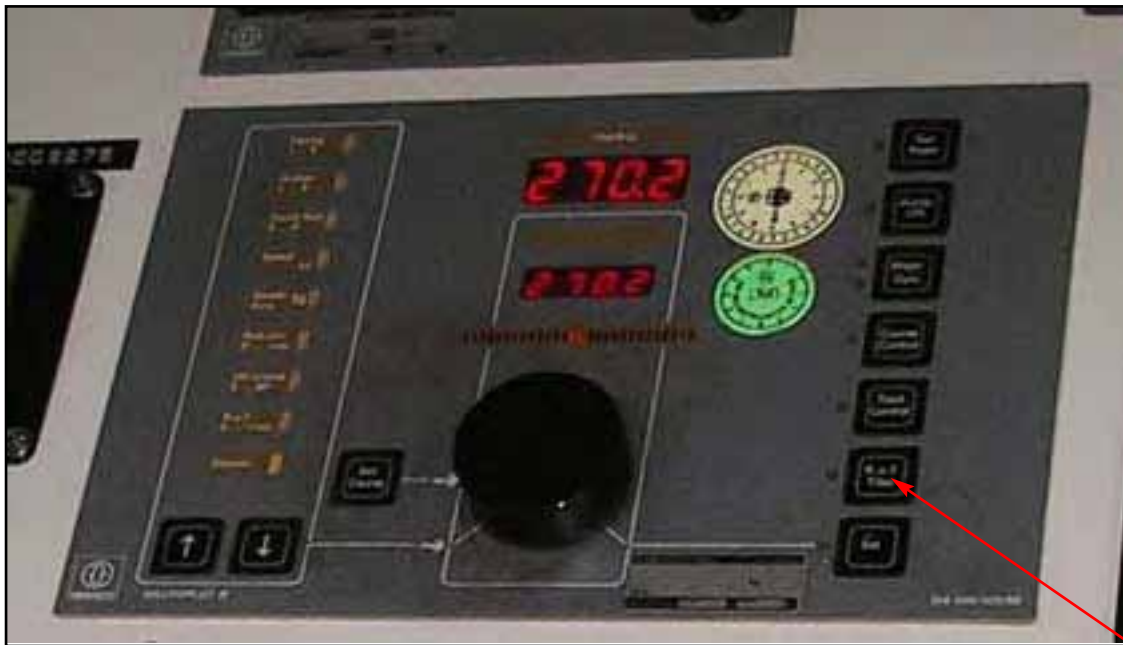
Figure 5

When autopilot was selected, the unit steered the vessel to maintain the gyro heading **current** at the time of changeover. The autopilot control panel also enabled the “rate-of-turn tiller” to be selected, by use of a button on the autopilot panel (**Figure 5**).

Autopilot

"rate-of-
turn tiller"
selection
button

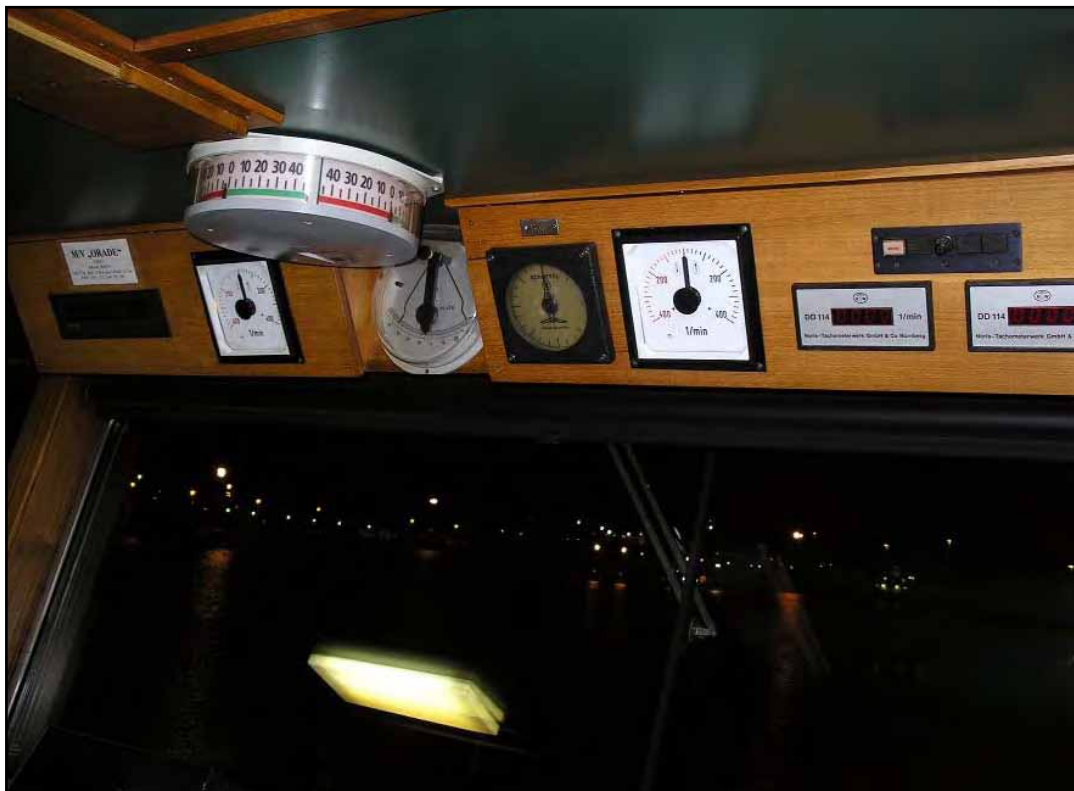
Figure 7

The pilot asked the master to switch to riverpilot as the rudder angle indicator (RAI) (**Figure 7**), which he had to constantly refer to, was directly above his head. In addition, the pilot considered the steering response from the manual tiller to be poor, and he was generally happier in either follow-up or riverpilot steering modes.

Rudder angle indicator

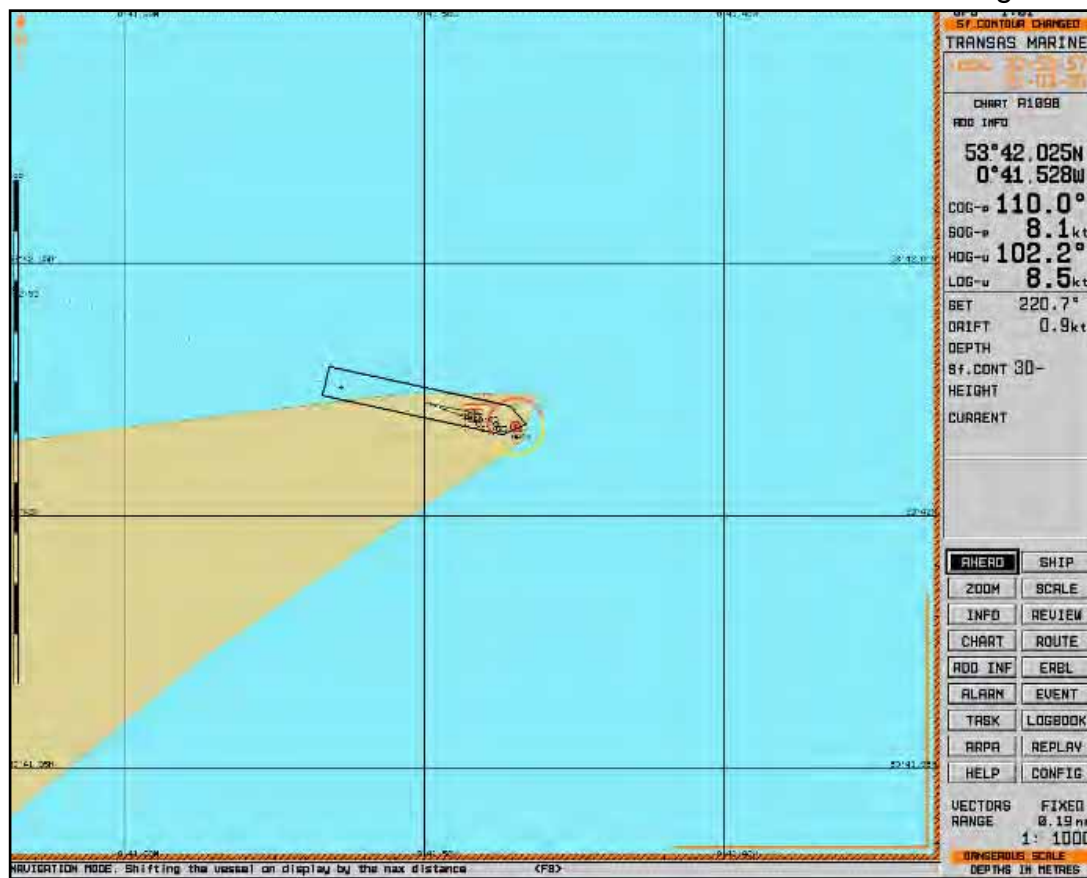
Figure 8

Transas snapshot of *Orade* aground at Apex Light

As soon as the change had been made, at about 2154, the pilot moved the joystick lever to the hard over to port position, and observed the RAI was indicating the requested rudder angle. Within seconds, the port bow struck the Apex Light and the hull bounced onto, and then over, the River Ouse training wall.

The master promptly stopped the engines. *Orade* moved forward slowly until her stern came to rest across the River Ouse training wall and her bow across the River Trent training wall – little of the mid length section was unsupported as the training walls merge into one almost solid structure at this point. Her bow was heading in an easterly direction into the River Trent (**Figure 8**). Gradually, due to the effects of the remaining flood tide, the bow steadily swung to starboard, eventually heading south.

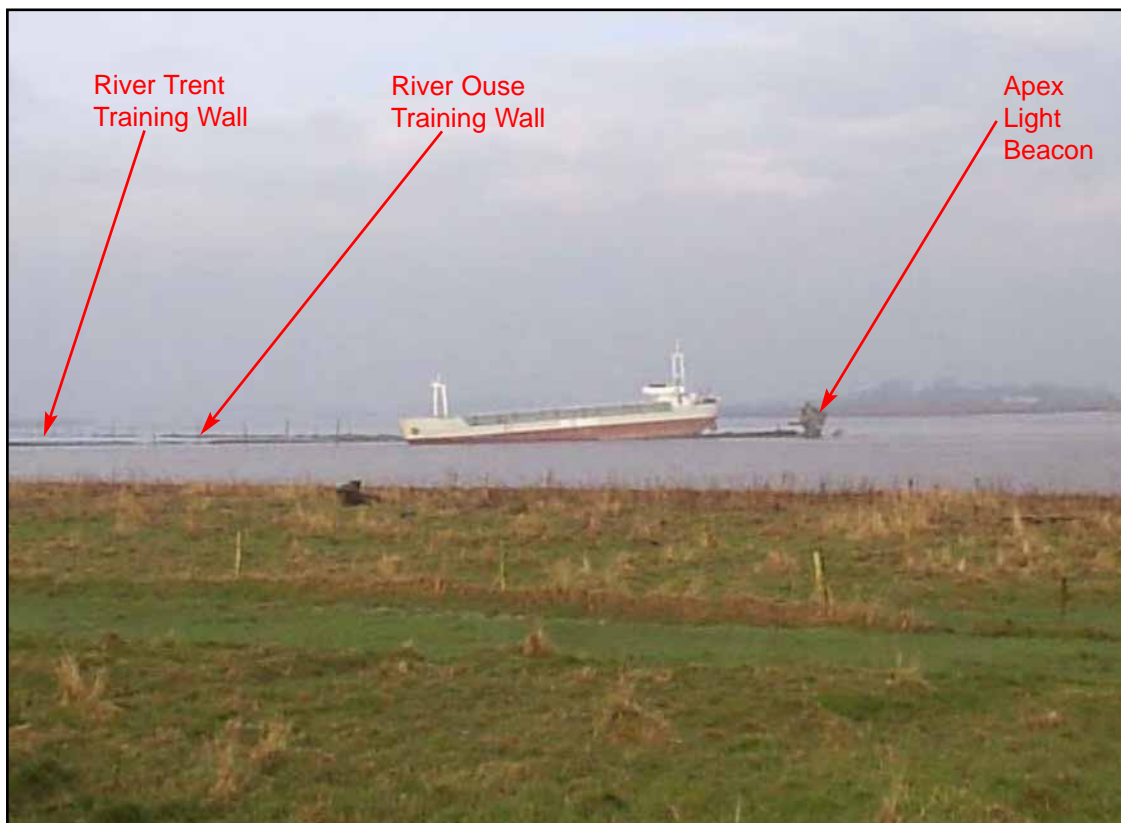
Figure 9

As the tide dropped, the bow sat in a deepwater pocket close to the training wall. The vessel's trim was estimated at 30° by the head at low water. No pollution or injuries to those on board had occurred.

Orade aground on River Trent Training Wall, 2 March 2005
