Report on the investigation of the
grounding of the passenger ro-ro ferry

Sardinia Vera

off Newhaven on

**Report No 19/2005
September 2005**

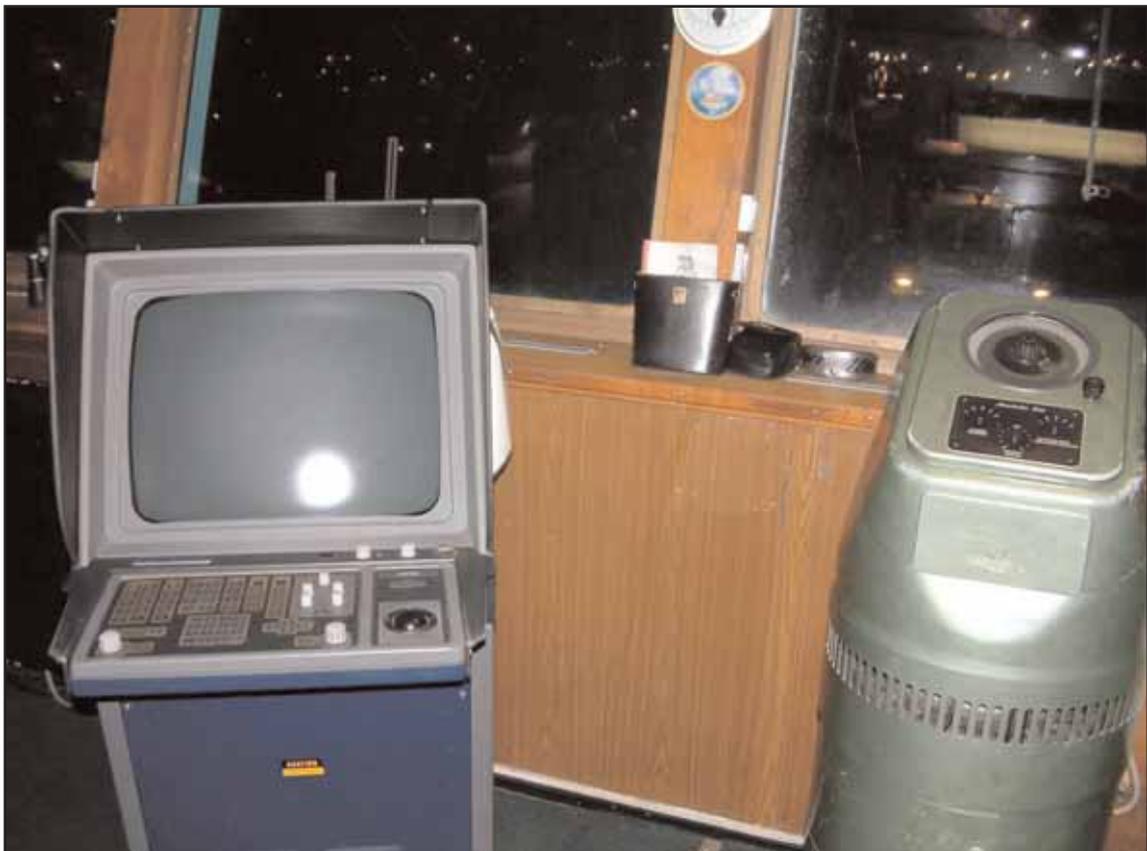
Figure 1

ARPA radar and auto pilot

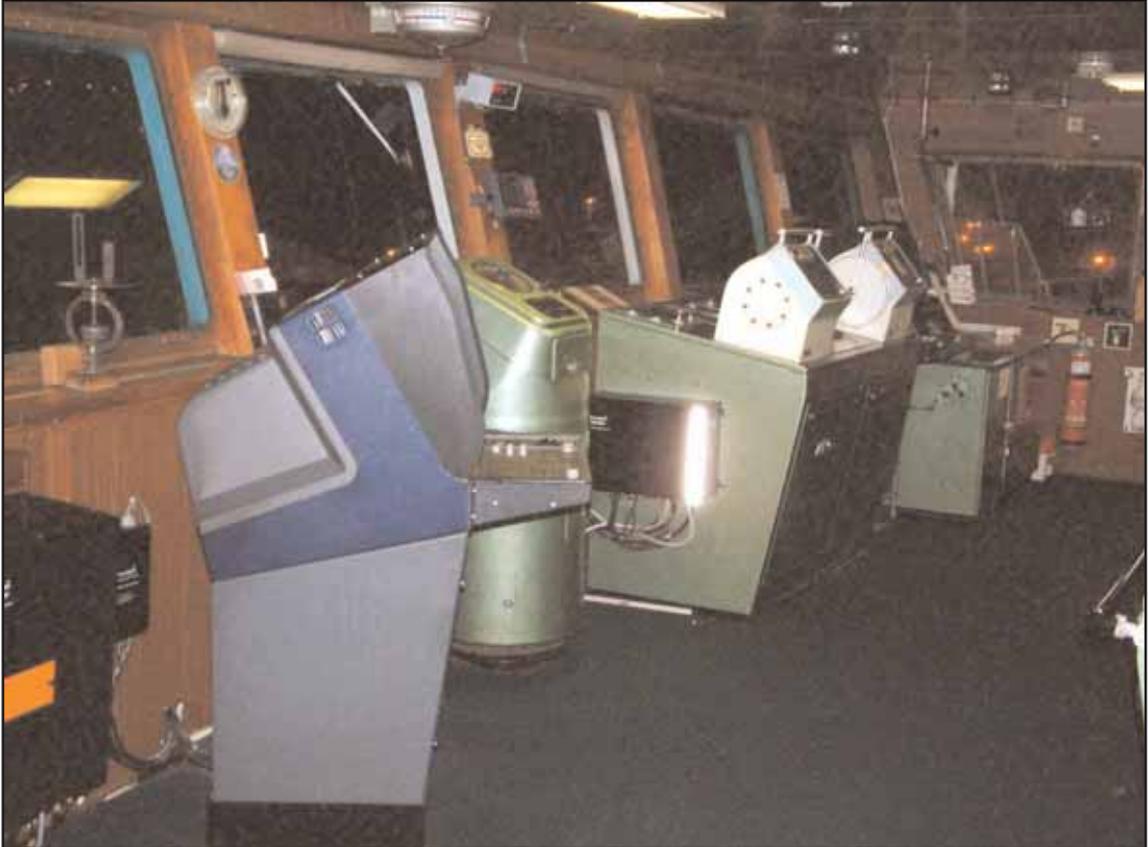
Figure 2

Bridge front layout

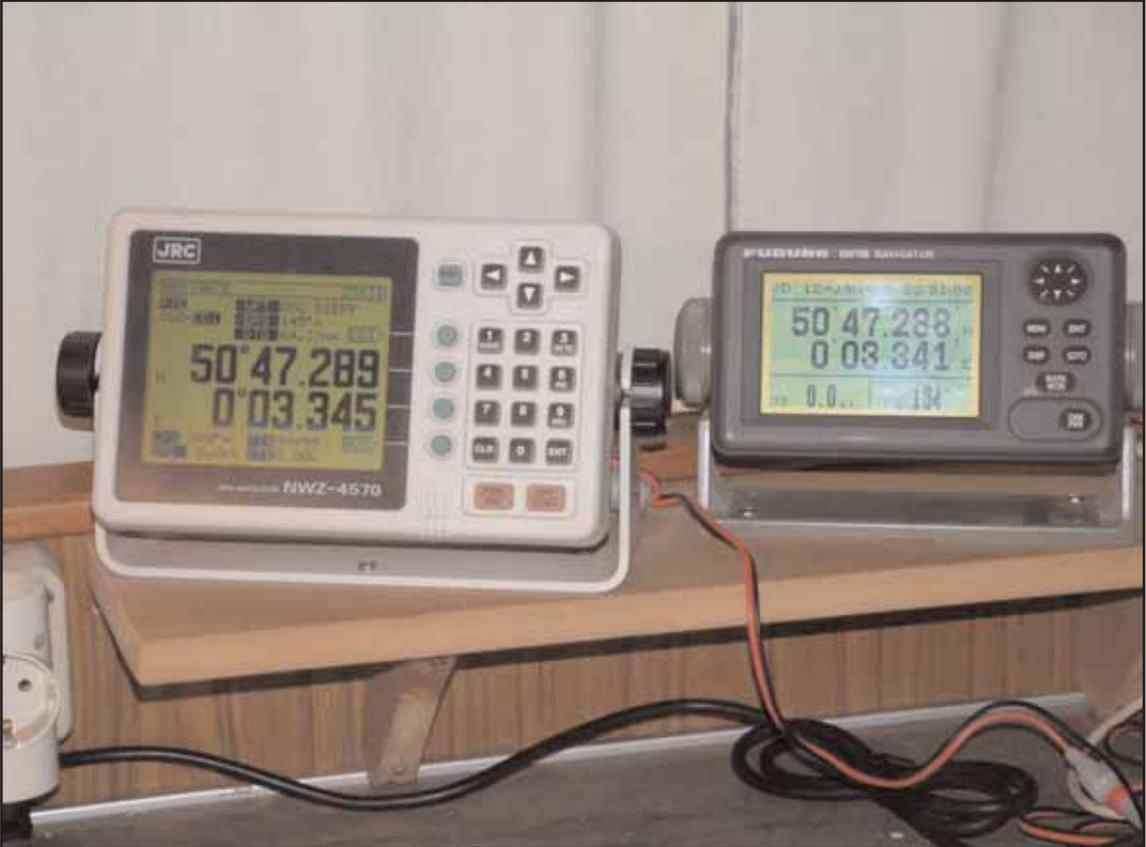
Figure 3

GPS (chart room repeaters)
