Report on the investigation of  
the contact between  
***Isle of Mull***  
and  
***Lord of the Isles***  
and subsequent contact with Oban Railway Pier  
Oban Bay  
29 December 2004

**Report No 13/2005**  
**July 2005**

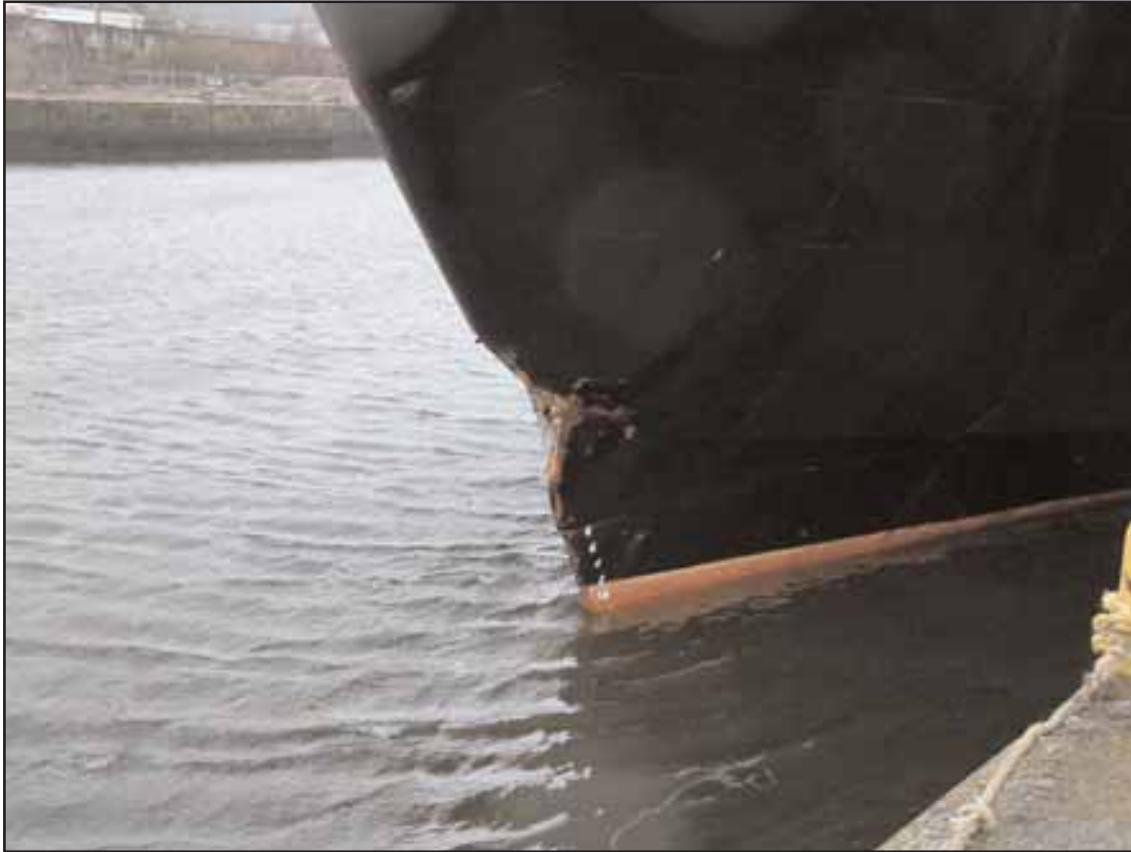
Figure 2

Time and date	:	19:05, 29 December 2004
Location of incident	:	Oban Harbour
Persons on board	:	26
Injuries/fatalities	:	None
Damage	:	Major damage to bow visor and port side of fo’c’sle at deck level. Vessel withdrawn from service for repair.

Bow visor damage

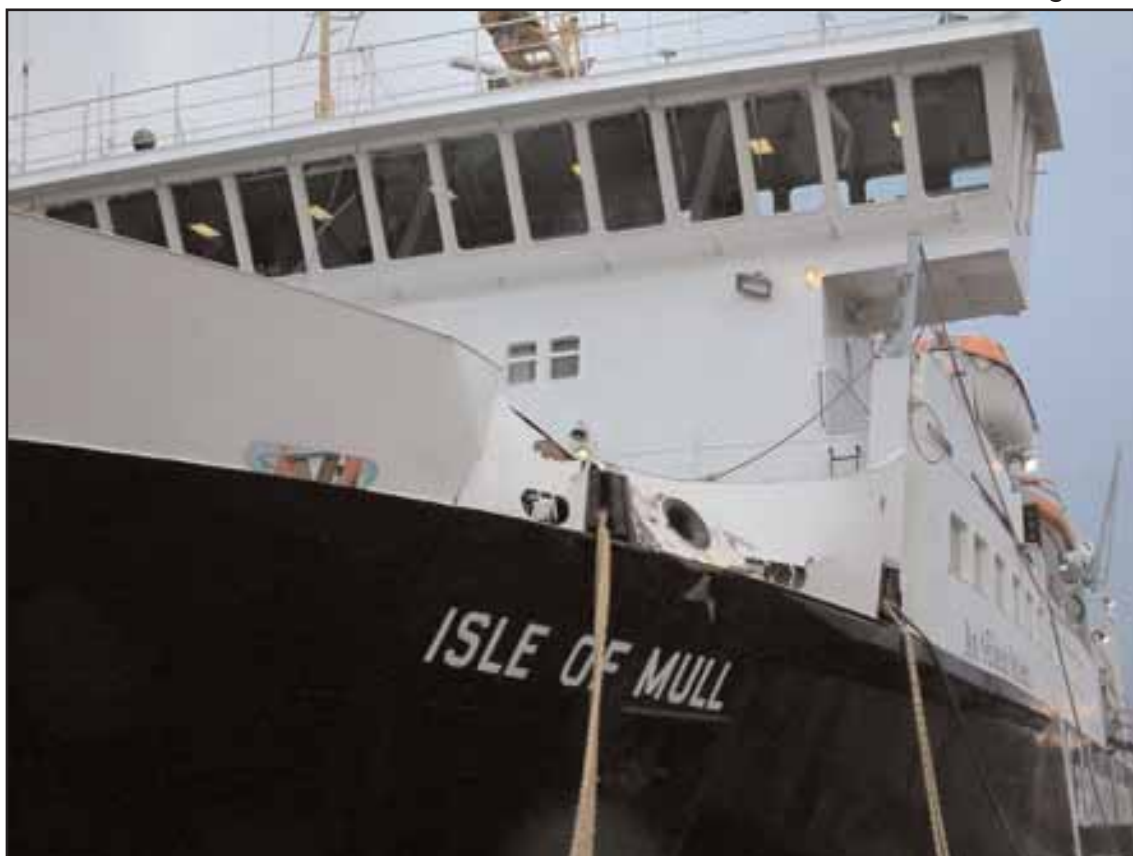
Figure 3

Port focsle damage

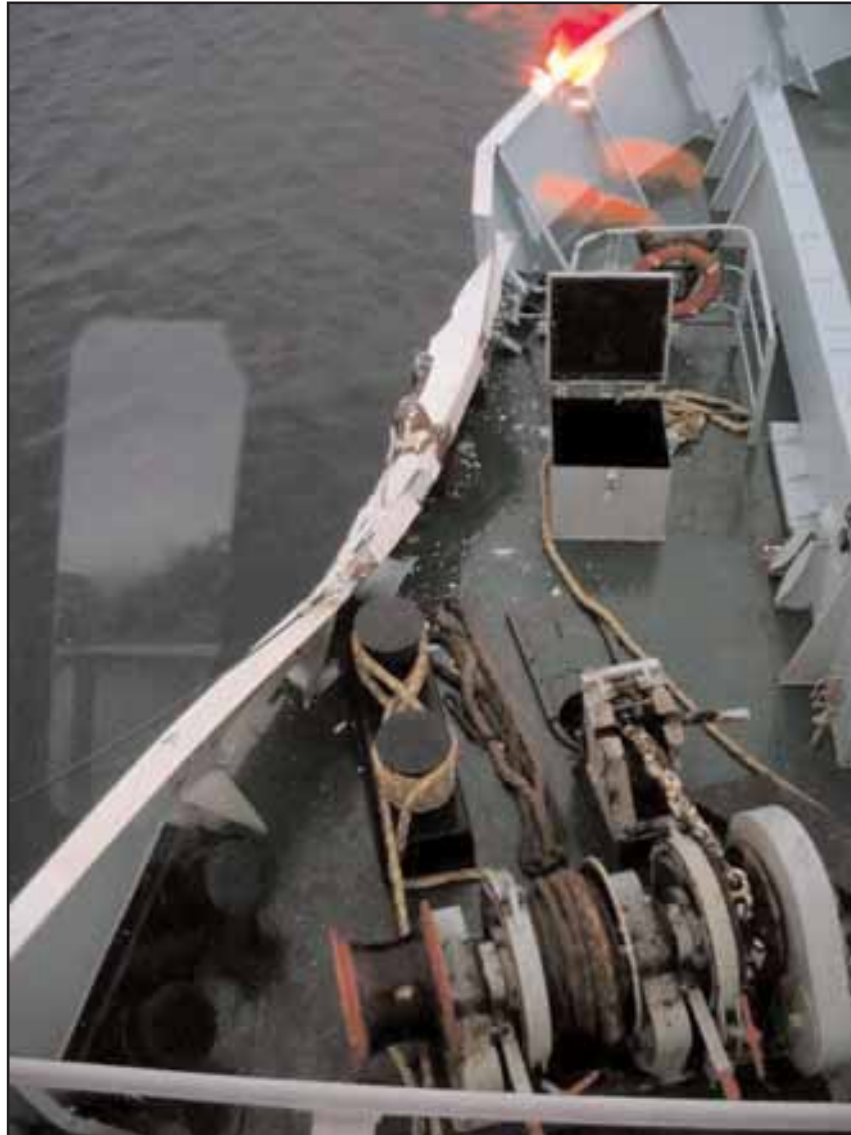
Figure 4

Foscle damage

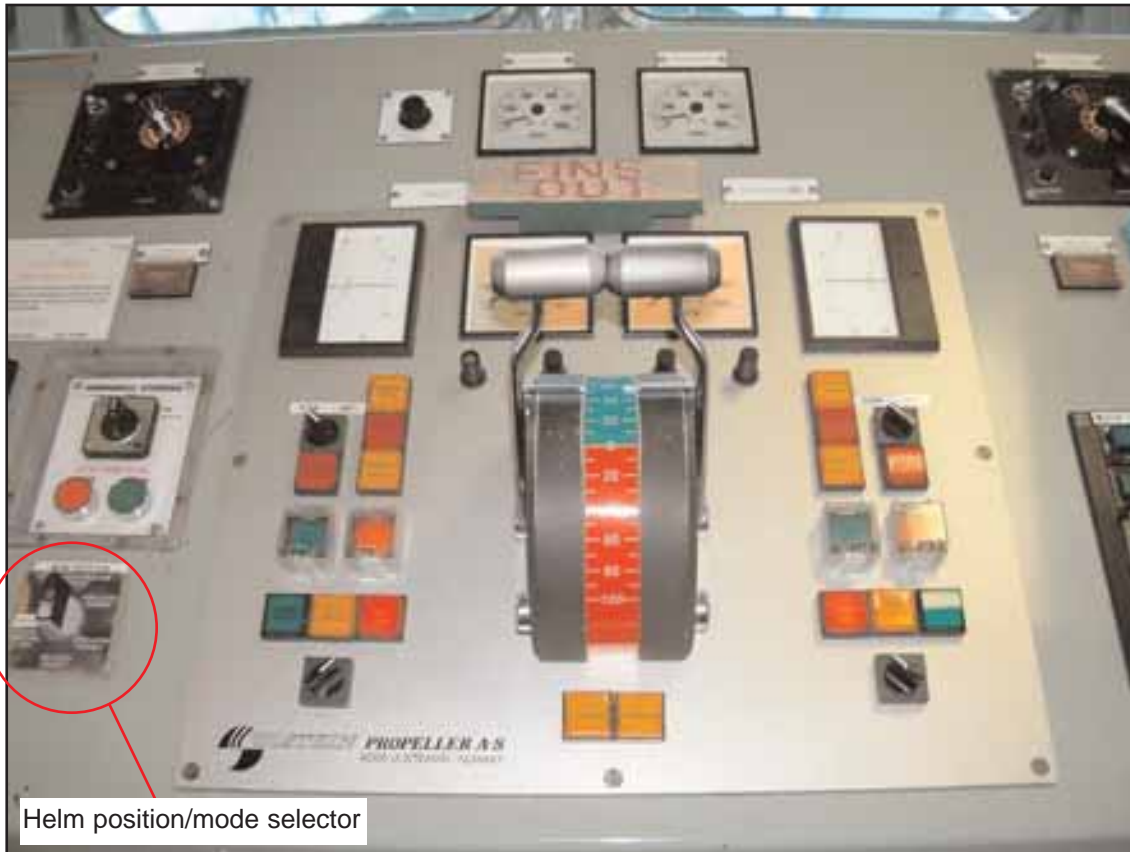
Figure 5

The bow thrusters could only be started at the central console. Transfer of control for the bow thrusters was achieved by pressing the 'control here' switch on the panel desired. The helm was transferred by the QM turning a switch on the central console to the desired control point (**see Figure 5**).

Central control console

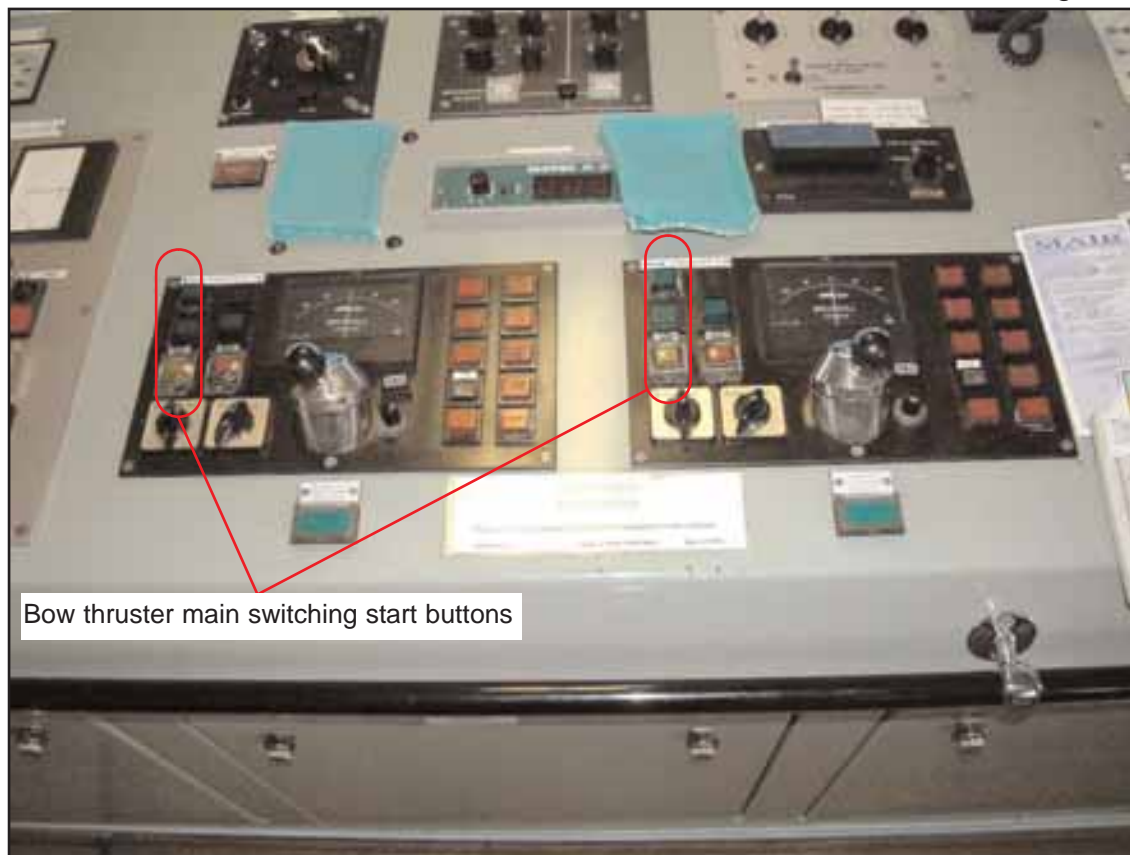
Figure 6

Bow thruster, central control console

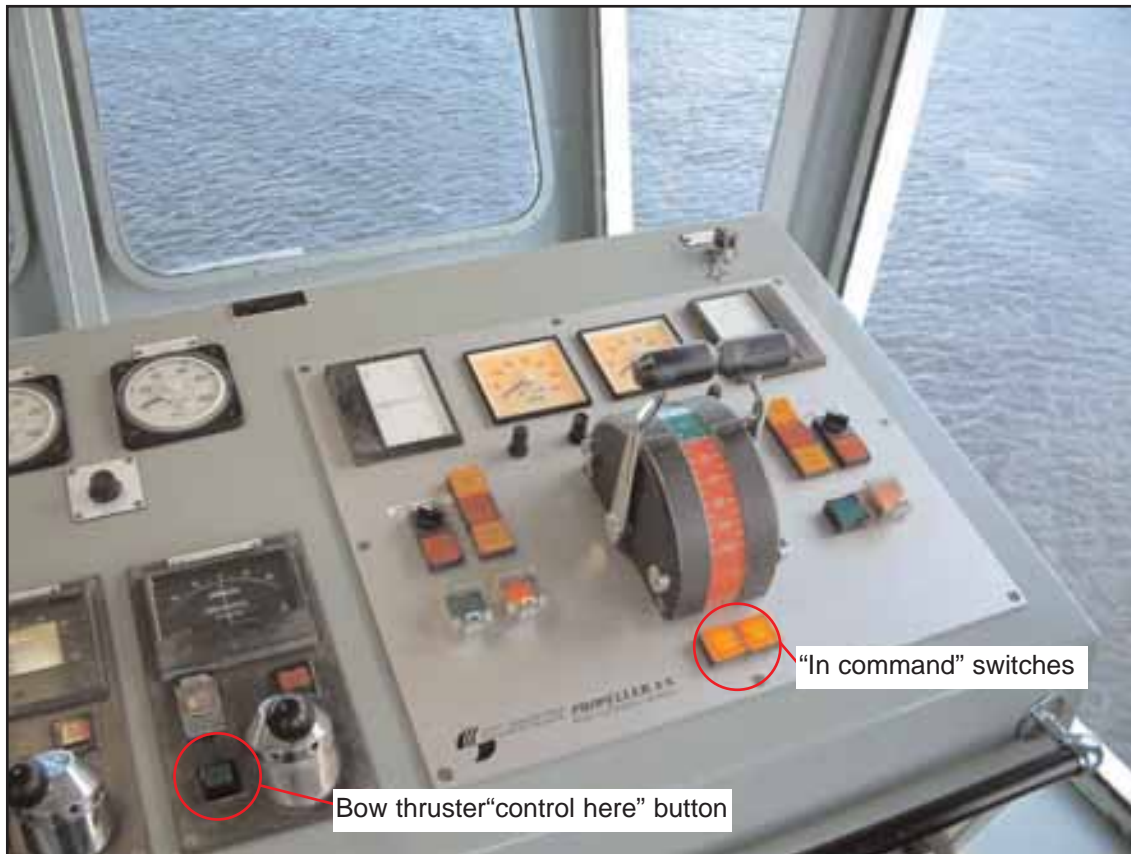
Figure 7

Starboard wing control console

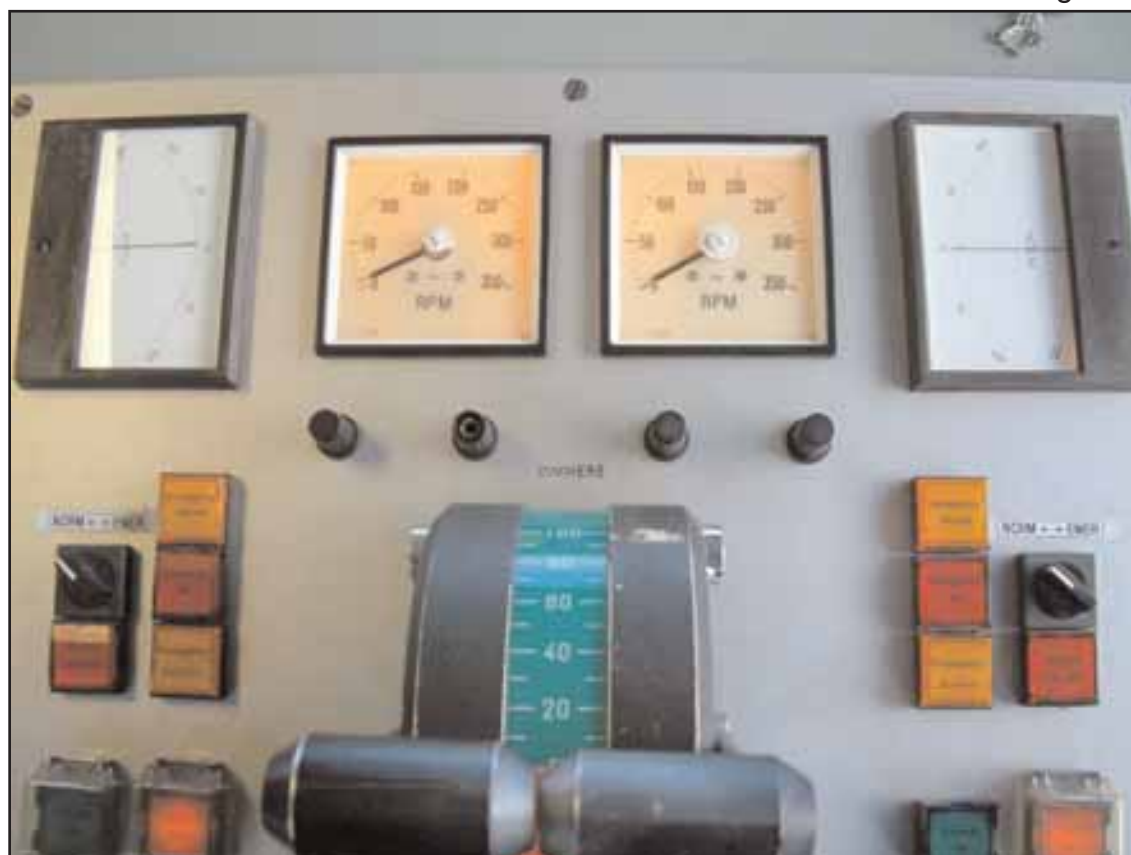
Figure 8

The dimmer controls in the bridge did not enable optimal viewing of critical gauges and switches when operating during the hours of darkness.

Instrument illumination was a problem at night on the bridge of *Isle of Mull*, and panel dimmer switches were usually turned down to preserve the OOWs' night vision. On the wing consols, the four dimmer knobs directly above the pitch levers controlled the brightness of the illumination of the panel (**see Figure 8**). The knobs operated in pairs, one pair controlling the starboard side of the panel and the other pair the port side. One of the knobs in the pair controlled the brightness of the gauges for the engine revolutions and the pitch setting. The other knob controlled the brightness of the switches beside the levers, and the 'in command switch' for that side. It was therefore possible to have the 'in command' switches illuminated at different intensities. With the dimmer knob adjusted to restrict the light from the engine revolutions gauge, the pitch gauge was very difficult to see.

Dimmer controls
