Report on the investigation of
the collision between

Brenda Prior and Beatrice

Lambeth Pier, River Thames

**Report No 16/2005
August 2005**

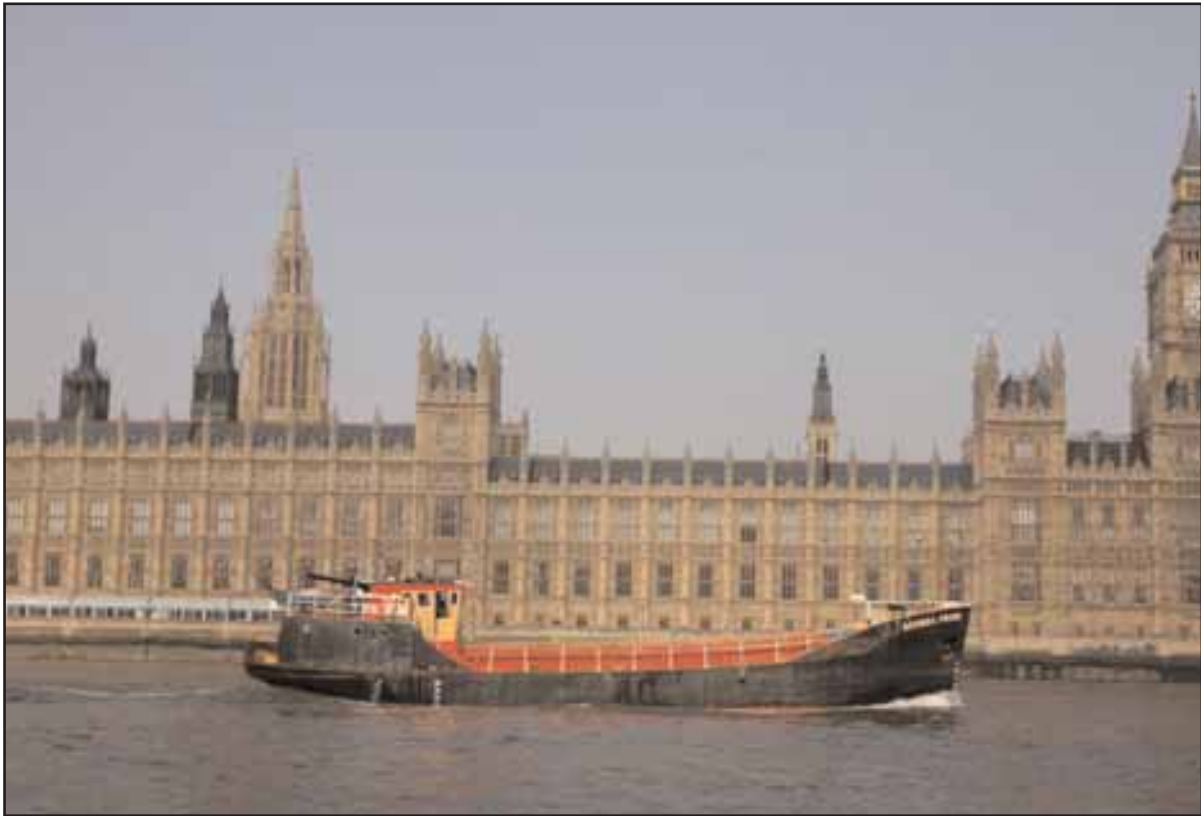
Figure 1

In the ballast condition, the vessel has a maximum draught of 1.83 metres aft, and 0.76 metres forward. With a resultant trim of 1.07 metres by the stern, this creates a considerable blind sector under the bow. Calculations show that for a master or officer on watch looking forward from the centreline wheelhouse window, the blind sector extends a distance of 53.3 metres from the bow through a sector of 14 degrees: 7 degrees either side of the centre line.

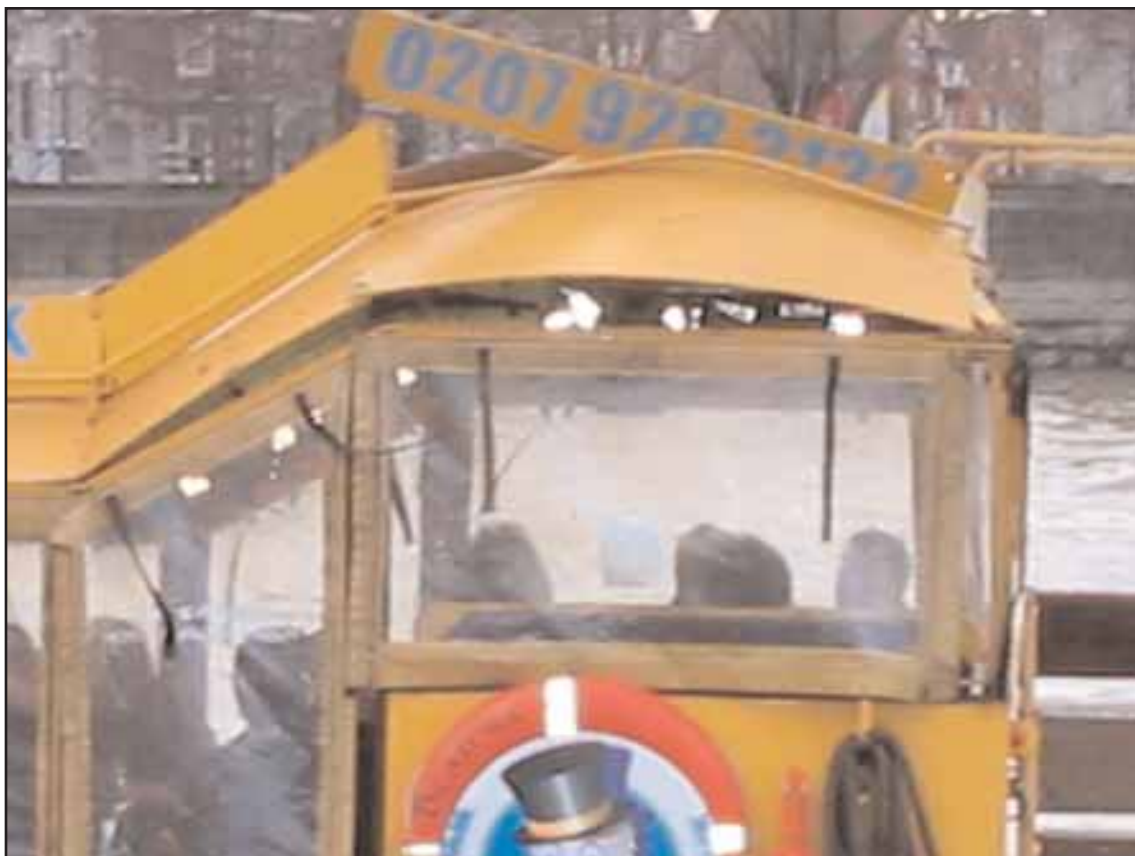
Figure 5

Damage sustained by the DUKW *Beatrice*

On return to Lacks Dock, the skipper of *Beatrice* reported the incident to Woolwich Radio VTS using his mobile telephone. In his report, he highlighted that he believed *Brenda Prior* had not seen him, because his vessel might have been situated in *Brenda Prior's* "blind spot", and that as *Beatrice* was only 1.5 to 3 metres away from the craft moored alongside Lambeth Pier, he could not manoeuvre any further to starboard. The report confirmed that no injuries were sustained, however, *Beatrice* had received a glancing blow and had suffered damage to the rear access ladders and canopy top.

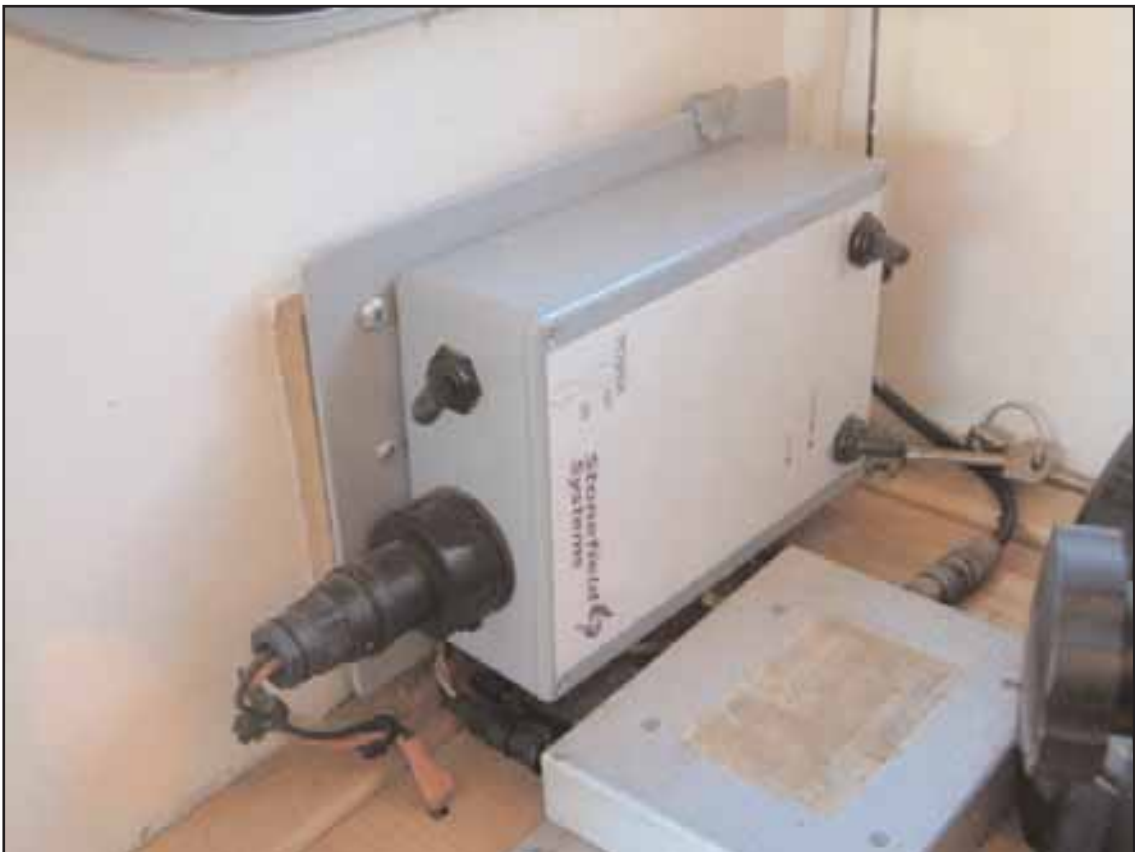
Figure 6

Keying device as fitted to *Brenda Prior*

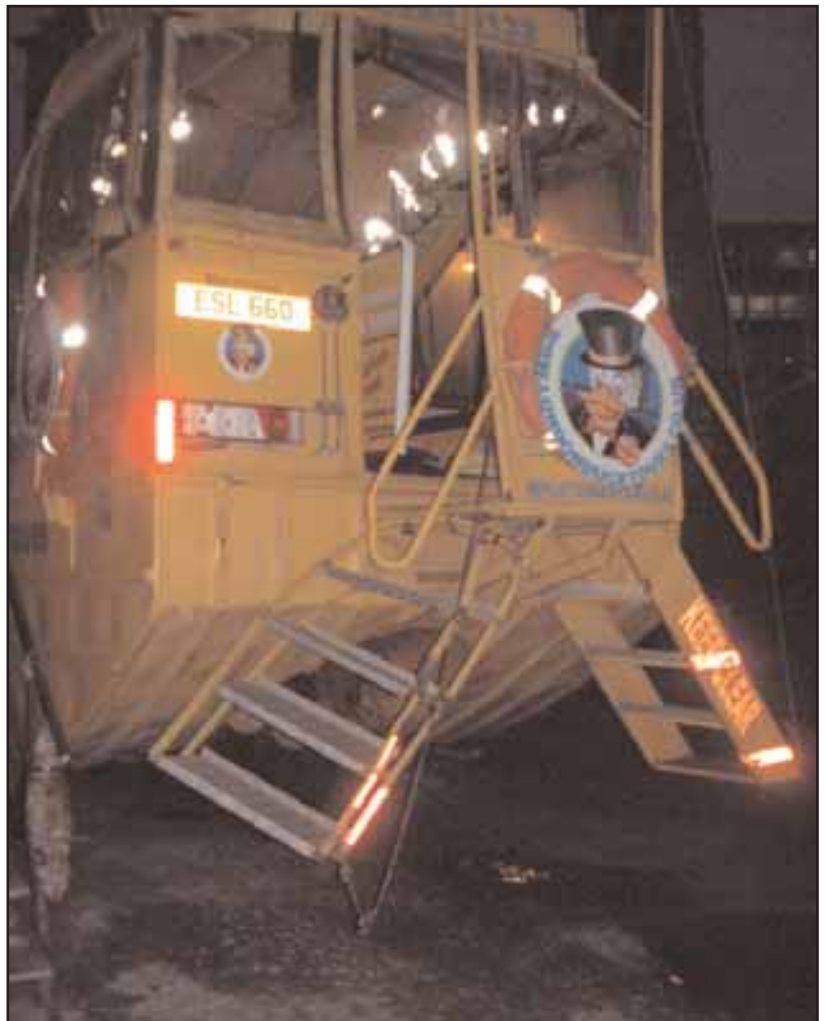
Figure 8

The single interior compartment accommodates the skipper, attendant, and 30 fare paying passengers on standard road transport seating (**see Figure 7**). Protection from the elements is achieved using a solid roof and vinyl side canopies supported by a steel framework. Access is gained by two retractable ladders positioned at the stern (**see Figure 8**).

Damage sustained at the stern of *Beatrice*

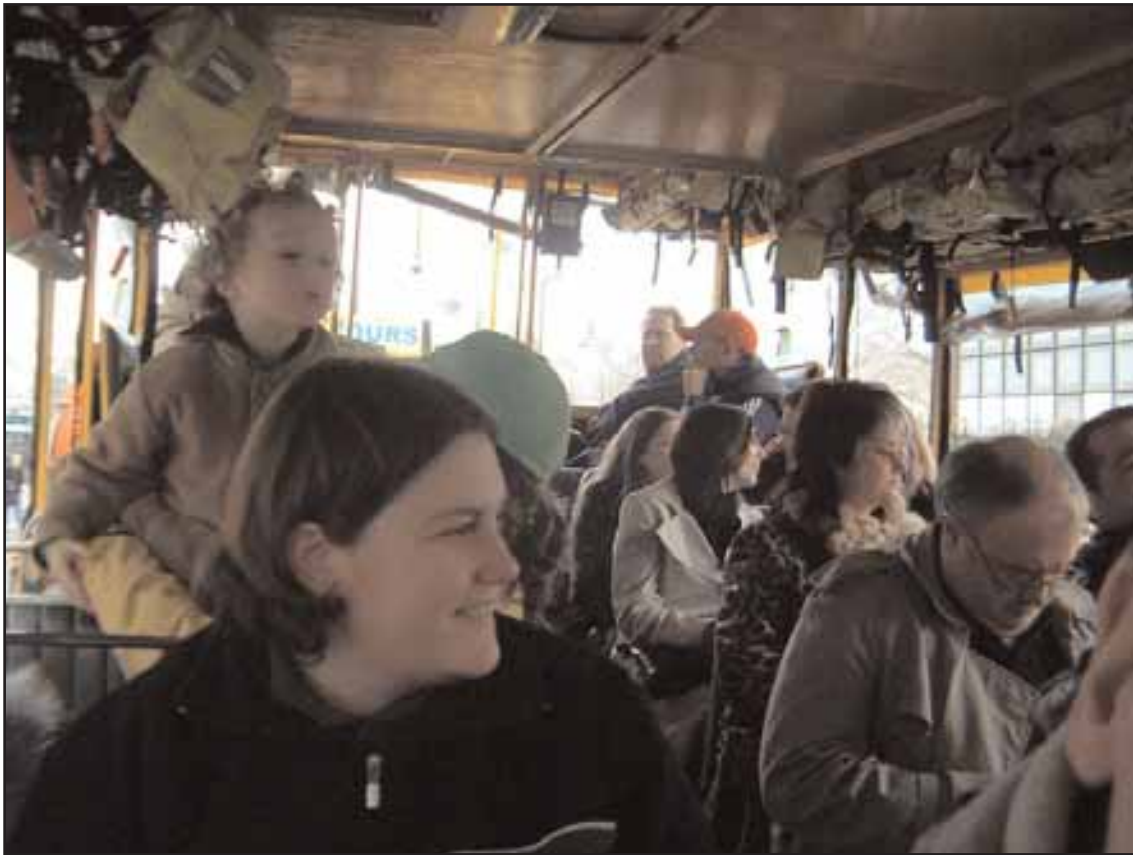
Figure 9

View looking astern from the attendant's position

Lookout responsibilities on a DUKW are shared between the skipper and the attendant. The attendant fulfils the statutory requirement for a dedicated lookout, but is also the safety advisor and Tour Guide. Both are seated forward of the passengers, and have direct sight ahead through the windscreen and to the sides through windows immediately to port and starboard. With passengers onboard, it is not possible for the skipper to gain a direct line of sight internally through the rear canopy, and he uses road vehicle wing mirrors to view astern (see Figures 9 and 10).

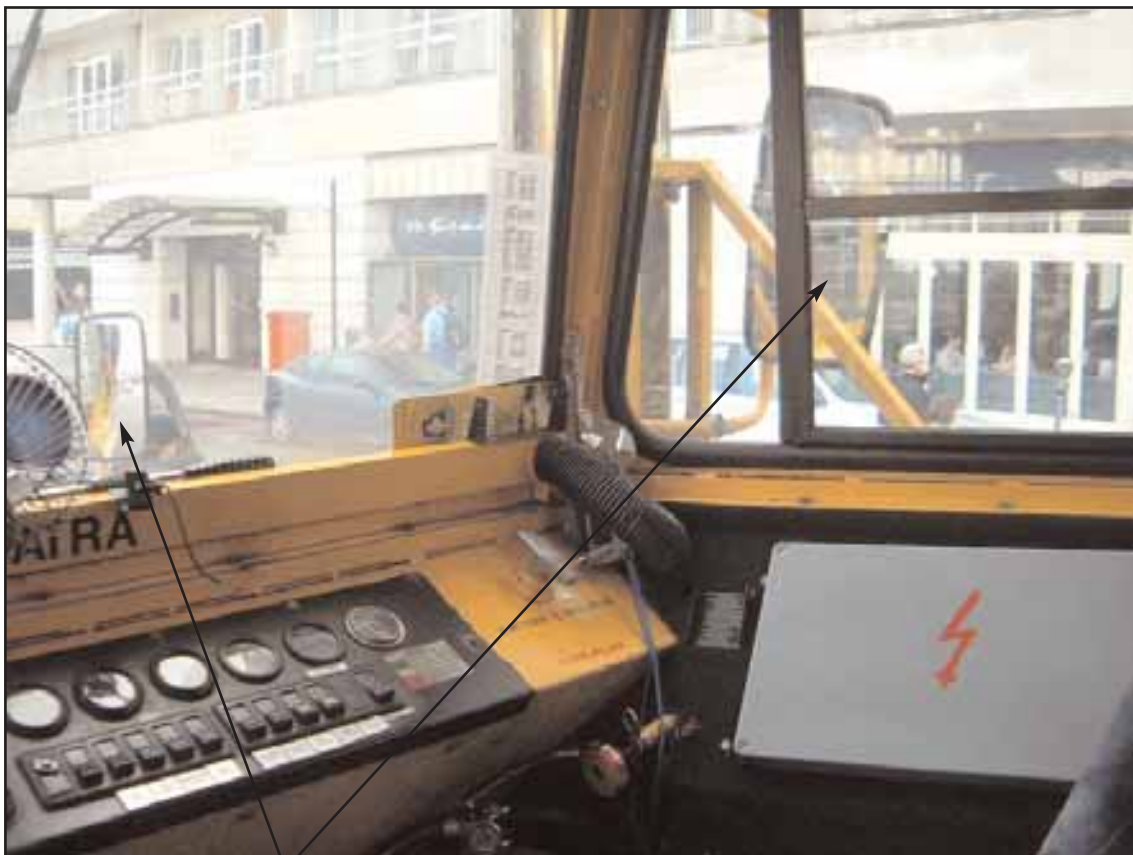
Figure 10

Vehicle wing mirrors used to assist skipper and lookout
