Report on the investigation of

the grounding of

British Enterprise

> Report No 25/2005 December 2005

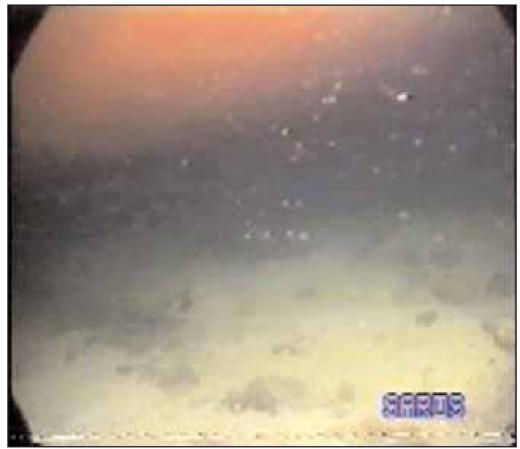
Figure 3

The divers entered the water at 1645 on 12 December, and recorded their findings on video. No hull damage was found, other than the hull coating being scored and scraped. The divers reported that just 42 metres of the vessel's midlength section, between frames 57 and 72, was aground, and there was about 4 metres depth of clear water under the stern, and between 1 and 2 metres under the fore part of the hull. They also reported they had found a small "hill" of sand and shells on the port side of the vessel at about mid-hull length (see Figures 3, 4, 5, 6 and 7).

Seabed and clearance under stern

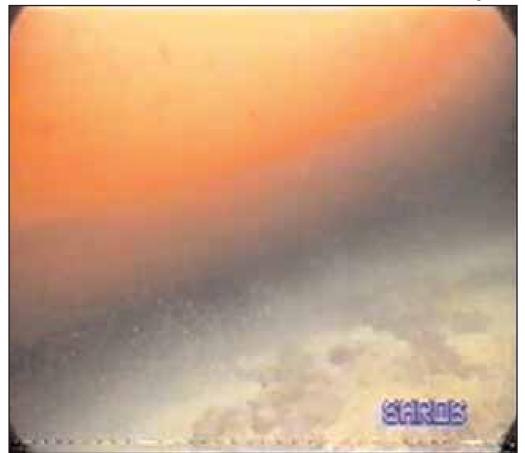
Hull grounded section on level sand

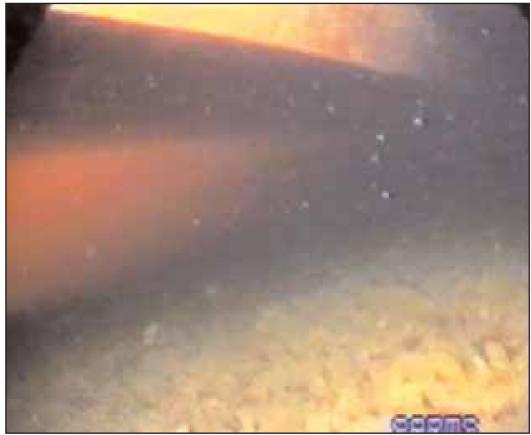
Figure 5

Vessel aground showing broken seabed

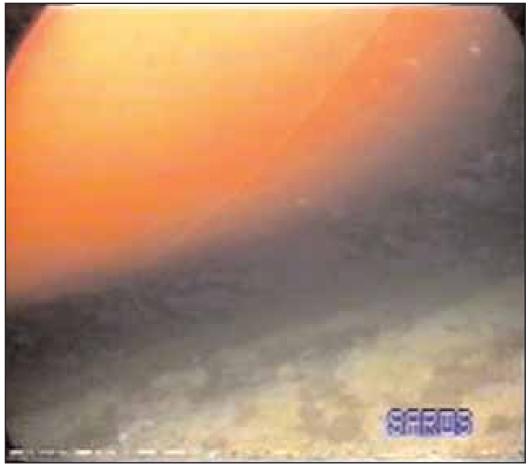
Showing keel clearance under the bow, and unbroken seabed

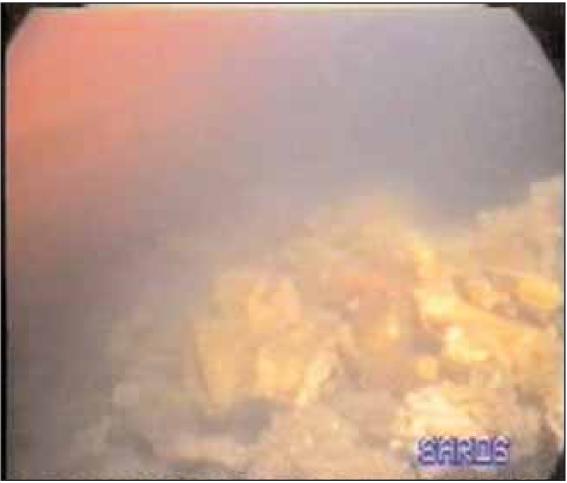
Port side of hull showing broken seabed and hill

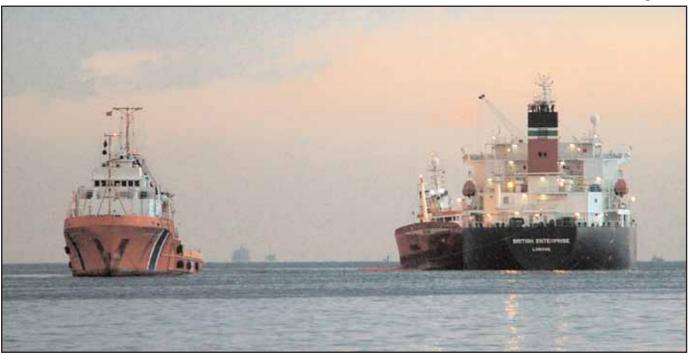
Cargo lightening operation and tug in attendence

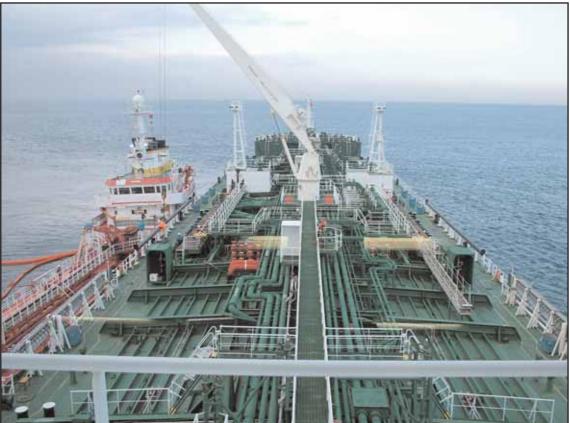
Cargo lightening operation

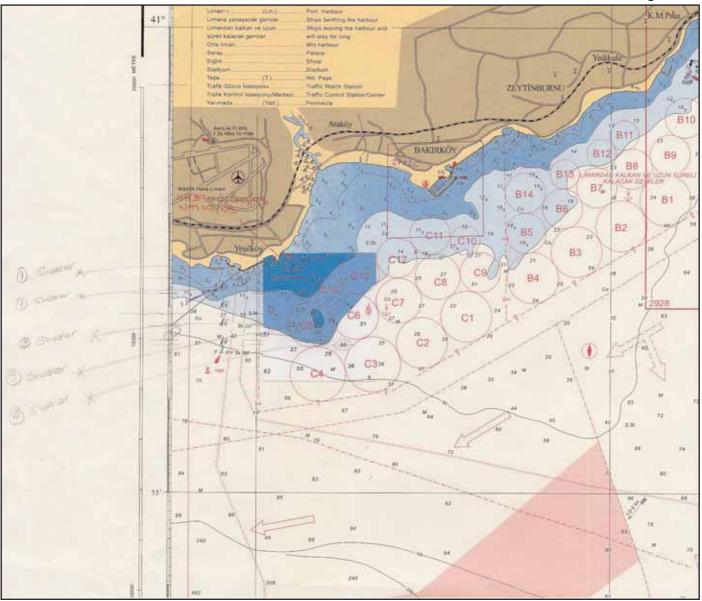
The THO issued a notice to mariners, 19/2005, on 29 January 2005, giving details of the actual soundings found during the survey, and included a block update for insertion onto the largest scale Turkish chart.

Turkish chart of area with added block from NM 2005-5

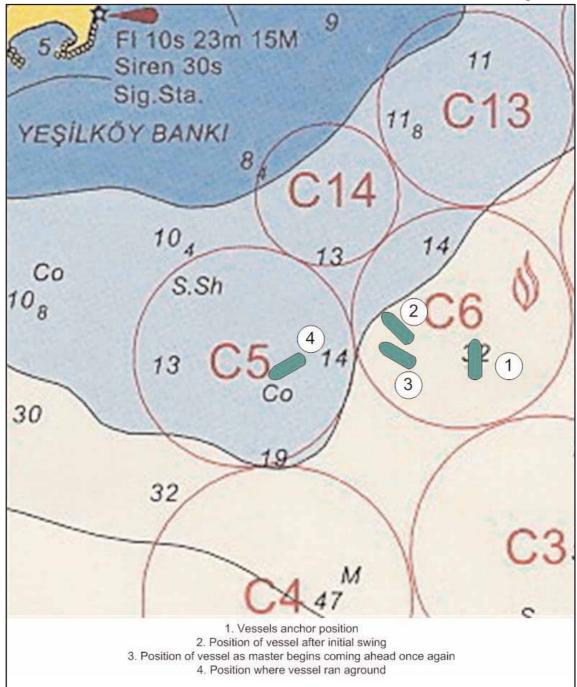
Figure 25

The vessel grounded with little or no vibration and the master stopped the engine immediately he became aware her speed had reduced to zero. The engineers on watch in the engine room were not aware of the situation until the master informed them. 31

Vessel manoeuvres prior to grounding

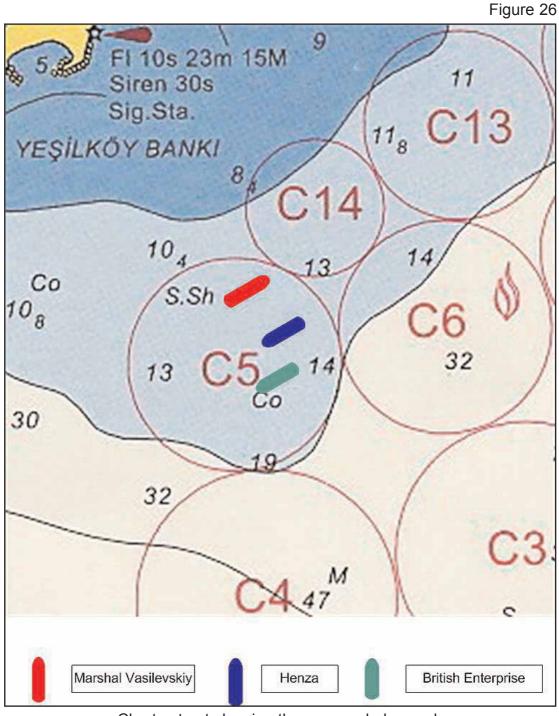
The Turkish flag bulk carrier *Henza,* on a voyage from the Black Sea to China, laden with 63,478 metric tonnes of fertiliser, grounded in C5 anchorage on 17 February 2003 (Figures 26 and 27).

Chart extract showing three grounded vessels

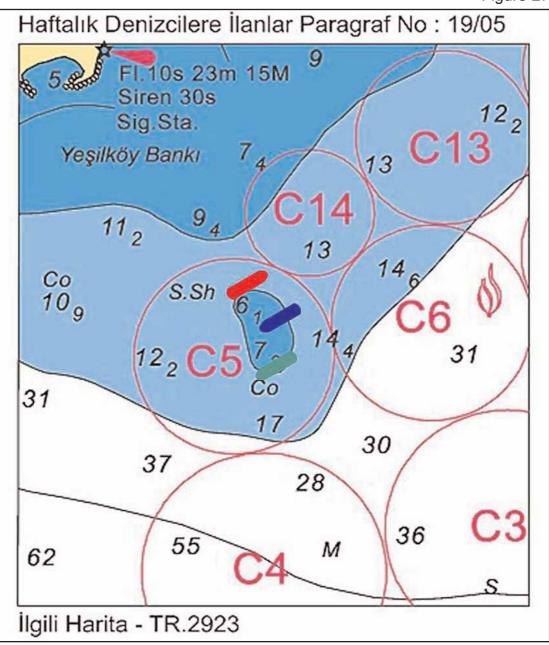
Chart extract showing three grounded vessels

An investigation into the grounding was completed by the port authority. The investigation concluded that, as the vessel had a maximum draught of 13.05 metres, and she grounded in an area with a charted depth of between 13 and 14 metres, the principal causal factors were the actions of the master and his navigating team. The investigation did not uncover any discrepancy between the actual and charted depths, therefore no re-survey of the area was made.
