Report on the investigation of
the grounding of
Stolt Tern
Holyhead, Wales
1 December 2004

Marine Accident Investigation Branch
Carlton House
Carlton Place
Southampton
United Kingdom
SO15 2DZ

Report No 18/2005
September 2005

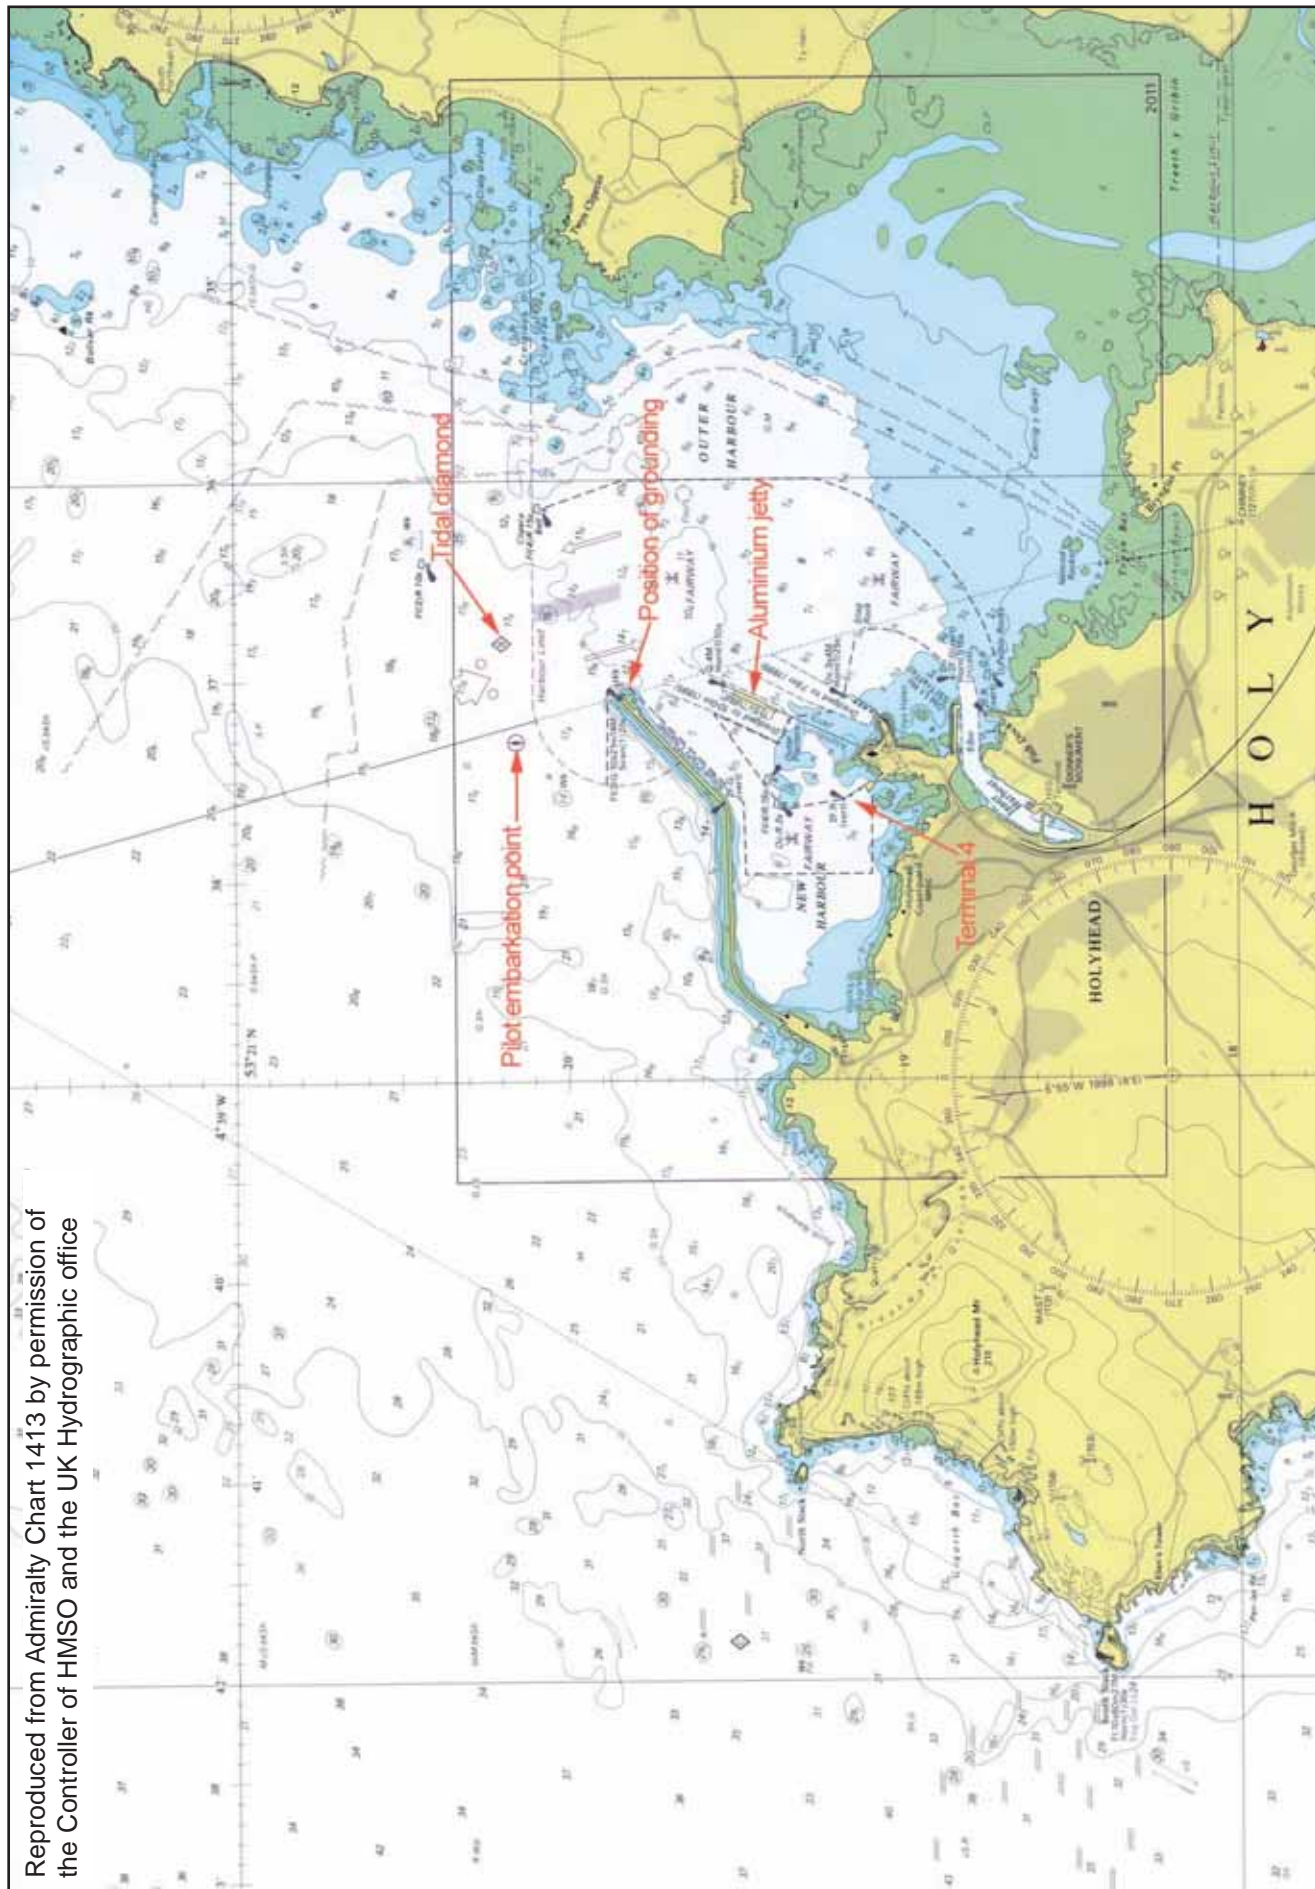
Figure 1

The tidal stream predictions for tidal diamond 'B' shown at **Figure 1** are based on a relatively recent survey, and are therefore considered to be accurate. However, it is anticipated that the breakwater would cause the rate of an east flowing tidal stream to accelerate, as described by the pilot. If this is the case, the information contained in the Sailing Directions, which describes the tidal stream close to the north of the breakwater as 'negligible', is misleading. As the tidal streams in this area affect all ships entering and leaving the harbour, clarification of the rates likely to be experienced is required, and, if necessary, amendment to the Sailing Directions initiated.

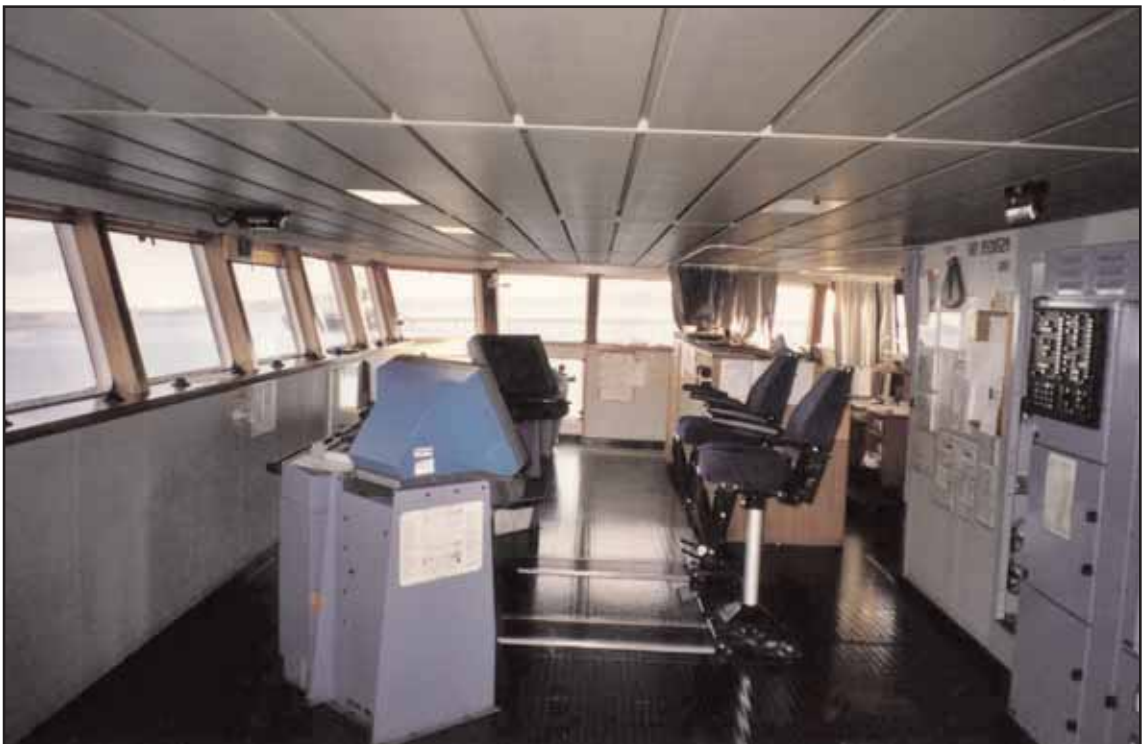
Figure 2

As the ship approached the harbour entrance, the master and third officer stood behind the control console sited in the centre of the bridge (**Figure 2**). The pilot stood in front of this console. The master controlled the pitch control lever, and the third officer was on the helm, except when relieved by the master to allow him to plot fixes on the paper chart at 0930 and 0935.

Photograph showing bridge layout

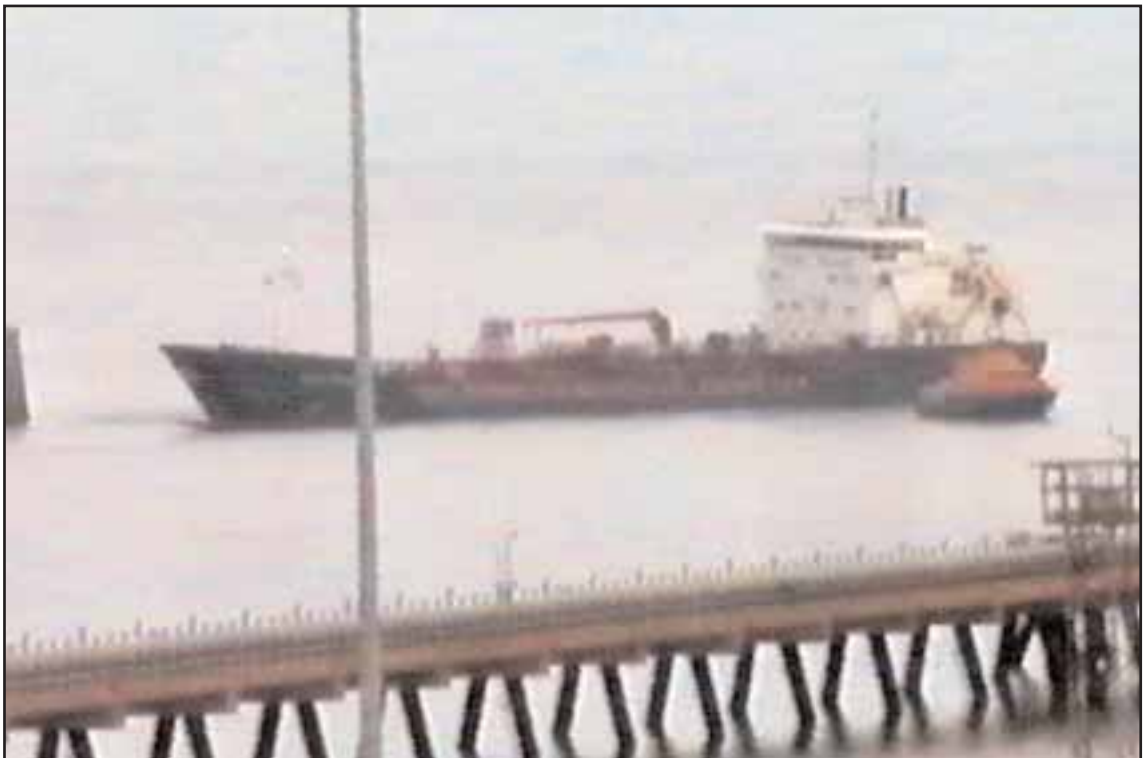
Figure 3

Photograph of *Stolt Tern* aground

An underwater survey conducted at Terminal 4, showed that the ship had sustained a 2.3m x 50mm split on the starboard side of the hull forward of the bow thruster, together with several indentations.

Following a temporary repair, the vessel sailed during the evening of 2 December 2004. Permanent repair was conducted in Rotterdam between 7 and 19 December 2004.

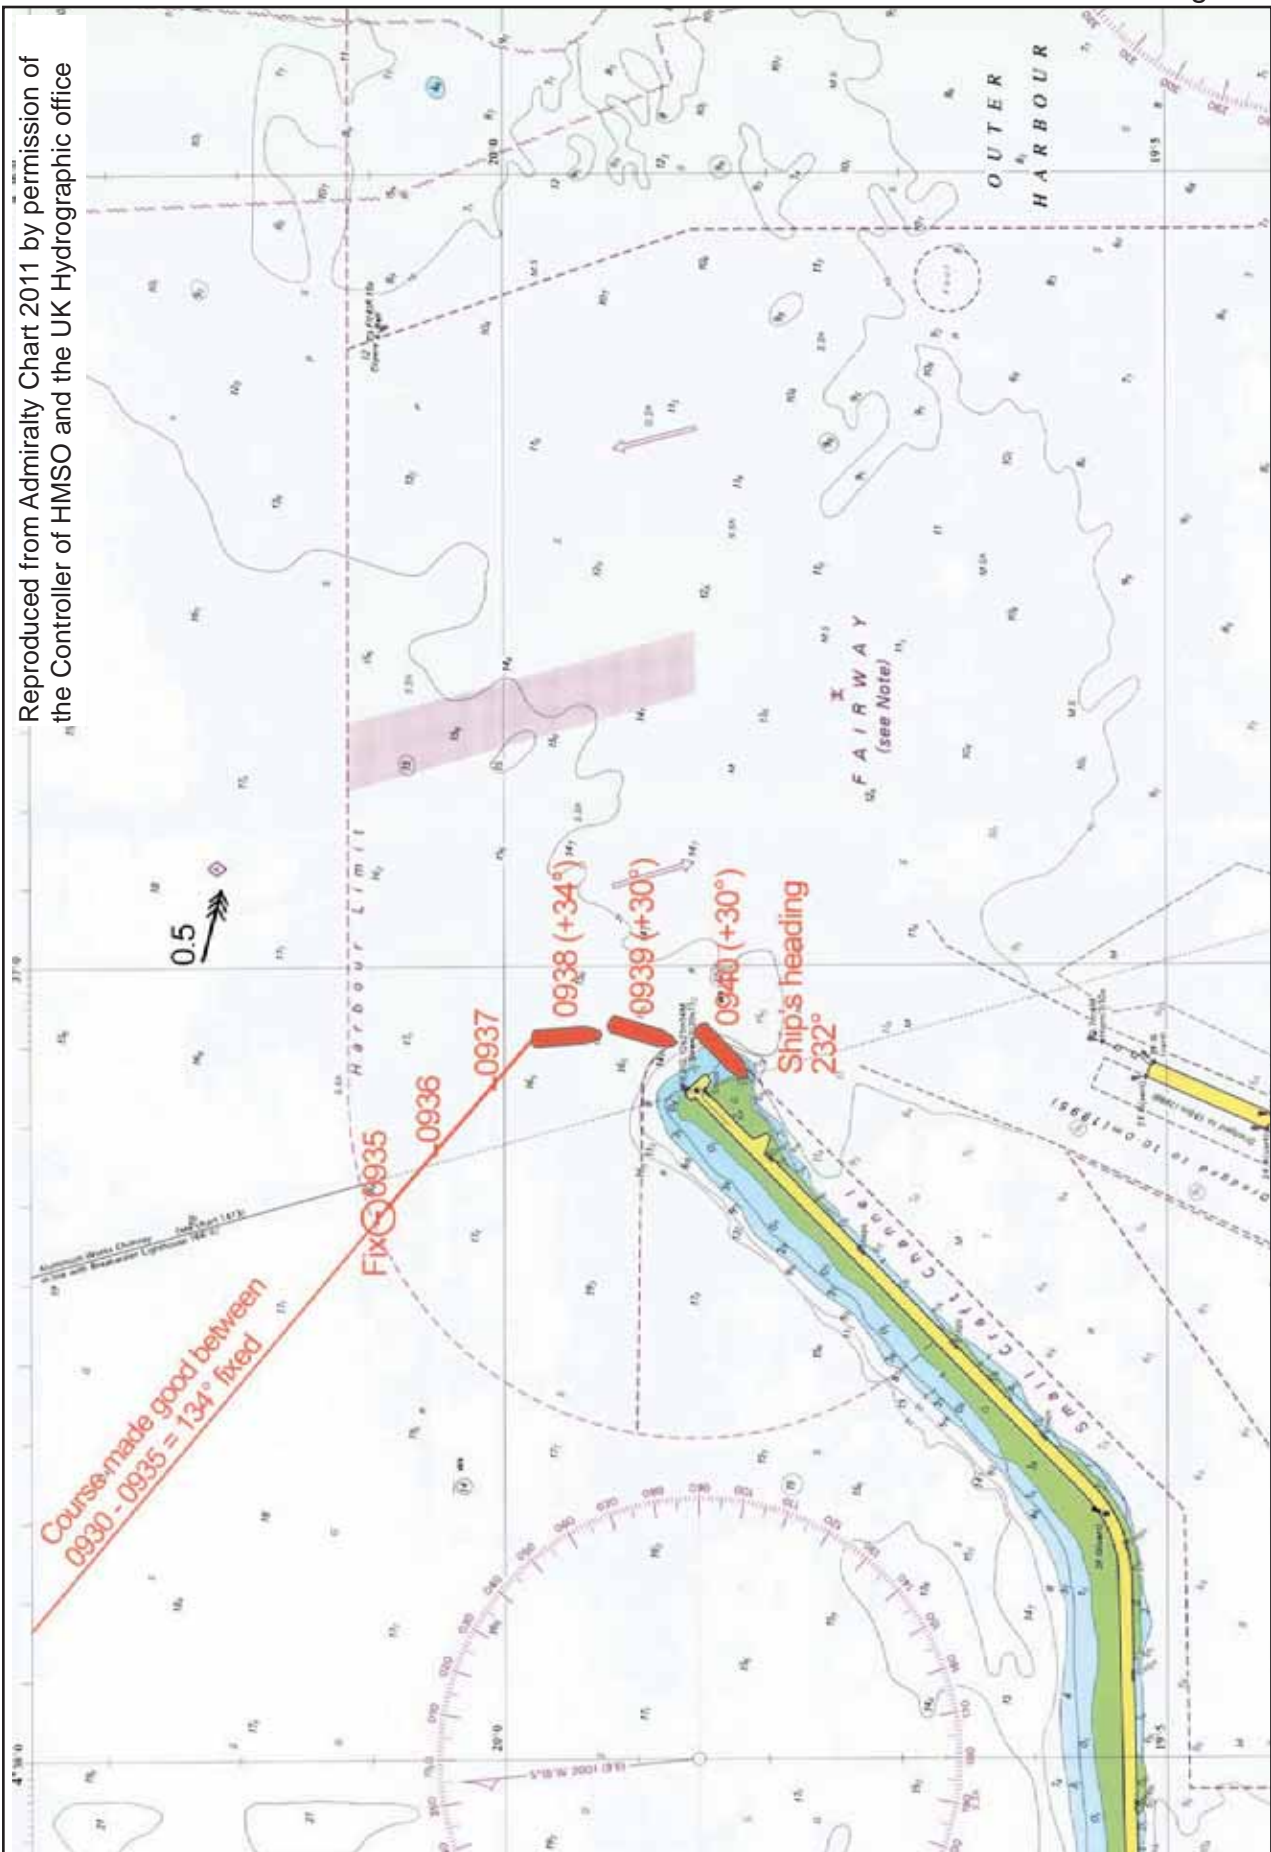
Figure 4

Third, although the time the bow thruster was used at the start of the turn was stated by the master to have lasted only a few seconds, its use is likely to have had an influence given the ship's slow speed. In conjunction with the 5° of starboard rudder, which according to the information in the pilot card equated to about 15° of conventional rudder, this could have induced a high rate of turn unless quickly checked.

Estimation of ship's ground track

The intended passing distance off the breakwater allowed insufficient sea room and time for corrective action to be taken. A similar accident could easily have occurred had the ship suffered a mechanical failure, or had to manoeuvre to avoid a small craft unexpectedly leaving the small craft channel, south of the breakwater.
