Report on the investigation of
the collision between
Cepheus J and Ileksa
in the Kattegat
22 November 2004

**Report No 12/2005
July 2005**

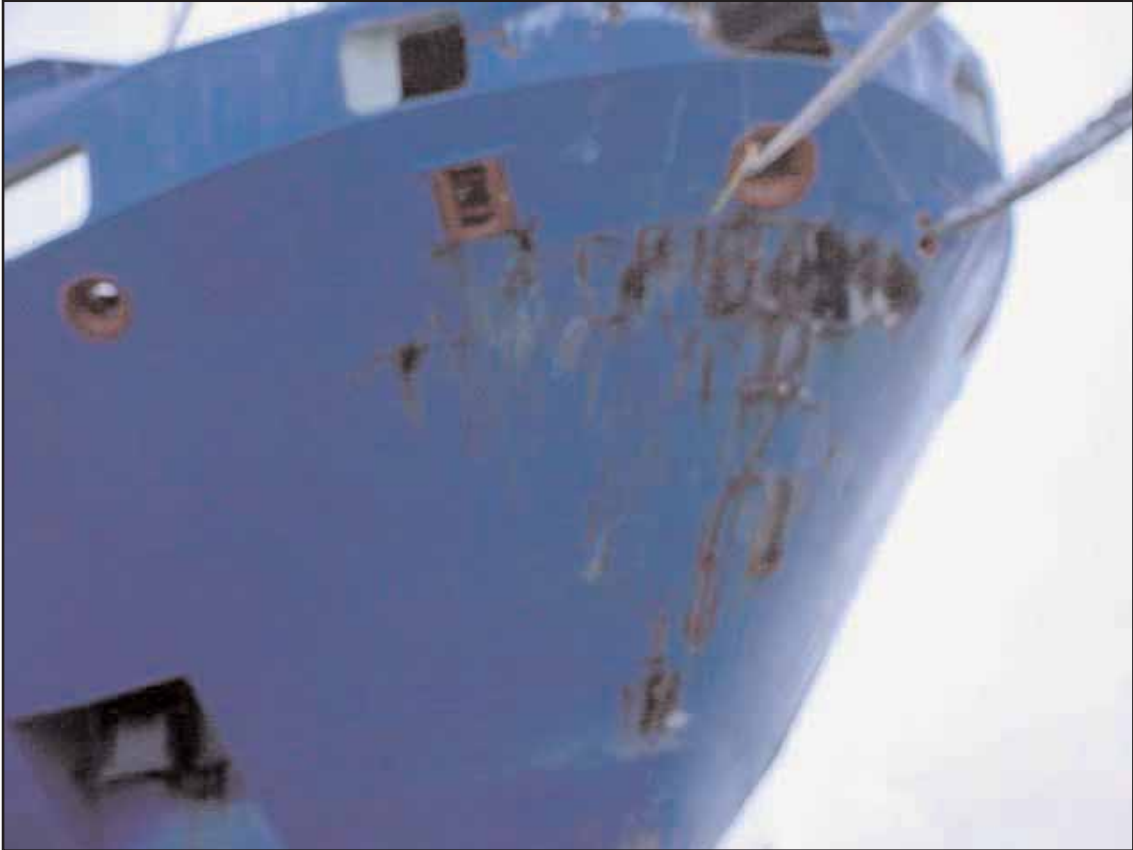
Figure 4

A hole in the shell plating at upper deck level at the bow, approximately 2.5m x 1.0m, in way of the forecastle store and upper deck bulwarks. Approximately 4m² of deck plating replaced in this area, and stringers replaced (**see Figure 4**).

Bow damage to *Cepheus J*

The following damage was temporarily repaired at the next port:

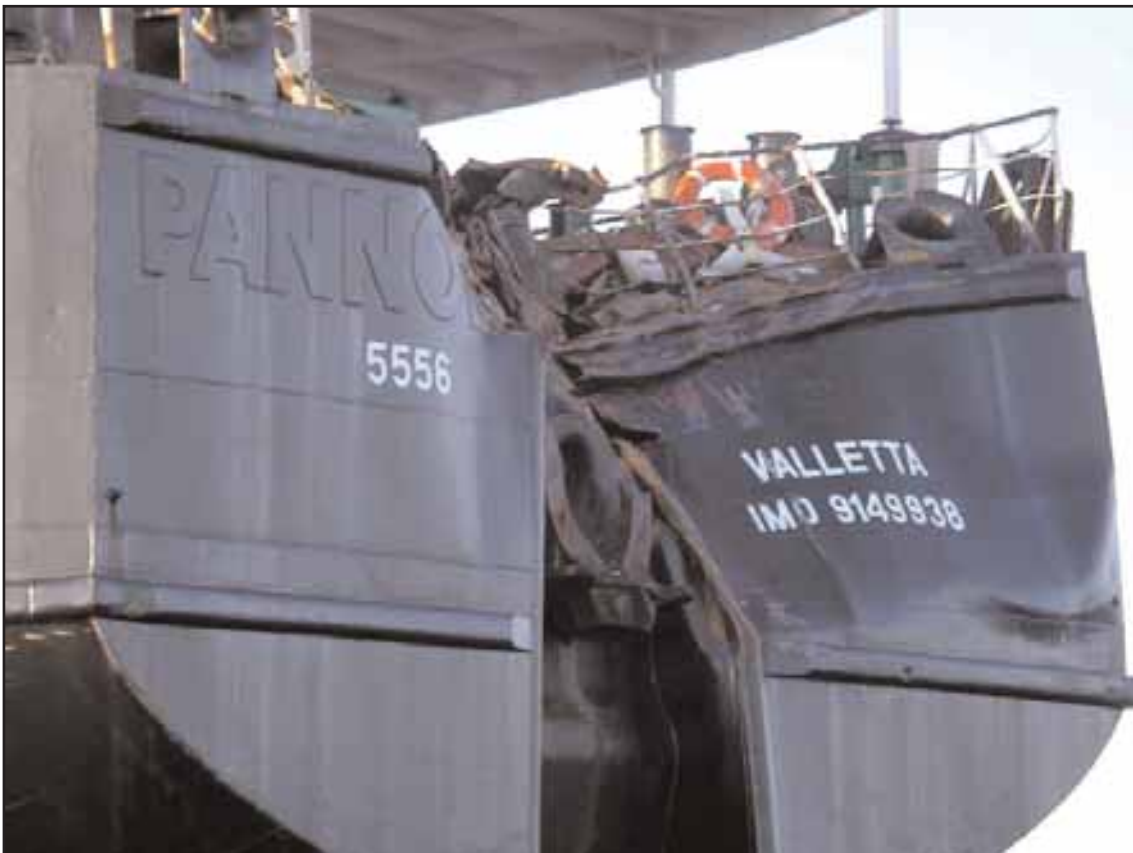
Figure 5

Visual examination of the damage by the classification society surveyor revealed: (**see Figure 5**).

- The shell and framing at the transom construction were badly damaged in way of connection with the upper deck, measuring about 800mm x 2000mm.
- Deformities of ship's structure in way of the poop deck.
- Damage to stern anchor.
- Split in the after ballast tank, measuring about 850mm x 1000mm, above the waterline.
- Aft mast bent and three lower lights damaged.
- Port side bulwark in way of frames 183 - 195, guardrails in way of frames 140 - 183 and fender guard in way of frame 140 -aft, partly bent and damaged. Air pipes in this area bent inwards.
- Hawse pipe for aft anchor deformed in way of frame 171.
- Deformities in way of the lifeboat deck.
- Slight deformation to the internal aft bulkhead in the emergency generator room.

All the above damage was above the waterline. However, there was some ingress of water into the after ballast tank through a split in the plating above the waterline.

Stern damage to *Illeksa*

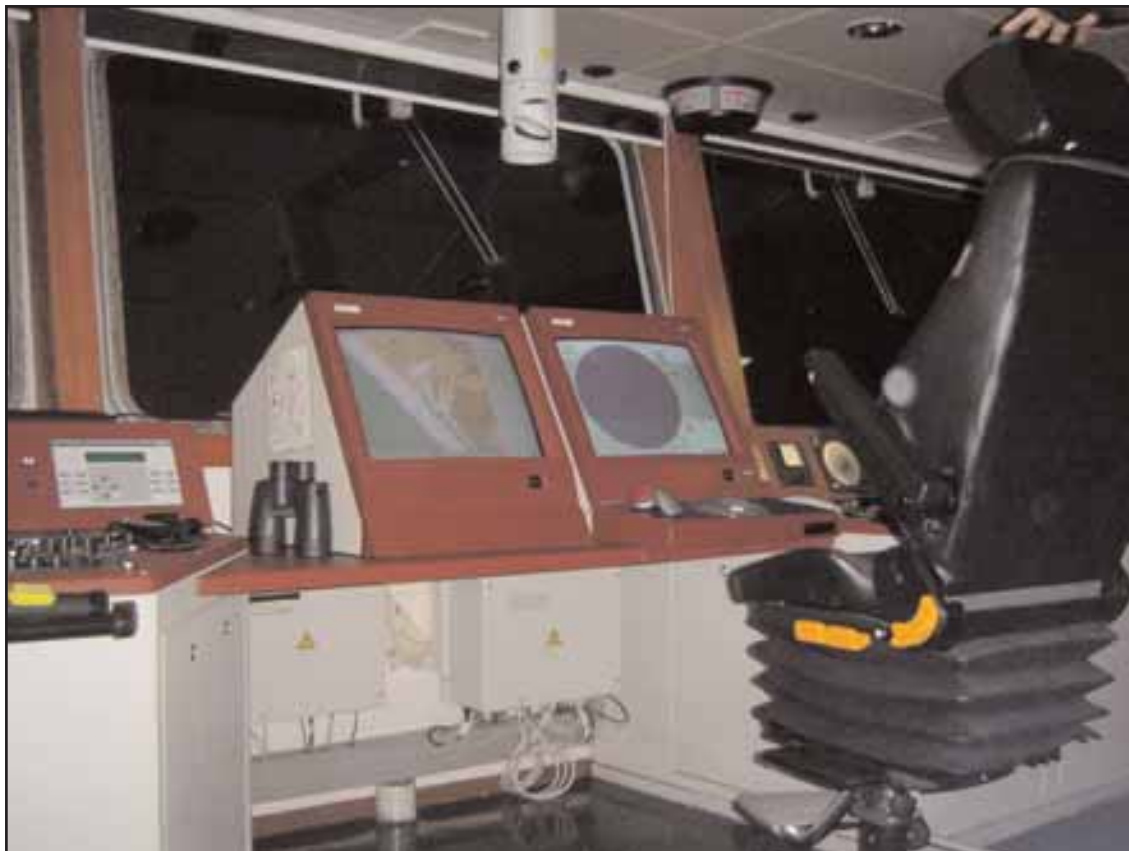
Figure 6

Cepheus J's bridge

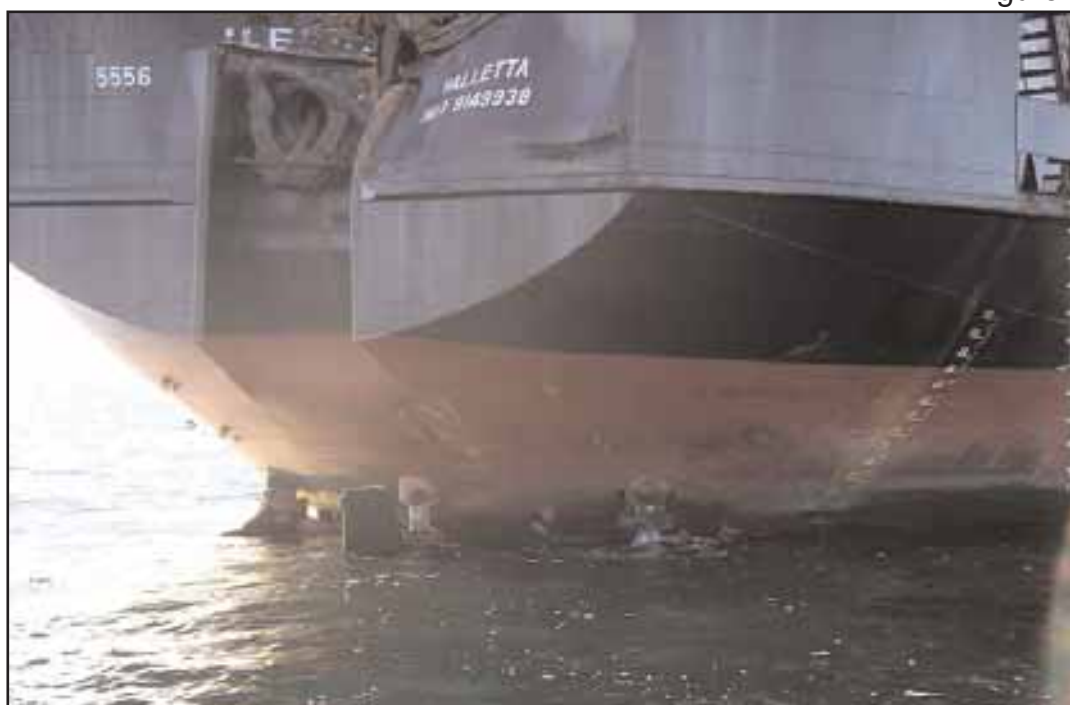
Figure 8

Ileksa was originally designed to trade on the rivers of southern Russia, and was defined as a Don class vessel. She was fitted with an unusual propulsion and steering arrangement. The twin propellers were in Kort nozzles, which could be operated either in tandem or independently. Kort nozzles constrain the propeller wash and increase the efficiency of the propeller, the nozzles can be rotated, increasing the vessel's manoeuvrability, especially at slow speeds and when berthing. A single rudder was fitted on the centreline, between the two nozzles. In the seagoing condition, the nozzles and the rudder were operated together, such that a movement of the wheel actuated the rudder and nozzles, with the nozzles limited to a small proportion of their maximum travel. In the manoeuvring mode, the nozzles could be operated independently, and this is what gave the improved manoeuvrability when berthing (see Figure 8).

Stern of the *Ileksa*, showing centre line rudder and, nozzles port and starboard

As the design and build of *Ileksa* was for inland waters operation, the propulsion and steering arrangements fitted produced limited manoeuvring characteristics in open sea operation. Her manoeuvring data showed that, in calm conditions, at full speed of 10.5 knots, in ballast, a turn through 90° would have taken 1 minute and 5 seconds, with an advance of 2.0 cables and a transfer of 0.9 cables (**see Annex 1**). As can be seen from the diagram, for the first 1.3 cables of the advance, there is no transfer. The alteration of course to this point would be about 45°, taking about 40 seconds.

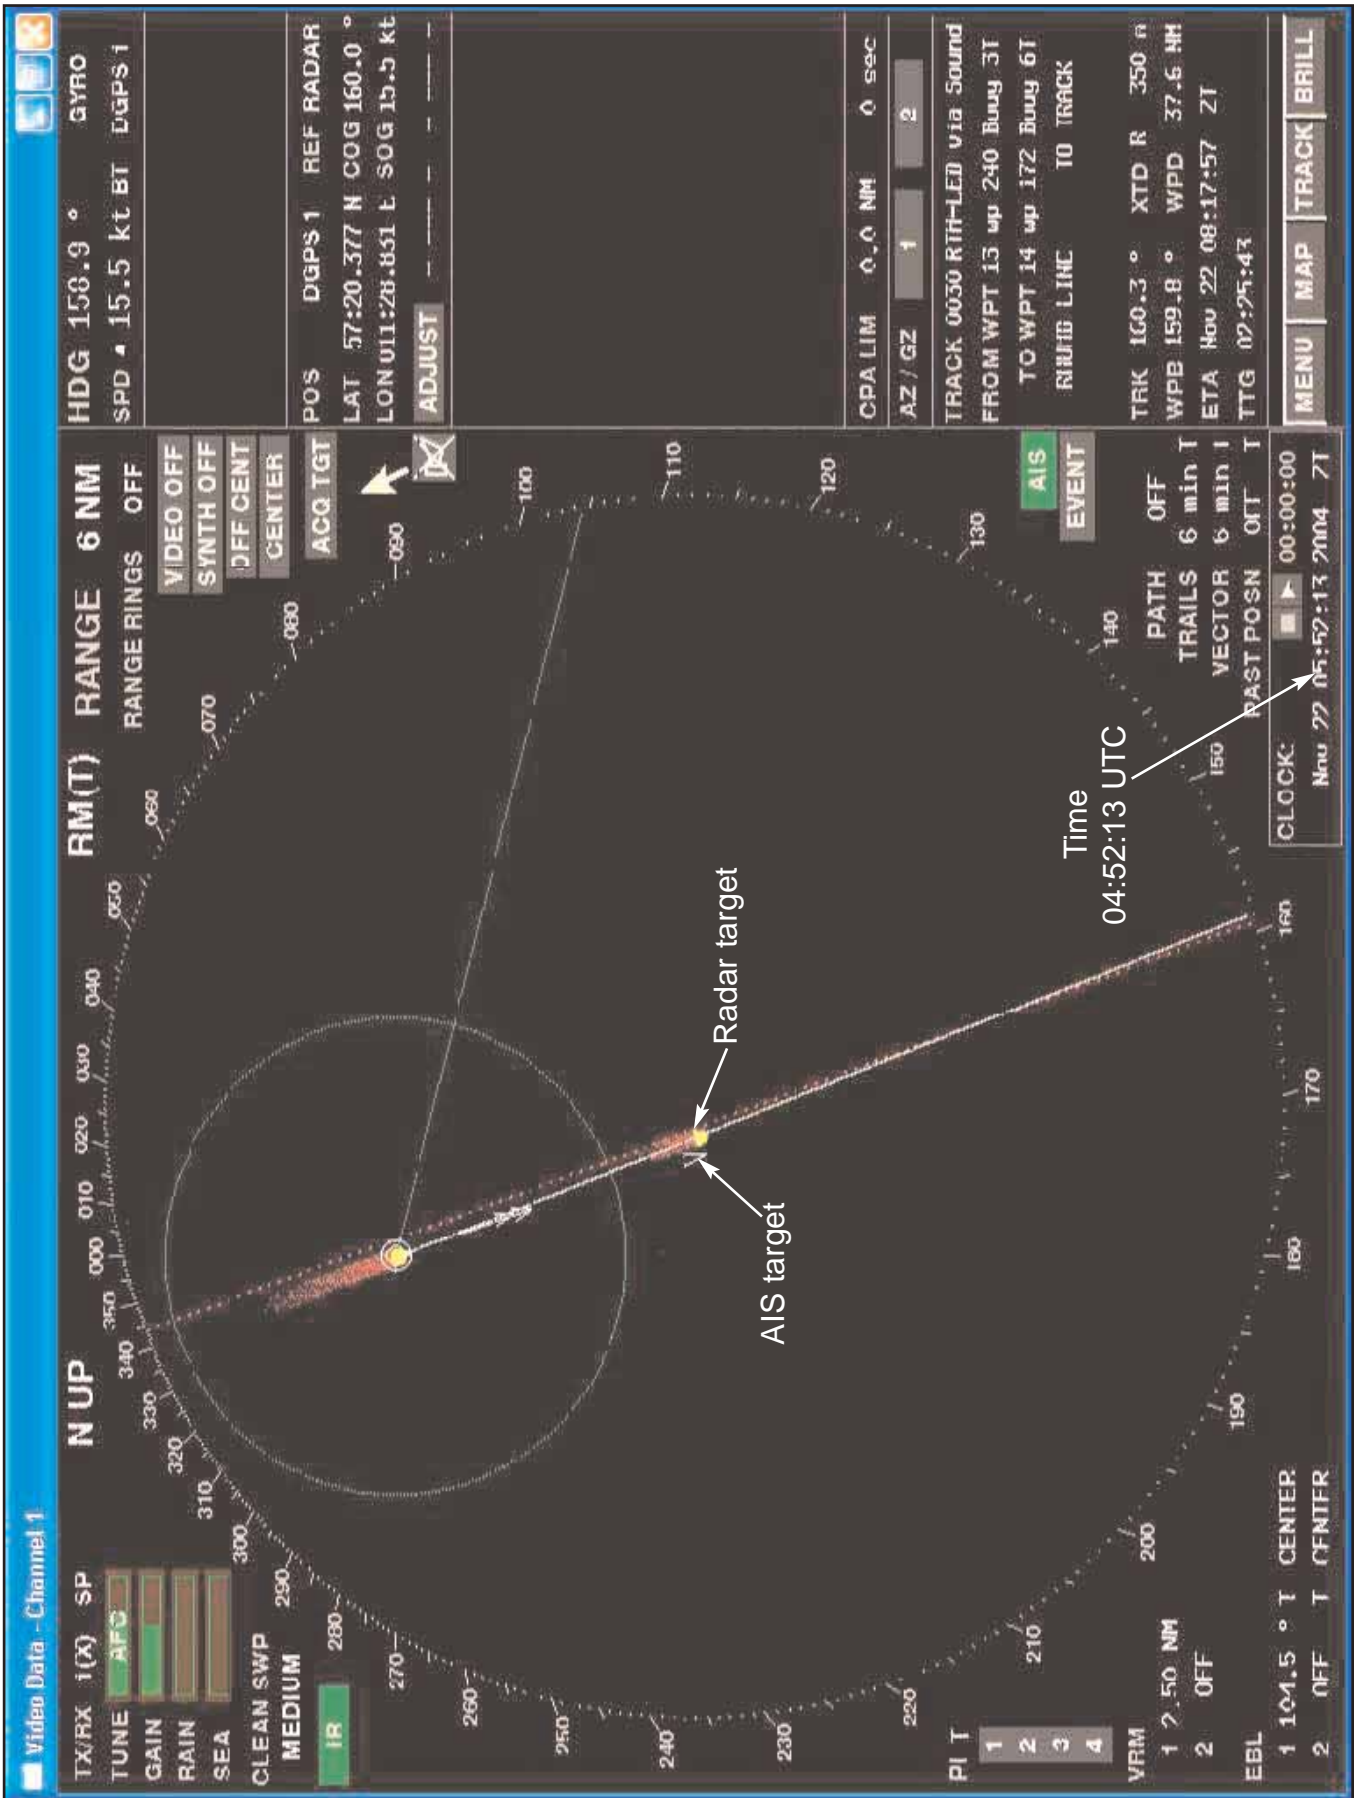
Figure 9

With the visibility restricted to 1.5 miles, *Ileksa* would have been visible from *Cepheus J* for 9 minutes before the collision. *Ileksa* was displaying the lights required for a vessel of her size, which would have meant that *Cepheus J* would have seen at least a single white sternlight. However, additional lighting was illuminated around the accommodation, which would have enhanced the visibility of the vessel from astern.

Plot from Cepheus J's radar display

The VDR recording shows that no targets had been acquired and that no guard zone had been established. Had either manual or automatic acquisition of targets been used, the OOW would have been alerted to the possible collision with *Ileksa*, and could have taken action to allow safe passing.

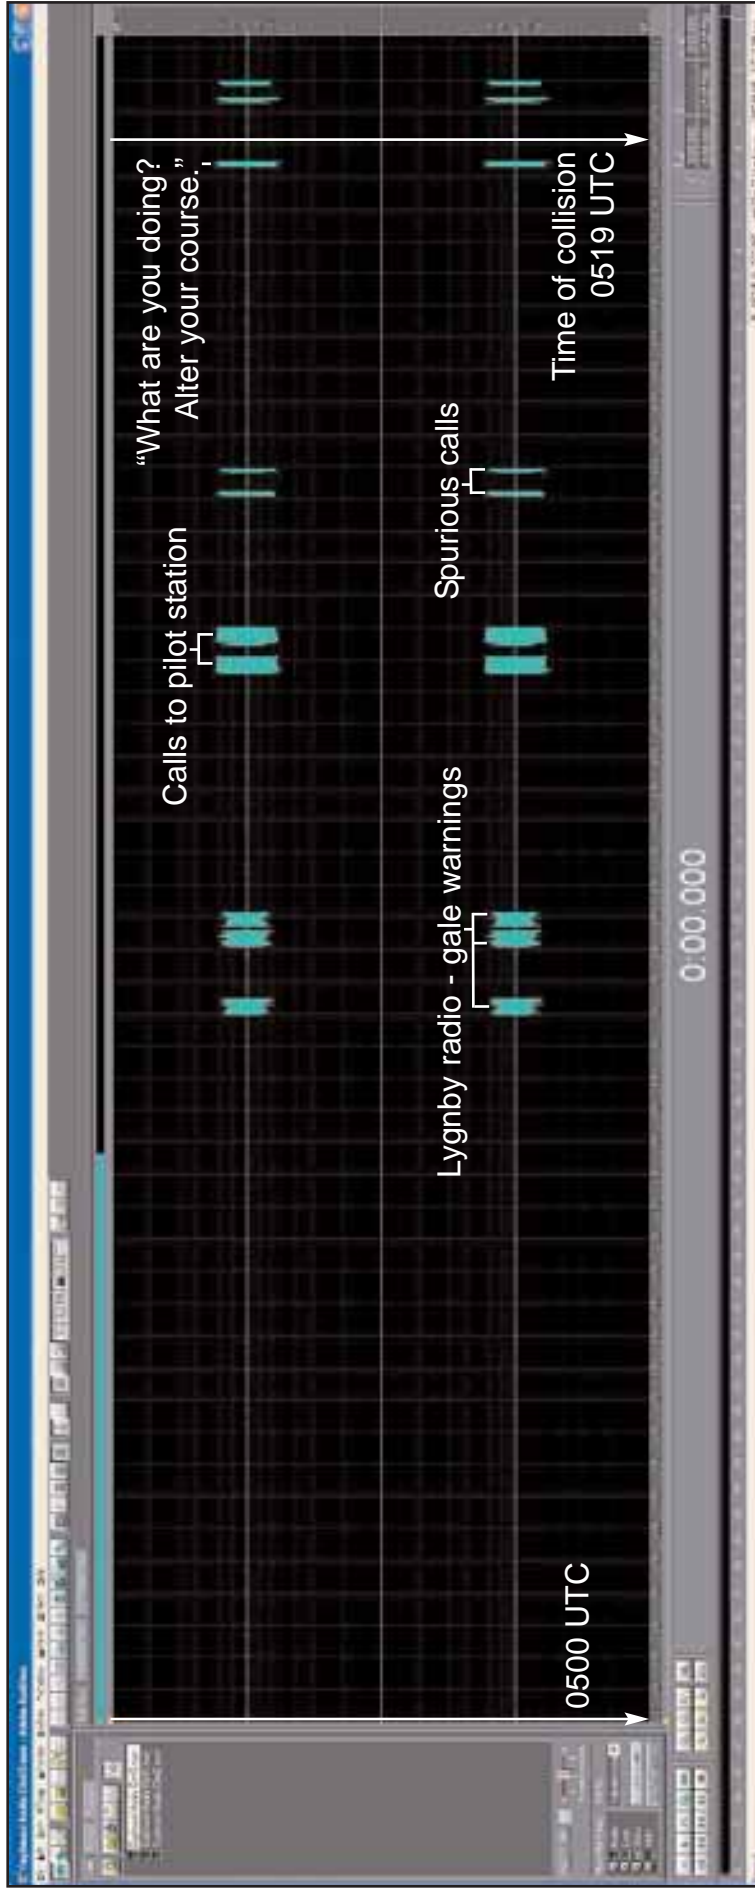
Figure 10

Recording from the VHF communications on board *Cepheus J*
