Report on the investigation of  
the collision between  
***Scot Explorer and Dorthie Dalsoe***  
Route 'T' in the Kattegat  
Scandinavia  
2 November 2004

Marine Accident Investigation Branch  
Carlton House  
Carlton Place  
Southampton  
United Kingdom  
SO15 2DZ

**Report No 10/2005  
June 2005**

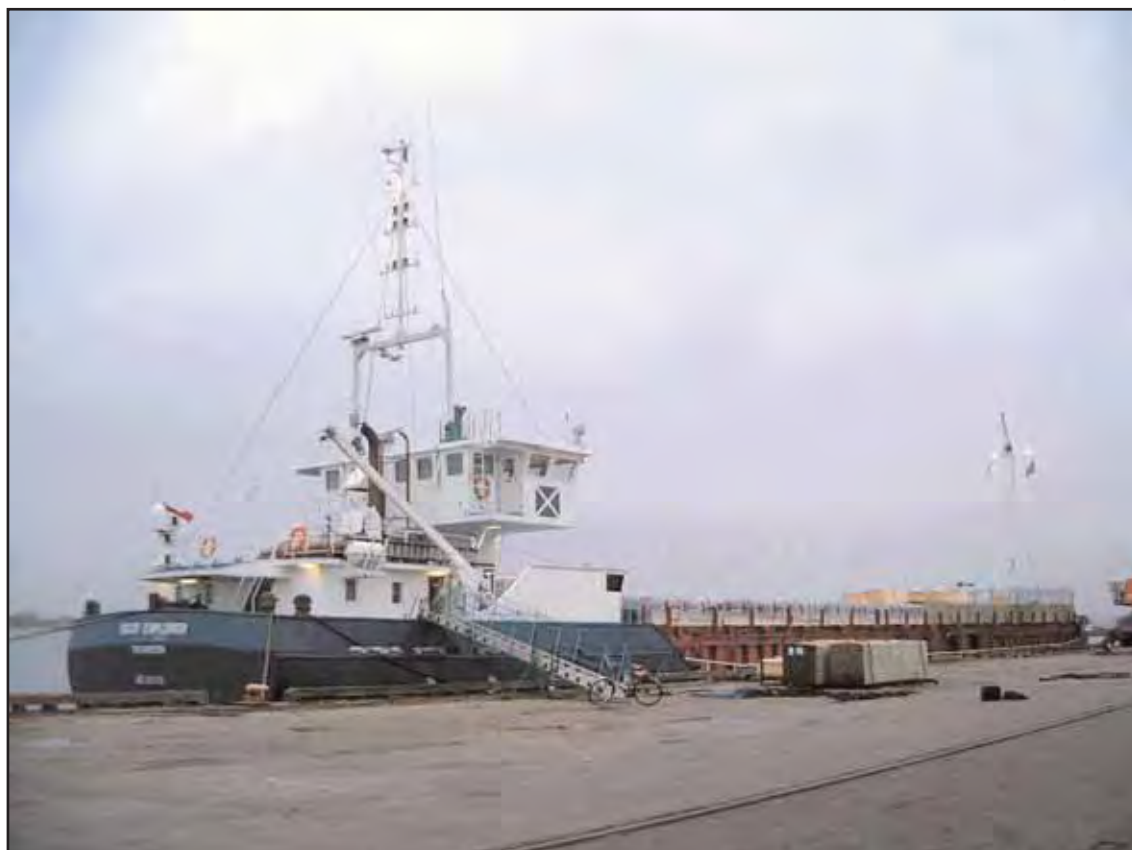
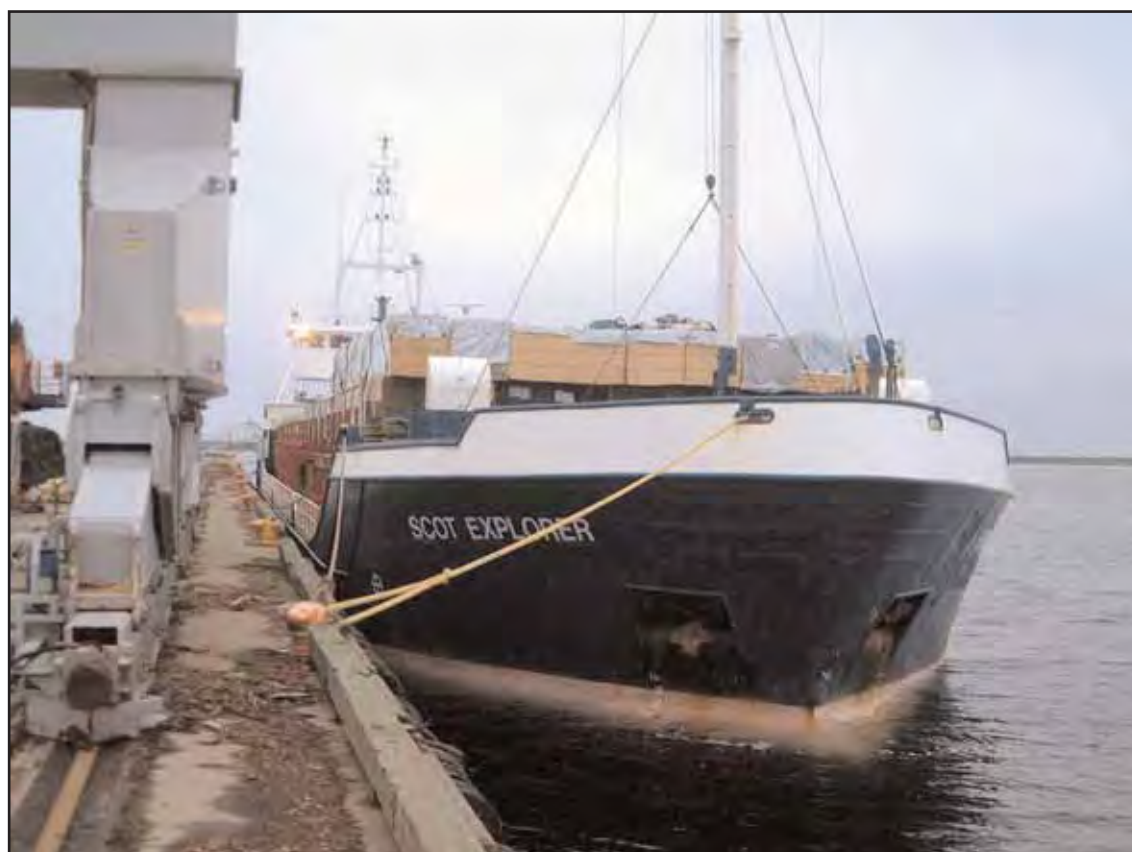
Figure 1

*Scot Explorer*

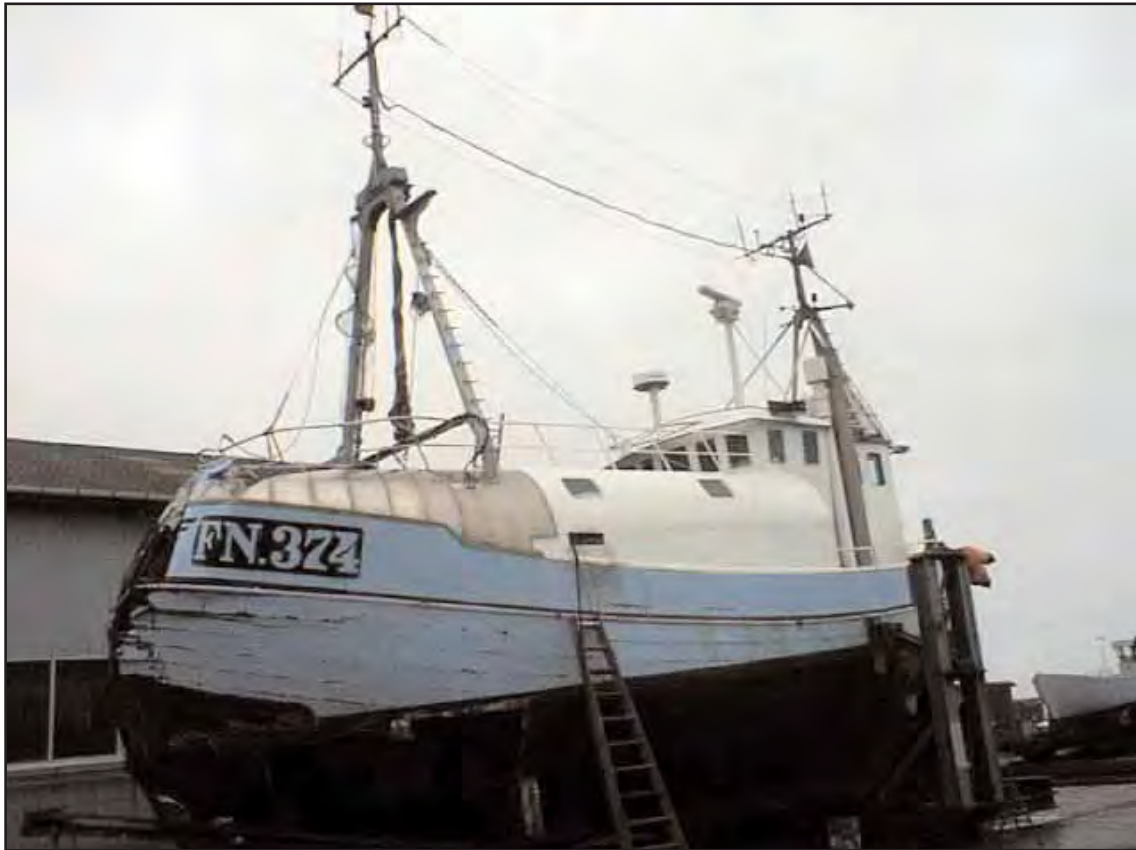
Figure 2

*Dorthe Dalsoe*

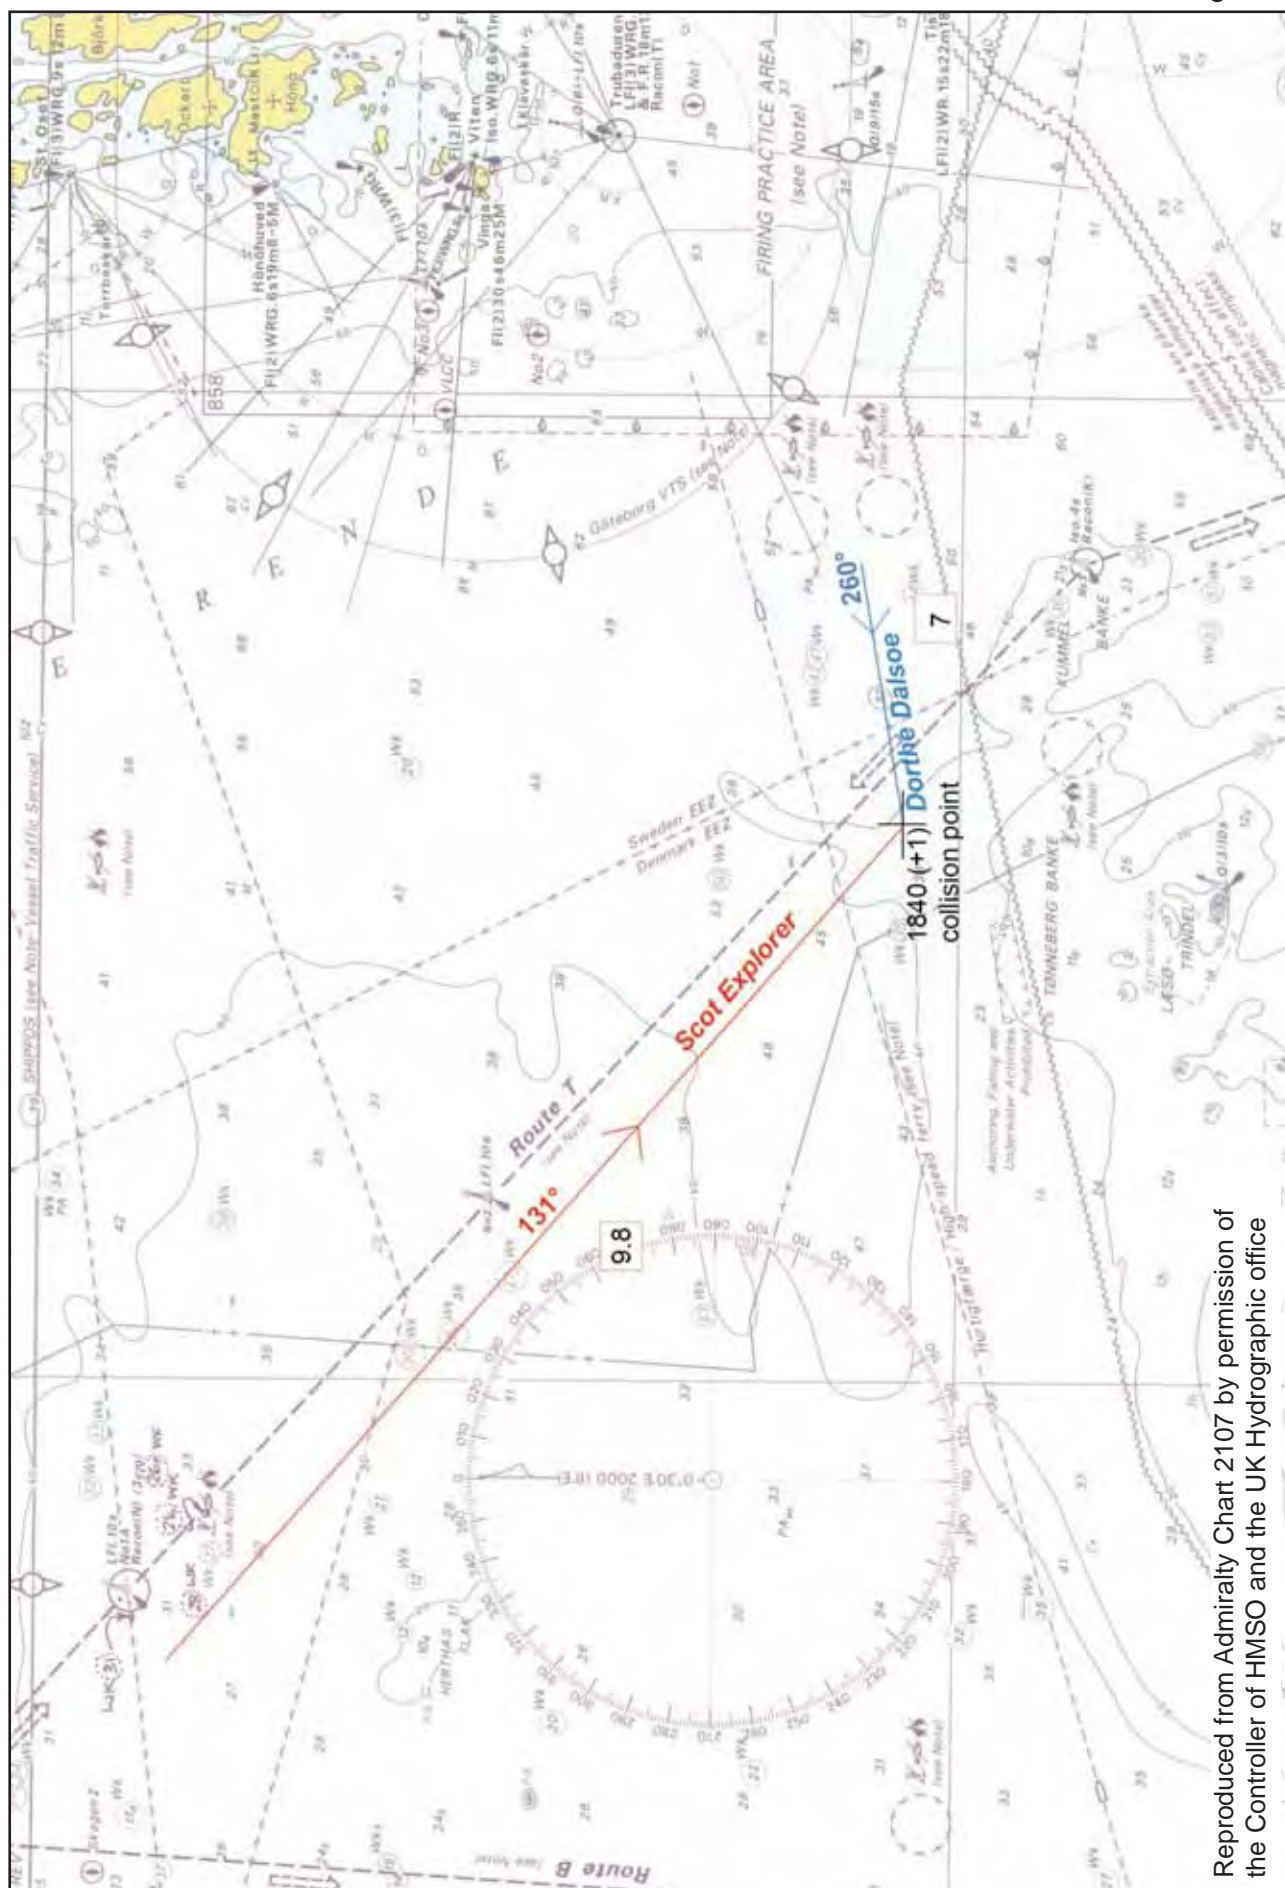
Reproduced from Admiralty Chart 2107 by permission of the Controller of HMSO and the UK Hydrographic office

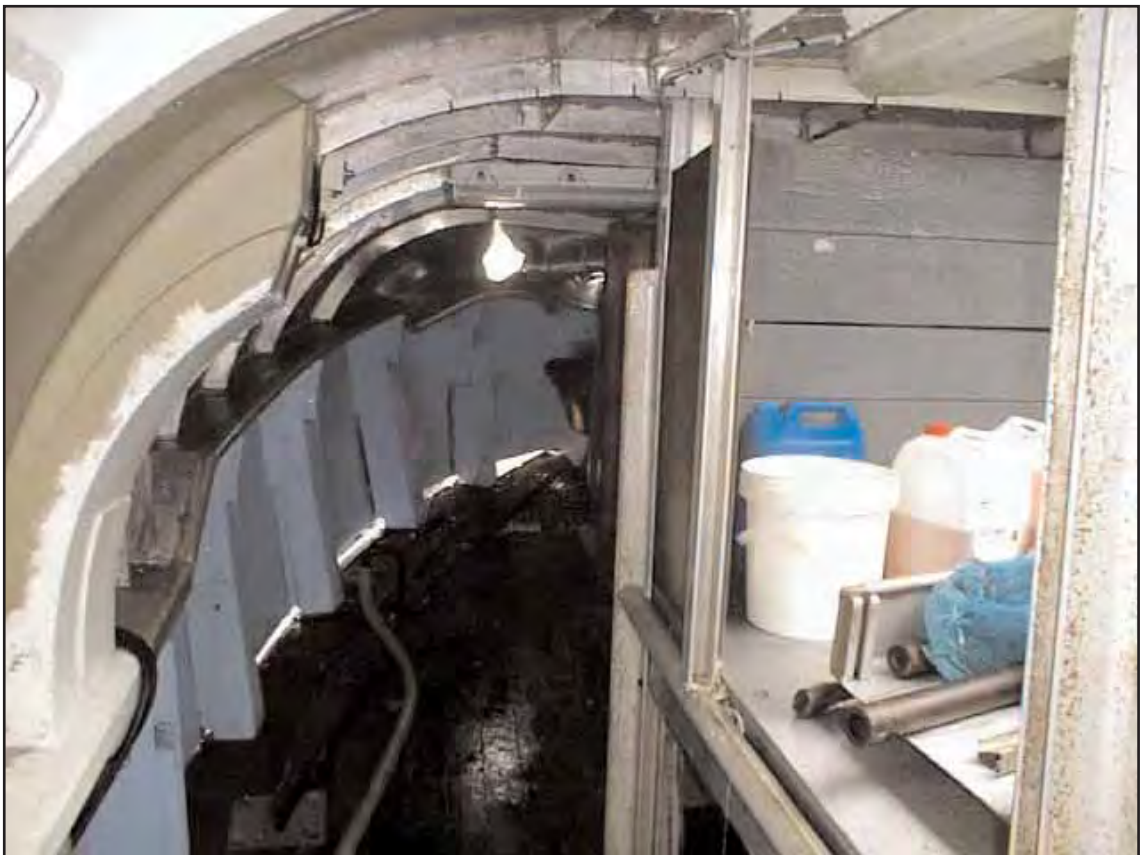
Figure 4

The shelter deck on board *Dorthe Dalsoe*

When the skipper left the wheelhouse and went to the shelter deck, from where he had virtually no external visibility, he could not maintain a proper lookout, or determine if a risk of collision existed. Although the COLREGS require these obligations to be met by every vessel, regardless of status or condition, such obligations were either not understood by the skipper, or were ignored by him. This was emphasised by the fact that the skipper went to the shelter deck even though he was aware that *Dorthe Dalsøe* was approaching Route “T” and the masthead light of *Scot Explorer* was seen closing on the starboard bow. Had the skipper increased the range set on his radar displays as required by COLREG Rule 7, this would have provided him with the information required to determine the CPA of *Scot Explorer*, and the risk of collision.

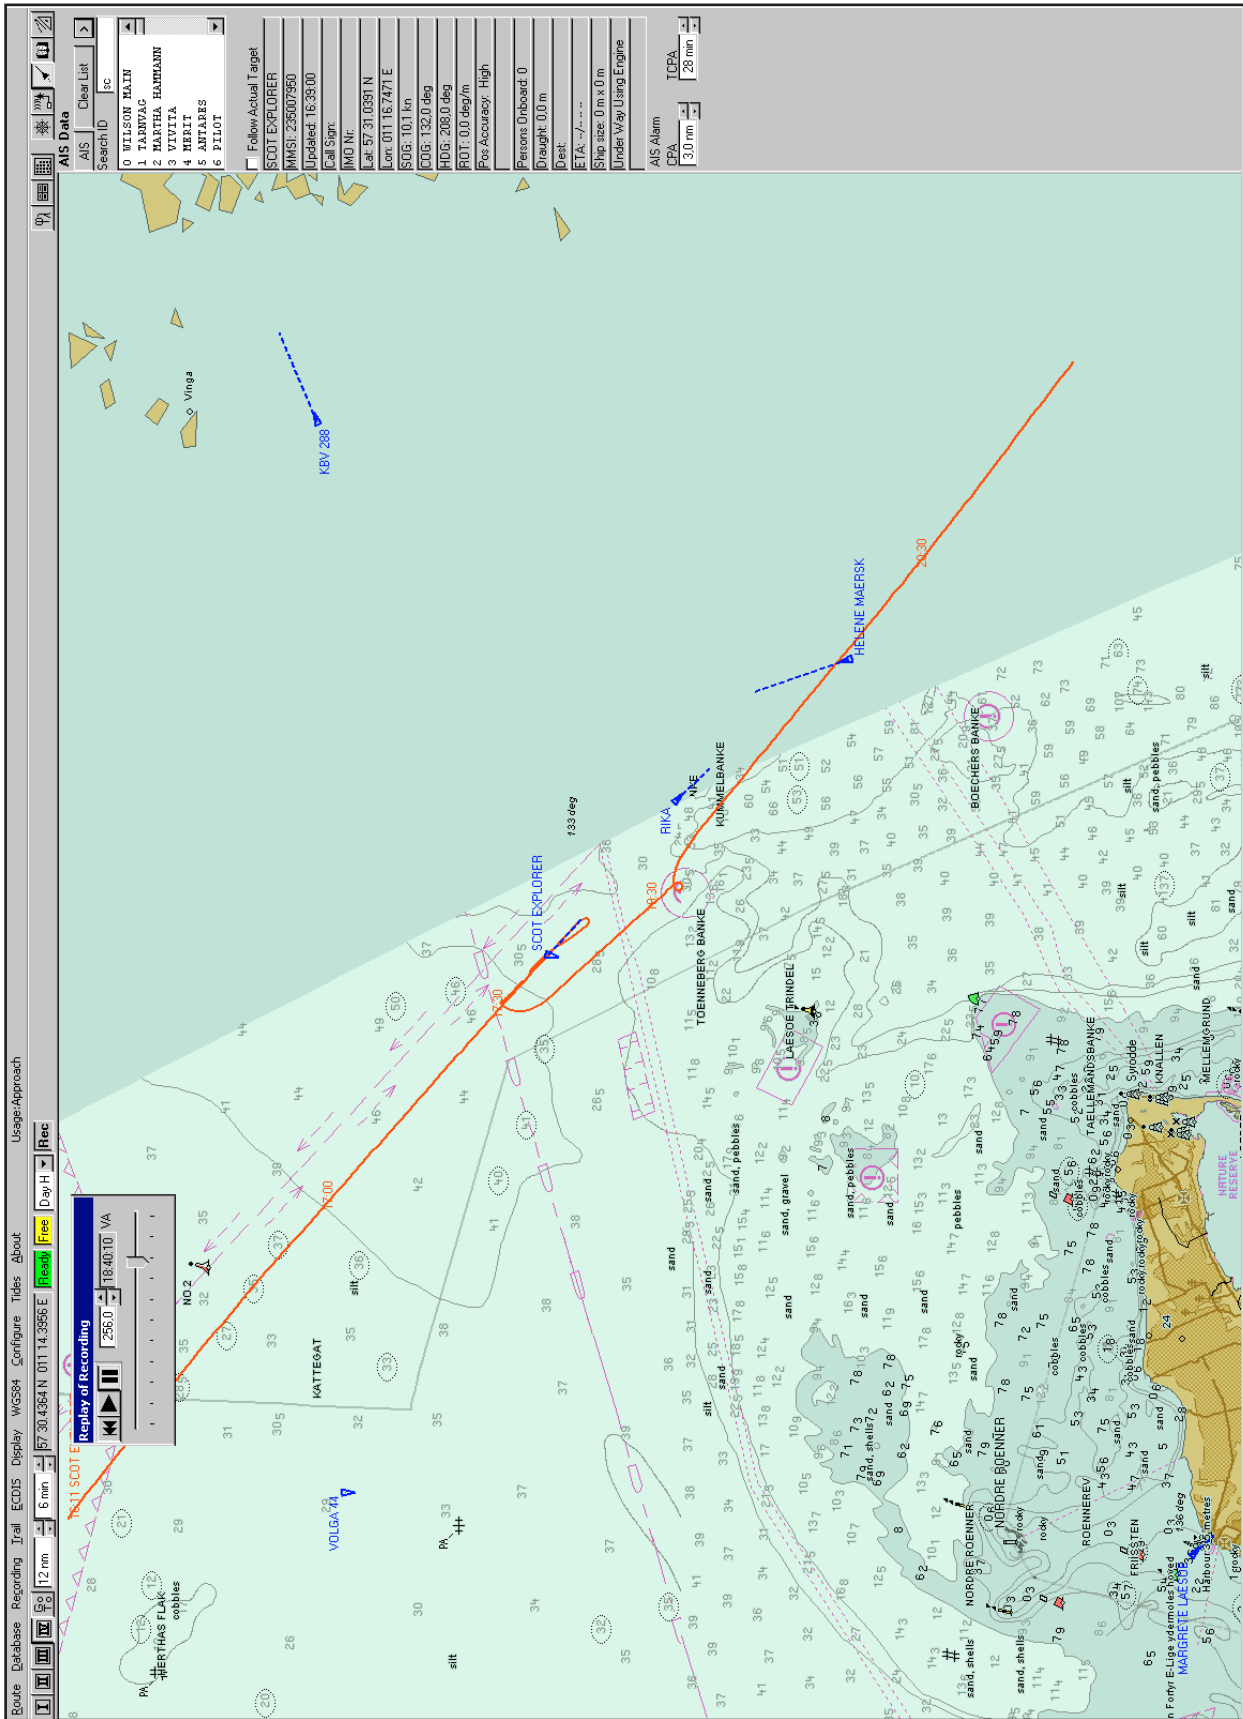
Figure 5

AIS display showing the track of Scot Explorer

The course and speed of *Scot Explorer* have been verified by AIS data (**Figure 5**). Similar data is not available for *Dorthe Dalsoe*, and it is possible that the fishing vessel altered course when the vessels were in close proximity due to a malfunction of her autopilot. However, as the skipper of *Dorthe Dalsoe* was not in a position to detect or notice such a malfunction, and the master of *Scot Explorer* was not observing the vessel at the time, there is no eye witness evidence to corroborate this possibility. Also, given that there had been no previous problems experienced with the autopilot on board *Dorthe Dalsoe*, its malfunction is considered to have been unlikely.

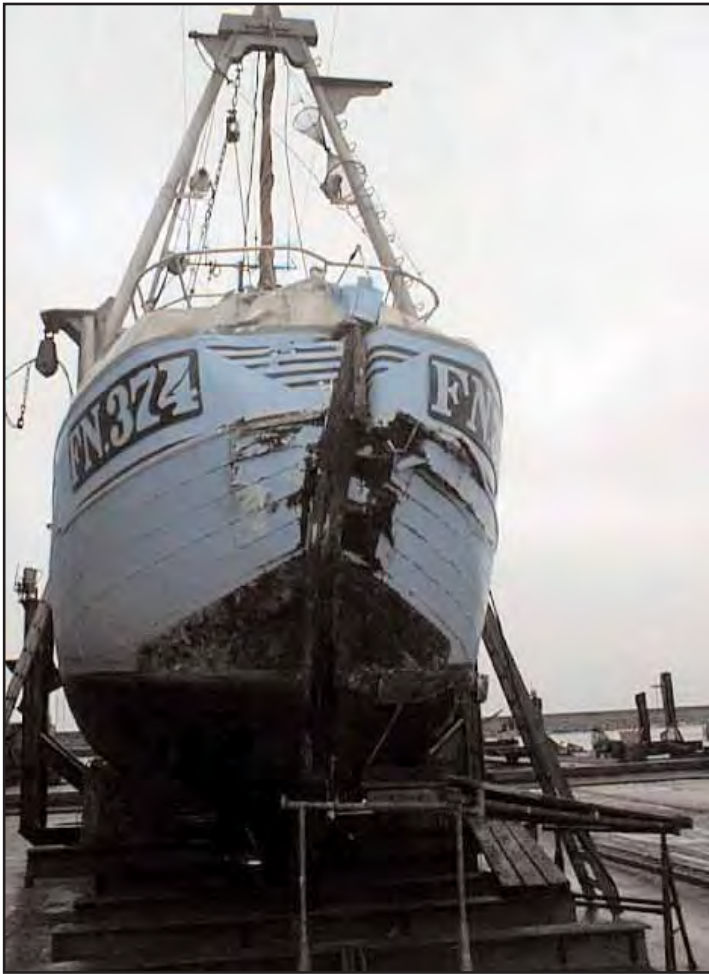
Figure 6

Time and date	:	1840(UTC+1) on 2 November 2004
Location of incident	:	57°30.9N 011°17.0E
Persons on board	:	<i>Scot Explorer</i> – 5 <i>Dorthe Dalsoe</i> – 2
Injuries/fatalities	:	Nil
Damage	:	<i>Scot Explorer</i> – Superficial <i>Dorthe Dalsoe</i> – The stem post was broken and the fore deck crushed. Damage was most extensive on the port side of the bow where the hull was breached close to the waterline.

Damage to the bow of *Dorthie Dalsøe*

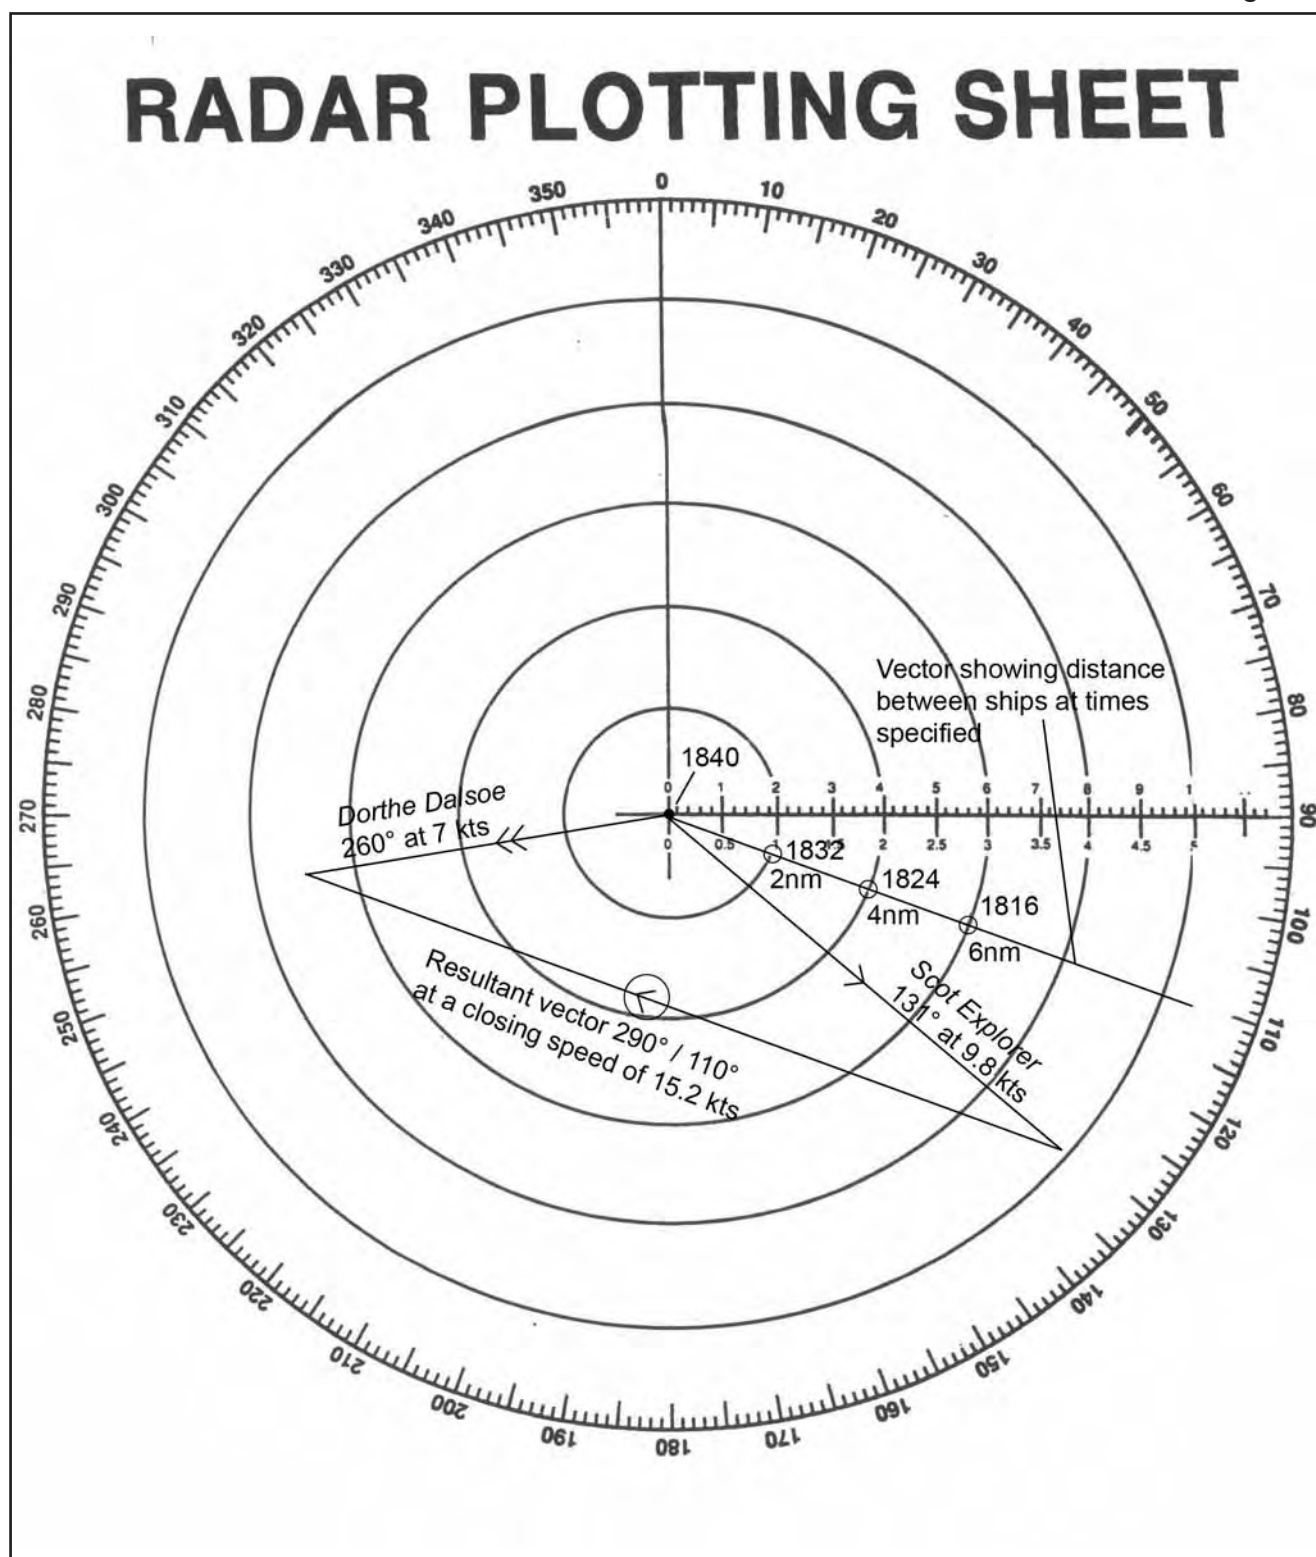
Figure 8

Radar plot based on the vessels' course and speed
