Report on the investigation of
the grounding of the passenger vessel

Balmoral

Dagger Reef - Gower Peninsula

Report No 14/2005
July 2005

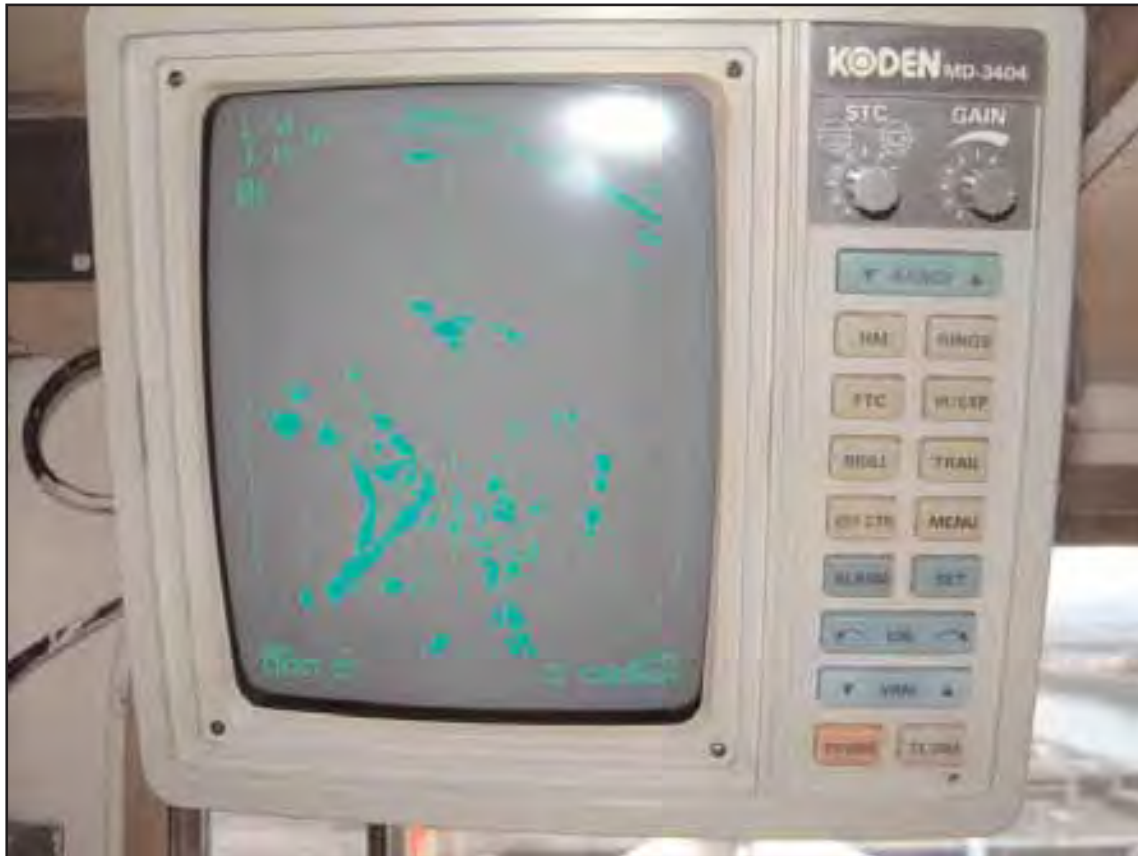
Figure 3

Radar in use

The plotting of parallel index lines was only possible on one of the radar displays, and was achieved by utilising a floating EBL and VRM. However, parallel index lines were not often used by the bridge watchkeepers and it was more usual for them to only utilise the VRM to monitor the vessel's distance off the coastline.

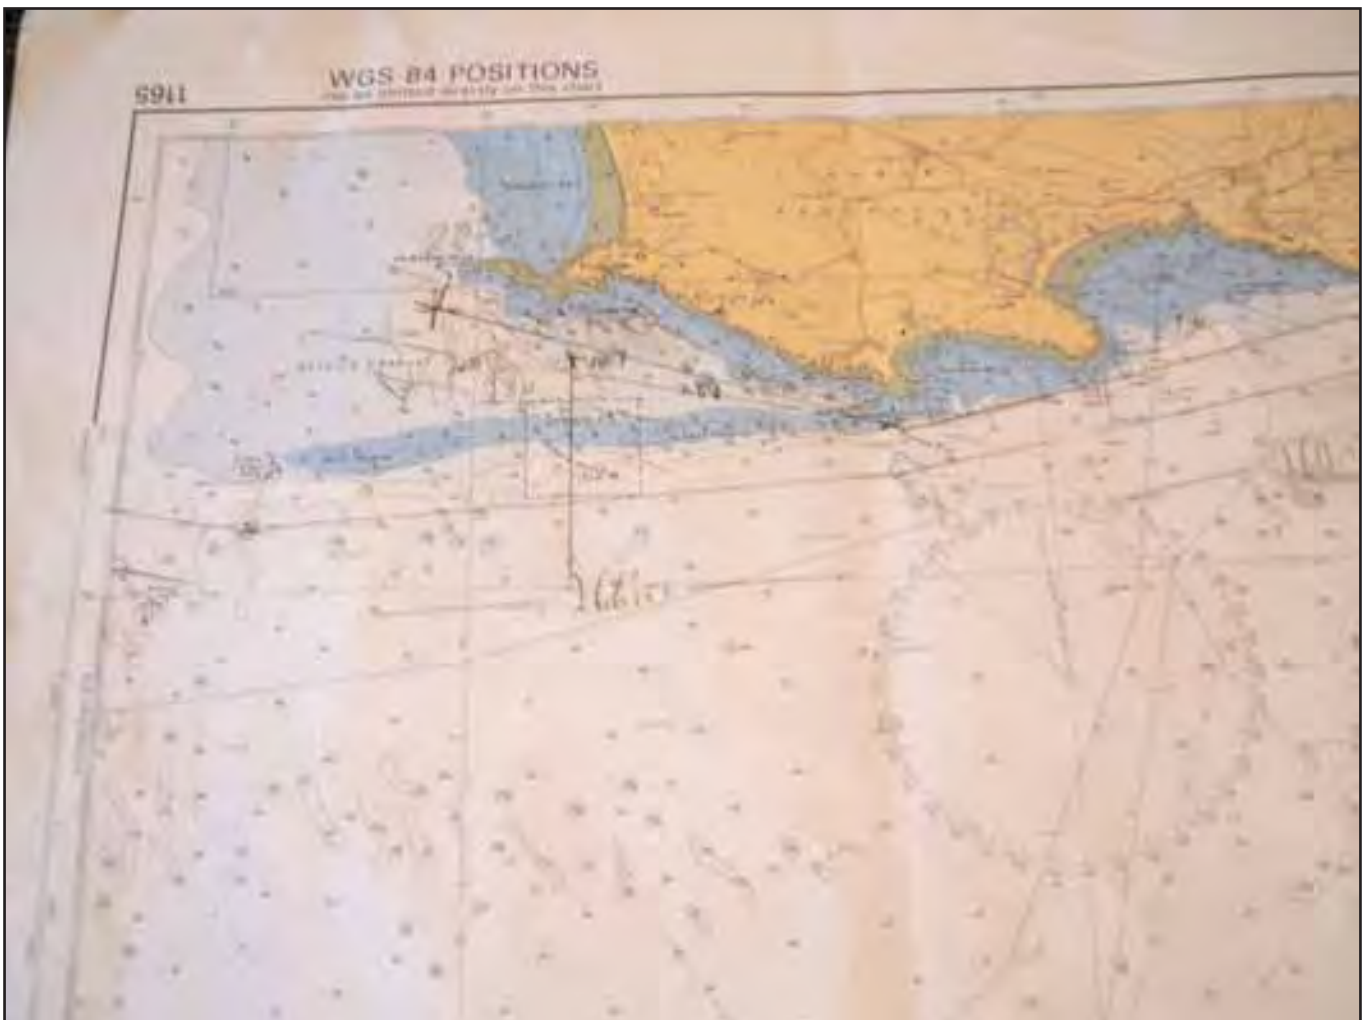
Figure 5

Monitoring of the vessel's position was achieved by infrequent GPS fixing on the chart and the use of the EBL and VRM on the ship's head-up display radar. Inspection of the chart by the MAIB, after the accident, showed little evidence of the use of visual limiting danger lines, planned under keel clearances or clearing bearings and ranges.

Photograph showing chart in use
