Report on the investigation of  
explosion and fire  
on  
***Border Heather***  
in Grangemouth  
Firth of Forth, Scotland  
31 October 2004

**Report No 5/2006  
February 2006**

At about 1823 UTC on 31 October 2004, the 2159gt Isle of Man registered tanker *Border Heather* suffered an explosion and fire in her forecastle while in Grangemouth. Significant damage was caused to the vessel's structure and systems but no-one was injured and there was no pollution.

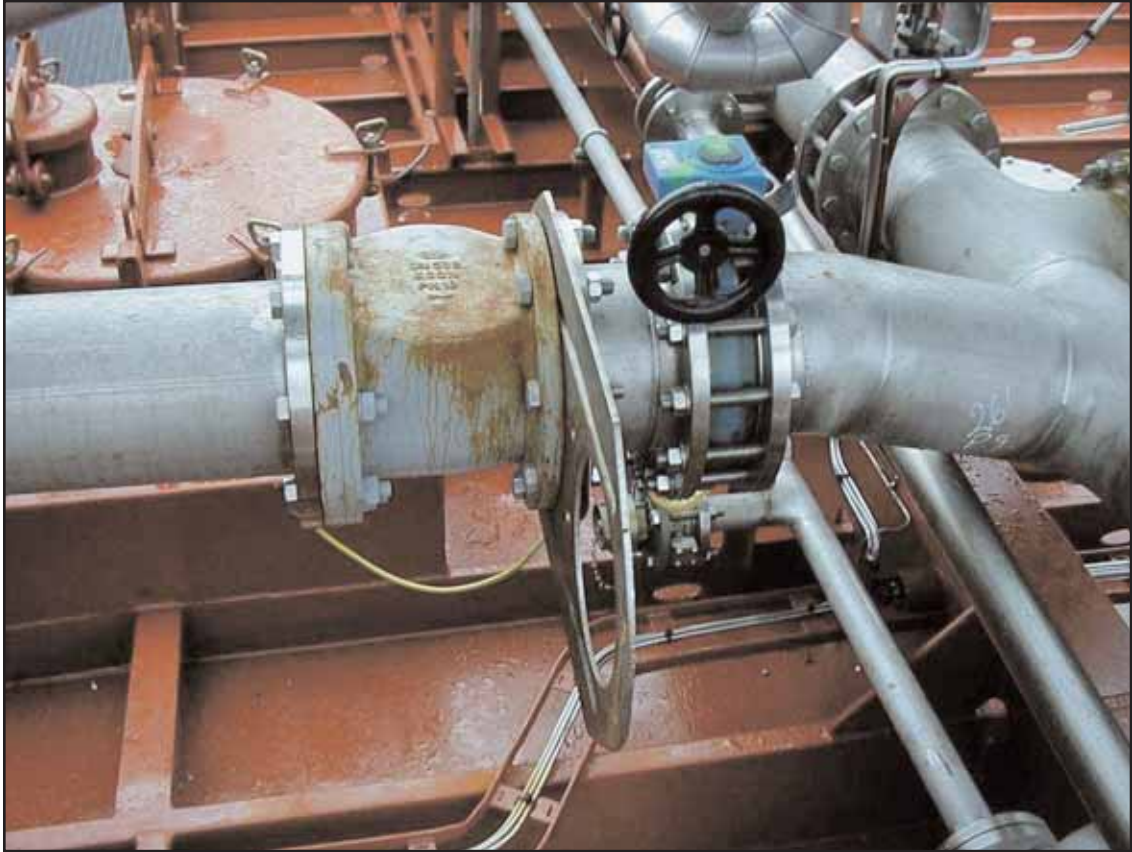
Spectacle plate in 'blanked' position

However, the spectacle plate could make no contribution to safety unless it was used. Although ISGOTT contains clear advice that connections between permanently installed gas freeing fans and cargo systems should be blanked when not gas freeing, and in spite of the Grangemouth terminal's requirement that ISGOTT should be fully complied with, the ISGOTT recommendation could not be satisfied by the 'as built' arrangement of the gas freeing system on *Border Heather* without the spectacle plate being put in the blanked position after the gas freeing fans were last used.

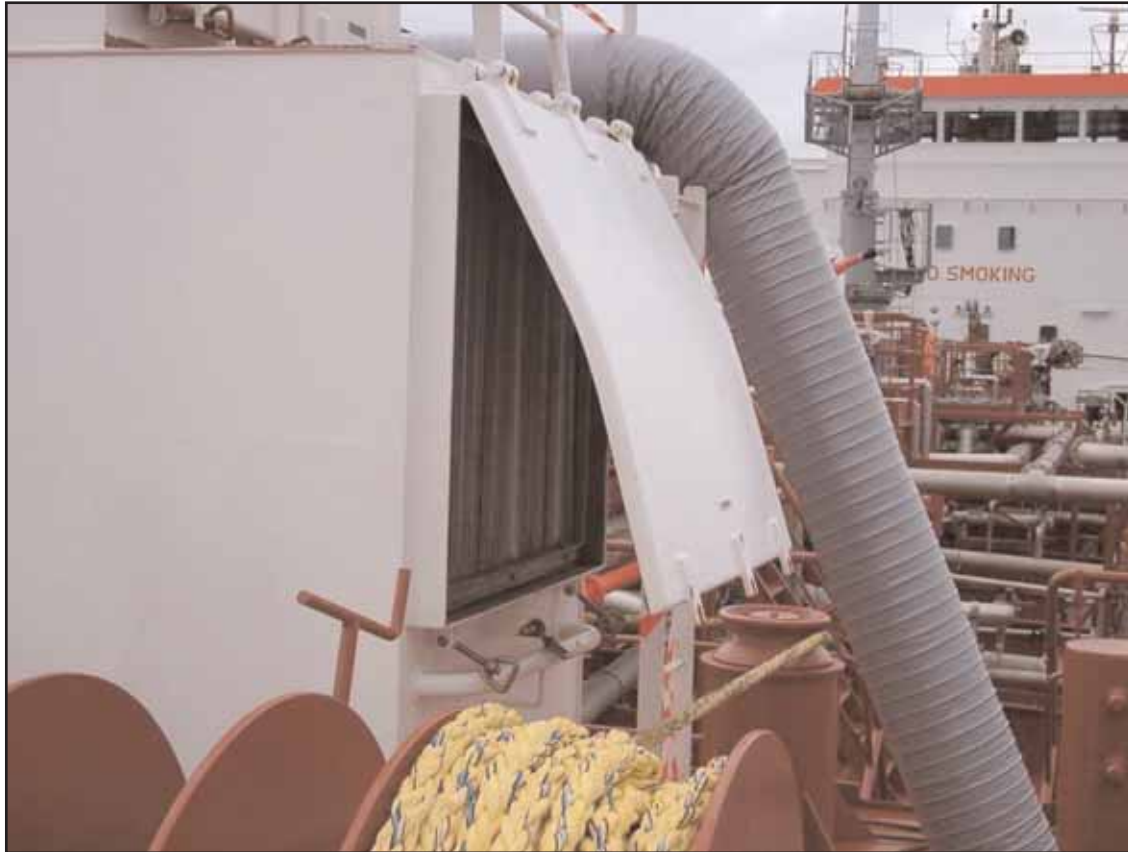
Figure 7

Vent flap

This is clear indication that ignition occurred in the bow thrust compartment. Once this hatchcover was blown open, vapour in the upper spaces was then exposed to the still burning gas passing through the hatch. Thus, combustion spread throughout the stairwell and, through its open door, into the gas freeing room. The increase of pressure generated by the hot gasses blew open the door to the purge air compressor room and the hatch in the top of the deckhouse, and caused other damage to doors and vent flaps.

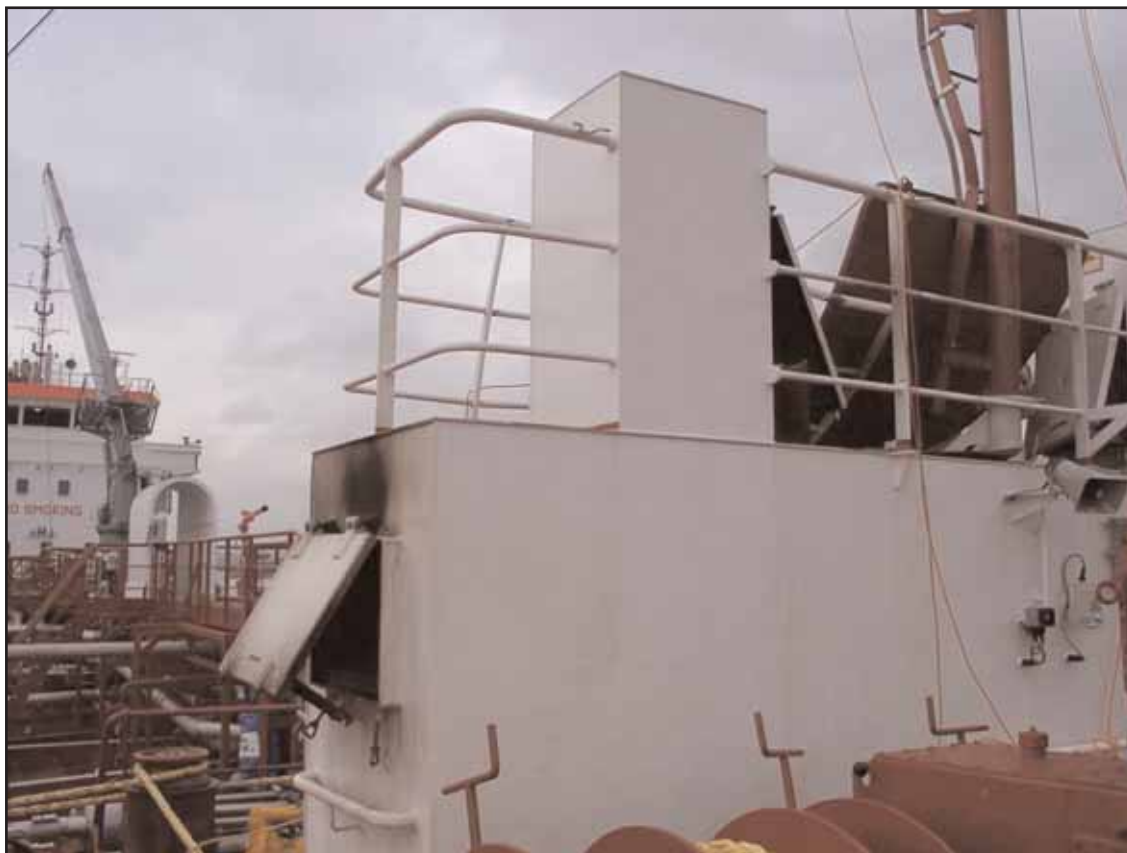
Figure 8

Hatch and fore mast ladder

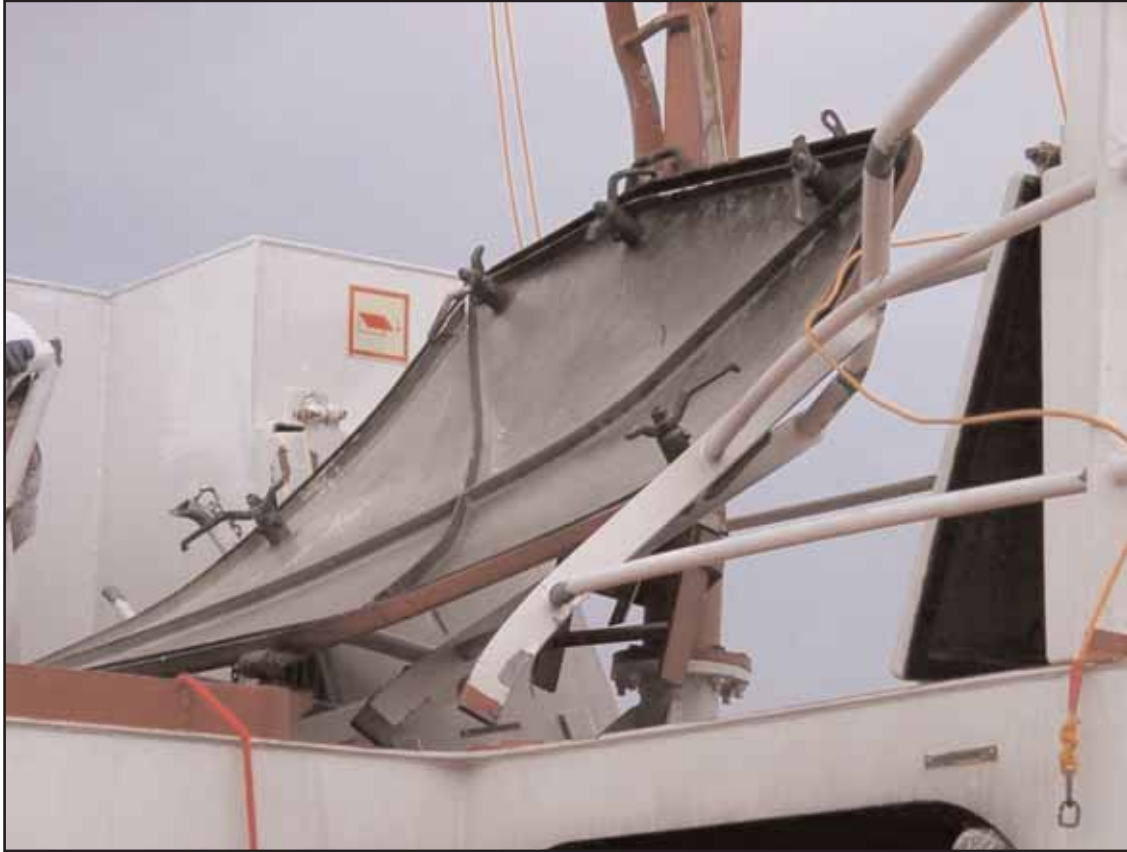
Figure 9

Hatch in deckhouse and guard rails

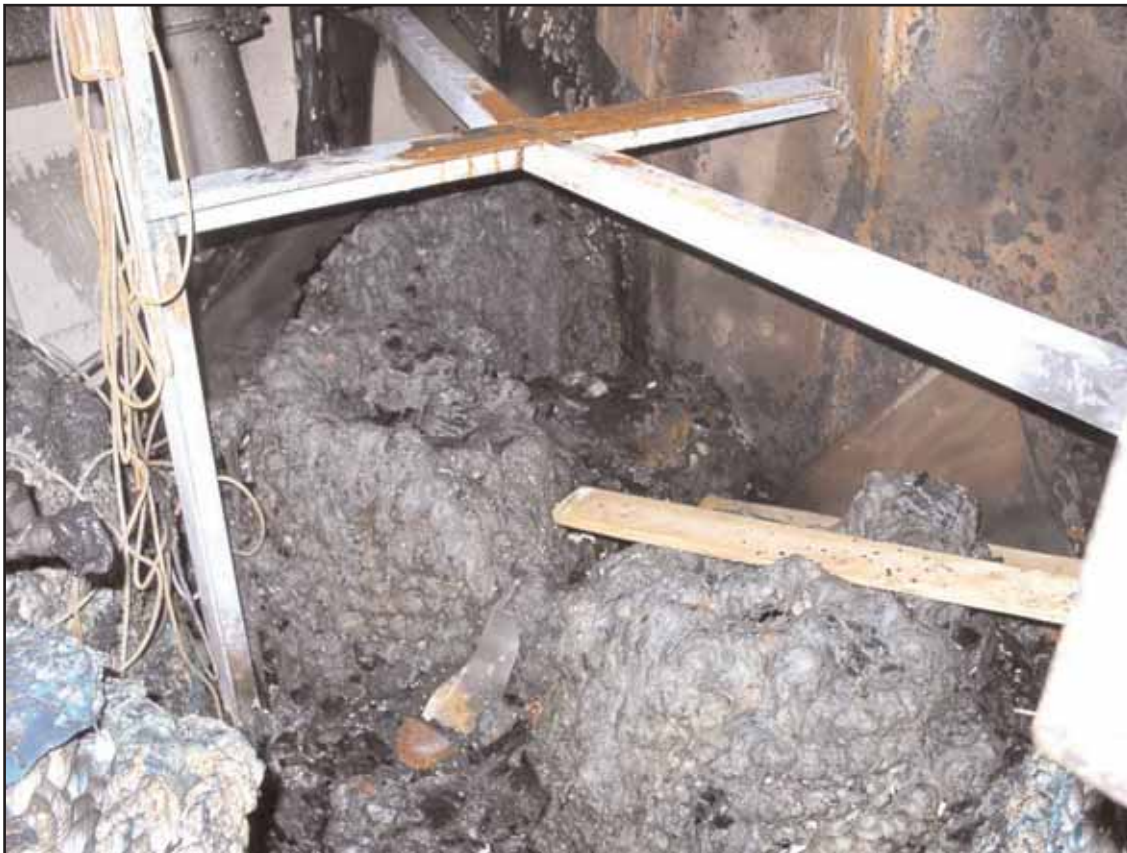
Figure 10

- heat damage to access door and seal
- heat damage to aft bulkhead and electrical fittings and wiring
- heat damage to rope coils stowed beneath forward gas freeing fan (**Figure 10**)

Rope coils

Although the burning ropes contributed to the amount of heat generated, and certainly extended the duration of the accident, because the gas freeing room was effectively a vestibule for the forward rope store their temporary stowage in that space was not unreasonable.

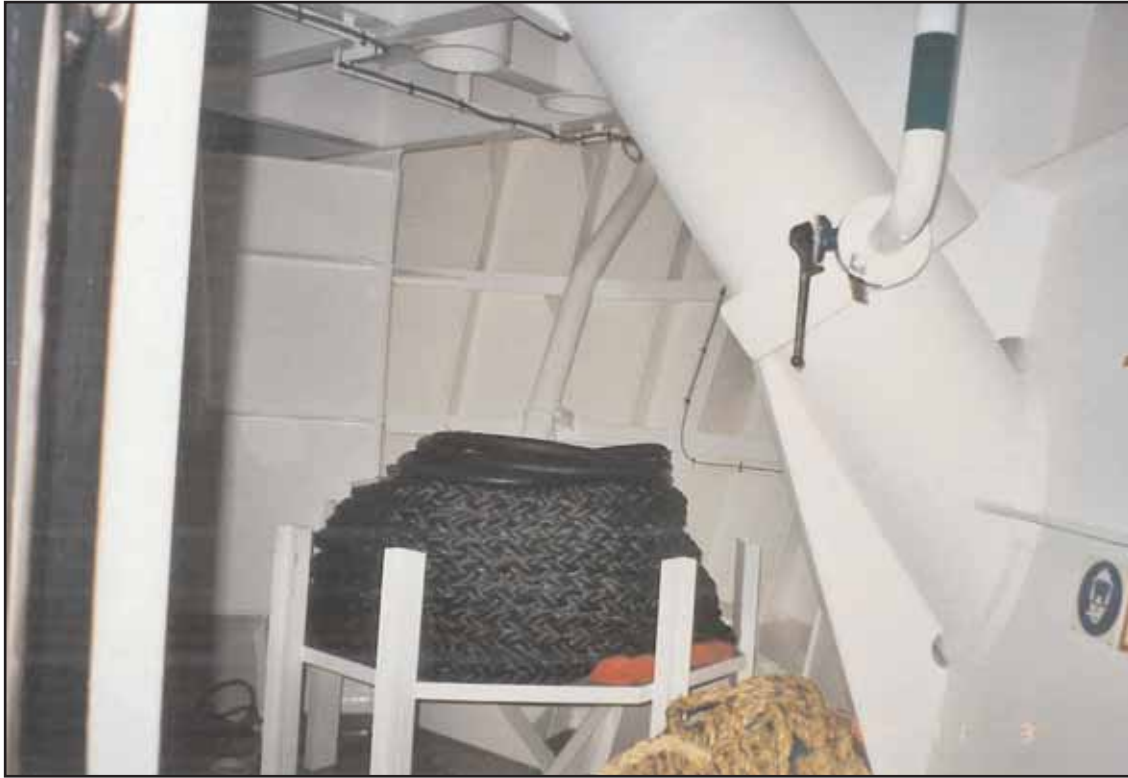
Figure 11

- no damage internally (**Figure 11**)

Forward store showing no internal damage

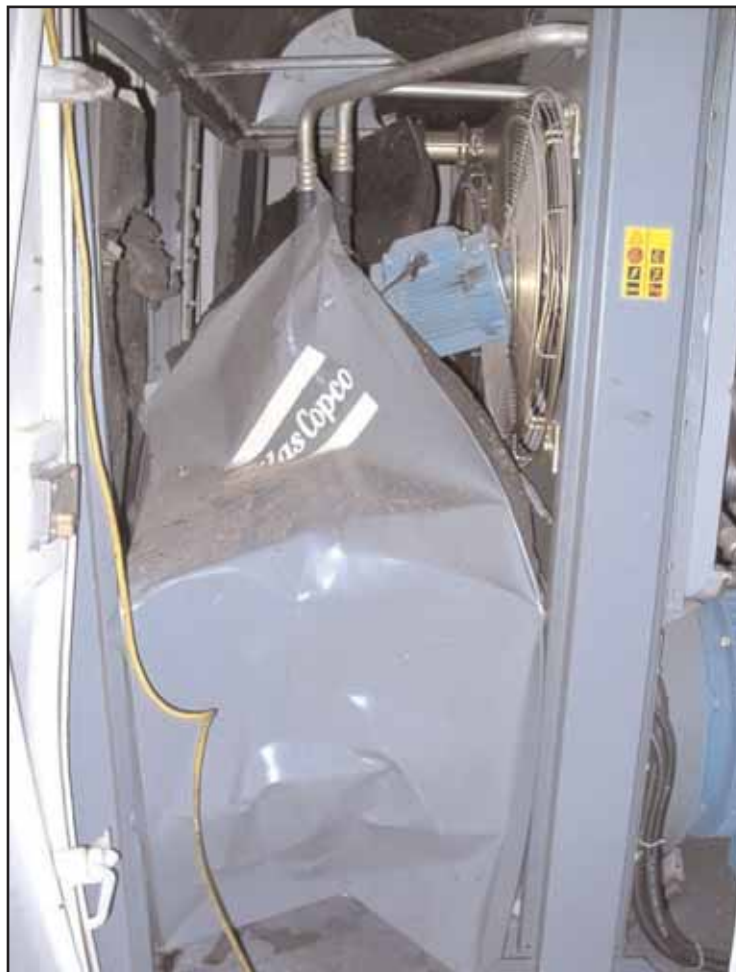
Figure 12

- access door set in
- pressure damage to compressor enclosure, fan motor mountings and air trunking (**Figure 12**)

Pressure damage to compressor enclosure

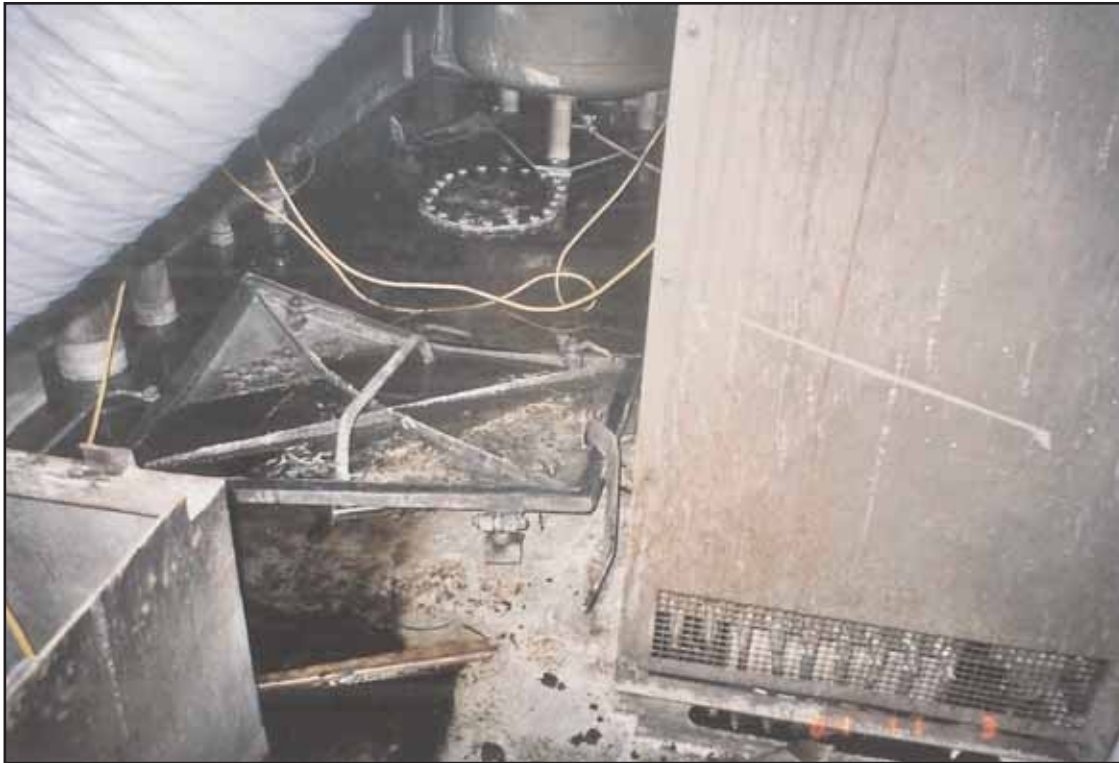
Figure 13

- smoke and pressure damage to electrical cabinets throughout
- hatch down to bow thruster room set up and broken from hinges (**Figure 13**)
- deck set up
- paint store door set in. No damage to paint store internally (**Figure 14**)

Damage to hatch

The pattern of damage in the forward spaces points to high pressure being generated in the bow thrust compartment, setting up the deckhead and blowing off the hatchcover in this deck.

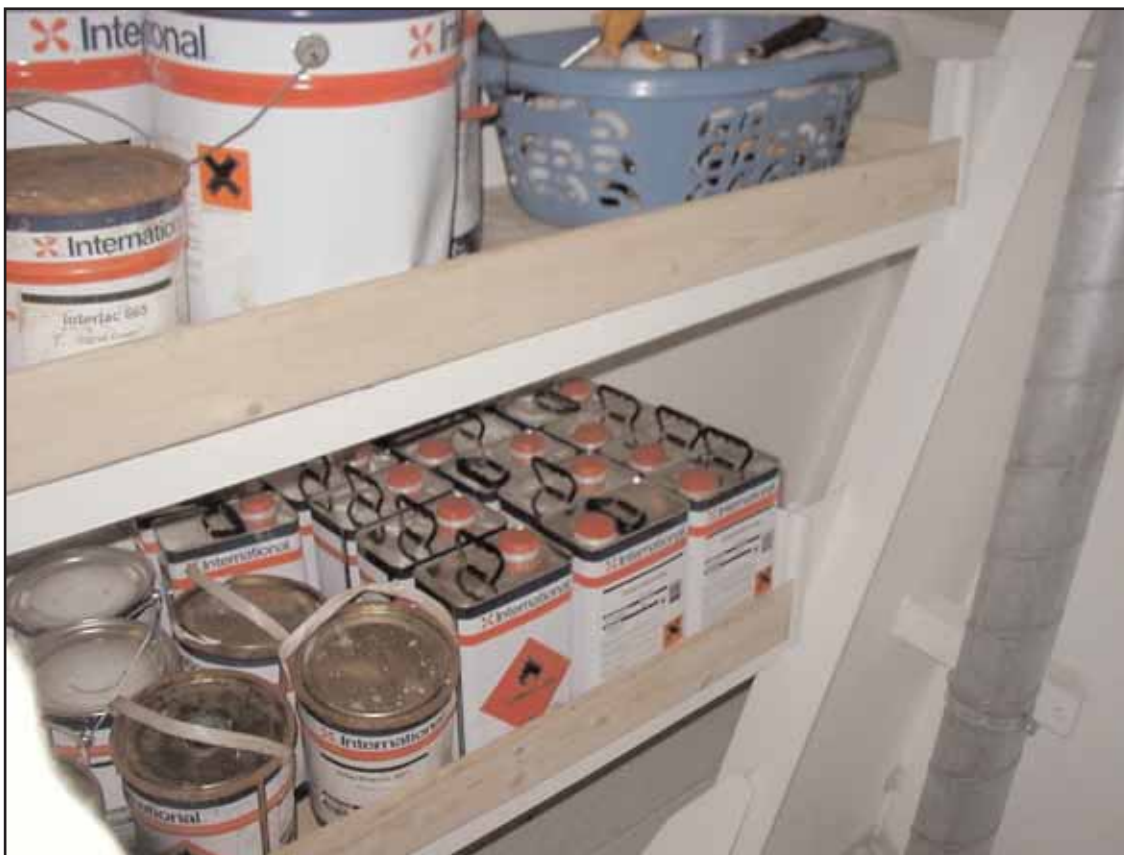
Figure 14

No damage internally to paint store

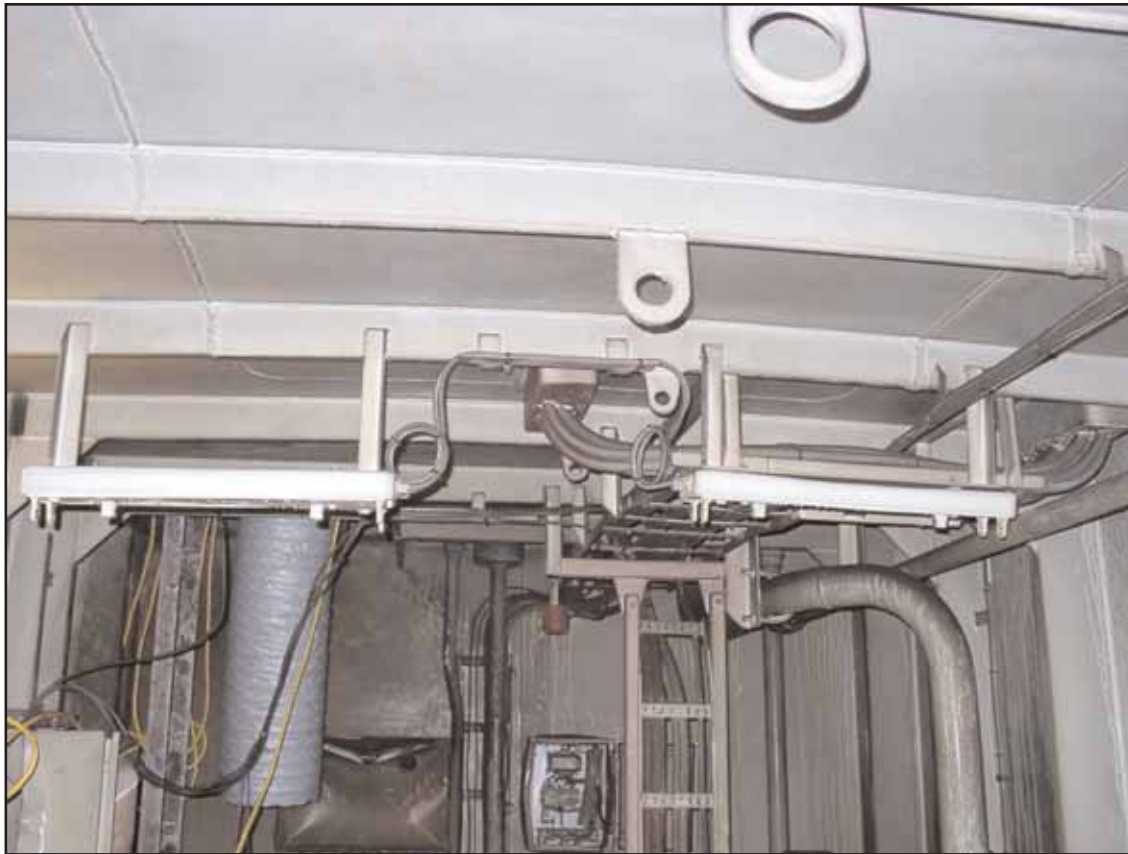
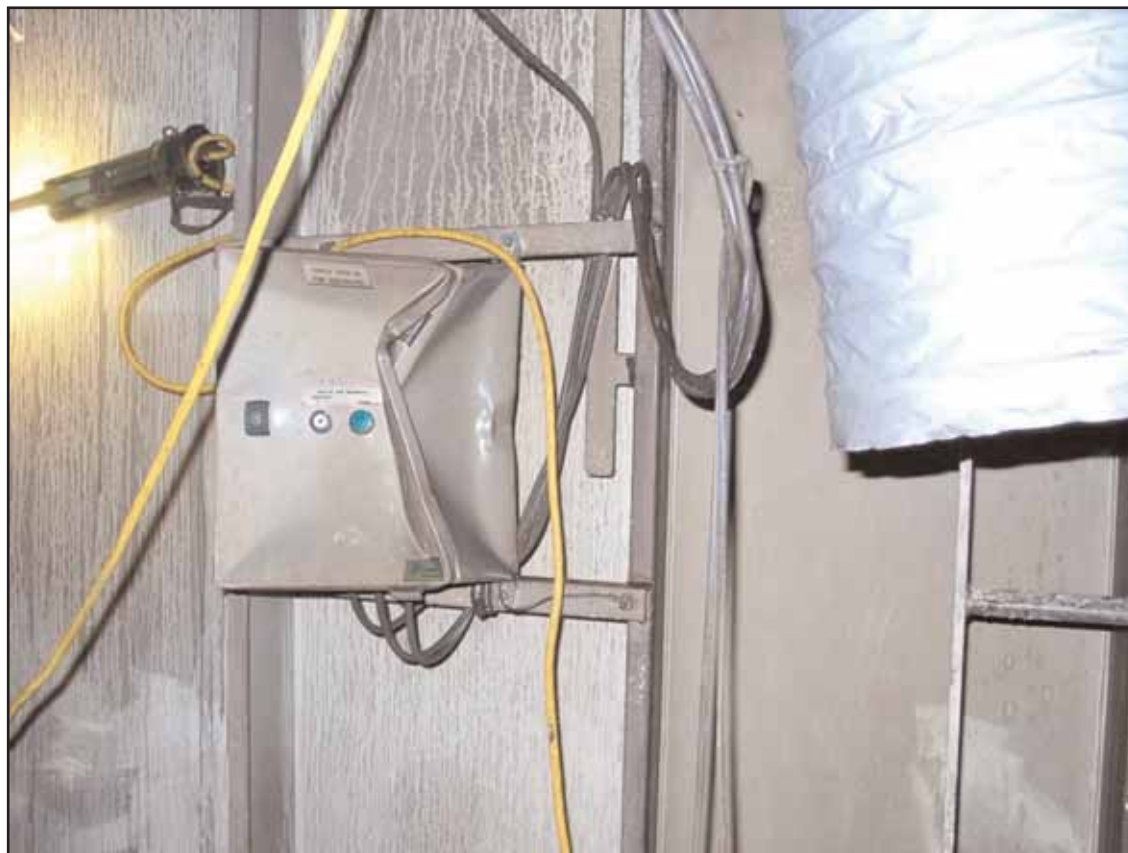
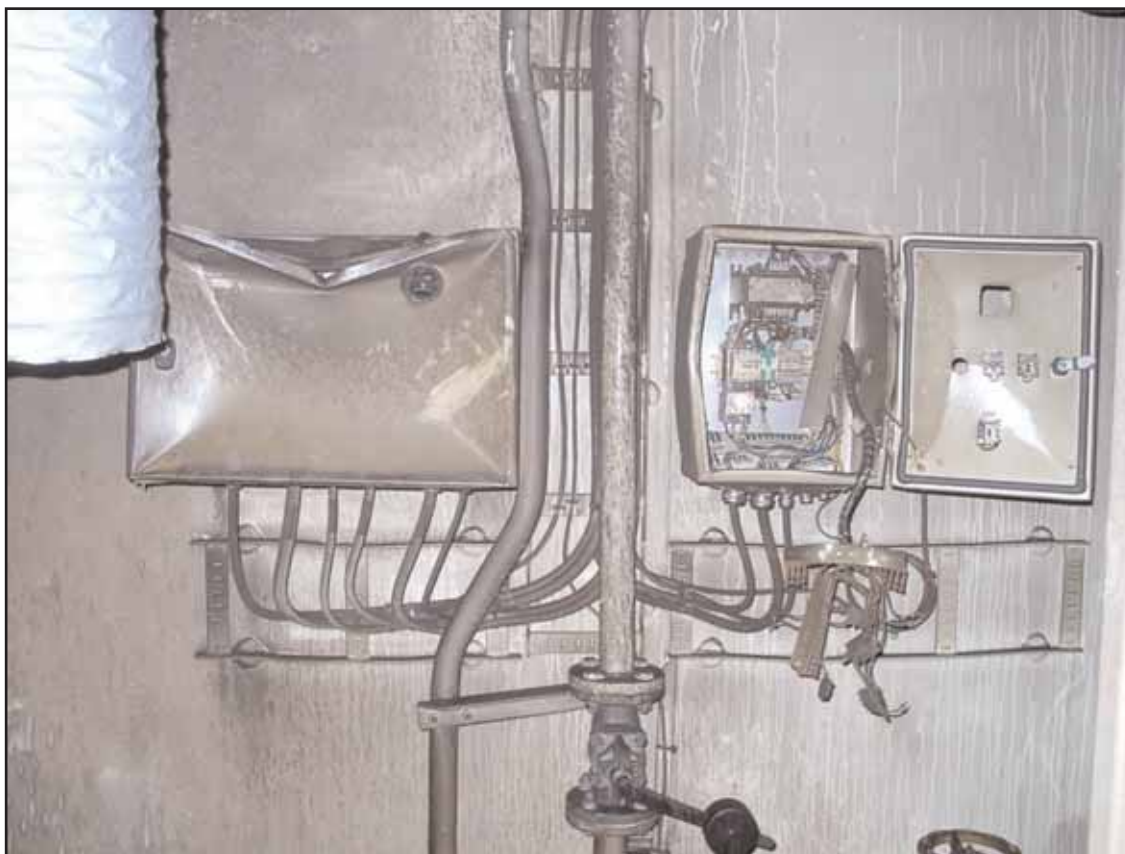
Figure 15 and 16

- deckhead set up
- pressure damage to three electrical cabinets
- light smoke damage throughout (**Figures 15,16 & 17**)

Damage in bow thruster room
