Report on the investigation of
the capsize of the passenger launch

Swan

on the River Avon, Bath

**Report No 11/2005
July 2005**

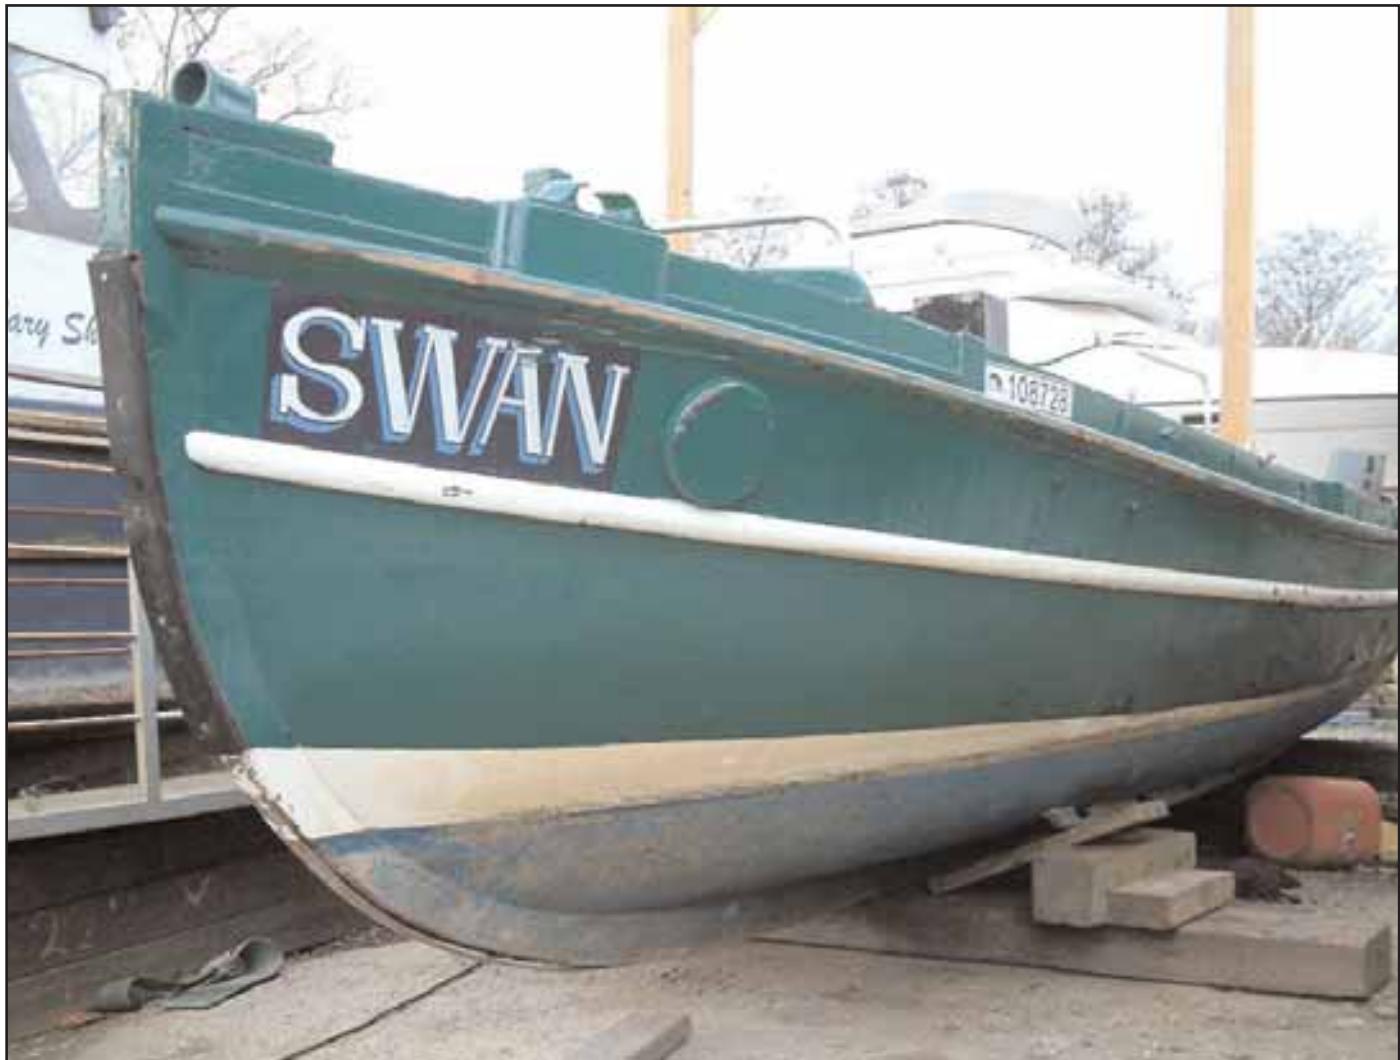
Figure 1

Swan in boatyard after the accident

Time and date	:	1600 on 14 October 2004
Location of incident	:	Below Pulteney Weir on River Avon at Bath
Persons on board	:	Skipper + 9 passengers
Injuries/fatalities	:	1 passenger fractured her wrist, others suffered mild hypothermia
Damage	:	Vessel flooded and holed below waterline and canopy lost

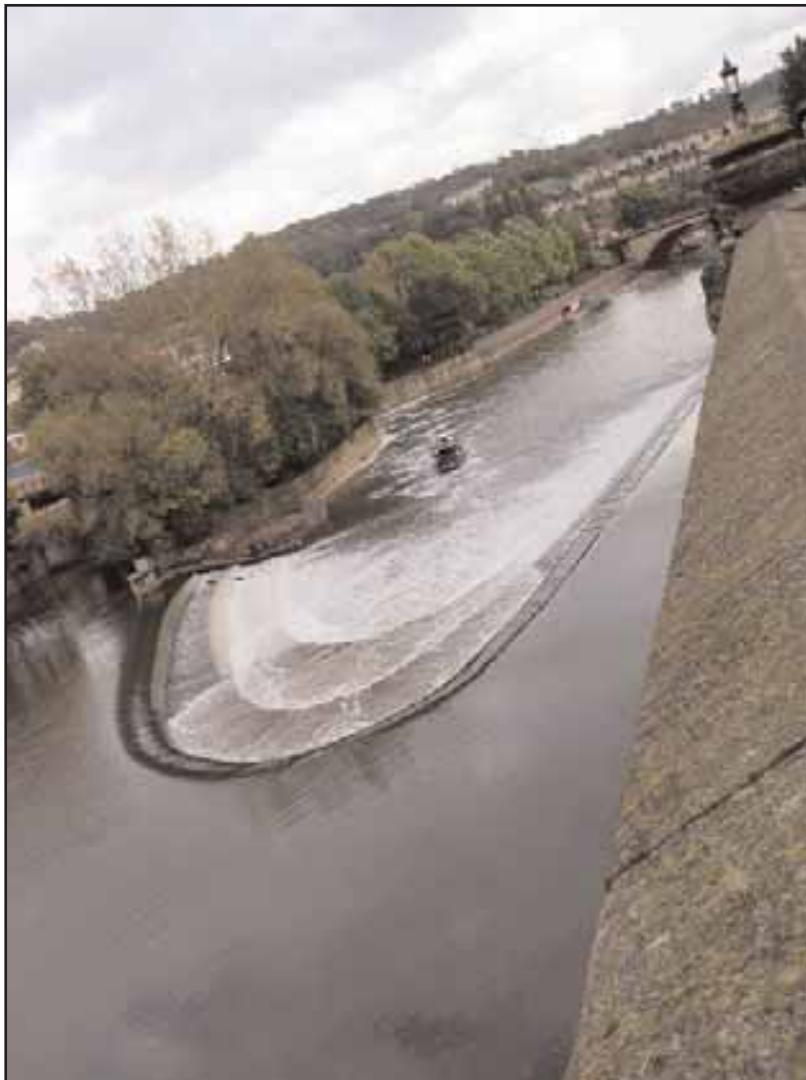
Figure 2

Swan slowly approached the weir (**Figure 2**) and the skipper manoeuvred her into the disturbed water until her bow was between 2 and 3 metres from the centre of the weir. Control of the boat was lost and it moved to port causing the port bow to enter into the water that was cascading over the weir. *Swan* began filling rapidly with water, as the skipper tried, in vain, to move her astern and clear of the weir.

Photograph taken by a member of public as vessel approached the weir

It is apparent that the skipper took *Swan* too close to the apex of the “v” or horseshoe shaped weir and became caught up in powerful eddy currents which moved her bodily to port and under the cascading water. The skipper had previously taken the boat close to the weir on numerous occasions without incident. However, the river was flowing much faster than would normally have been expected for the time of year, and it is likely that the skipper underestimated the effect the eddy currents would have on his boat.

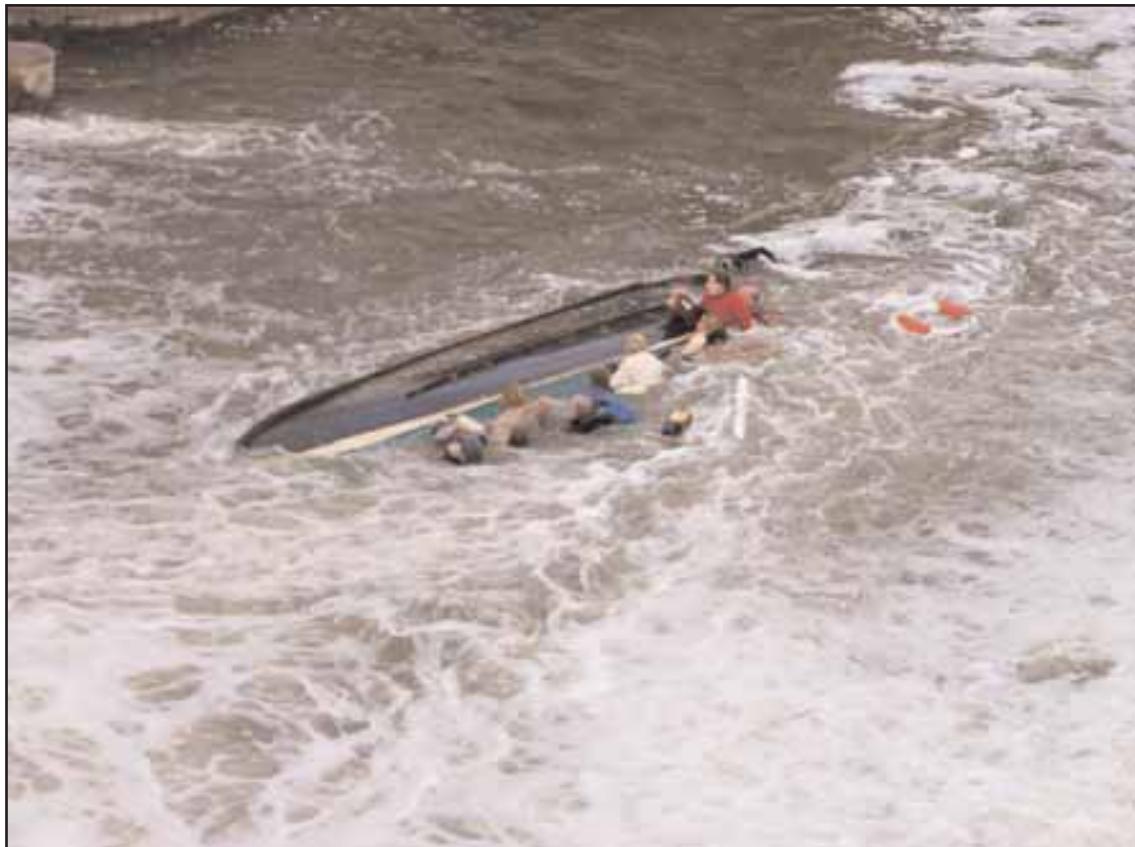
Figure 3

The upturned boat drifted slowly downriver, with the passengers and skipper clinging onto the hull as best they could (**Figures 3 and 4**).

Upturned boat drifting down river

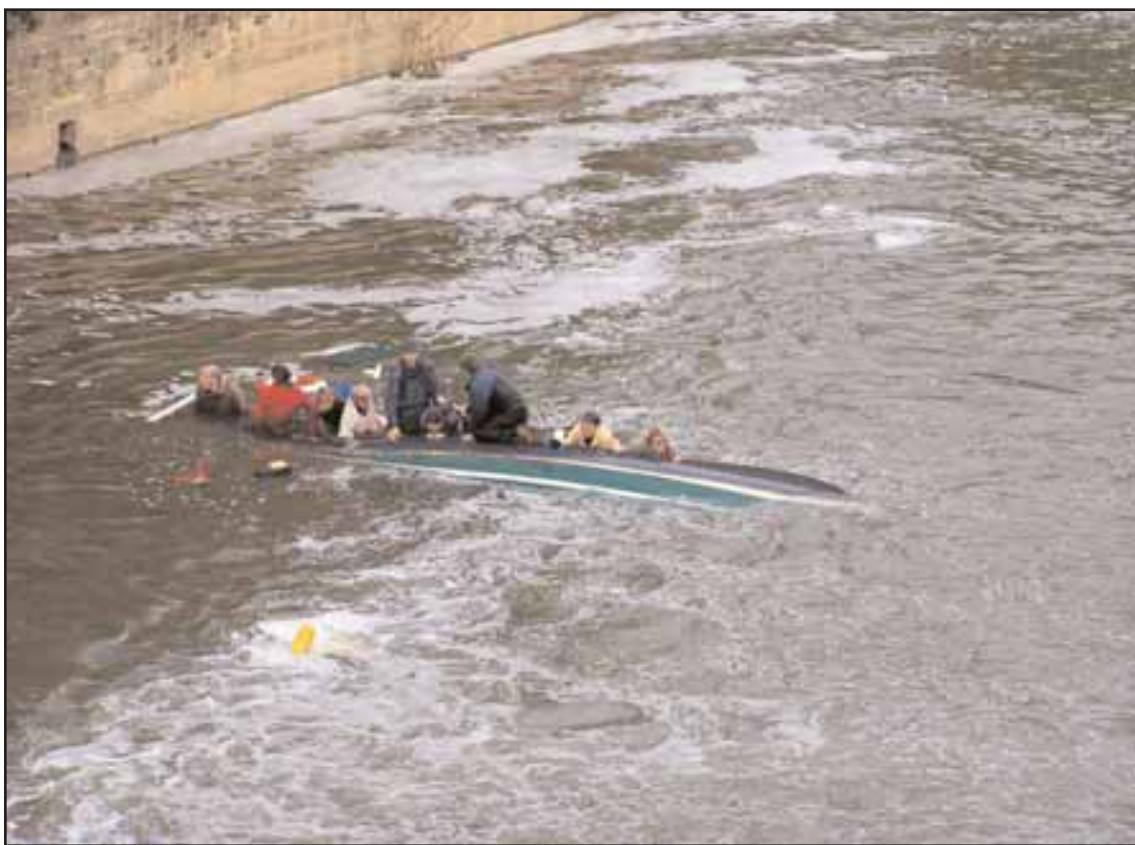
Figure 4

Upturned boat and survivors near river island wall

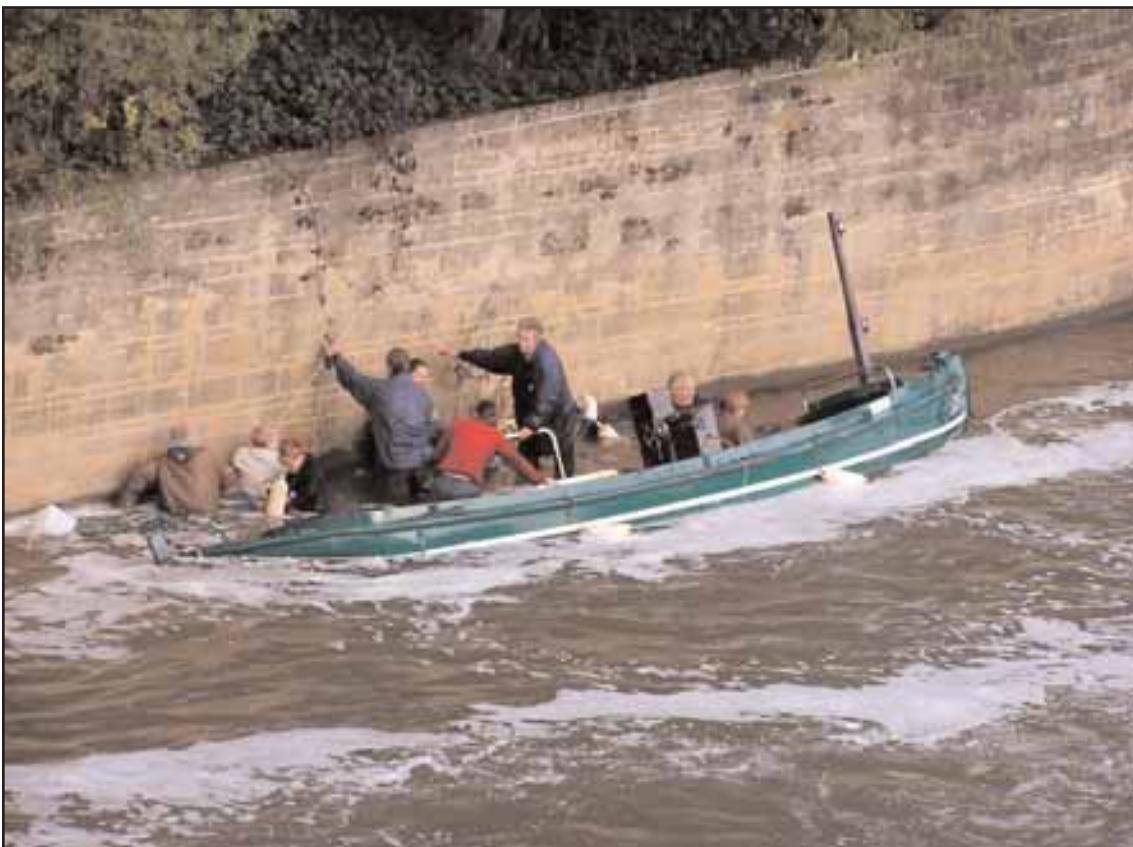
Figure 5

Swan drifted downriver in the current, and towards the right-hand side of the riverbank. Some of the passengers managed to grasp a rope that was strung along the riverbank wall close to a sluice gate. By this method they were able to stop the boat from drifting further downstream. By that time, *Swan* had righted herself. The skipper, helped by some of the male passengers, assisted some of the female passengers into the swamped boat (**Figure 5**).

Boat comes to rest alongside river island wall

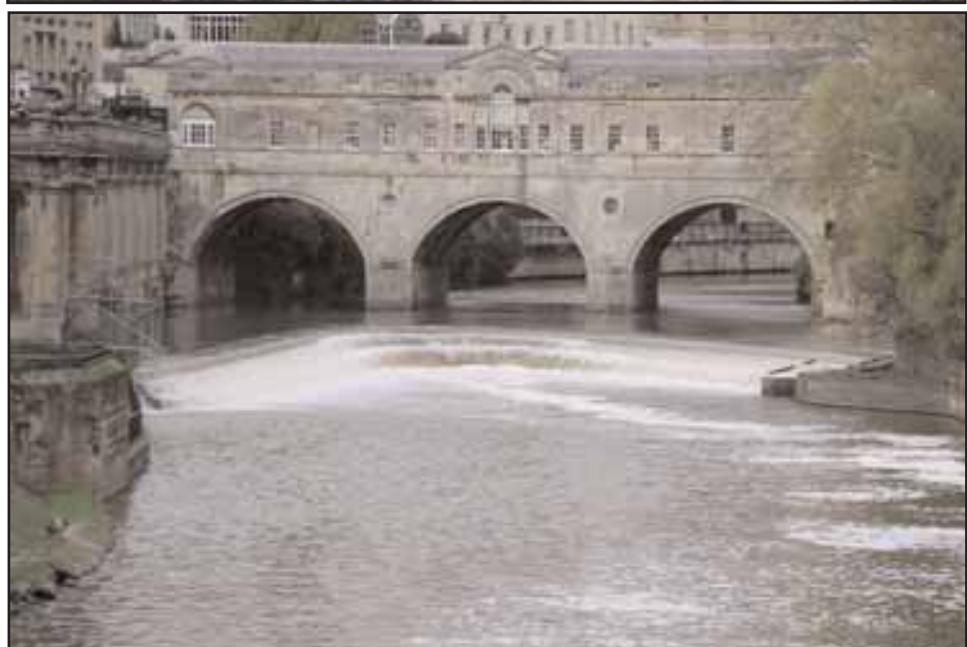
Heavy rain had fallen in the Avon catchment area during Wednesday 13 and Thursday 14 October. The daily mean flow on the River Avon at Bath on the day of the accident was 19.282 cumecs. This was high compared with the rate on the previous day which had been 12.194 cumecs and the monthly average rate which was 13.33 cumecs.

Figure 10
Conditions at weir on
the day after the
accident

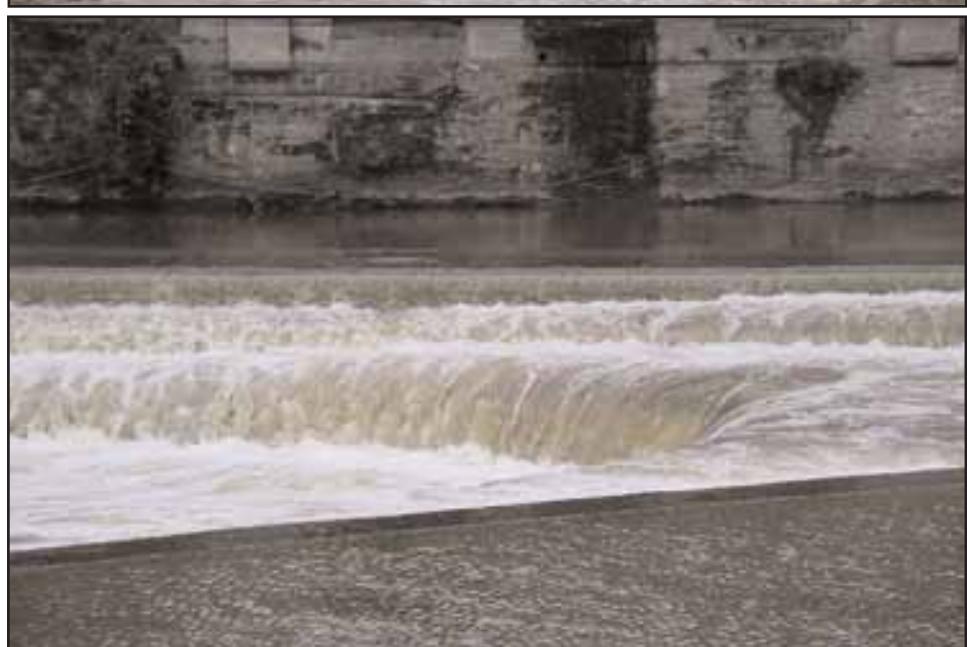
Figure 11
Close-up of water flow
over weir

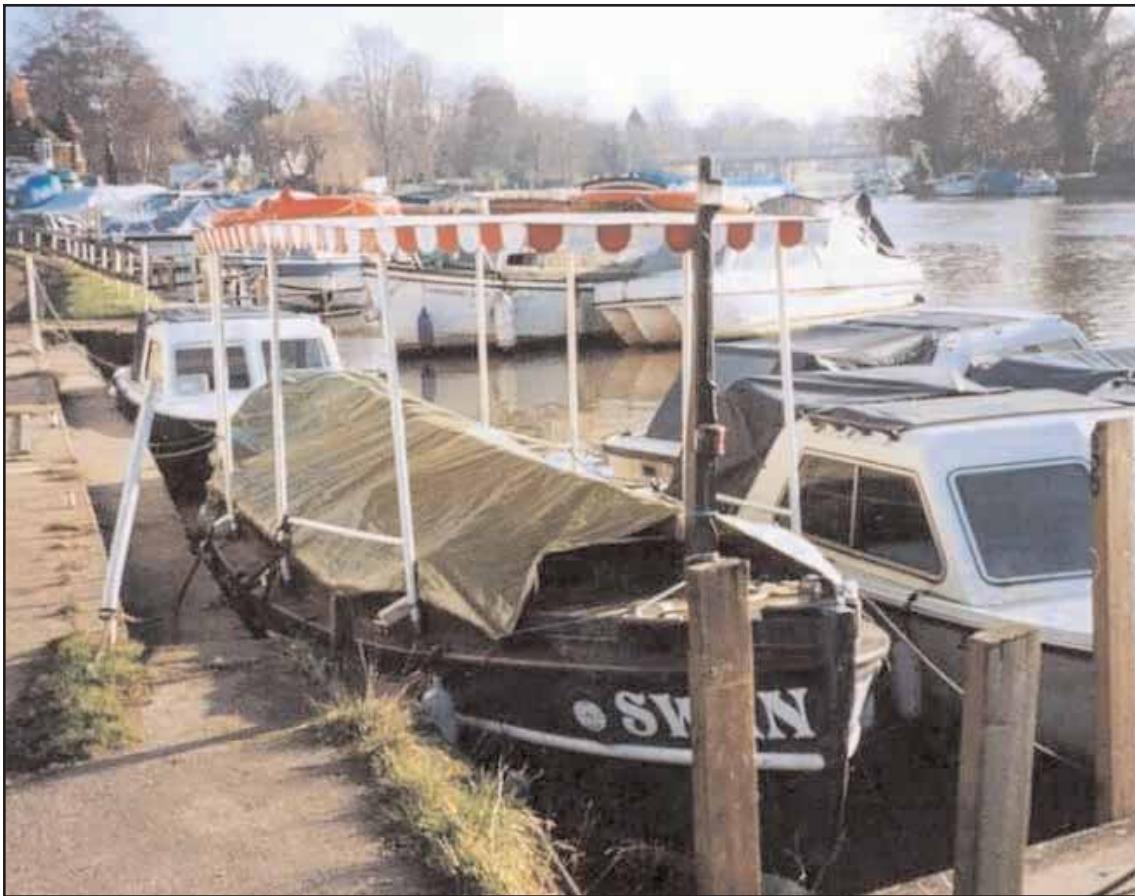
Figure 13

Swan differed from the standard Admiralty Whaler design in that a steel canopy had been fitted to provide shelter for passengers (**Figure 13**). The addition of the canopy with a high centre of gravity affected the boat's stability. This had been recognised, and the effect on stability had been reduced by lowering the canopy about 450mm (18 inches) (**Figure 14**). Additionally, about 250kg of concrete kerbstones had been added as ballast under the bottom boards, to try and improve the boat's stability (**Figures 15 and 16**). The boat's original designed levels of freeboard and stability had been changed by these and other modifications during her life. Despite the fact that she was used to carry passengers, there was no control over what modifications were made to the boat, as there were no statutory minimum rules on stability against which the effect of any changes could be measured.

Because the canopy had been lost during the accident, and had not been recovered by the time of the test, the results of the inclining experiment were adjusted to reflect the effect the canopy would have had on the boat's stability. The construction of the canopy was established from anecdotal evidence supplied by former owners and boatyards and from photographs. The MAIB estimated that it would have weighed about 300kg.

Early photograph of *Swan* with raised canopy

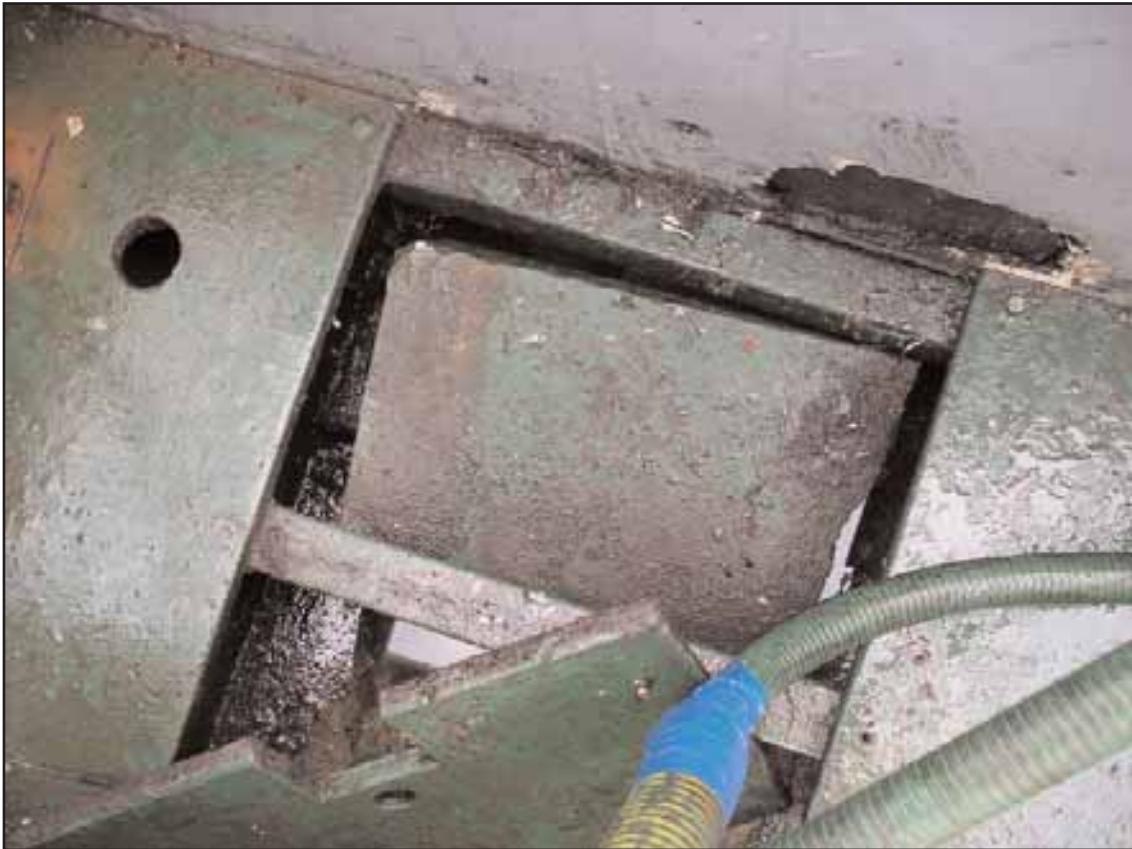
Figure 15

One of many kerbstones positioned under bottom boards

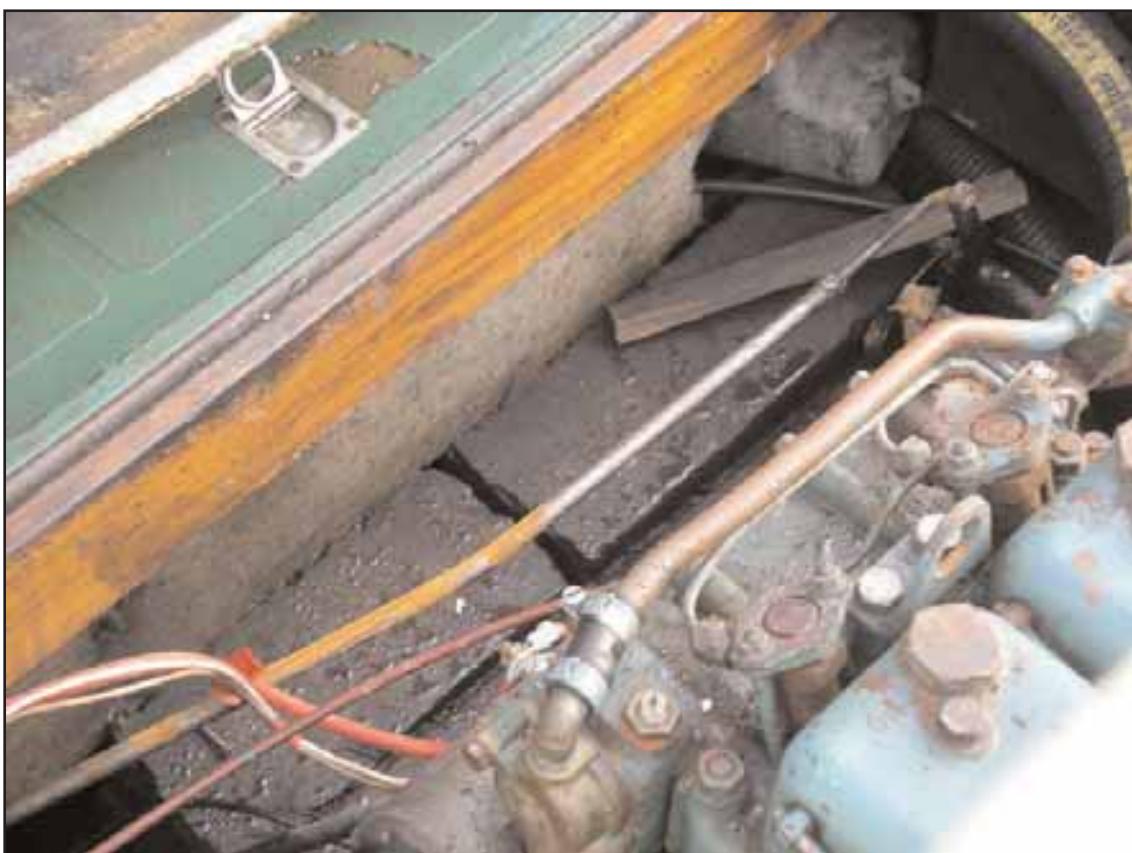
Figure 16

Kerbstones positioned in engine compartment

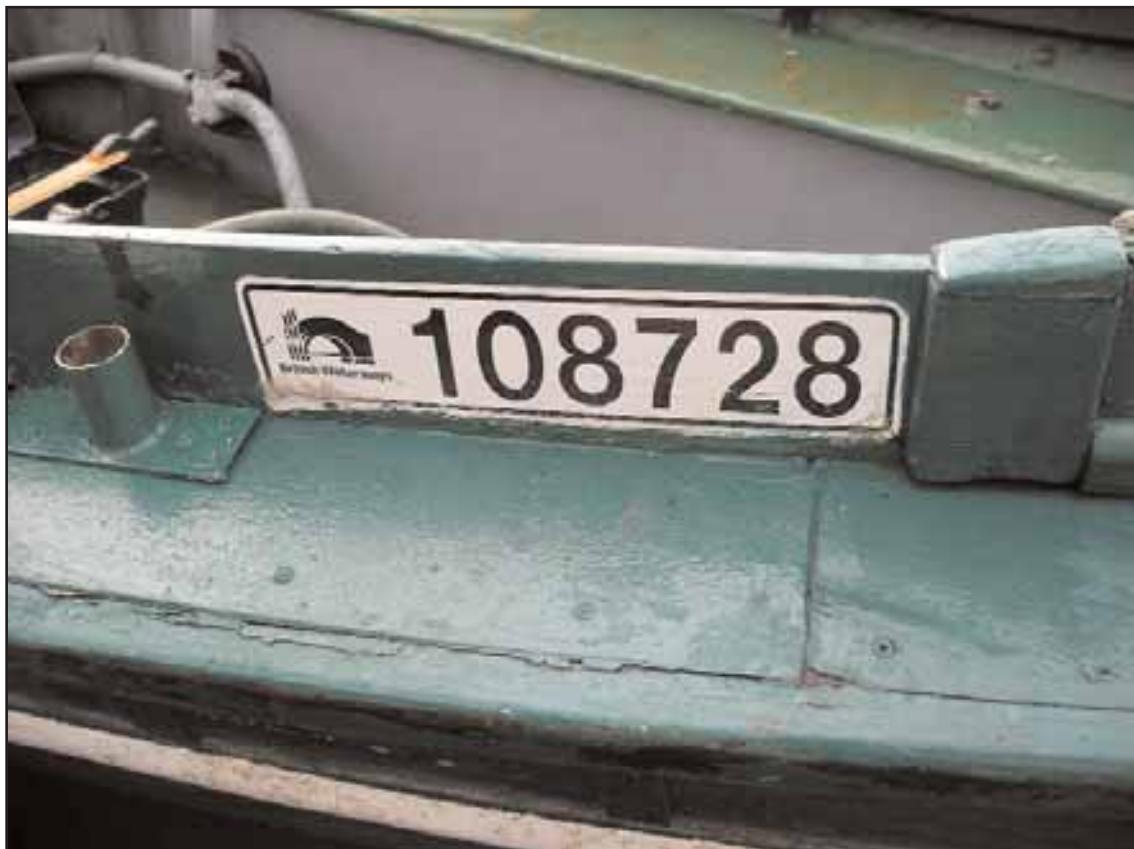
BW was unaware that *Swan* was operating on its waterway. *Swan* still had a BW boat registration number on her side from her previous area of operation (**Figure 19**) and, as she tied up on the stretch of water outside its jurisdiction, a river patrol officer would not have had the opportunity to closely inspect the vessel or to board her.

BW identification number
