Report of the investigation of
the lifeboat release gear test on
RFA *Fort Victoria*
which caused injuries to two people
at Falmouth ship repair yard
10 September 2004

Marine Accident Investigation Branch
Carlton House
Carlton Place
Southampton
United Kingdom
SO15 2DZ

Report No 9/2005
May 2005

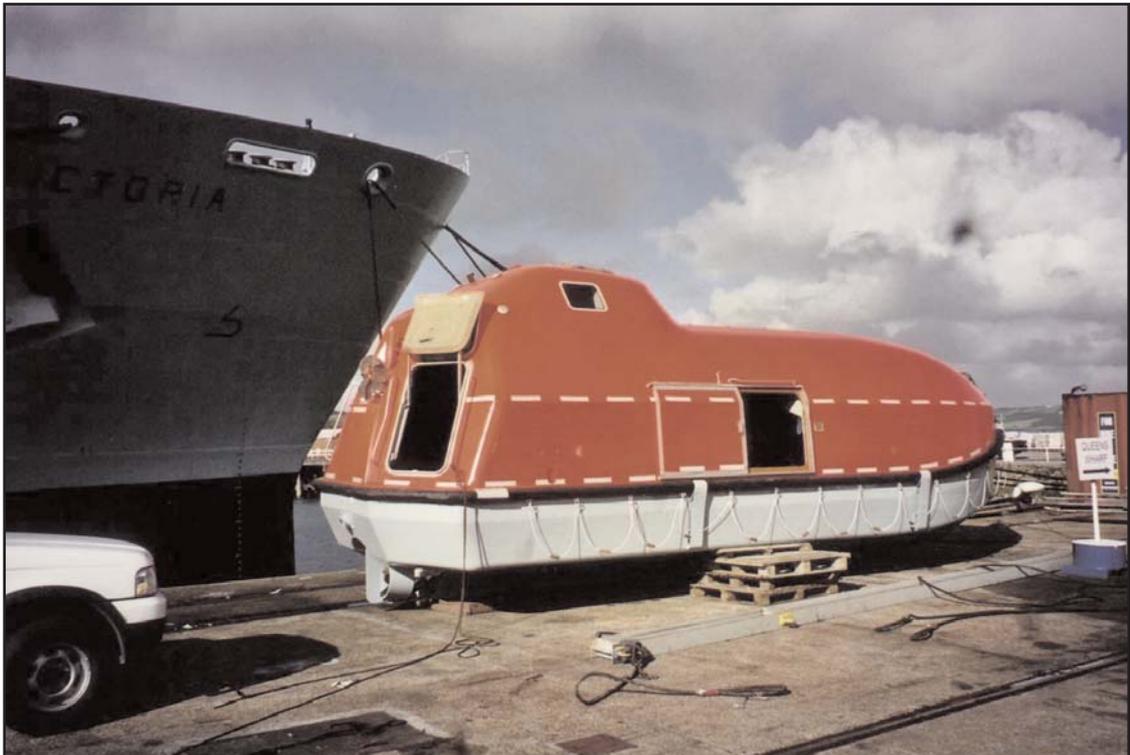
Figure 2

View of No 2 lifeboat after recovery

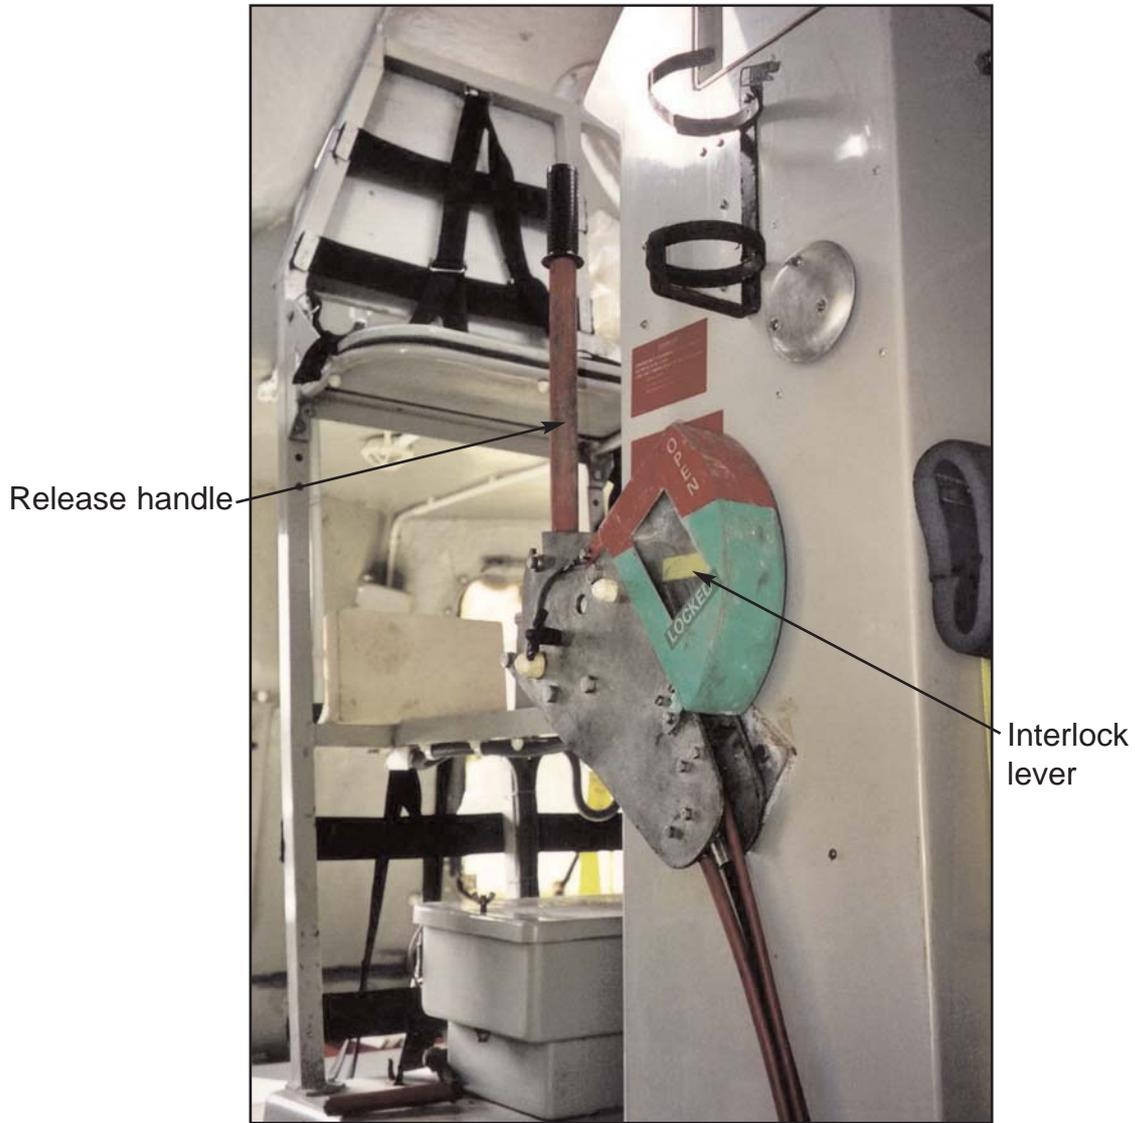
Figure 3

Release gear and coxswain's seat

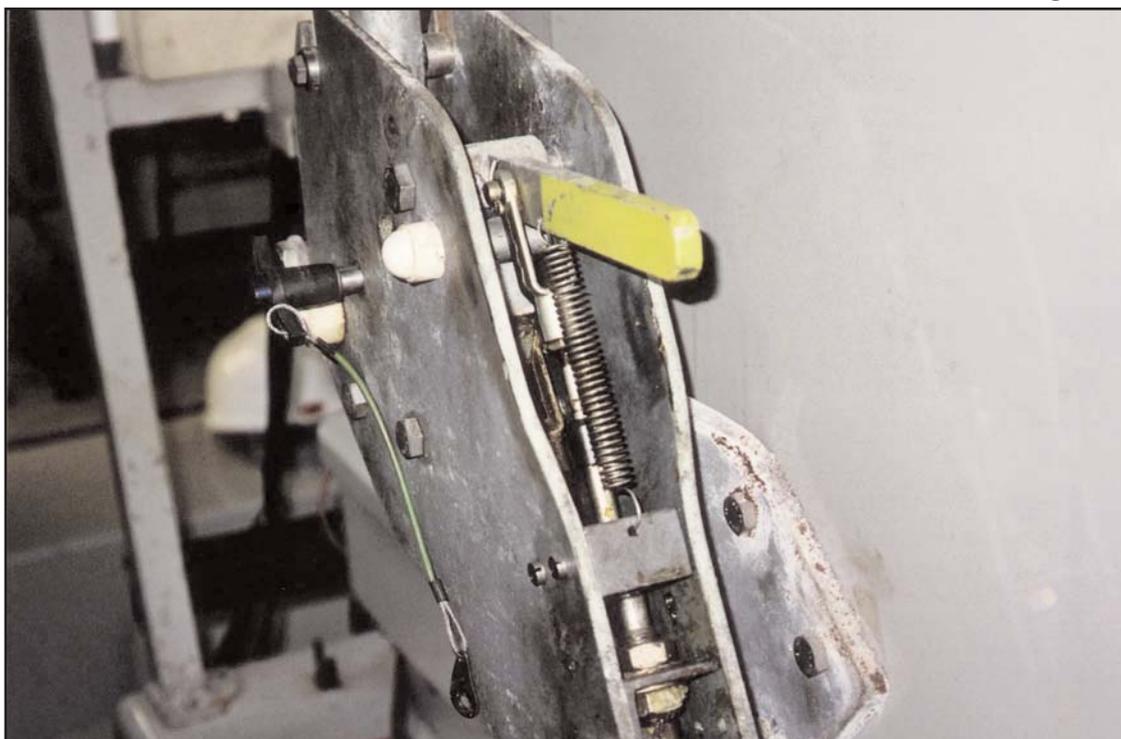
The interlock lever (**Figure 4**) is painted yellow, and is enclosed within a housing, one side of which has a clear Perspex screen. The housing is painted in red and green to denote the lever position, either in the open (red) or locked (green) position. During an emergency, the screen can be smashed to gain access to the lever. For testing purposes, it is usual to remove the housing, to enable manual operation of the interlock lever.

Interlock lever with protective cover removed

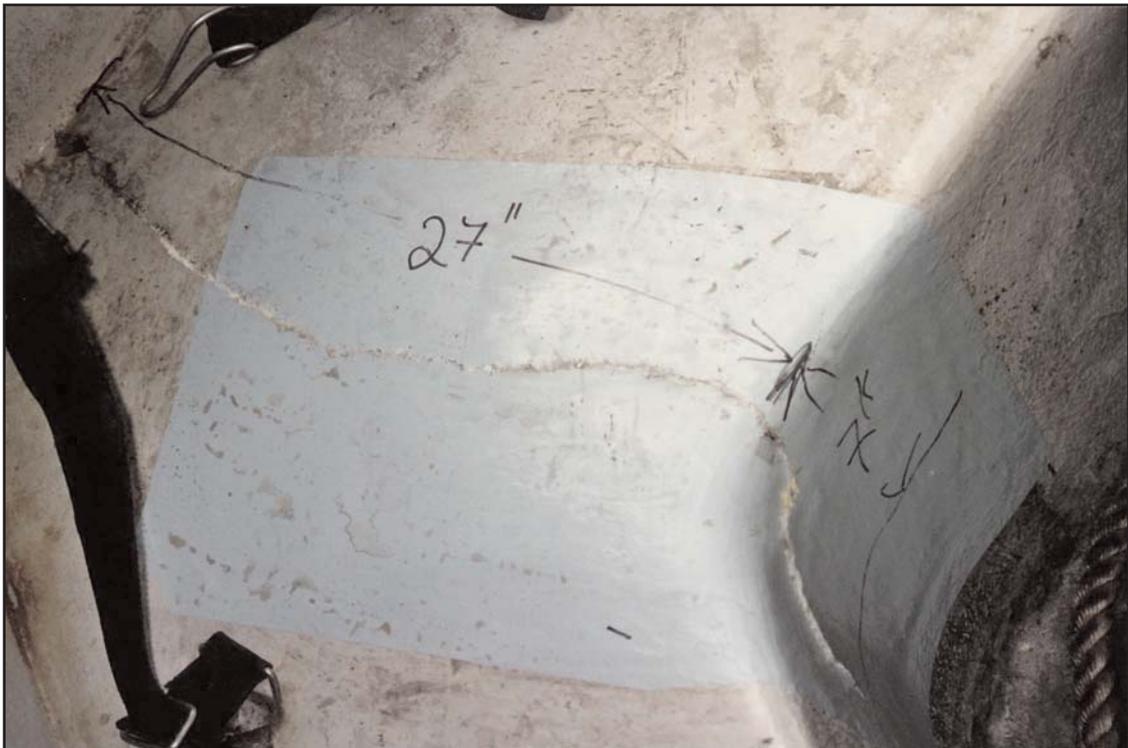
Figure 5

Damage sustained to number 2 lifeboat consisted of:

- A longitudinal fracture approximately 1m long in the seat adjacent to the starboard aft access hatch, and which formed part of the buoyancy tank;
- A transverse fracture approximately 60mm long in the seat adjacent to the starboard aft access hatch, and which formed part of the buoyancy tank **(Figure 5)**;
- A longitudinal fracture approximately 150mm long in the canopy adjacent to the starboard aft access hatch;
- A stanchion, starboard aft of the longitudinal seating, separated from the canopy.

Notwithstanding the above, the damage sustained by the lifeboat would not have affected its operational capabilities.

Crack in seating

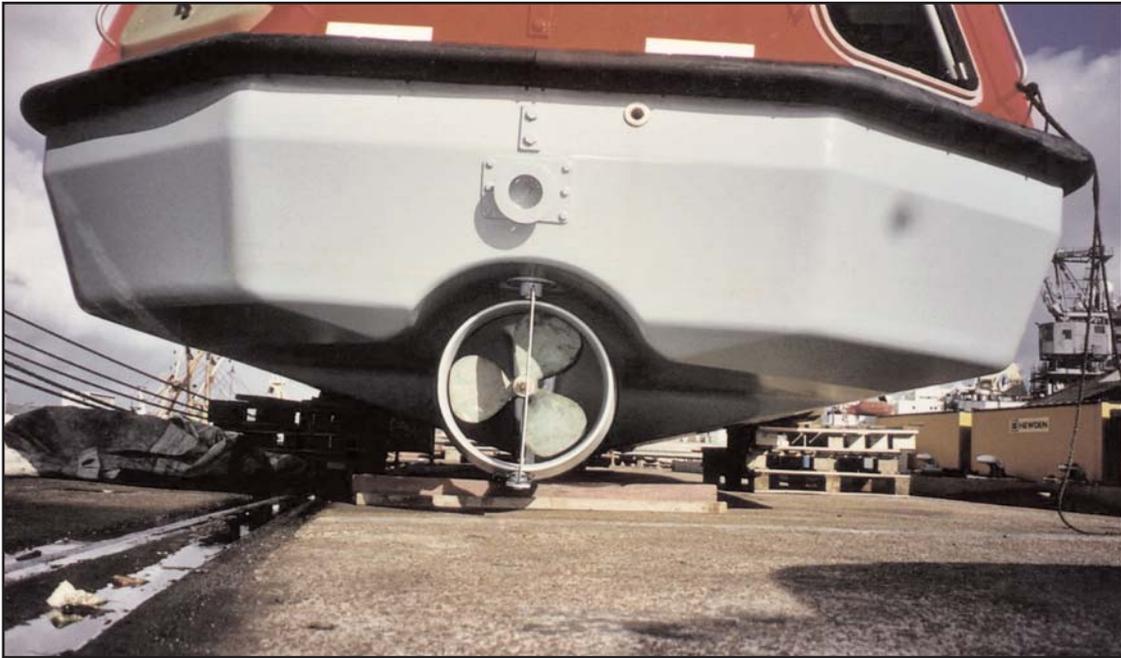
This accident has demonstrated the danger of dropping a near flat bottomed boat onto a smooth water surface. In this situation there is little hull shape to deflect the water on impact (**Figure 6**) and this leads to large forces being transmitted to the boat and its occupants even when the drop height appears to be small.

Aft view of bottom of lifeboat showing shallow deadrise

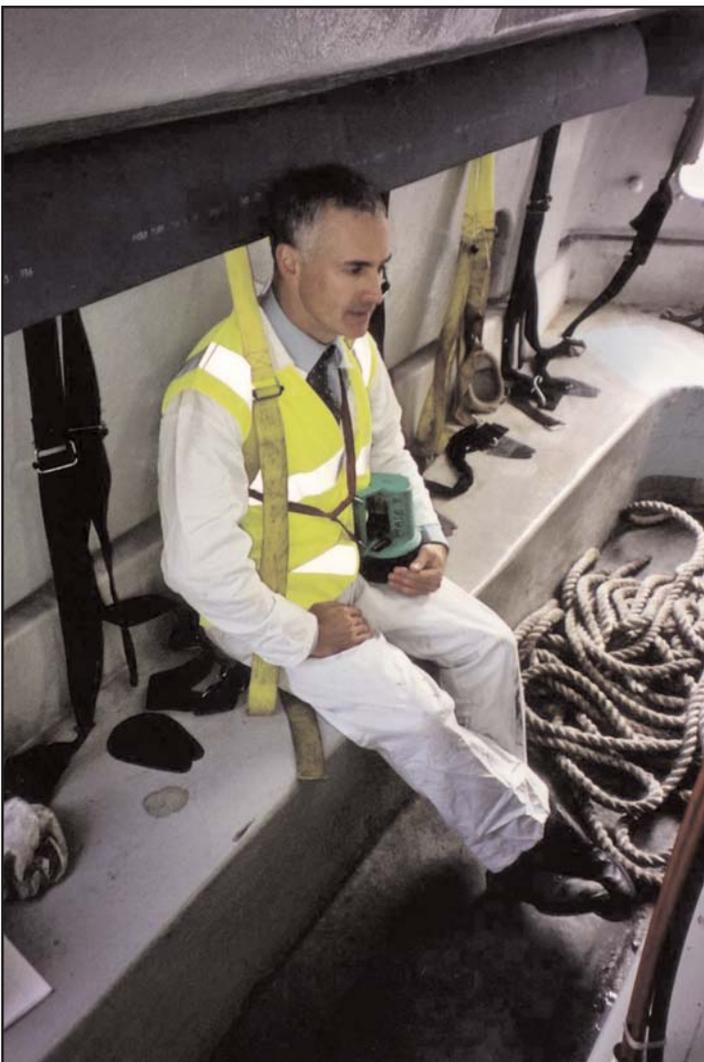
Figure 7

Example of harness and seating in use opposite the release gear

It is also important for the occupants to be seated in an upright position (**Figure 7**). Lifeboat manufacturers should bear in mind that occupants will be wearing hard hats and bulky lifejackets which, when combined with the effect of head padding, might cause them to have to lean forward slightly in the seated position.

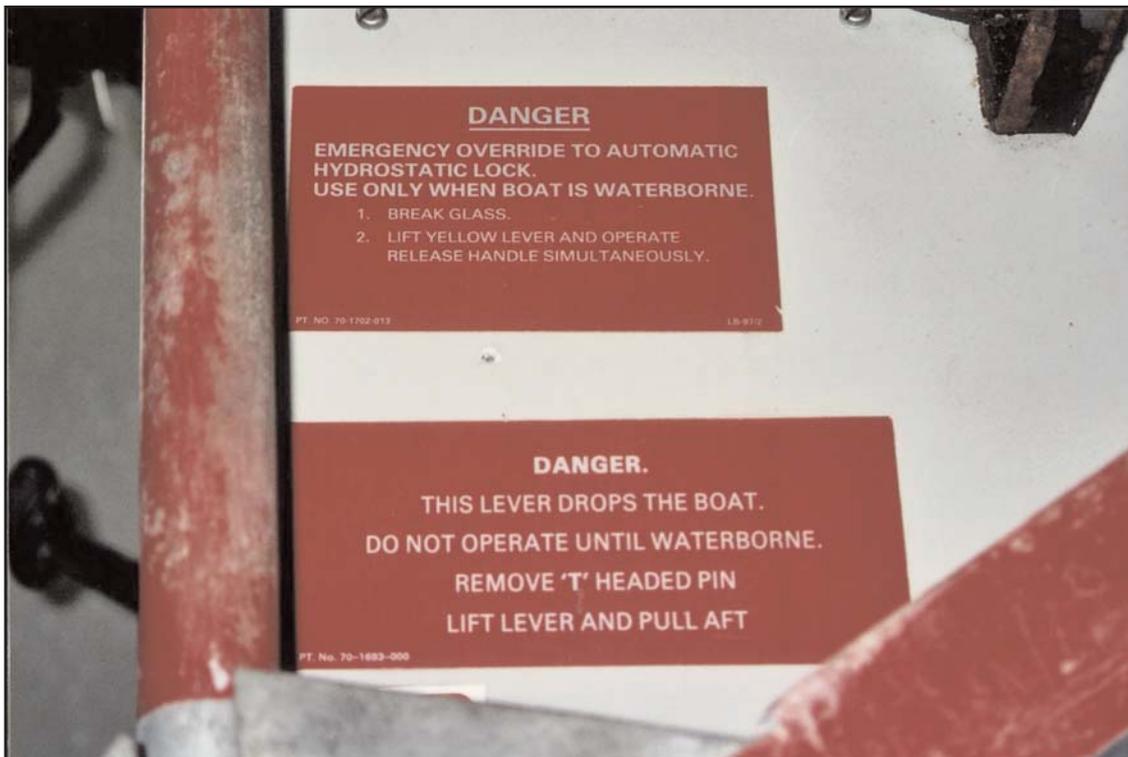
There appears to be a general lack of clear understanding about when the on-load release gear should be used in an emergency. The signage in the lifeboat does not allow for the commonly held opinion that the gear could be used when deploying the lifeboat in an emergency in rough sea conditions after first lowering to wave top height. The MAIB believes that the signage could be improved in this respect, and that it should provide clear indications of the potential for serious injury to result from using the lifeboat on-load release gear when suspended above calm water.

Warning notices for release gear
