Report on the investigation of  
an accident on board  
the commercial sailing vessel

***Albatros***

22 August 2004

**Report No 7/2005**  
**April 2005**

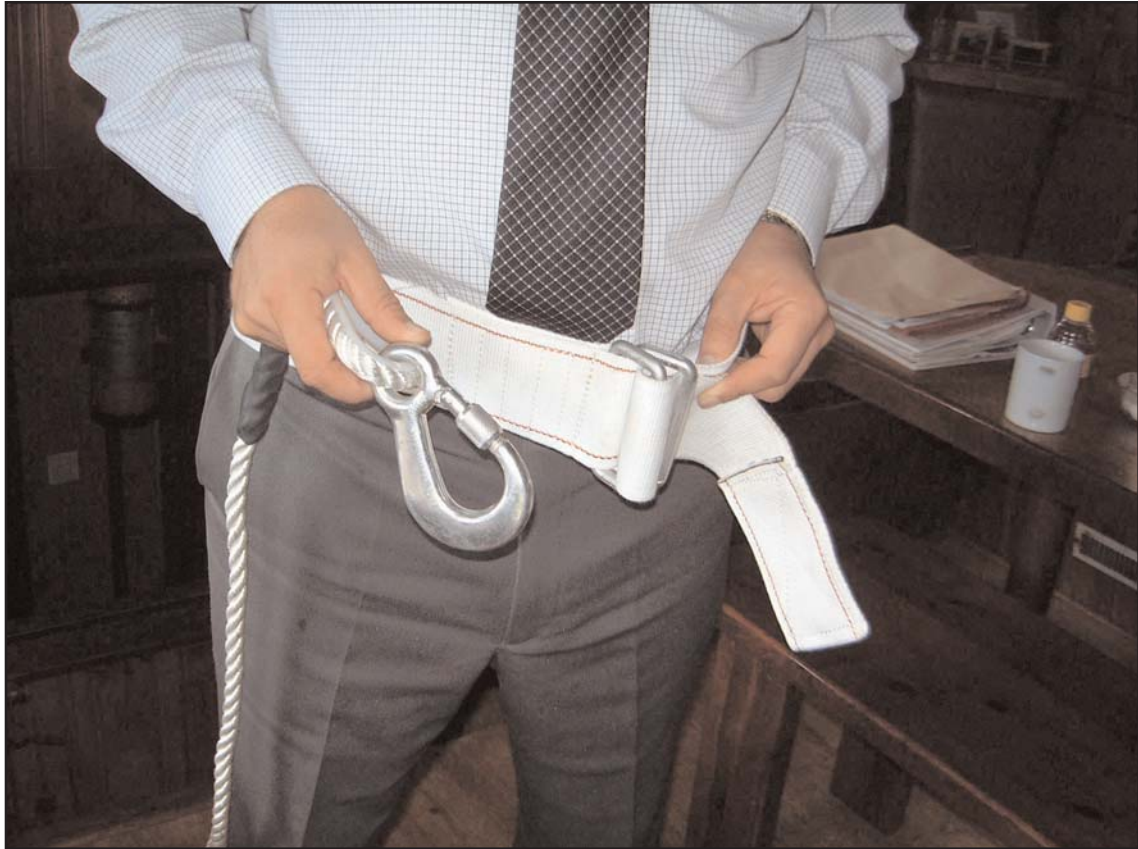
Figure 3

The restraint belts were manufactured by Kong - Bonaiti in Italy and designed for a maximum load of 1500kg. Mr Kneller was wearing one of these belts when he fell from the rigging.

Restraint belt - type fitted to Mr Kneller

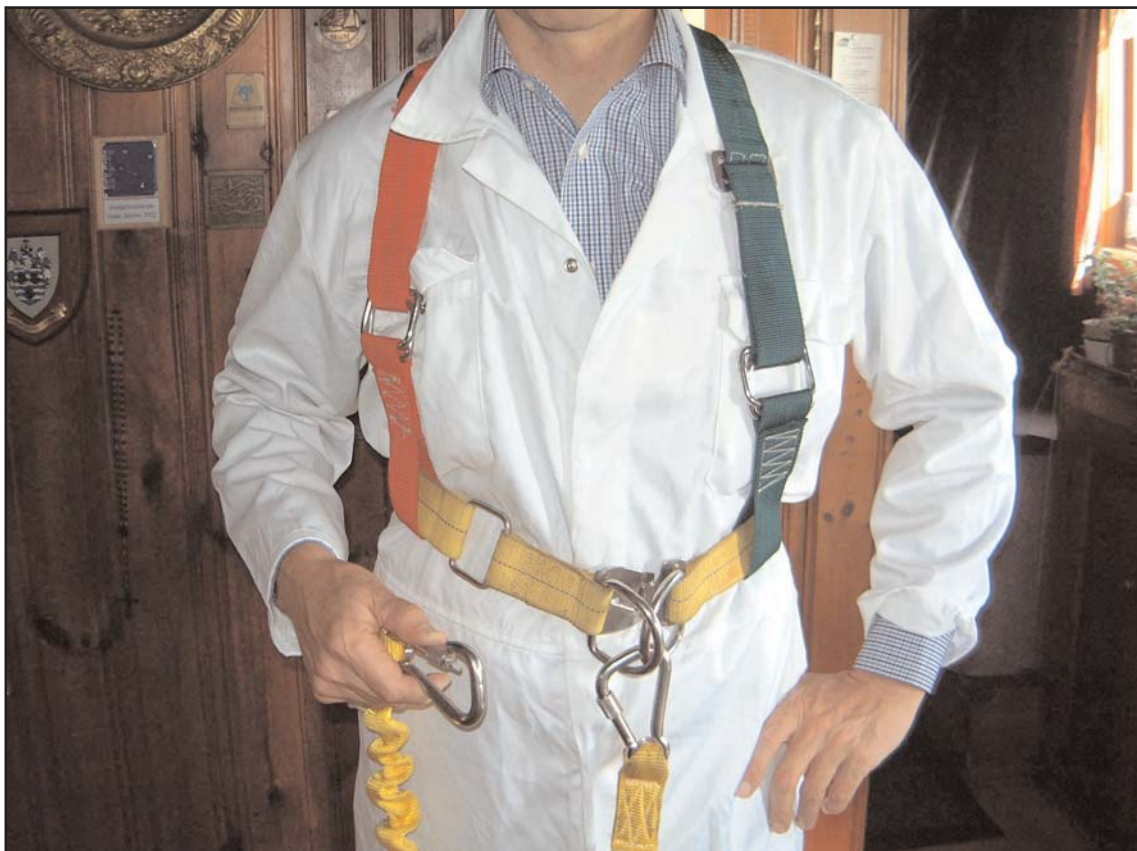
Figure 4

The safety harnesses on board fitted around the user's waist and chest, but did not incorporate leg and crotch support. They were fitted with an elasticised lifeline, complete with karibiner clip attachment. The lifeline was attached to the harness by another karibiner clip, passing through two stainless steel D rings fitted into the harness webbing.

The type of safety harness carried on board *Albatros*

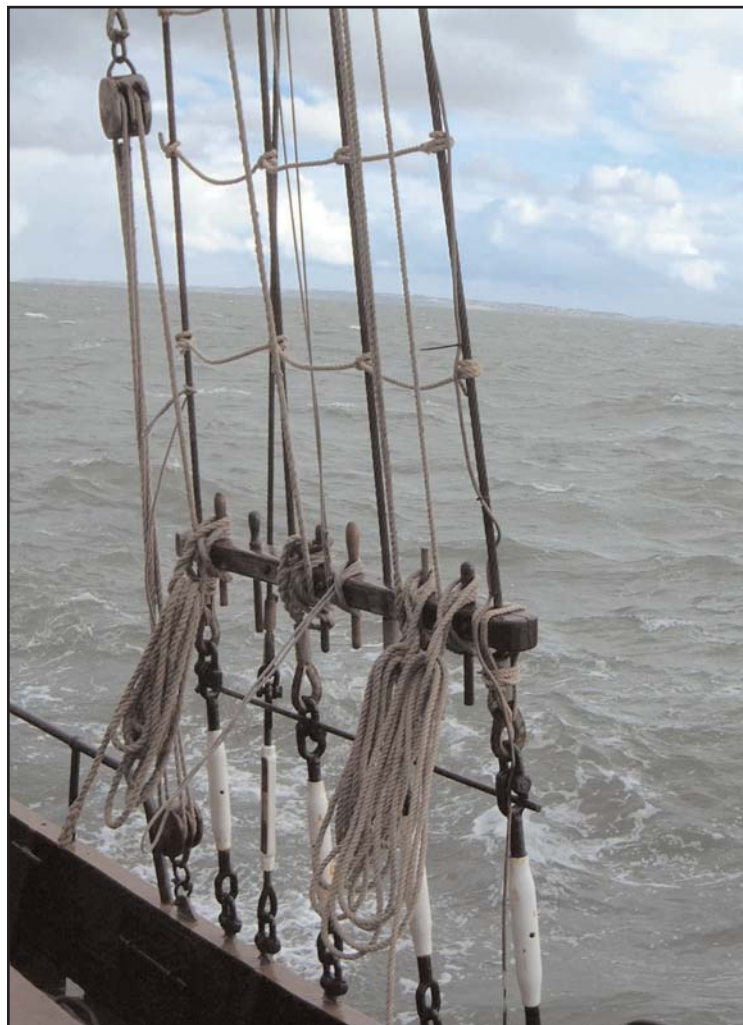
Figure 5

The only rigging available for climbing was situated on the port side of the mainmast and was known as ratlines (**Figure 5**). Lengths of man-made polypropylene fibre rope were secured to the forward, middle and after shrouds to effectively form a rope ladder, the steps of which gradually decreased in size as they approached the upper mast band (**Figure 6**). The technique used

Lower ratlines

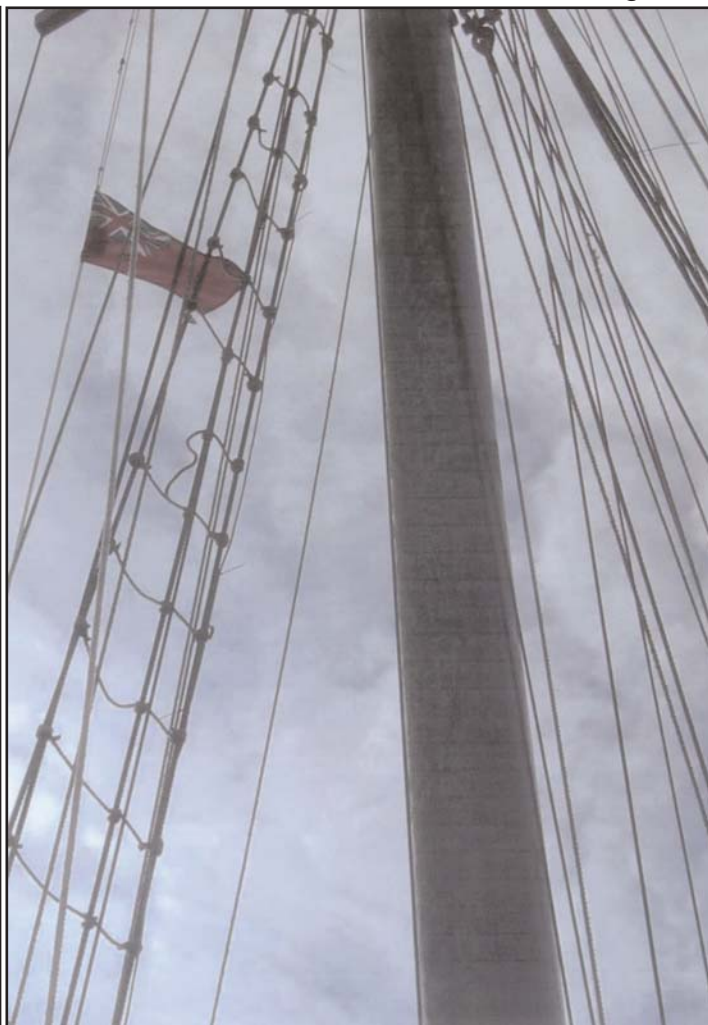
Figure 6

Upper ratlines

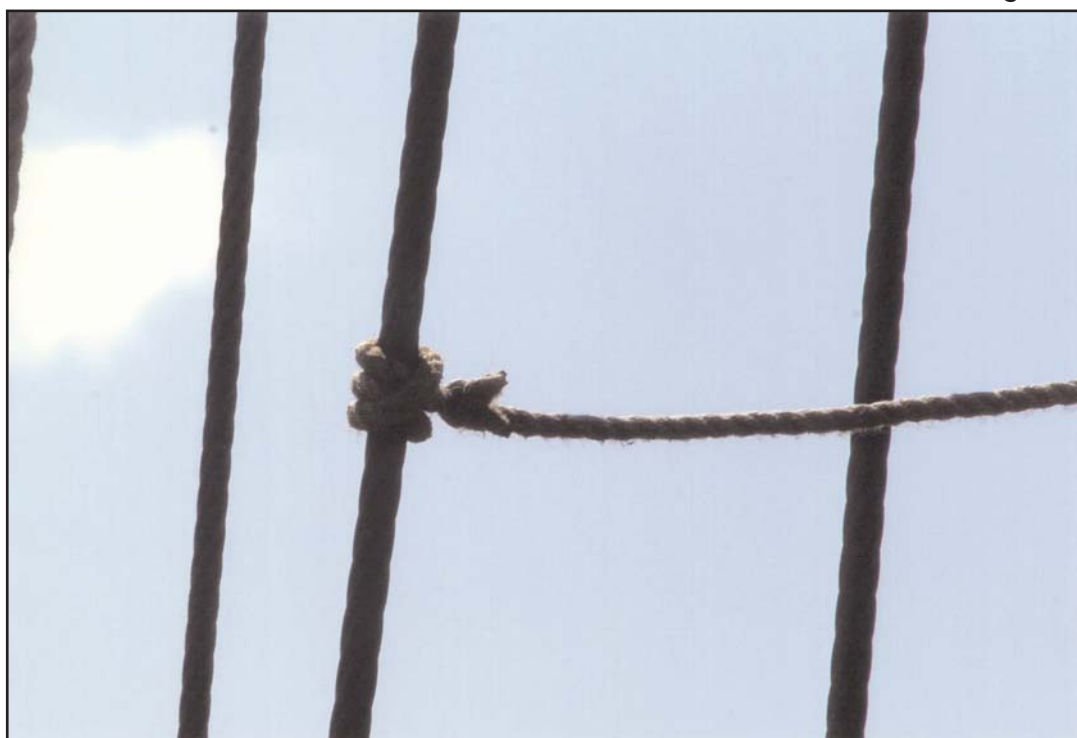
Figure 7

Method of securing the ratlines to shrouds on board *Albatros*

on board *Albatros* to secure the ratline to the shrouds, consisted of a rolling hitch on the forward and after shrouds and a clove hitch on the middle shroud. Each end of the line was tucked back under a strand of the standing part, and the end melted to prevent fraying (**Figure 7**).

In the case of *Albatros*, the ratlines' reliability would have been improved had their loose ends been whipped around the standing part, after being tucked through a strand. This could have prevented the end of the line from becoming loose and reducing the effectiveness of the rolling hitch. Ultimate failure might then have been avoided.

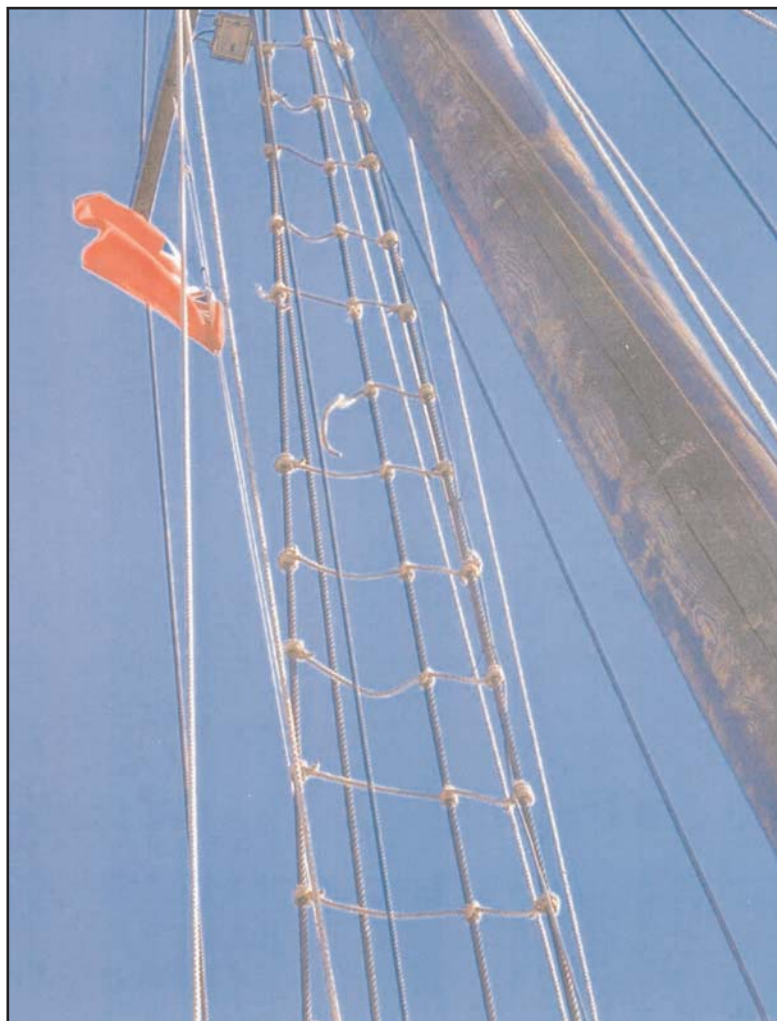
Figure 8

Both the master and the deckhands reported that they were aware of a loose ratline some 8 to 9 metres from the deck. This had been identified some 2 to 3 days before the accident. It is thought to have become loose when *Albatros* encountered high wind and sea conditions in the English channel, en route to Southend. All of the crew described the ratline as hanging loose and adrift from the after shroud (**Figure 8**).

The parted ratline viewed on arrival at the scene

The only witness at the time Mr Kneller fell was the deckhand, who saw him unclip his lifeline, momentarily freeze and then fall backwards. The deckhand reported that Mr Kneller had not reached the level of the broken ratline before he fell. However, photographic evidence clearly shows that his chest was level with the height of the damaged ratline when the accident occurred. Furthermore, contrary to crew reports that the ratline was detached from the aft shroud, photographic evidence clearly shows that the rolling hitch securing the ratline was attached to the shroud. Inspection of the photograph shows that the ratline was secured by little more than a half hitch. The knot was not substantial enough to take the weight of Mr Kneller. After the accident, the end of the ratline was found to have parted from the after shroud. It is possible that while unclipping his lifeline, at the same time gripping the damaged ratline, his weight was sufficient to cause the ratline to give way, causing him to fall.

The crew reported that they were aware that the ratline was defective. Despite this knowledge, there was no attempt or plan made to repair it.

The passenger fell down the mast when he was at chest level with the damaged ratline. How he fell down is uncertain. It is possible that while unclipping his lifeline, at the same time gripping the damaged ratline, his weight was sufficient to cause the ratline to give way, causing him to fall. [2.2]

- Ensure that the vessel is, at all times, safely manned with a competent crew to enable an effective response in an emergency.
- Introduce a maintenance regime to ensure timely and effective repairs of safety critical equipment.
- Develop an unambiguous policy and guidelines on the use of passengers to assist crew.

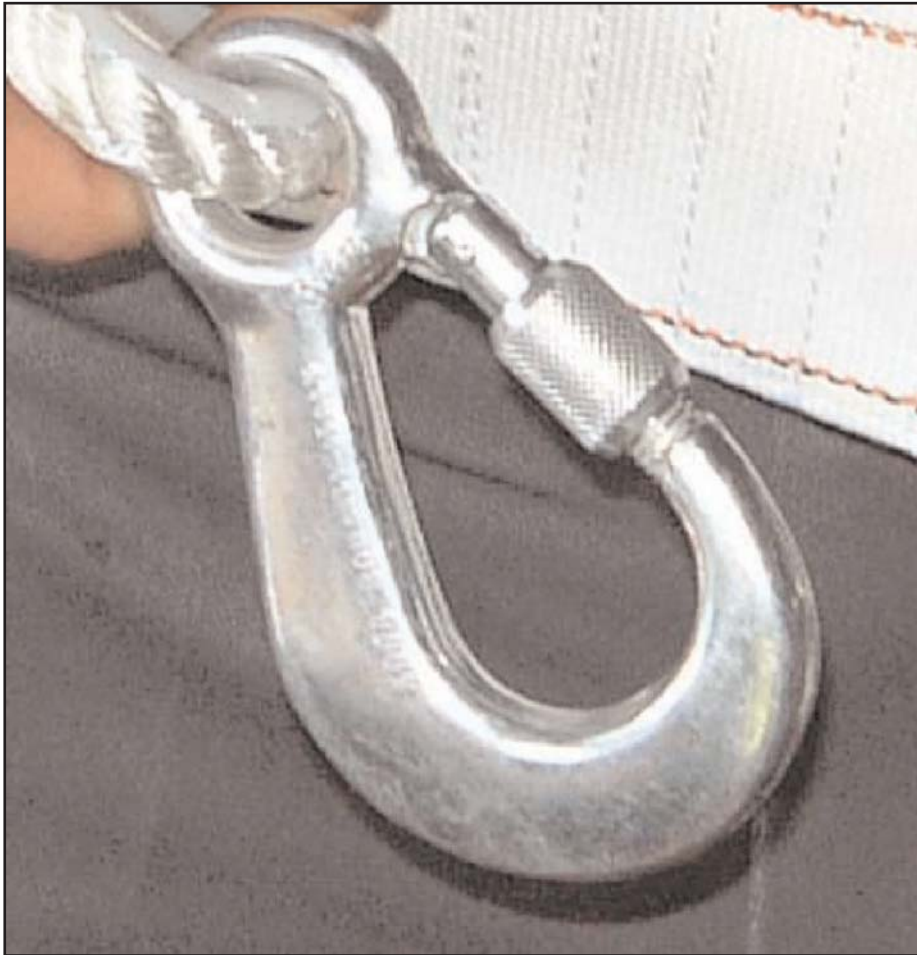
Figure 9

Karibiner clip - fitted to the restraint belt used by Mr Kneller

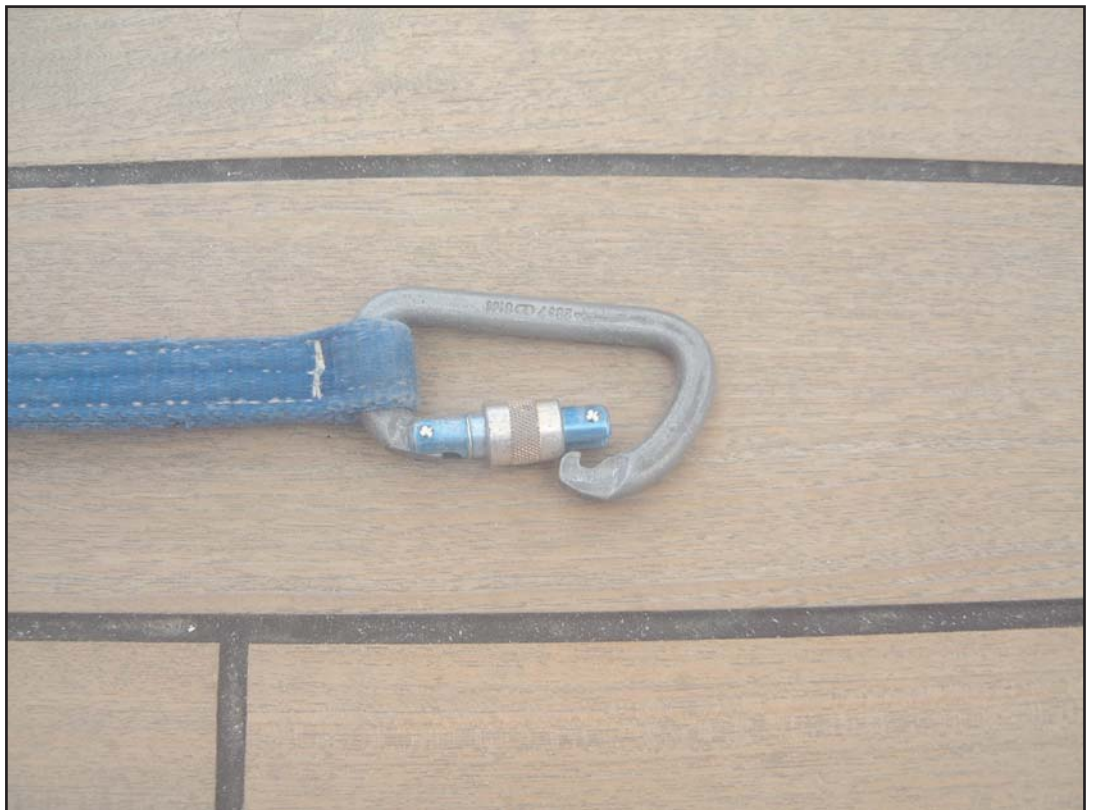
Figure 10

Karibiner clip with screw arrangement partially closed

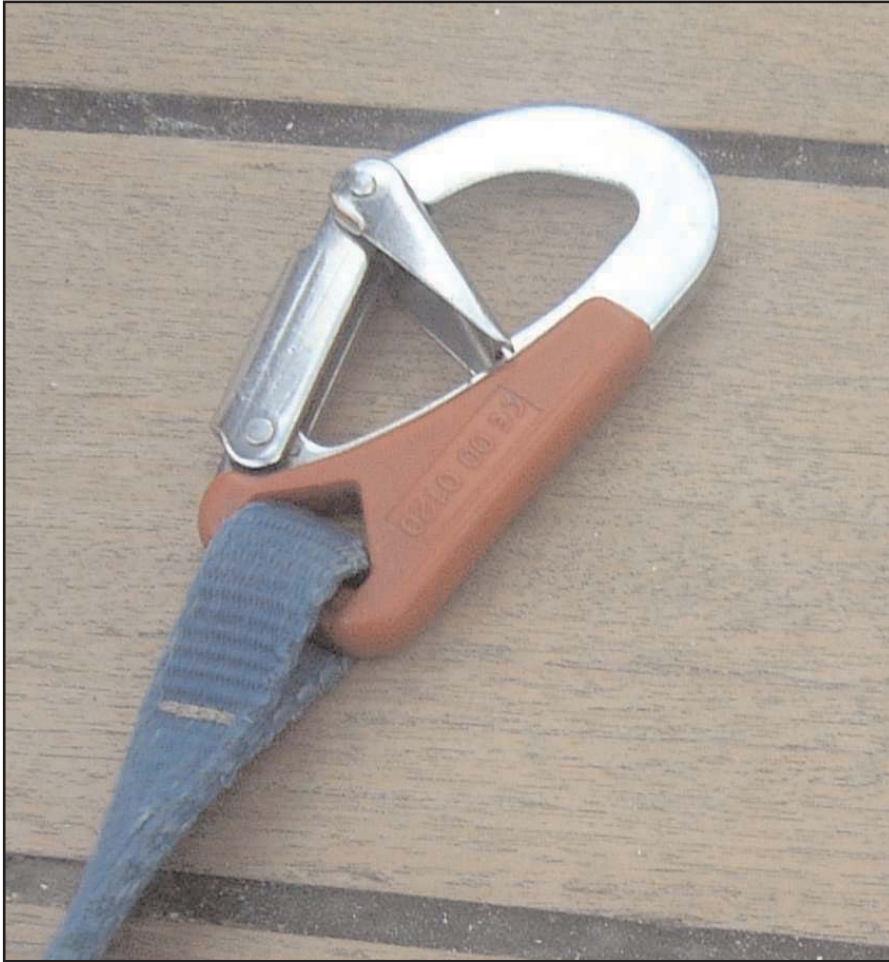
Figure 11

Alternative arrangement of a double action spring loaded clip

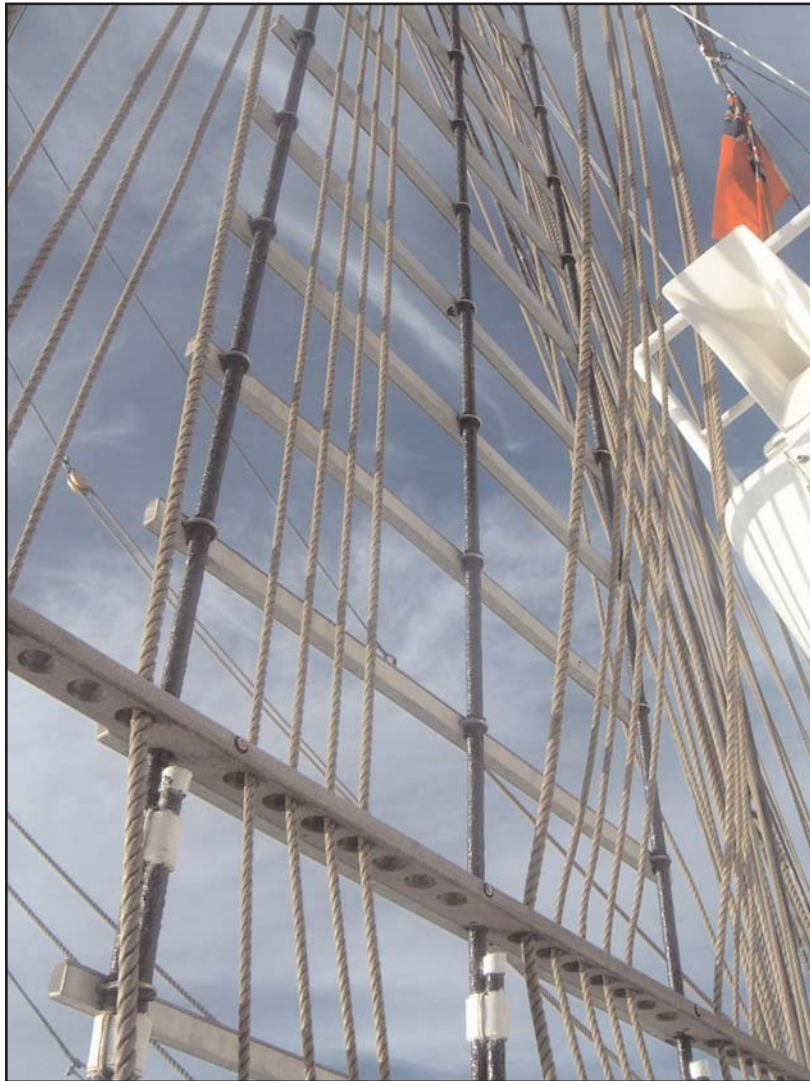
An alternative solid ratline

Throughout the sail training environment, ratlines are an accepted tool used for climbing. However, they have been known to come adrift through age, wear and tear, and weather conditions. On many vessels, the risk associated with ratlines has been overcome by removing the rope, and replacing it with hardwood battens, supported by an aluminium angle bar which is secured to the shrouds using U bolts (**Figure 13**). This method is a stronger and safer option, and should be considered for future use on board *Albatros*.
