Report on the investigation of the contact made by
the UK registered ro-ro ferry

Daggri

with the breakwater at Ulsta, Shetland Islands

Report No 6/2005
April 2005

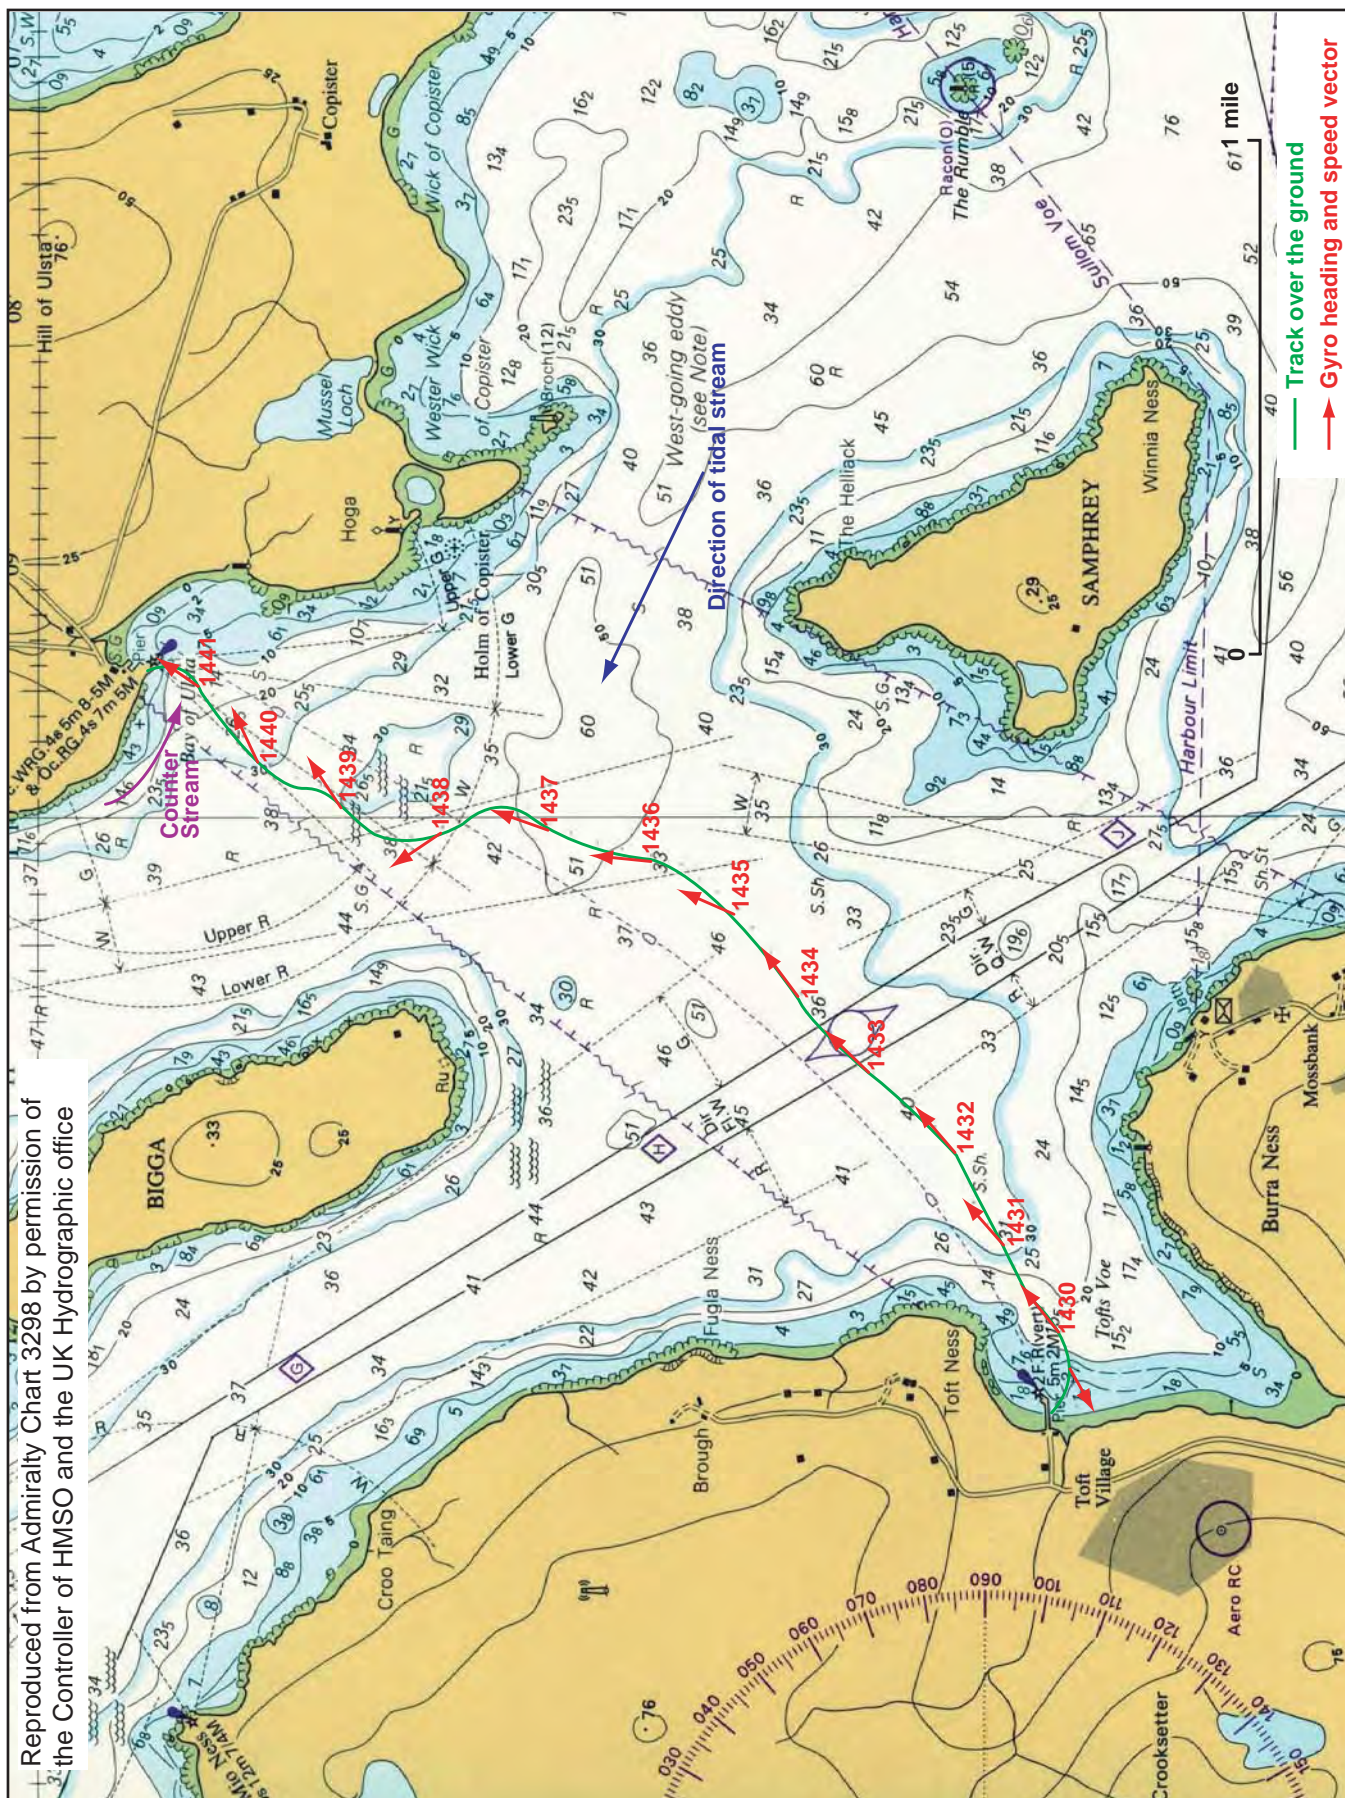
Figure 2

The master manoeuvred the vessel off the berth. Once the vessel was clear of the terminal, the mate arrived on the bridge from the vehicle deck and took over the con. A lookout was on the bridge, but the engineer was down below in one of the engine spaces. The mate sat in the starboard chair and hand-steered the vessel across Yell Sound, by making adjustments to the aft thruster control as required (**see Section 1.5.1**), while the master sat in the port chair. In front of each chair, were individual radar displays, whilst between them was an ECDIS. During the voyage, various courses were steered as the vessel proceeded across Yell Sound at between 11.8 and 15.5 knots over the ground (**see Figure 2**).

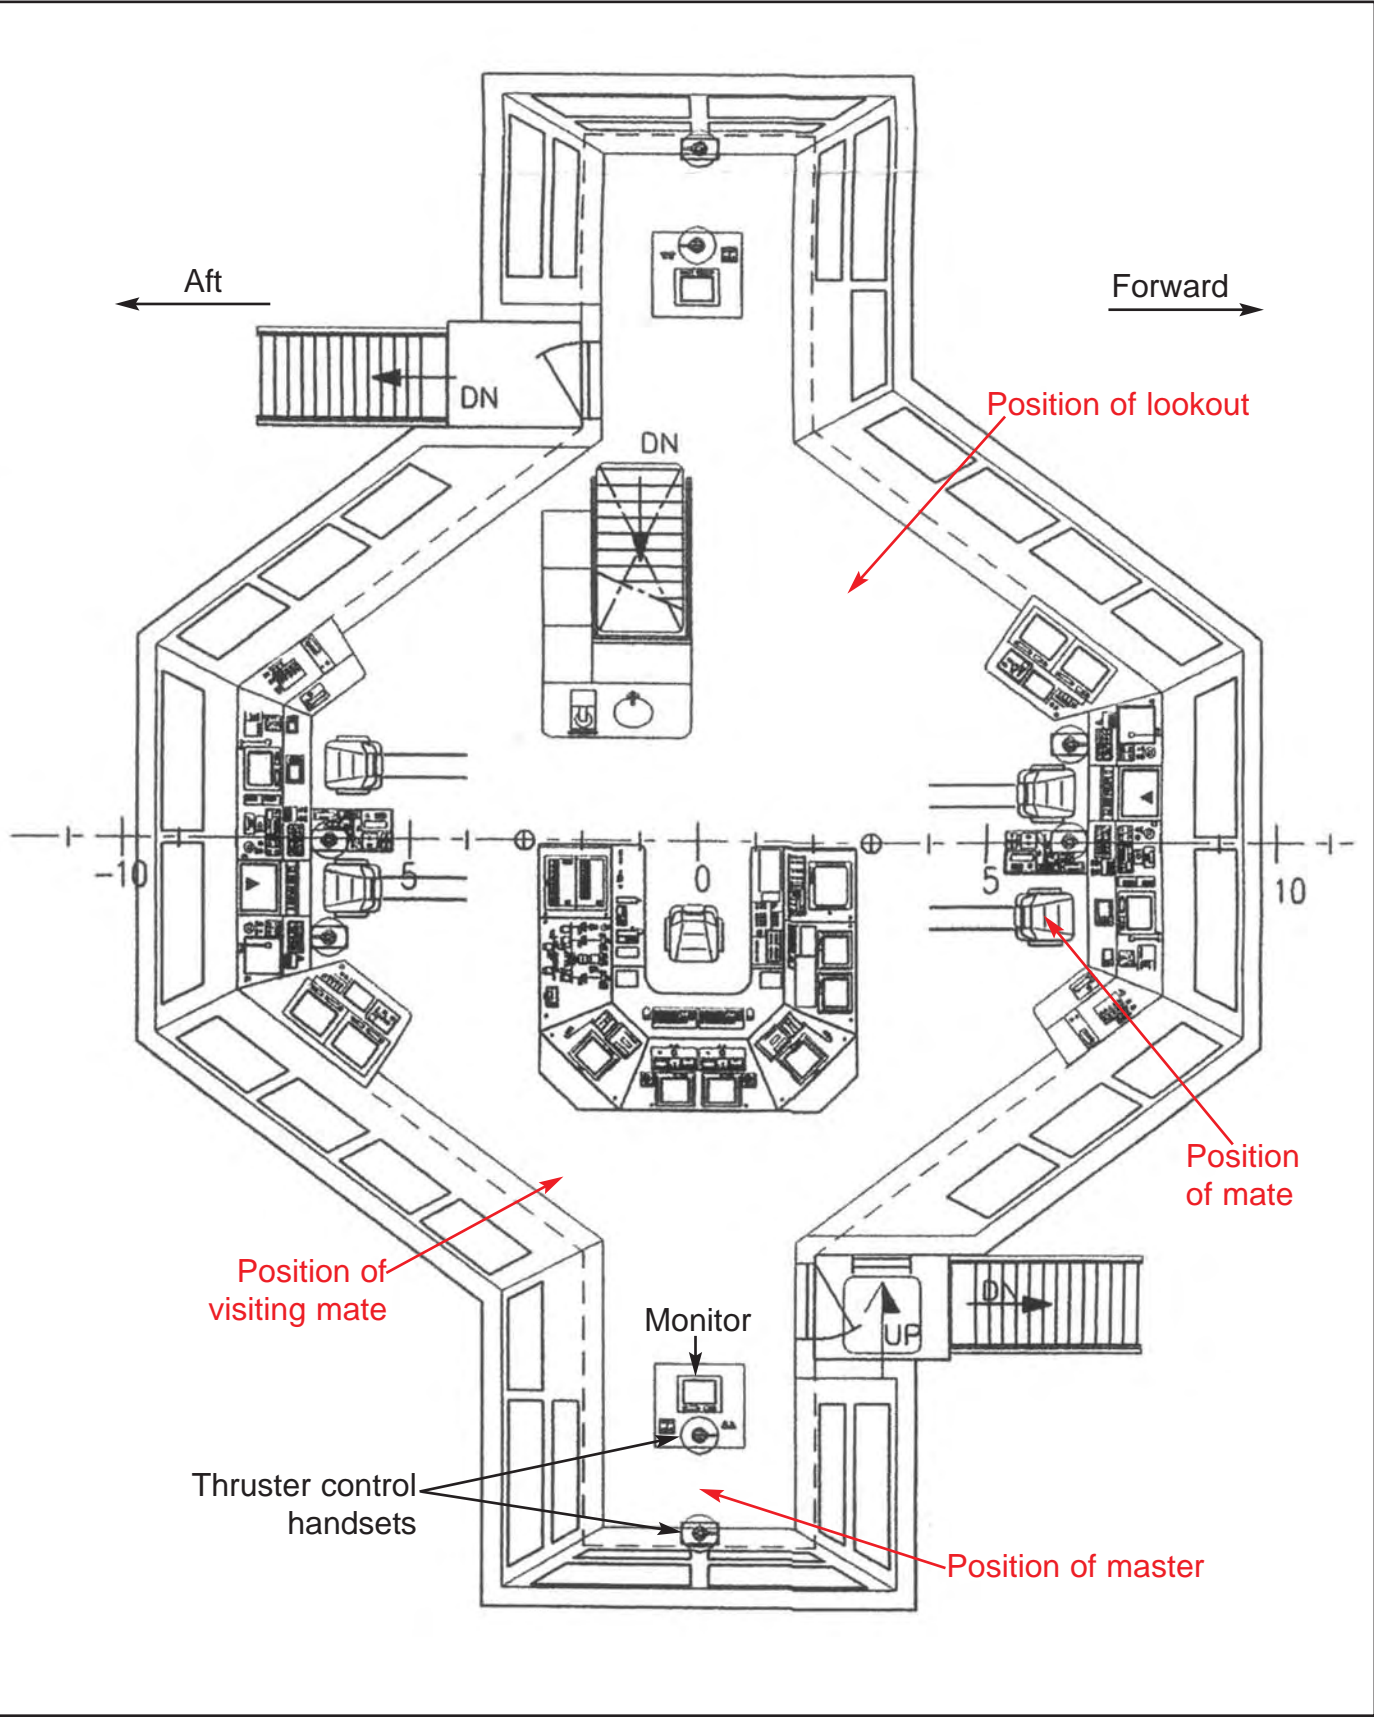
Figure 3

As *Daggri* was double-ended, and could travel in either direction without the need to swing the vessel, there were two identical integrated bridge system consoles on the bridge, one "forward" and one "aft" (**see Figure 3**).

A layout of *Daggr*'s bridge showing positions of people at time of accident
