Report on the investigations of

the foundering of
fv Kathryn Jane
4.6nm west of Skye
on or about 28 July 2004
with the loss of the skipper and
one possible crew member

the capsize and foundering of
fv Emerald Dawn
off Kilkeel
on 10 November 2004
with the loss of one life

the foundering of
fv Jann Denise II
5 miles SSE of the River Tyne
on 17 November 2004
with the loss of her two crew

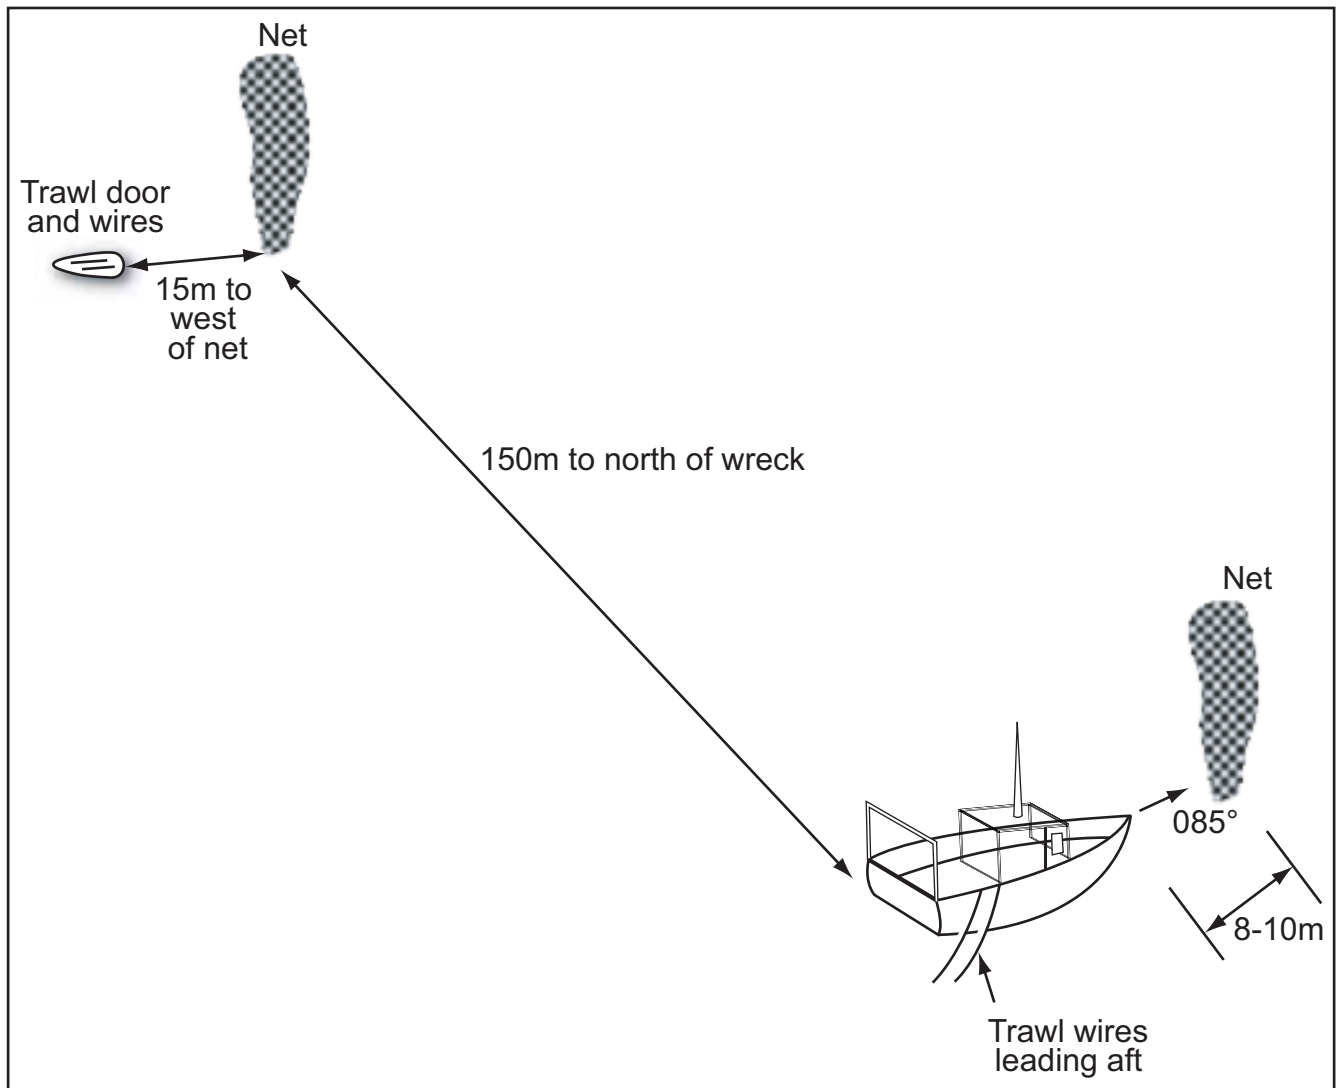
Figure 6

The survey found the vessel to be in the upright position, leaning slightly to starboard and with her bow partly embedded in the mud/silt seabed.

Illustration of wreck and trawl gear disposition

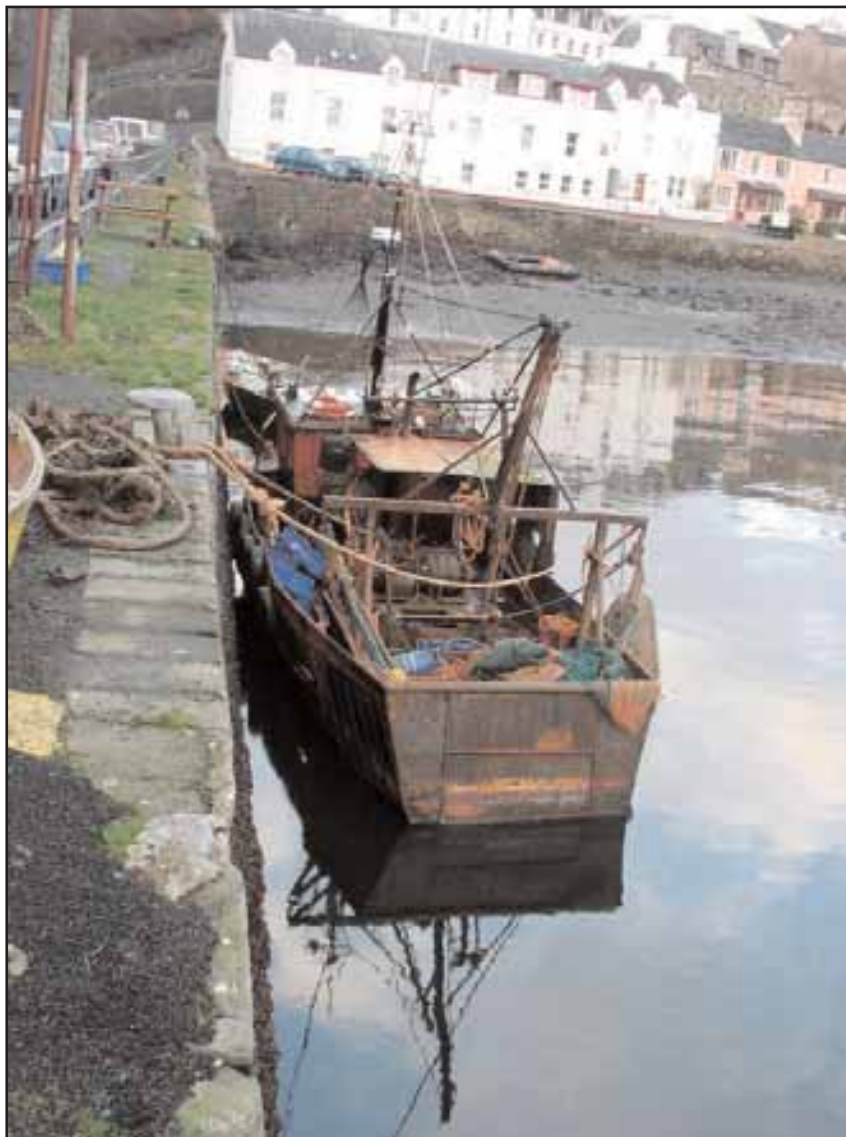
Figure 7

The vessel was reported to have a freeboard of about 150mm. The bulwarks were about 600mm high, and were reported to be corroded and holed in various areas. The exposed fish room hatch was not fitted with a watertight cover or tarpaulin. Non watertight boards were used to cover the hatch and provide a degree of watertight integrity.

General arrangement of *Kathryn Jane* seen in Portree Harbour

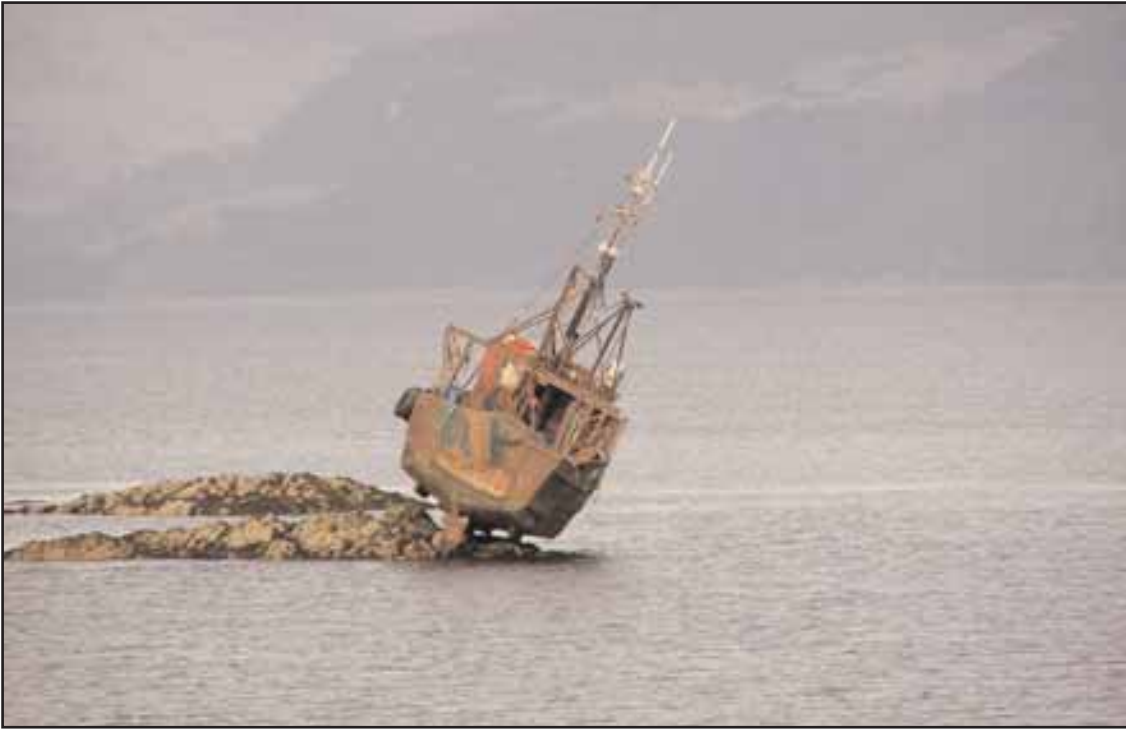
Figure 8

Grounding of *Kathryn Jane* off Kyle of Lochalsh on 27 May 2004

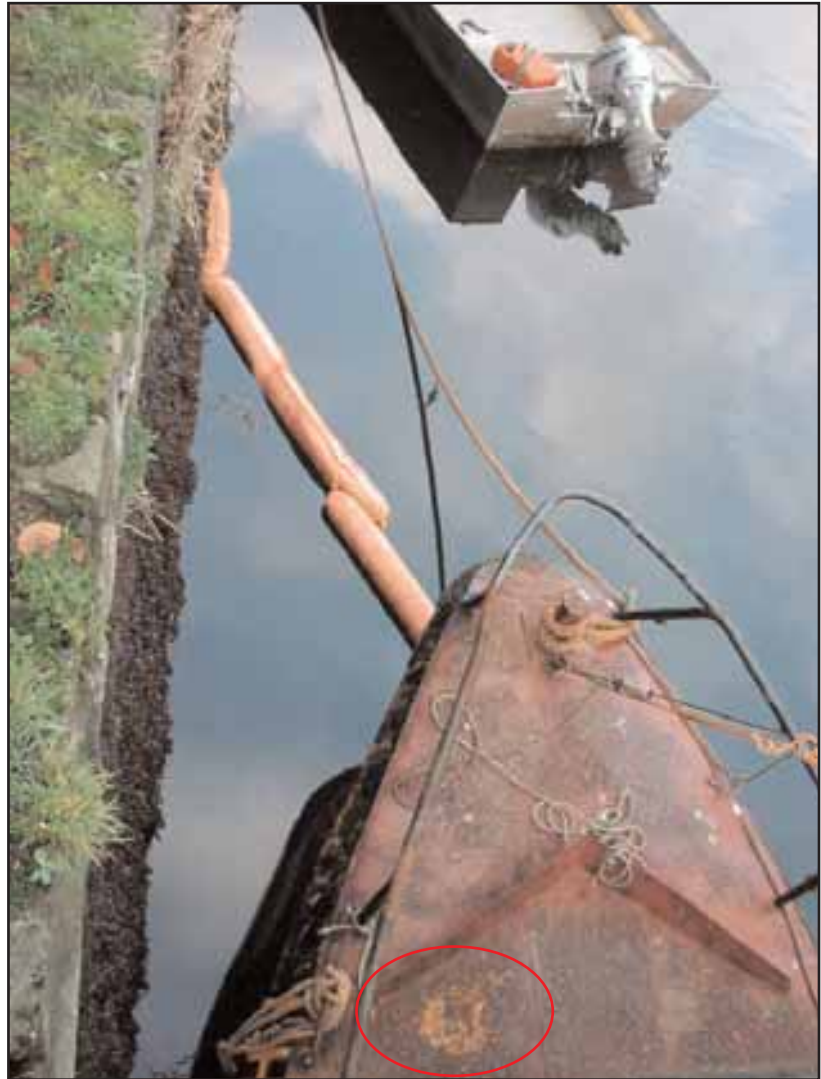
Figure 9

Area of foredeck repair work (circled)

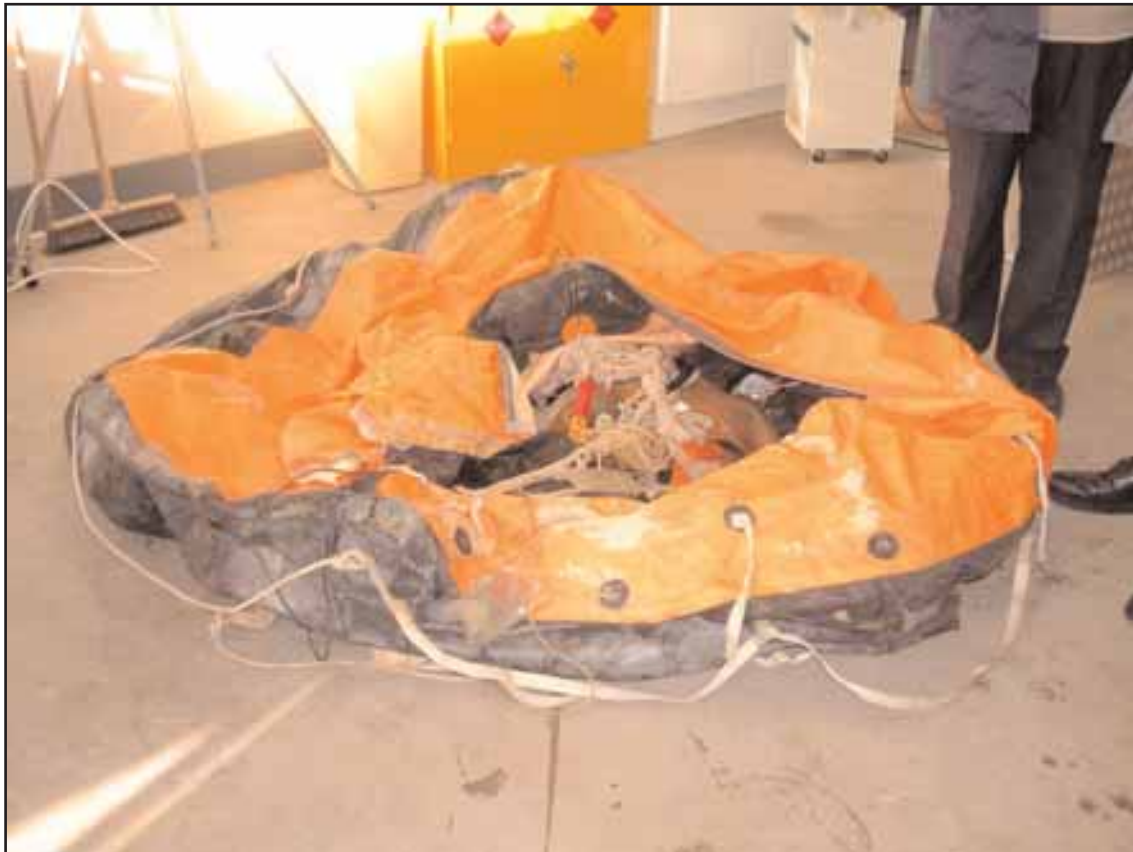
Figure 14

The liferaft's rubber buoyancy tubes were perished and leaking air. The raft's pump had broken into two pieces, so the owner kept the raft inflated by blowing into the tubes. The liferaft was also not watertight and he frequently had to use the bowl part of the broken pump to bail the water out (**Figure 15**). Surviving through the night was an ordeal, and the owner was cold and tired by the next day.

Photograph showing condition of liferaft

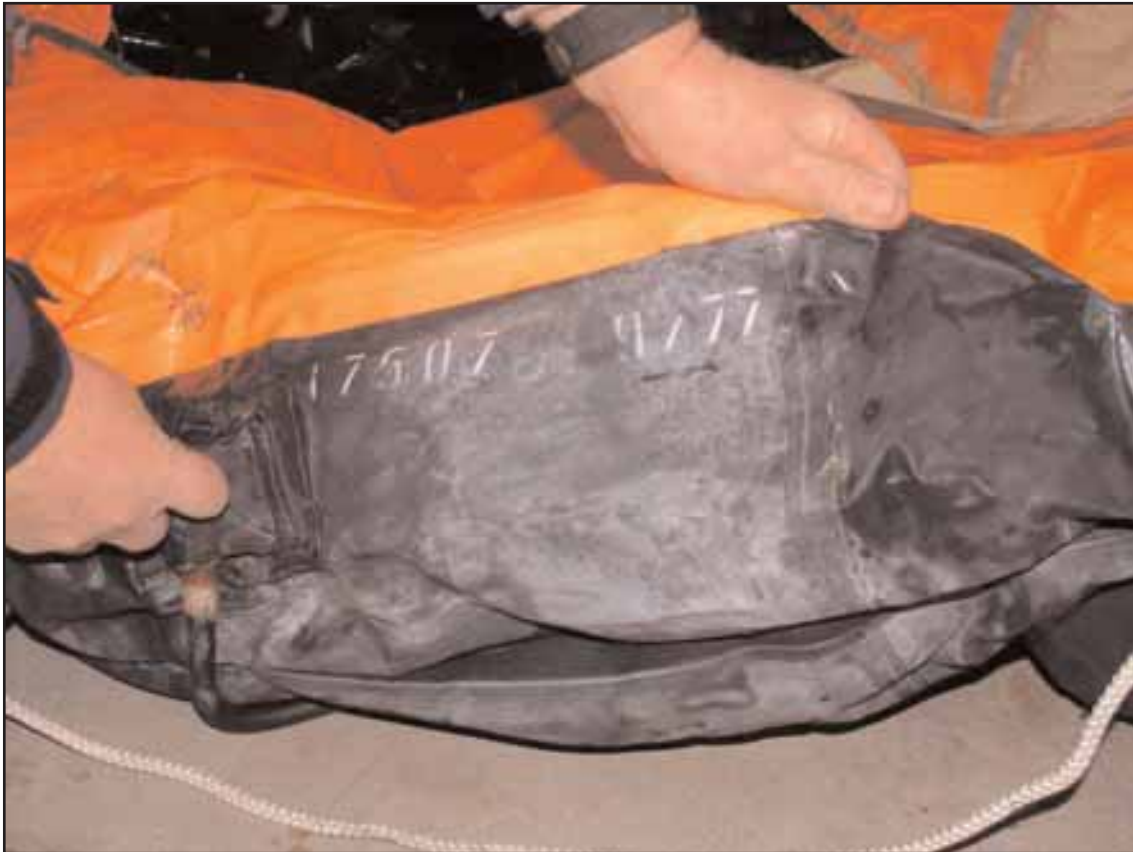
Figure 16

Identification number and date on buoyancy tube

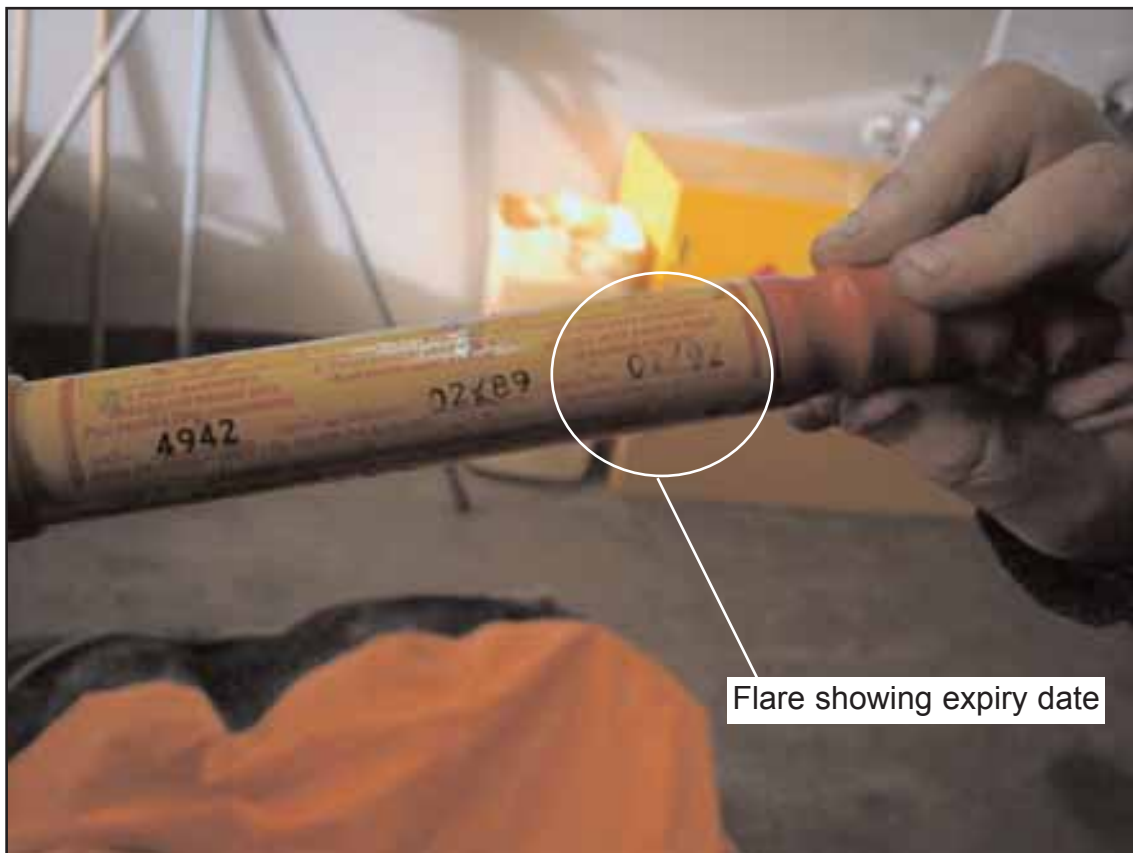
Figure 17

Flare showing expiry date

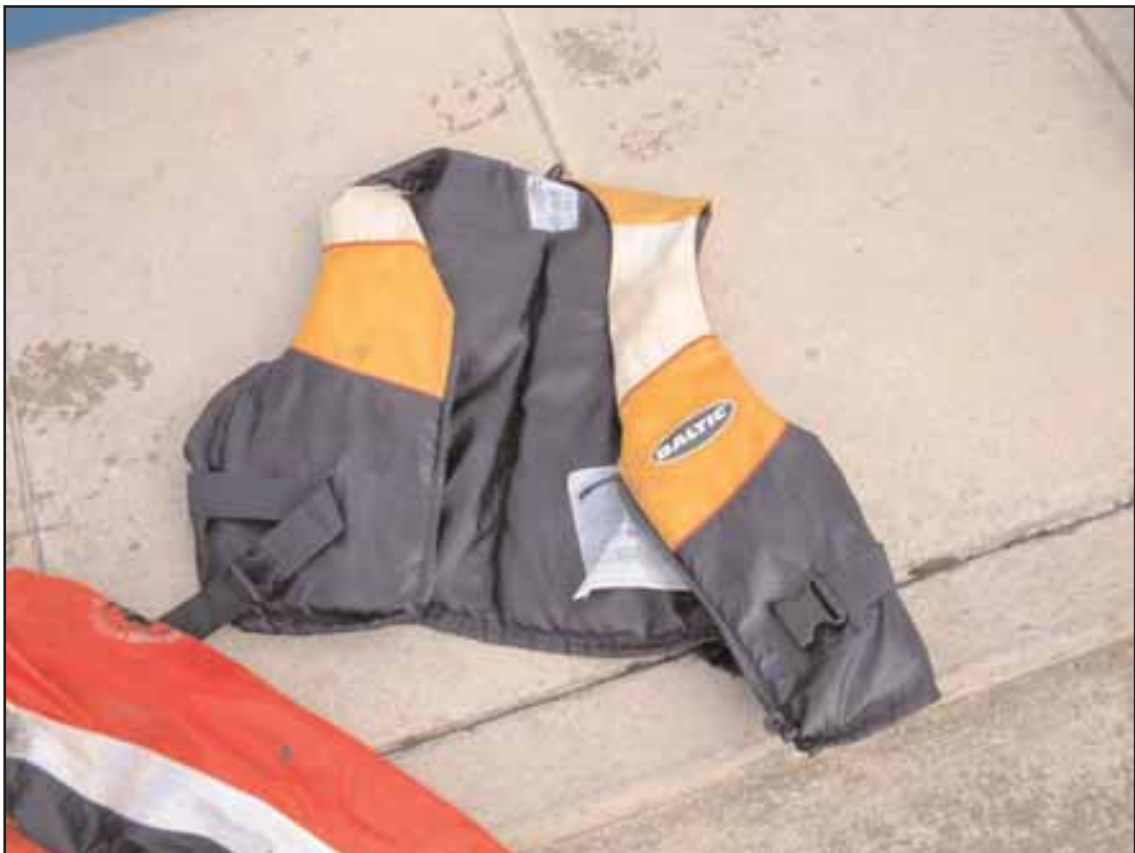
Figure 20

The MAIB has recommended, several times in the past, that fishermen should routinely wear self-inflating lifejackets all the time when they are at sea. Accidents like this one can and do occur, even in benign weather conditions, and often without warning. There are now a number of self-inflating lifejackets that are designed for constant wear. They are compact, rugged and should not cause undue hindrance when fishermen are working. Lifejackets that comply with the Code of Practice for the Safety of Small Fishing Vessels are required to be fitted with a light. The MCA inspection of the vessel identified that the lifejackets on *Emerald Dawn* did not have lights (**Annex 16**). If the skipper had been wearing an approved lifejacket, his life might have been saved. If the owner had been wearing a lifejacket, this would have helped him to get back to the vessel, especially bearing in mind he was a poor swimmer. Had the lifejacket been fitted with a light, this could have been used to draw attention to himself during the night.

Photograph of the buoyancy waistcoat
