Extract from Cambridge Test House Ltd Report T50068, dated 22 February 2005

LABORATORY REPORT

EXAMINATION OF STEEL HULL SAMPLES FROM THE SALVAGED FISHING TRAWLER *JANN DENISE II*

EXAMINATION OF STEEL HULL SAMPLES FROM THE SALVAGED FISHING TRAWLER *JAN DENISE II*

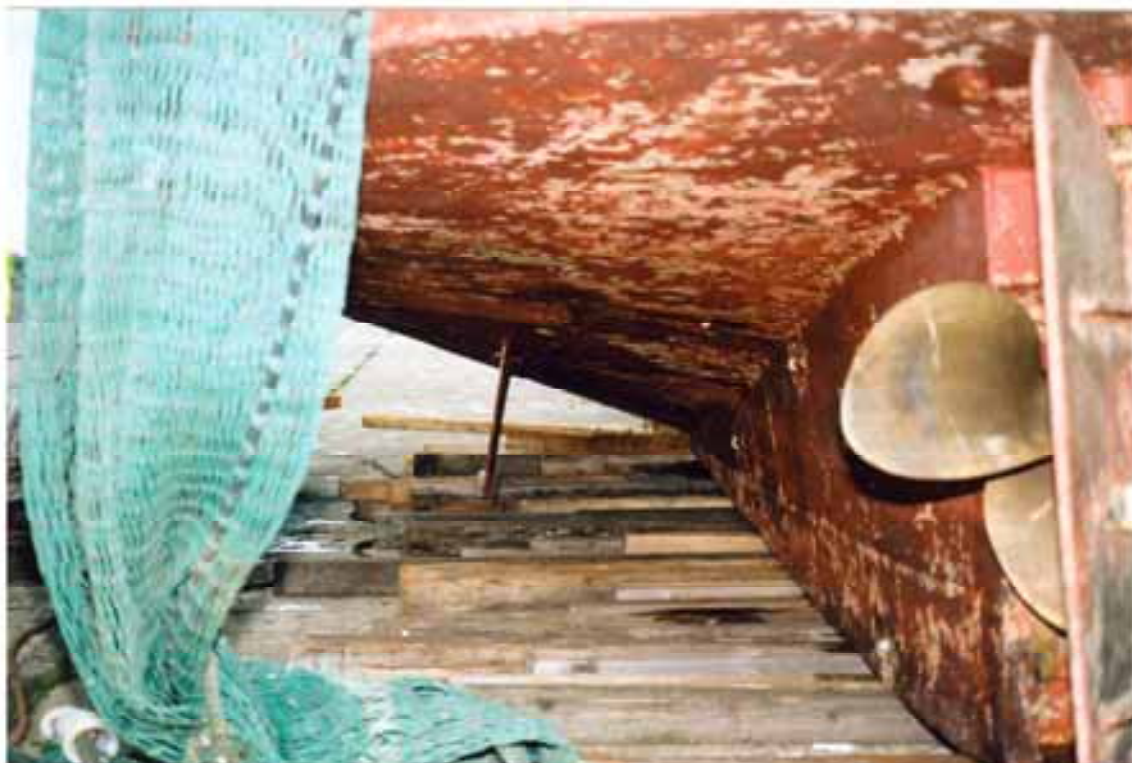
Figure 39: Port side hull and keel, showing largely consumed protective keel mounted anodes and widespread local breakdown of the paint system.

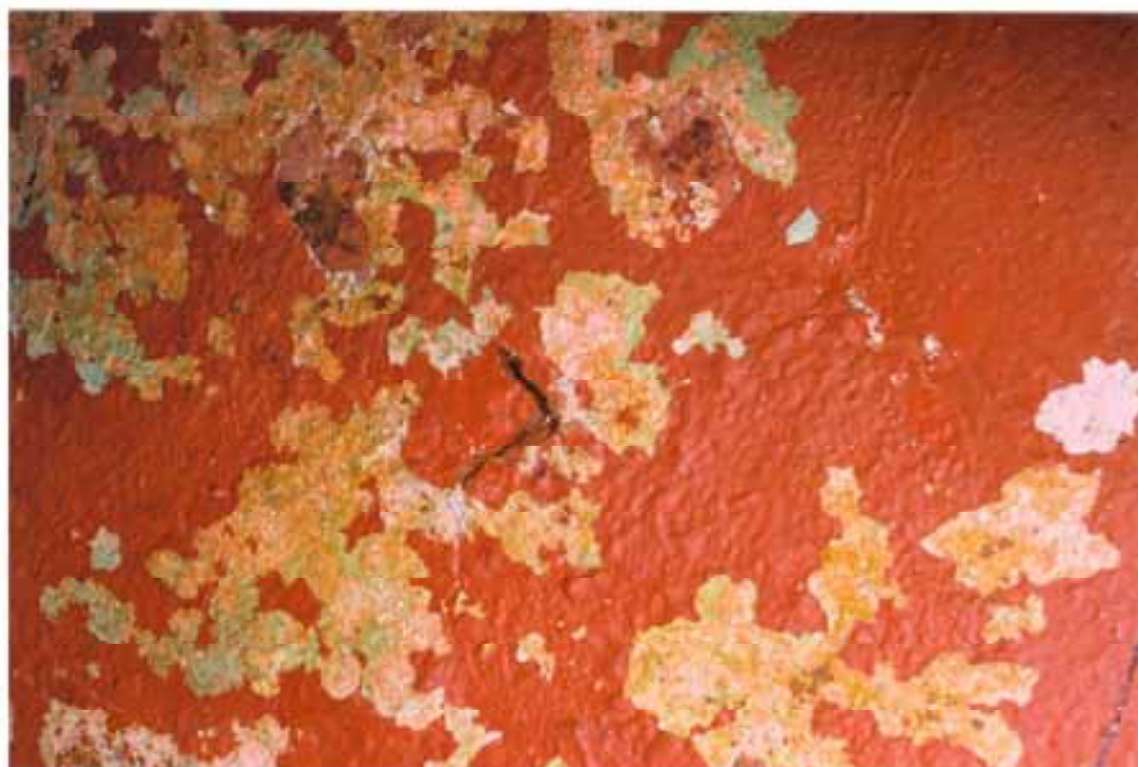
The crack discovered during the salvage operation was vee-shaped and located in the port underside hull plating just aft of the stabiliser fin (Figure 40). The second crack site discovered by a MAIB surveyor during the day was also in the port underside plating and comprised two close proximity transverse parallel cracks. The two cracks were located aft of the vee-shaped crack and just aft of the stern most keel mounted anode (Figure 41).

One leg of the vee shaped crack had a length of 41.7mm and a gape at the outer sea side which ranged from 0.5mm to 1.5mm. The cracks shorter leg exhibited a length of 30.3mm and a gape which ranged from nothing to 1.05mm. The estimated total gape area of the cracks combined legs was 52.5mm². The estimated gape area of the longitudinal crack portion included in the sample was estimated at 13mm².

Figure 40: Detail showing extent of port side vee shaped crack mouth gape.

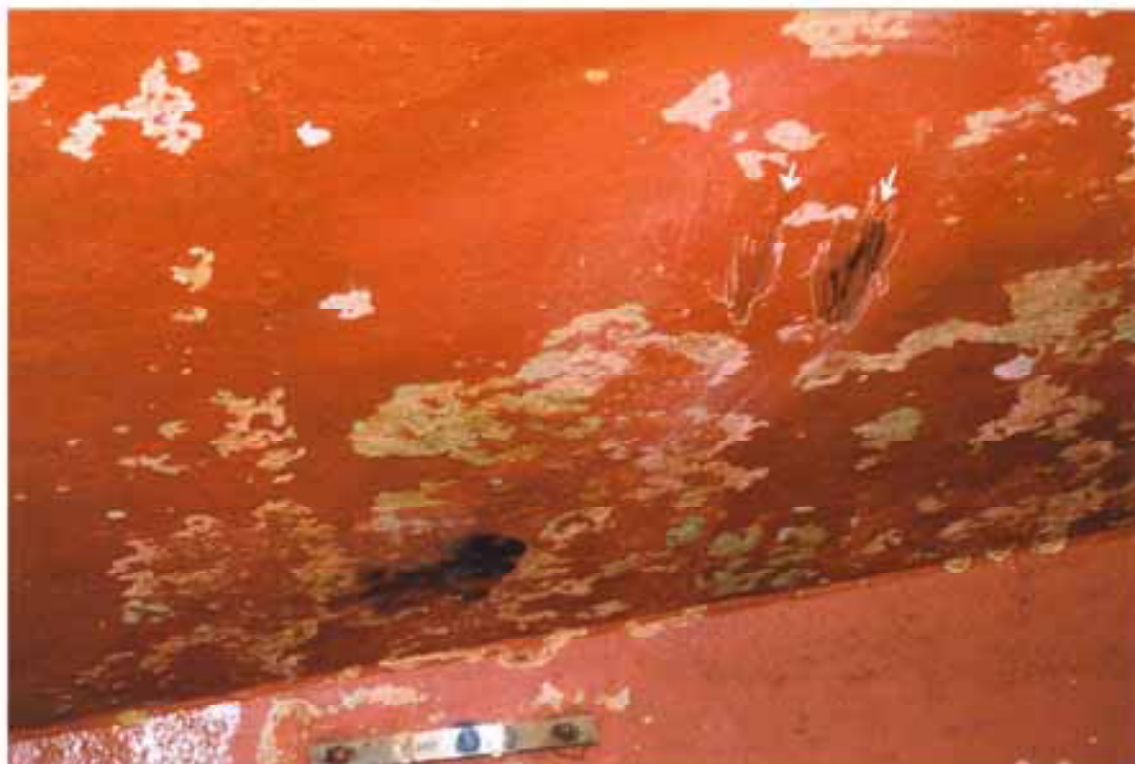
The aft crack exhibited a length of 150mm and was located along the weld toe of a fillet weld attaching a transverse member to the hull plating. The forward crack exhibited a length of 117mm and was located in corrosion wasted hull plate material just beyond the end of the fillet weld joining the longitudinal member to the hull plating (Figure 43). The crack edges in both cases were close mating and neither crack exhibited any measurable gape.

Fracture face samples removed from the two cracks exhibited very heavy post cracking corrosion damage. The cracks had both originated at the inner hull side, propagated without branching and terminated in a fracture step at the outer hull side. The depth of corrosion damage apparent at the crack faces, and evidence of incursions along the plate segregation and non-metallic inclusions, suggested that cracking was of some age and pre-dated the casualty.

Metallographic specimens were removed from the two crack sites. The section removed from the aft crack of the pair was confirmed to exhibit a fatigue crack which had originated in corrosion grooving at the fillet weld toe. Evidence of a corrosion groove incursion was also apparent at the hull side weld toe of the fillet weld at the joint's opposite side. The fracture edge exhibited evidence of post cracking pitting corrosion, and deep post cracking corrosion incursions along the plate's microstructural texture were also apparent. The crack had terminated in a fracture step at the outer sea side hull surface and a parallel secondary fatigue crack was seen to have initiated from a corrosion pit close to the principal fracture edge.

The forward crack in the pair was also confirmed to be a fatigue crack, which had originated in corrosion pitting at the inner hull side. This crack, like the aft one, exhibited evidence of widespread post cracking corrosion incursions along the hull plate's microstructural texture. The outer hull surface exhibited widespread pitting damage in regions still protected by the paint system, and such areas also exhibited shallow associated strain damage. Isolated instances of copper like particles were also seen to be present at the pit sites. Collectively the evidence would suggest that the outer hull surface pitting was old damage, which had been arrested by blast cleaning and re-painting. The evidence of copper particles in the vicinity of pit sites exhibiting blast cleaning strain damage would suggest that a copper slag-blasting medium had been used for the pre-paint preparation.

Figure 41: General view of the aft port side crack site (cracks arrowed).

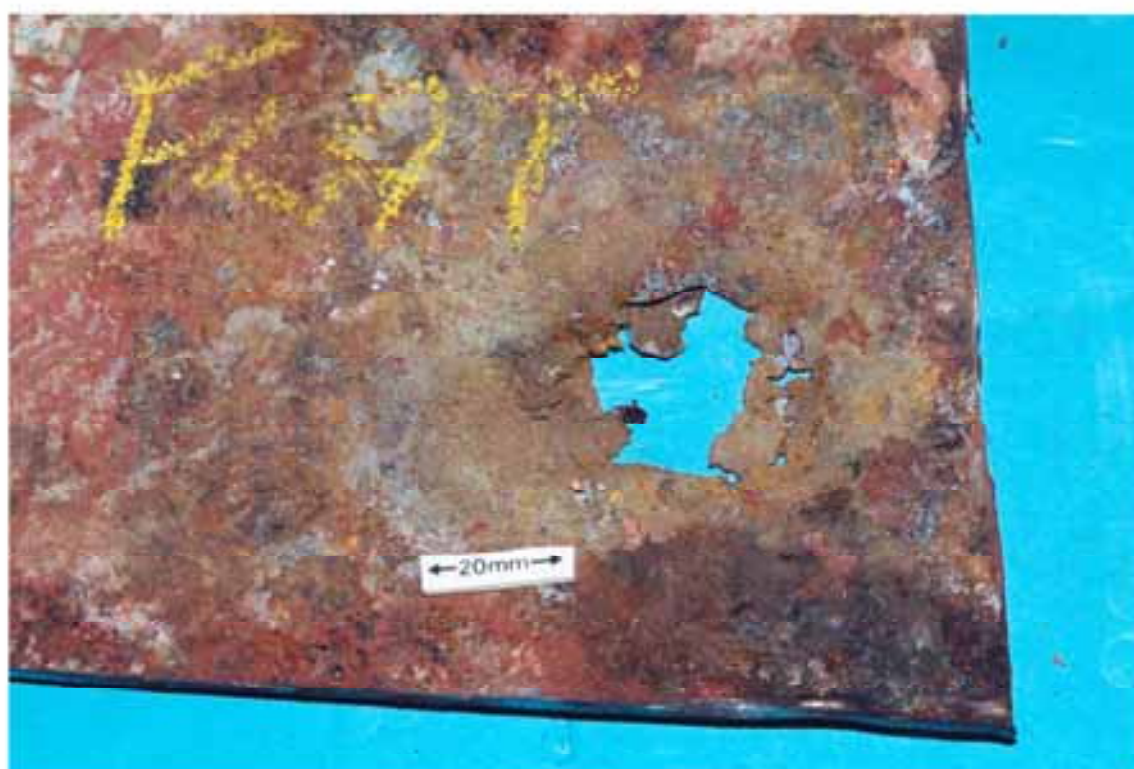
The sample provided comprised a 150mm x 163mm rectangular piece containing a through thickness local perforation of overall 32mm x 28mm maximum dimensions (Figure 42). The plates outer sea facing side exhibited widespread local breakdown of the protective red paint (Figure 42). The inboard plate side was coated in corrosion products and sludge type deposits and exhibited no evidence of a protective paint coating.

A maximum remnant plate thickness of 5.8mm was recorded. Large areas of the inboard plate side had suffered general corrosion wastage, in which the thickness had been reduced to 1.5mm. The cross sectional area of the through plate perforation was confirmed to be 416mm², and this had similarly resulted from general corrosion wastage from the plate's unprotected inboard side.

A single metallographic specimen was removed from perforation site. The section served to confirm that perforation had occurred by plastic instability and collapse of a region which had been severely wasted by predominantly inboard side corrosion. The presence of heavy corrosion products at both sides of the perforation edge suggested that the area had exhibited some through thickness seepage for a period preceding the collapse, which had formed the gaping perforation.

- 7.1** The port side steering flat compartment sample exhibited severe inboard side corrosion wasting at a surface which exhibited no evidence of a protective paint coating. The perforation (416mm² area) had subsequently occurred by instability and collapse at a local site of very severe corrosion wastage. Corrosion products apparent in way of the perforation suggested that a phase of through thickness seepage had occurred prior to bulk perforation.

Figure 42: Detail showing perforation site and widespread local breakdown of the protective paint system.

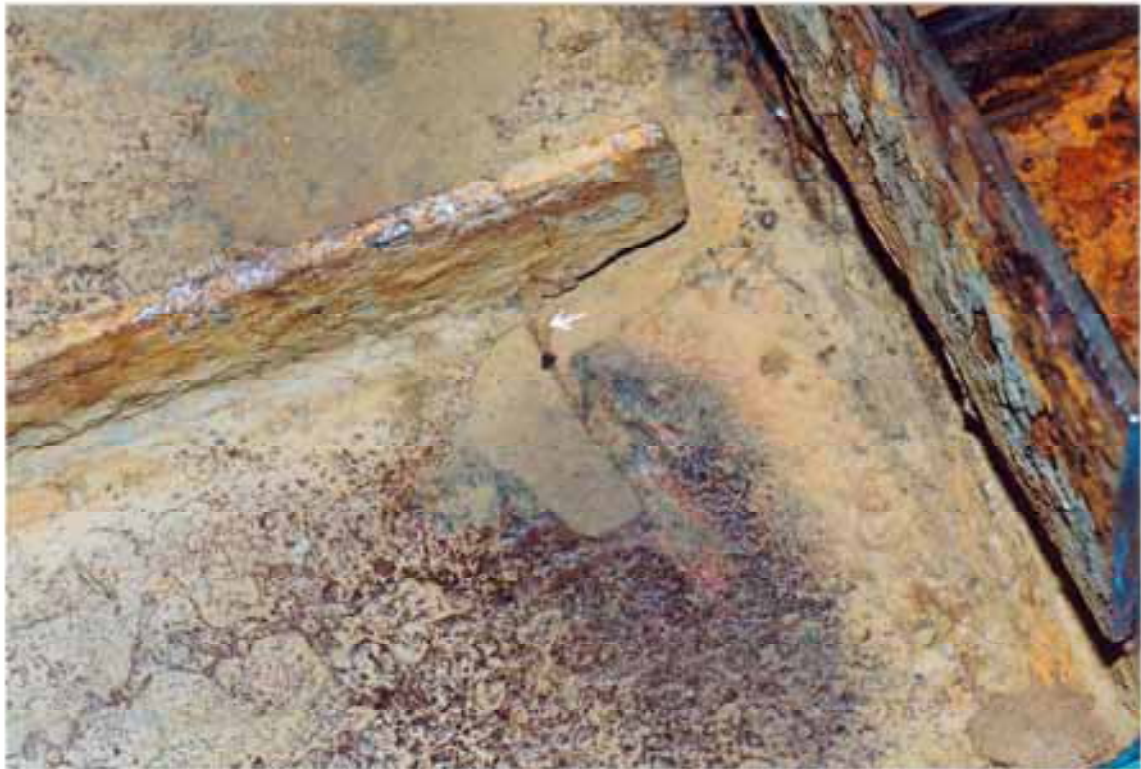
Figure 43: Detail showing crack (arrowed) originating from the fillet weld end.

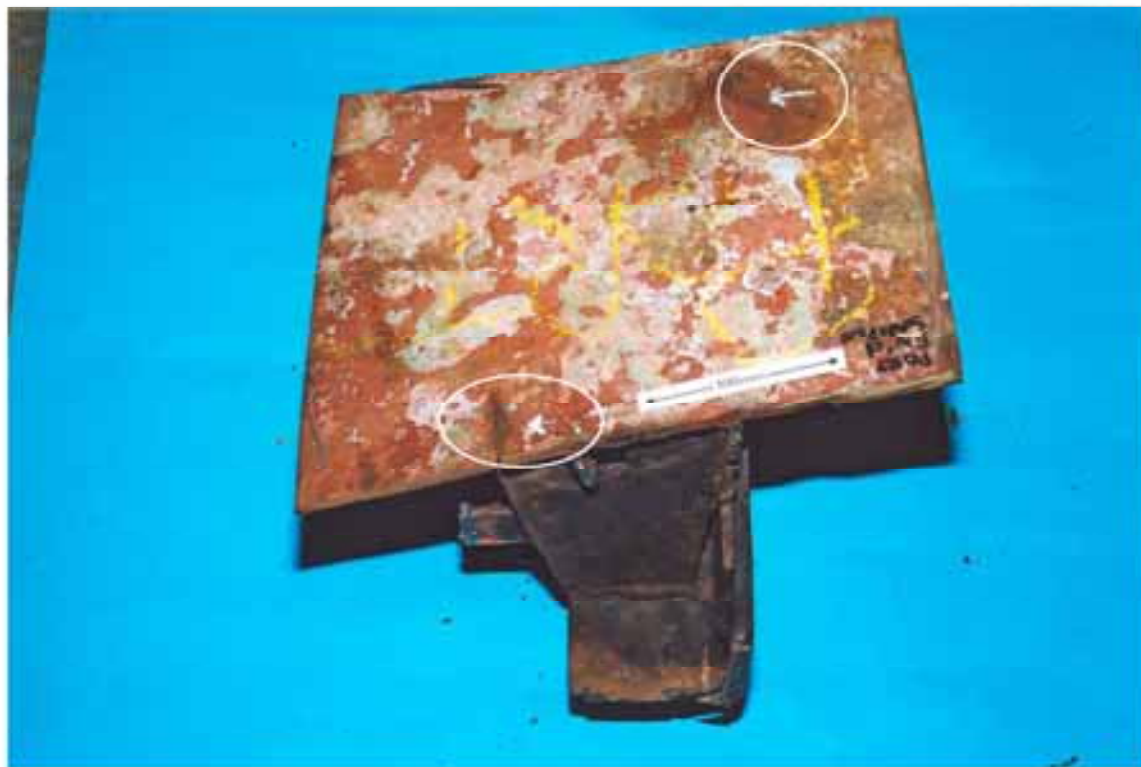
The sample provided contained two cracks (Figures 44 and 45) and comprised a section of hull plating measuring 344mm x 292mm with an internally welded stiffener and engine bearer. The hull plating measured 5.6mm thickness in regions free from local corrosion damage, but was wasted down to 3.1mm at local corrosion pit sites. Internal surfaces of the plating exhibited no evidence of paint protection, and the external paint system was also showing evidence of local breakdown (Figure 44).

Fracture face samples were removed from the two cracks and exhibited very heavy post cracking corrosion damage. The cracks had both originated at the inner hull side, propagated without branching, and terminated in a fracture step at the outer hull side. The depth of corrosion damage apparent at the crack faces suggested the cracking was of some considerable age and pre-dated the casualty. The depth of post cracking pitting corrosion of the vee shaped crack fracture surface suggested that this crack in particular was of a very substantial age.

The section removed from the vee shaped crack confirmed a presence of widespread pre and post-cracking corrosion damage. The section from the longitudinal crack exhibited a particularly wide gape and appeared more typical of a corrosion fatigue type crack. The section removed from the fillet weld associated with the longitudinal crack exhibited widespread evidence of inboard side corrosion damage, and an incipient fatigue crack was apparent at one weld toe.

Figure 44: Forward port side sample viewed from the outer sea side and showing the two crack sites arrowed.

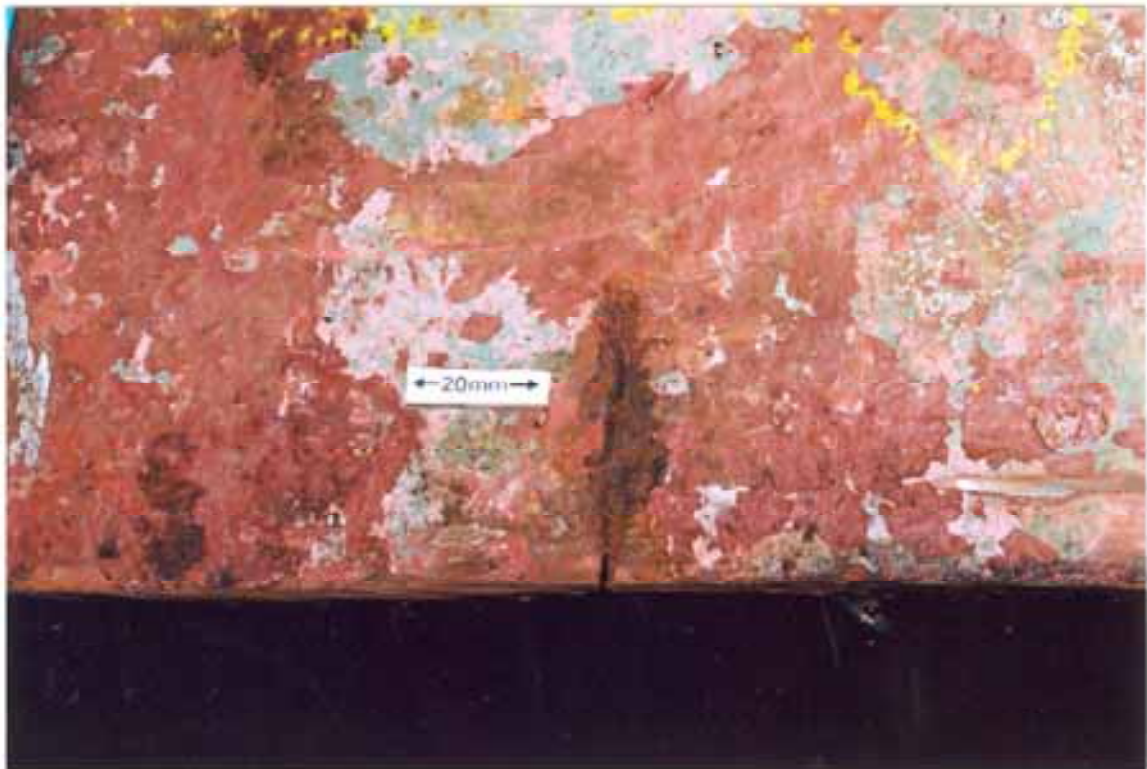
The vee shaped crack was located at the end of a welded longitudinal attachment (Figure 46), and was associated with a region of deep inboard side pitting corrosion. The longitudinal crack was located at the end of a transverse welded attachment, and was again associated with a region of inboard side pitting corrosion and wastage.

Figure 45: Detail of figure 44 showing second longitudinal crack.

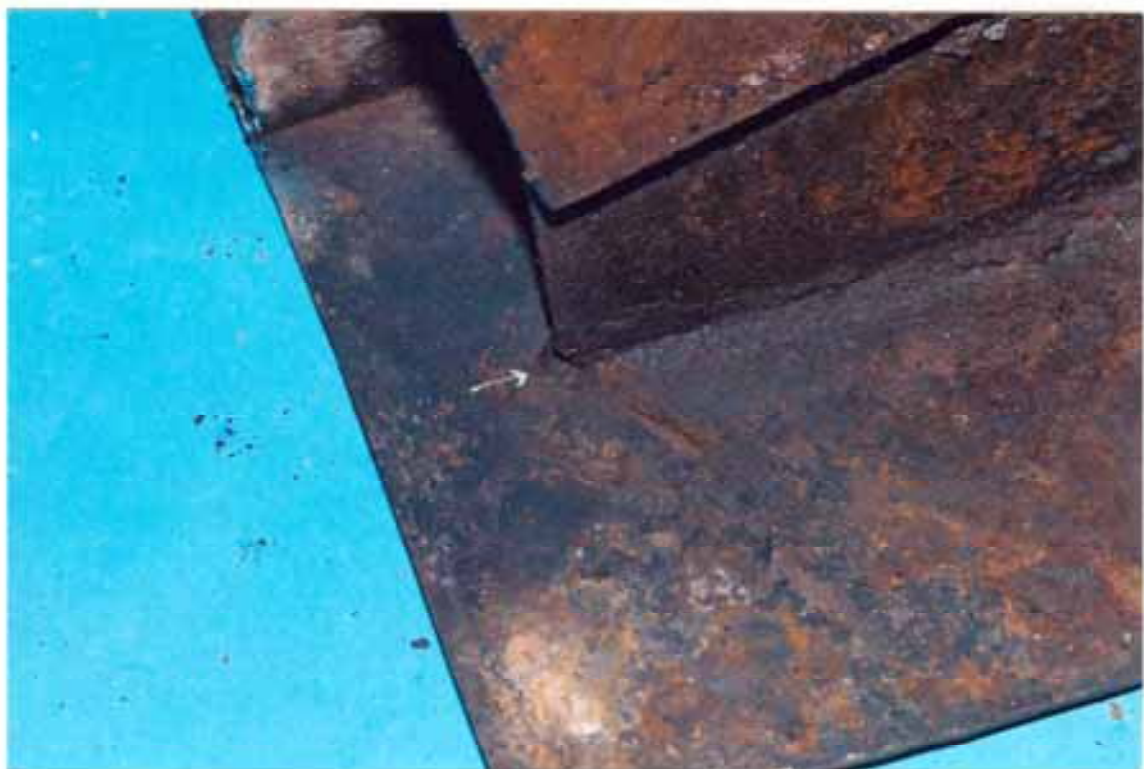
Figure 46: Vee shaped crack (arrowed), which was located at the end of a welded longitudinal attachment.
