Extract from Cambridge Test House Ltd Report T50068, dated 22 February 2005

THE TEST HOUSE JOB AND REPORT REFERENCE: T50068

EXAMINATION OF STEEL HULL SAMPLES FROM THE SALVAGED FISHING TRAWLER *JANN DENISE II*

EXAMINATION OF STEEL HULL SAMPLES FROM THE SALVAGED FISHING TRAWLER *JAN DENISE II*

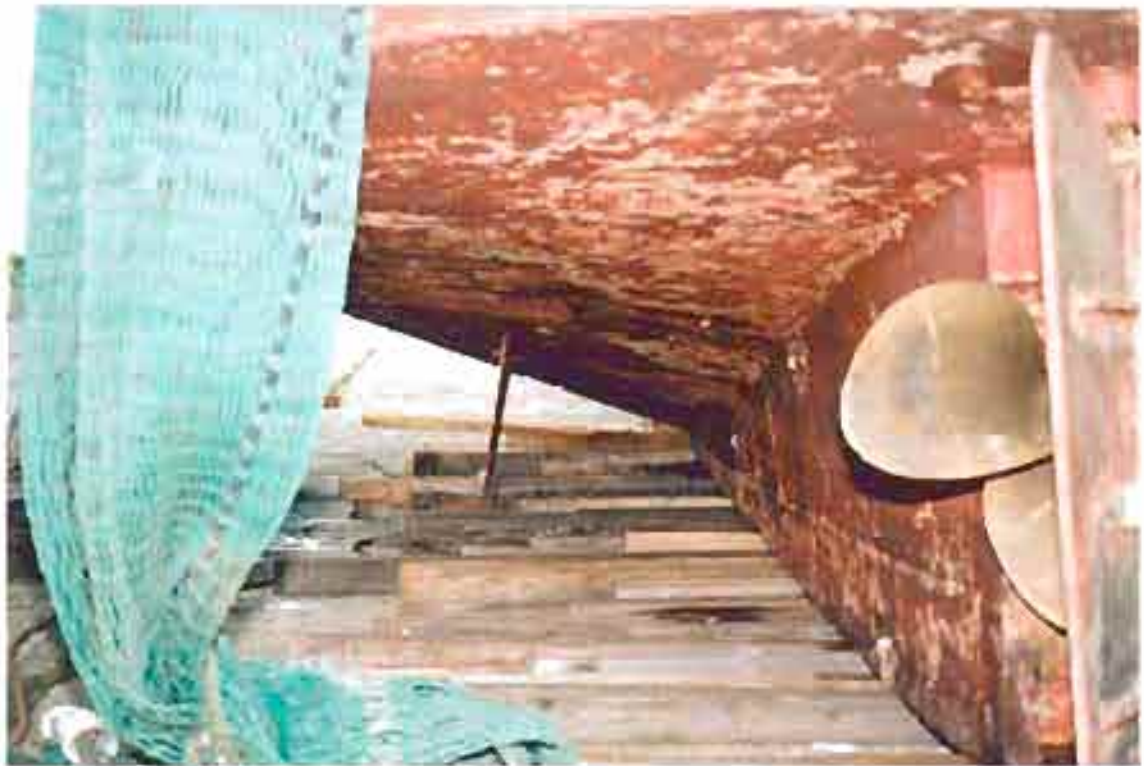
Figure 39: Port side hull and keel, showing largely consumed protective keel mounted anodes and widespread local breakdown of the paint system

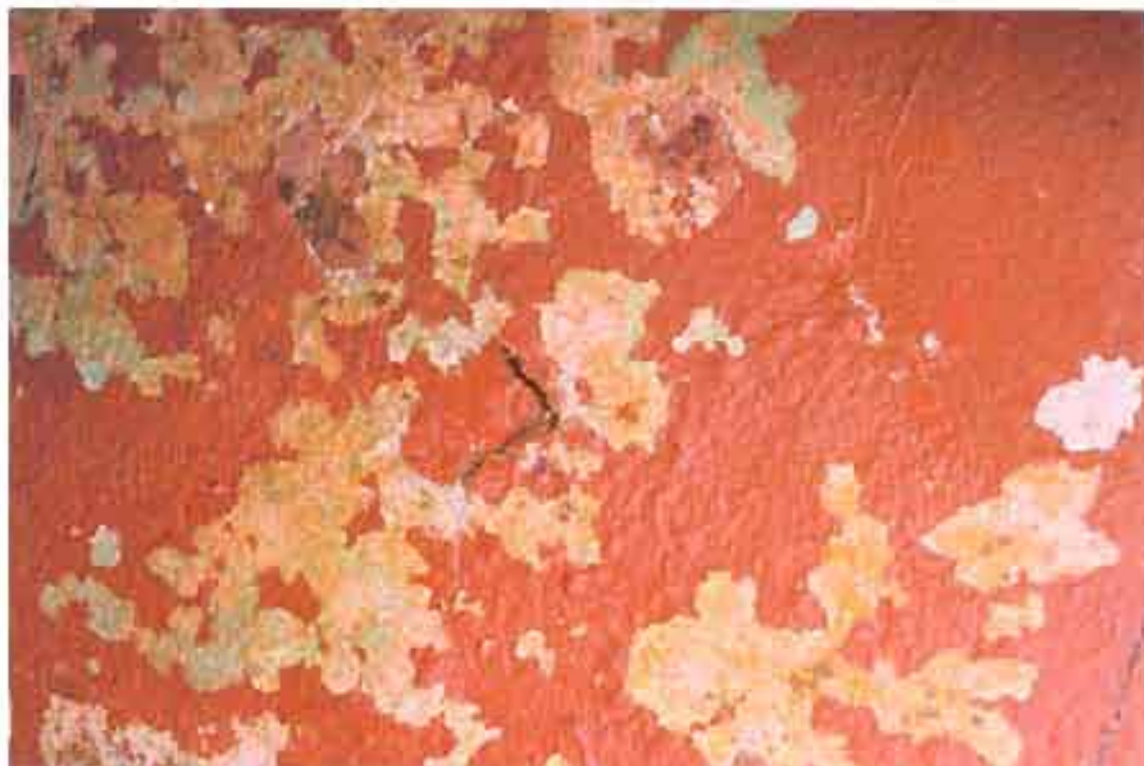
The crack discovered during the salvage operation was vee-shaped and located in the port underside hull plating just aft of the stabiliser fin (Figure 40). The second crack site discovered by a MAIB surveyor during the day was also in the port underside plating and comprised two close proximity transverse parallel cracks. The two cracks were located aft of the vee-shaped crack and just aft of the stem most keel mounted anode (Figure 41).

Figure 40: Detail showing extent of port side vee shaped crack mouth gape.

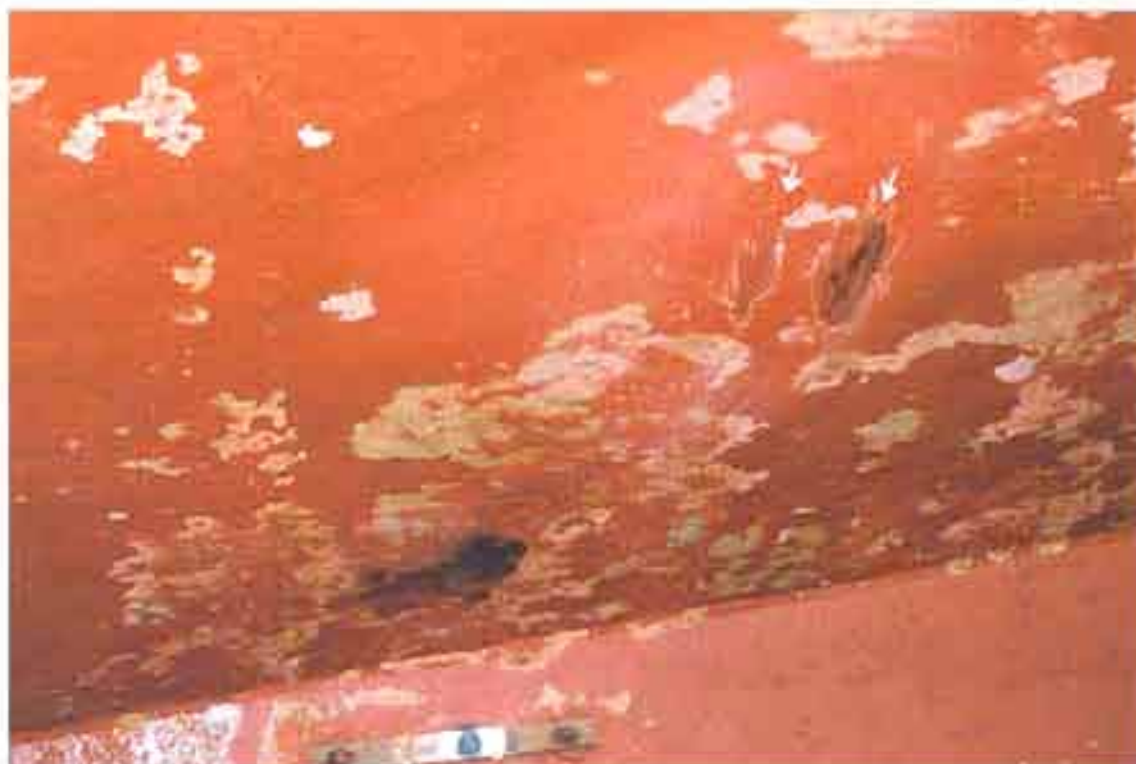
Figure 41: General view of the aft port side crack site (cracks arrowed)

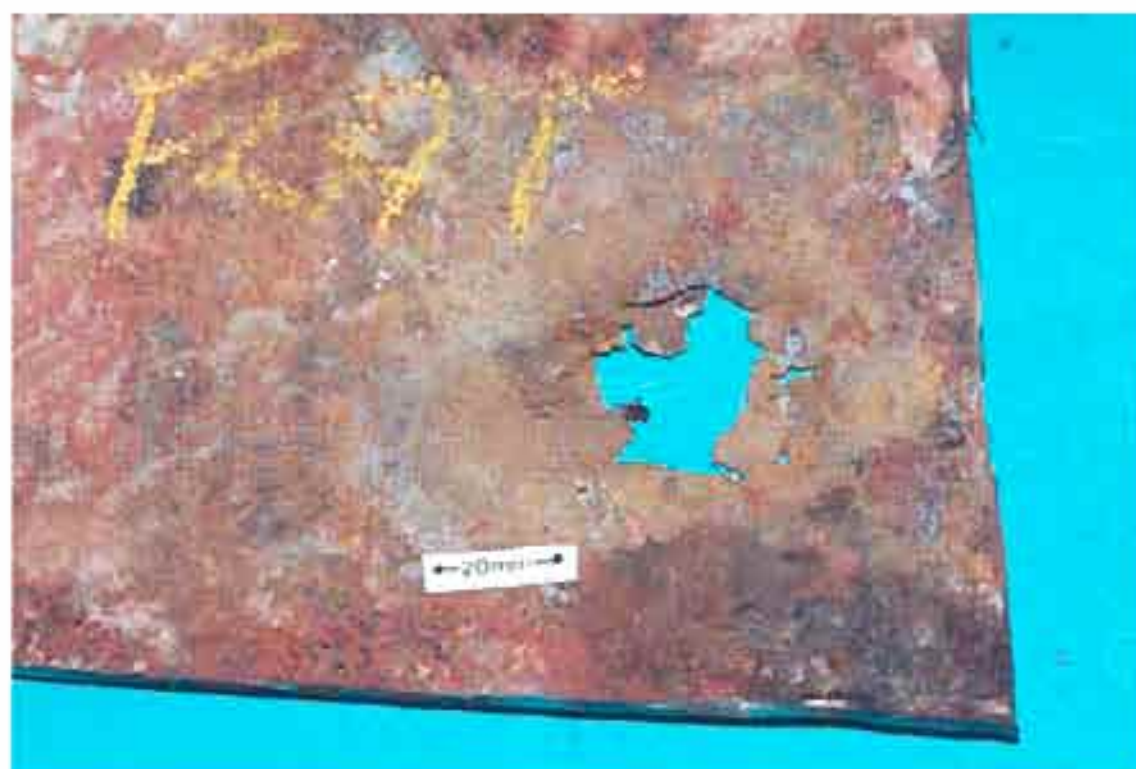
The sample provided comprised a 150mm x 163mm rectangular piece containing a through thickness local perforation of overall 32mm x 28mm maximum dimensions (Figure 42). The plates outer sea facing side exhibited widespread local breakdown of the protective red paint (Figure 42). The inboard plate side was coated in corrosion products and sludge type deposits and exhibited no evidence of a protective paint coating.

A maximum remnant plate thickness of 5.8mm was recorded. Large areas of the inboard plate side had suffered general corrosion wastage, in which the thickness had been reduced to 1.5mm. The cross sectional area of the through plate perforation was confirmed to be 416mm², and this had similarly resulted from general corrosion wastage from the plate's unprotected inboard side.

A single metallographic specimen was removed from perforation site. The section served to confirm that perforation had occurred by plastic instability and collapse of a region which had been severely wasted by predominantly inboard side corrosion. The presence of heavy corrosion products at both sides of the perforation edge suggested that the area had exhibited some through thickness seepage for a period preceding the collapse, which had formed the gaping perforation.

Figure 42: Detail showing perforation site and widespread local breakdown of the protective paint system.

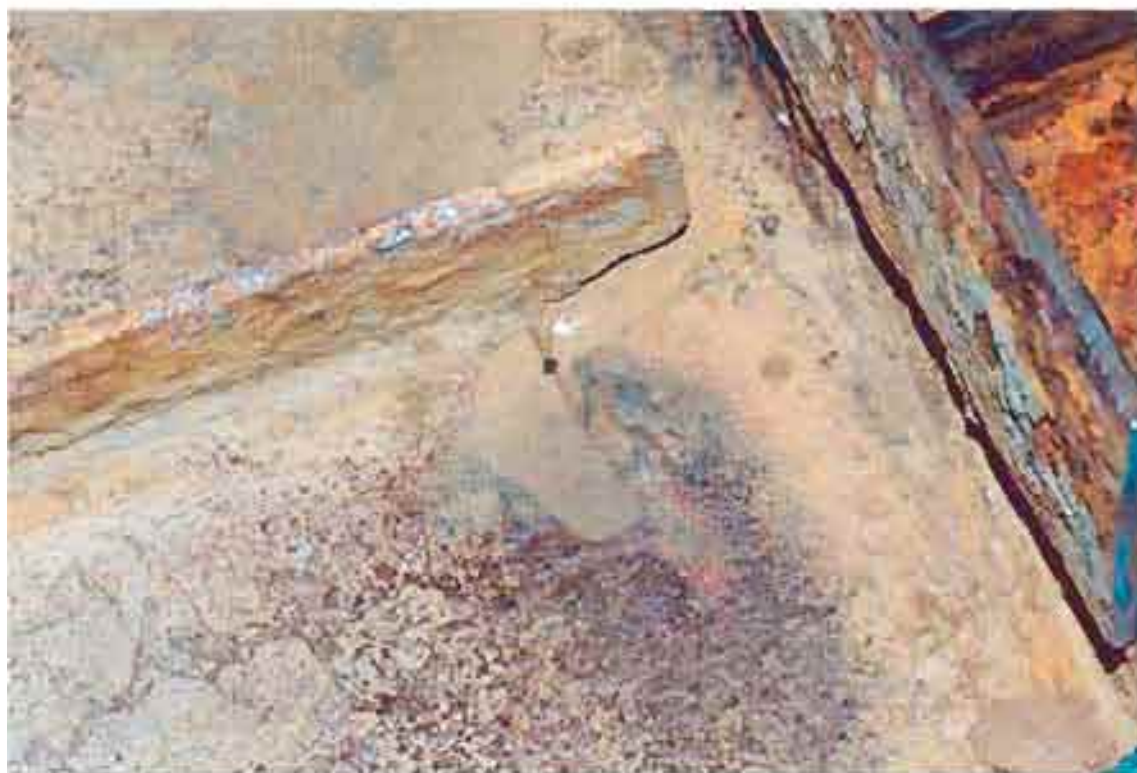
Figure 43: Detail showing crack (arrowed) originating from the fillet weld end

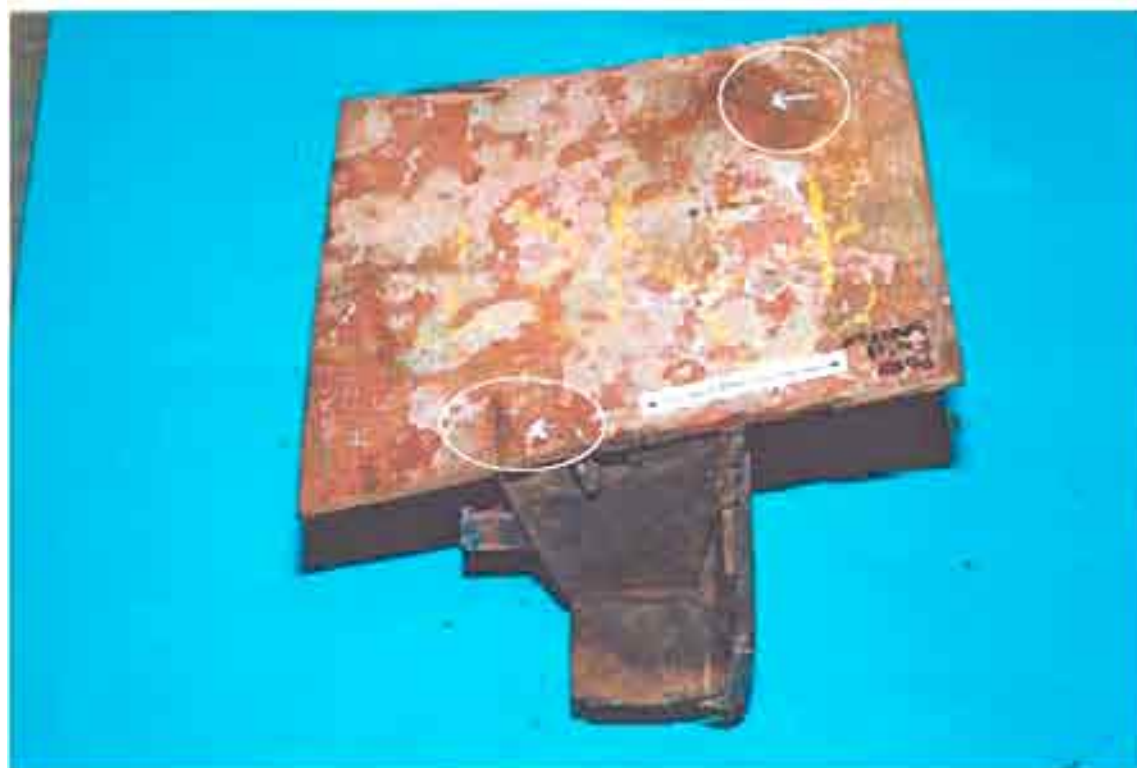
The sample provided contained two cracks (Figures 44 and 45) and comprised a section of hull plating measuring 344mm x 292mm with an internally welded stiffener and engine bearer. The hull plating measured 5.6mm thickness in regions free from local corrosion damage, but was wasted down to 3.1mm at local corrosion pit sites. Internal surfaces of the plating exhibited no evidence of paint protection, and the external paint system was also showing evidence of local breakdown (Figure 44).

One leg of the vee shaped crack had a length of 41.7mm and a gape at the outer sea side which ranged from 0.5mm to 1.5mm. The cracks shorter leg exhibited a length of 30.3mm and a gape which ranged from nothing to 1.05mm. The estimated total gape area of the cracks combined legs was 52.5mm². The estimated gape area of the longitudinal crack portion included in the sample was estimated at 13mm².

Figure 44: Forward port side sample viewed from the outer sea side and showing the two crack sites arrowed.

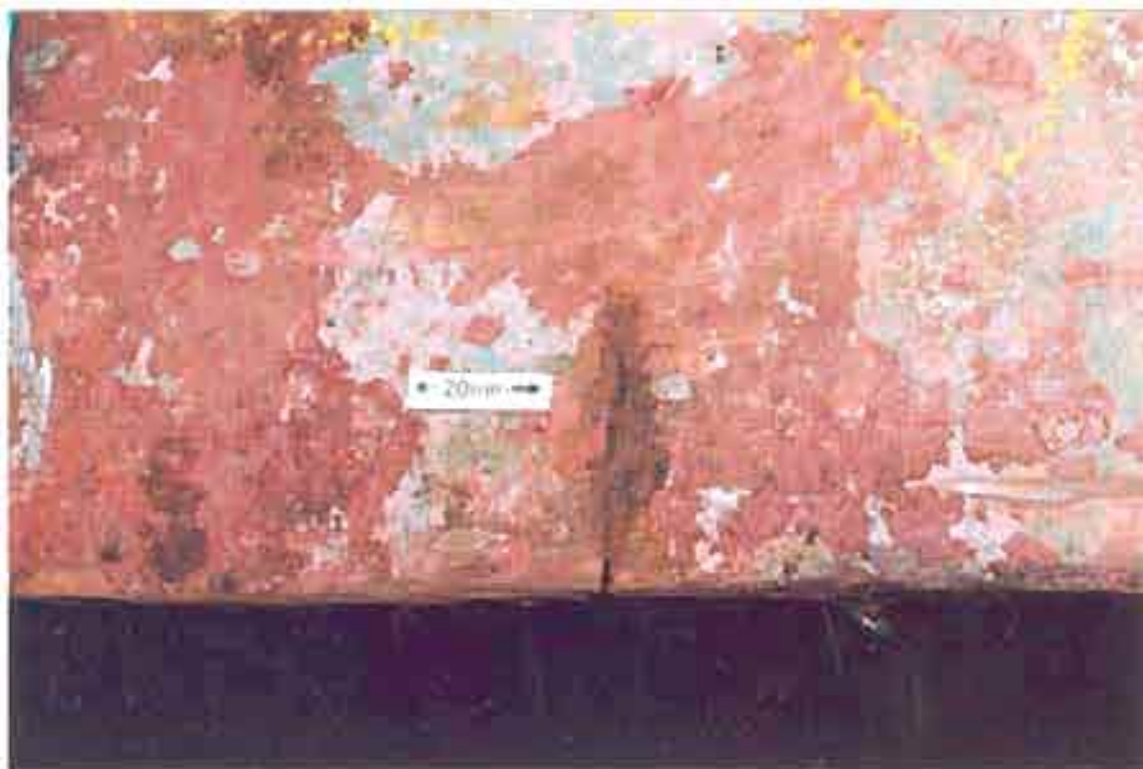
Figure 45: Detail of figure 44 showing second longitudinal crack.

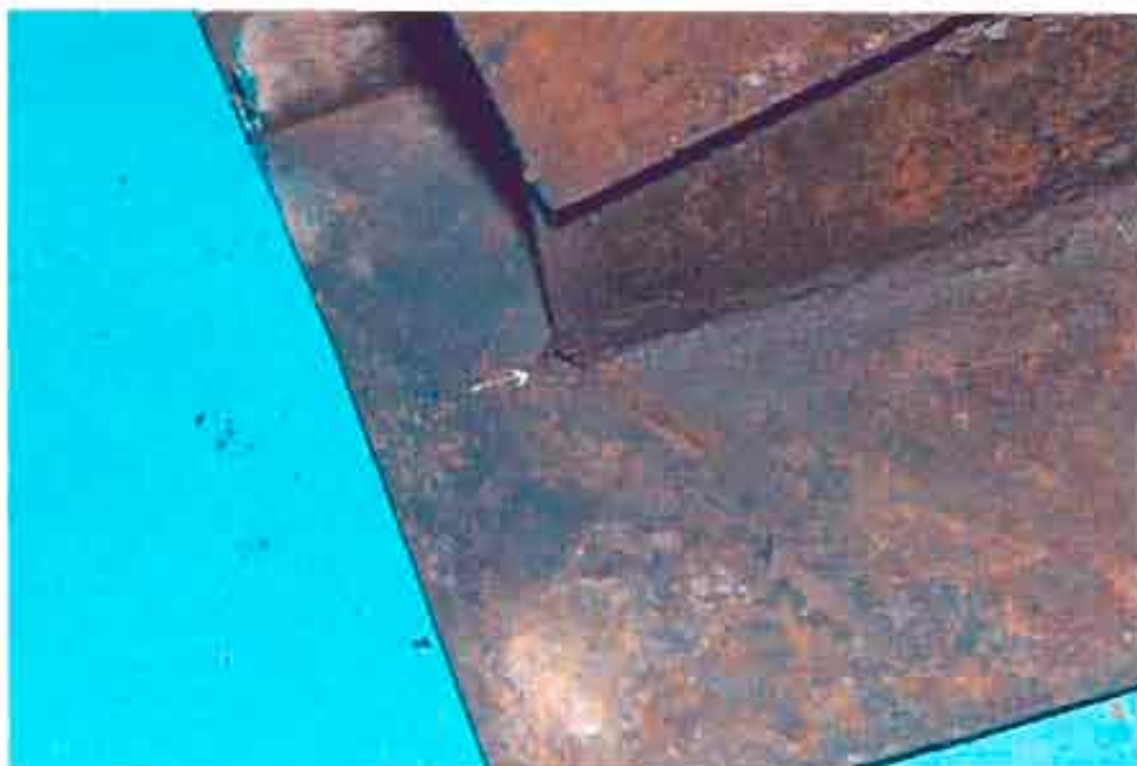
The vee shaped crack was located at the end of a welded longitudinal attachment (Figure 46), and was associated with a region of deep inboard side pitting corrosion. The longitudinal crack was located at the end of a transverse welded attachment, and was again associated with a region of inboard side pitting corrosion and wastage.

Figure 46: Vee shaped crack (arrowed), which was located at the end of a welded longitudinal attachment.
