Report on the investigation of the
swamping and foundering of a
4.6m grp open sports boat
with the loss of three lives
on Loch Ryan
south-west Scotland
12 July 2003

Marine Accident Investigation Branch
First Floor
Carlton House
Carlton Place
Southampton
United Kingdom
SO15 2DZ

Report No 5/2004
April 2004

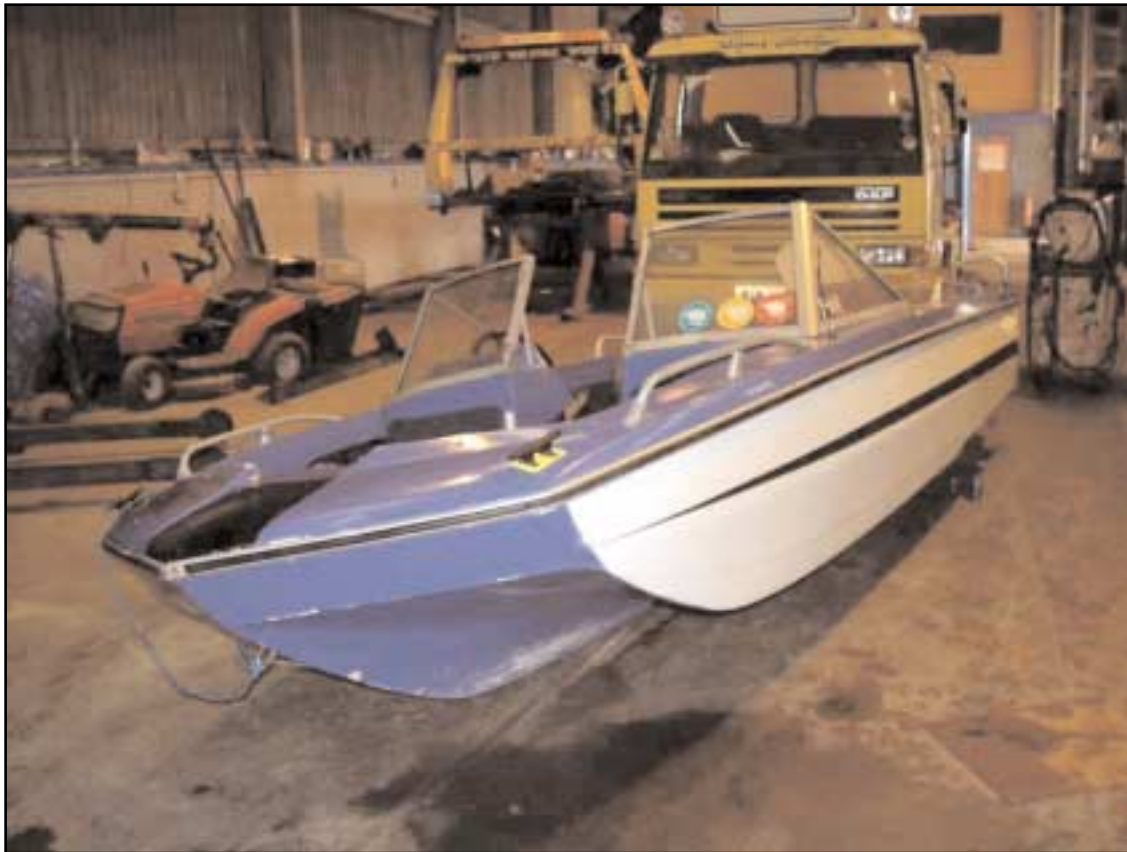
Photograph 1

View of the GRP boat

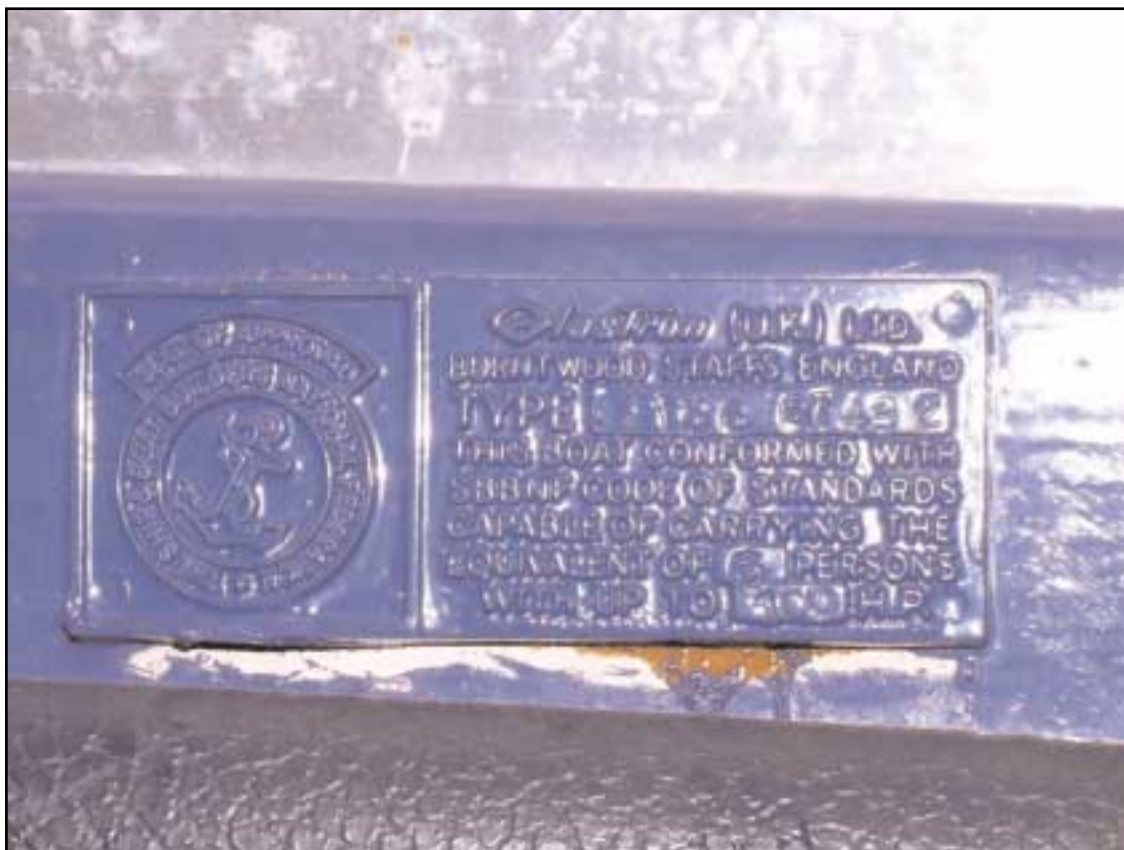
The builders' identification stamp

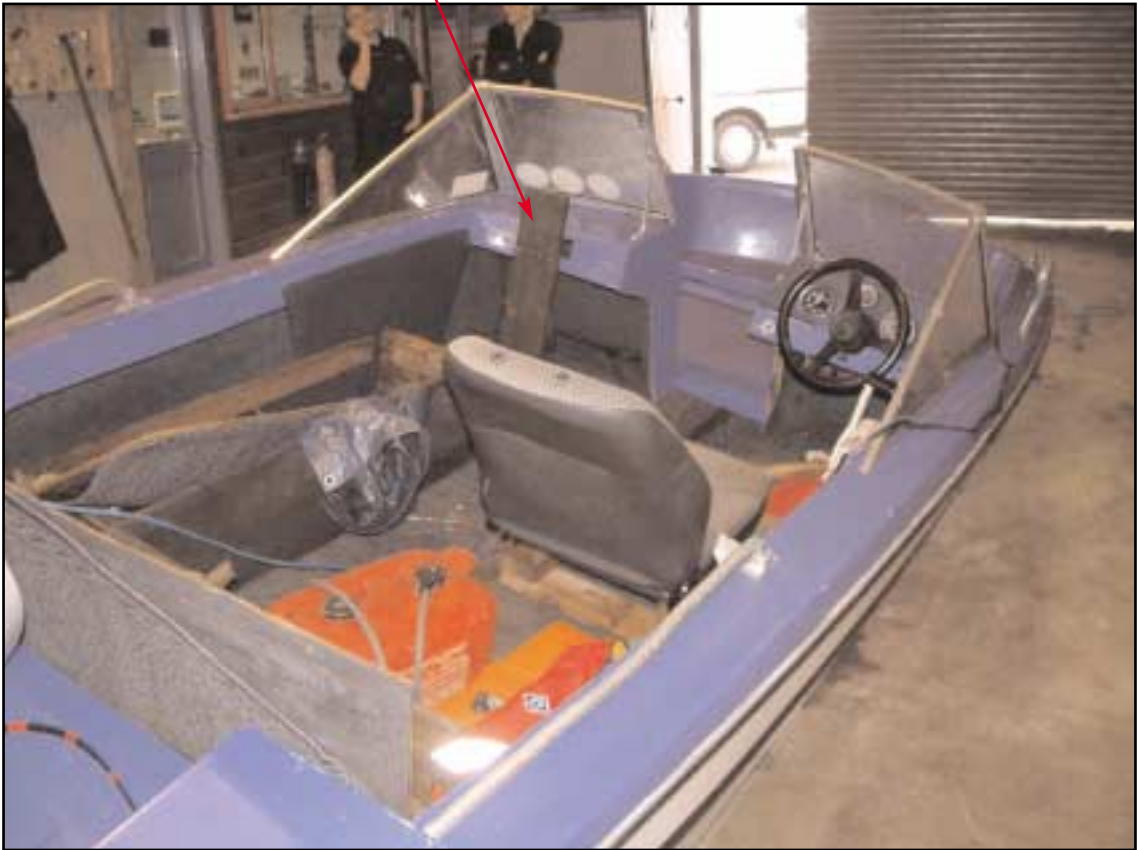
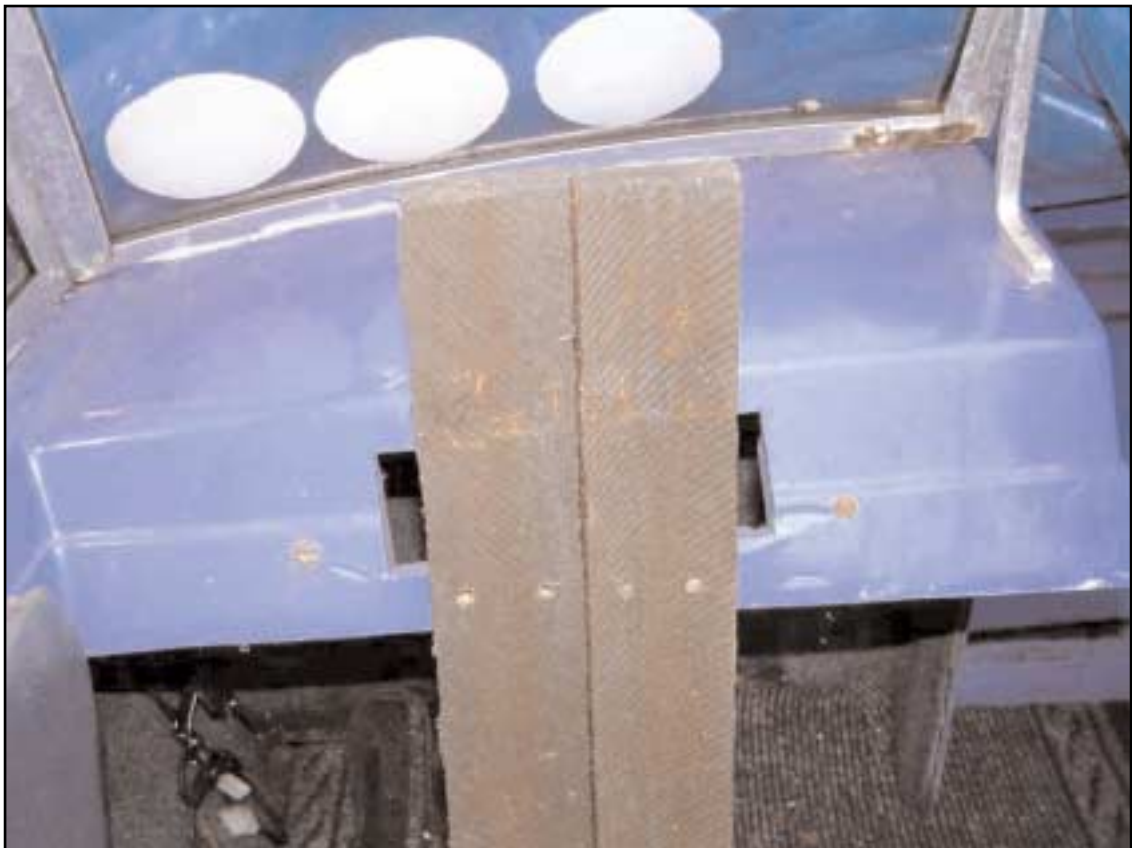
Photograph 5

- The original pressure fuel pump was replaced with a diaphragm pump, for safety reasons. This made the steering-console-mounted fuel pump switch redundant.
- The hull was painted blue with white sides and a black stripe added.
- The original deck had become flexible, so a large section of it was cut out, and a sheet of plywood was laid over the opening. The new plywood was screwed to the stiffeners in the hull.
- A seat at the stern was built to house the engine battery.
- A wooden bracket was fitted to stow the auxiliary outboard engine (**Photographs 5 & 6**).
- The bilge pump had new electrical connectors fitted.

Wood bracket fitted to stow the auxiliary outboard

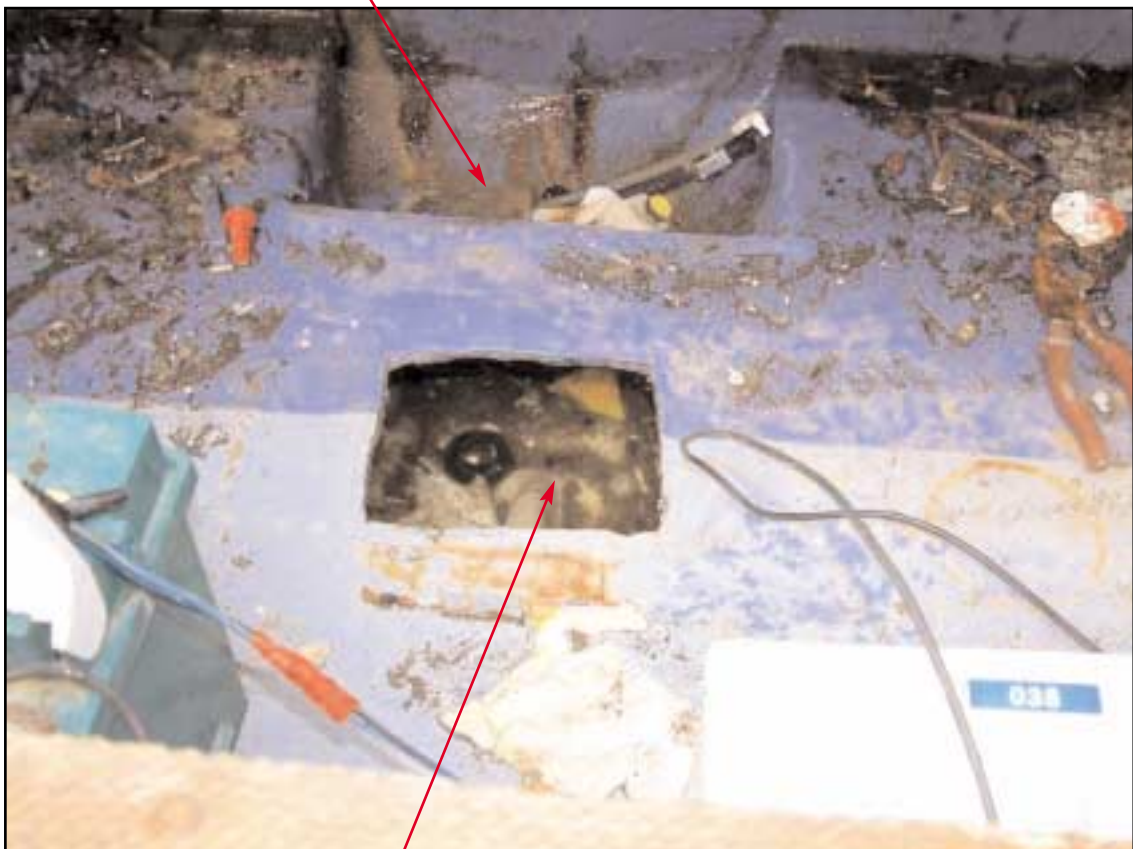
Photograph 7

The opening cut in the top of the void at the aft end

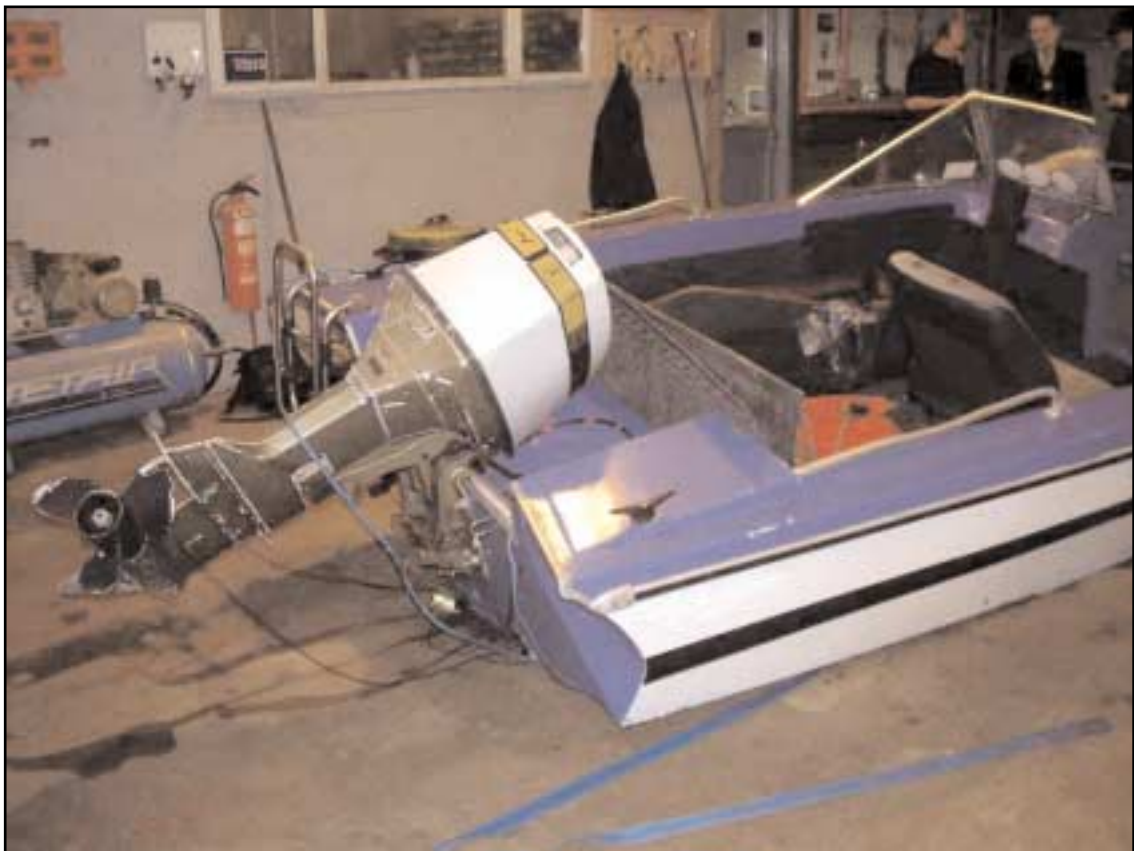
Photograph 8

The survivors of the accident stated that the engine stopped soon after the boat was swamped, but before it sank.

Outboard engine

An outboard engine specialist inspected the main outboard after the accident. The 1973 model, Johnson 48kW (65hp) two-stroke engine was fully dismantled to expose the crankshaft, con rods and the three pistons. If the engine had drawn water in through the carburettors while it was running, con rod damage would be expected, because of hydraulic lock in the cylinders. The specialist found no damage of that kind, and he concluded that the engine was not running when it was submerged.

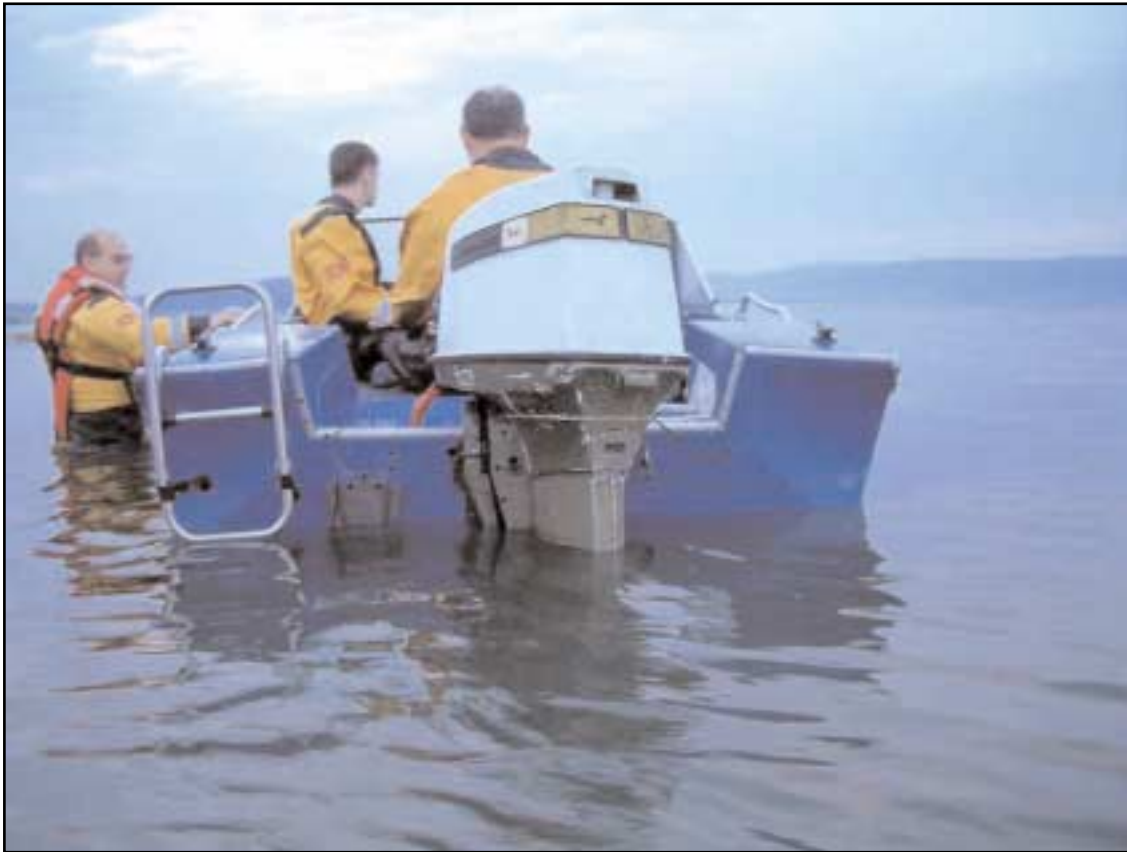
Photograph 9

For the trial, the boat was put afloat and volunteer lifeboatmen were embarked until the loading condition, in terms of weight and distribution, was similar to that just before the accident. The freeboard at the starboard side at mid length was measured as 425mm, and at the transom it was about 215mm (**Photograph 9**). After the first wave was taken on board, apparently Shaun Ridley moved aft to assist his father to try to bail out the boat; his weight would have further reduced the freeboard at the transom. His weight would also have trimmed the boat so that the floodwater would have run aft, adding to the trim and reducing the freeboard still further. The amount of water from the first wash wave taken on board is not known, so an accurate trial to determine the freeboard could not be conducted. However, a trial was conducted to simulate Shaun Ridley moving aft, and it was found that the freeboard at the transom would have reduced to about 130mm. The weight of the floodwater reduced the freeboard further, making the boat particularly vulnerable at the aft end.

Loading trials - loading condition similar to that just prior to the accident
Note: other crew not visible from photograph angle

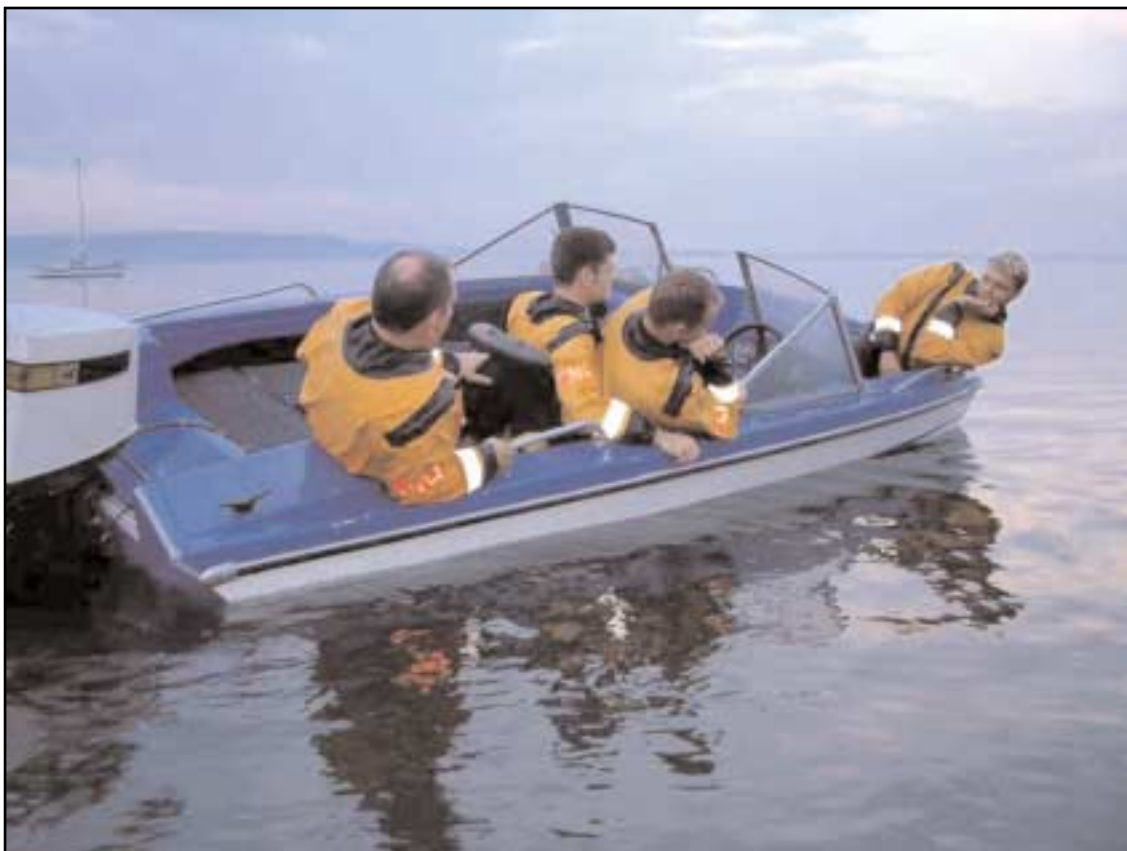
Photograph 10

Loading trials - lifeboatmen moved to the starboard side of the boat to assess stability

All the lifeboatmen were moved to the starboard side of the boat to assess stability (**Photograph 10**). This resulted in an angle of list of about 14°, with a freeboard at the starboard side at mid length of 210mm, and at the starboard side of the transom of only 85mm. Although not a requirement for privately owned small boats, the stability standard in the MCA Code of Practice for Workboats can be used as a guide. This Code states, for vessels under 15 metres in length, that when the people and cargo are shifted to one side, the angle of list should not be more than 7°, and the freeboard should not be less than 250mm. This boat would have failed both of these requirements.

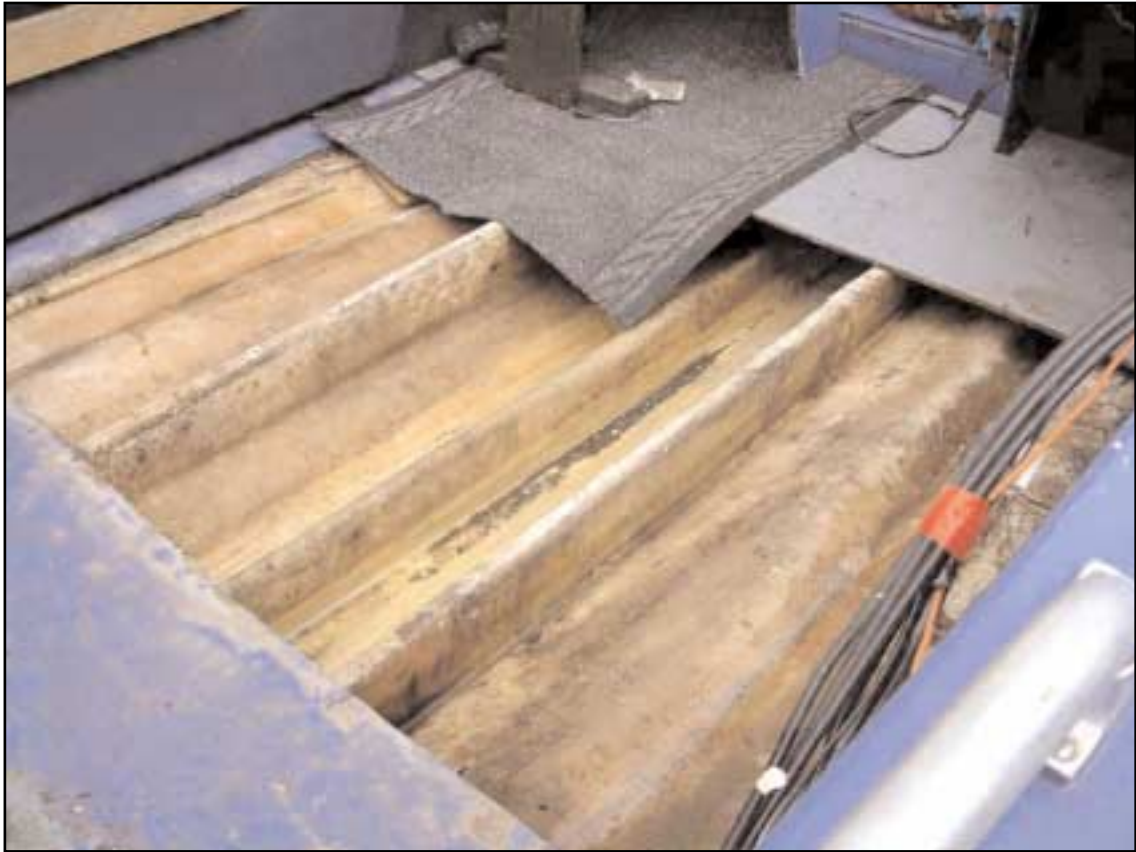
Photograph 11

On 28 August 2003, the cockpit fittings were dismantled. The seats were taken out and the large sheet of plywood fitted by the previous owner was unscrewed and removed. The hull structure was then clearly visible (**Photograph 11**). To check the results of the previous trial, the void was filled with water (**Photograph 12**). It was found that the capacity was about 300 litres, which confirmed the previous result (**see Section 2.6.2**).

Hull structure

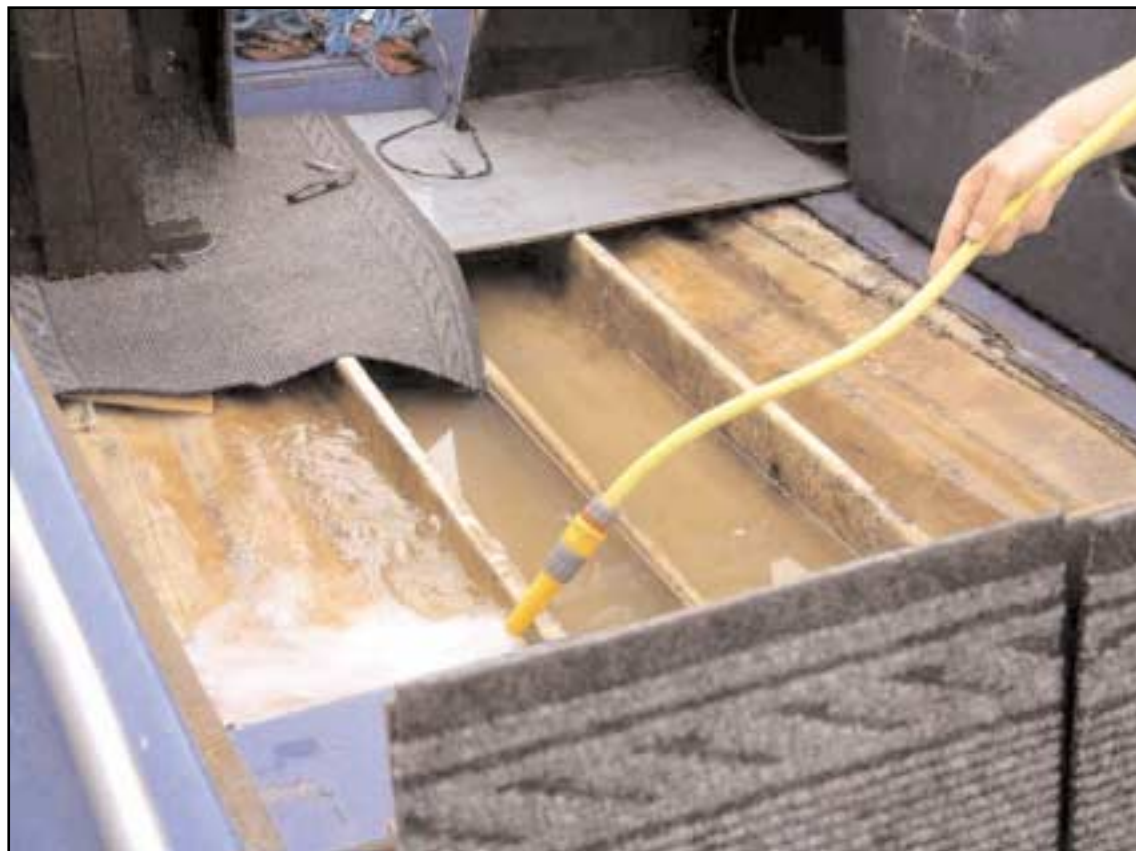
Photograph 12

Void filled with water

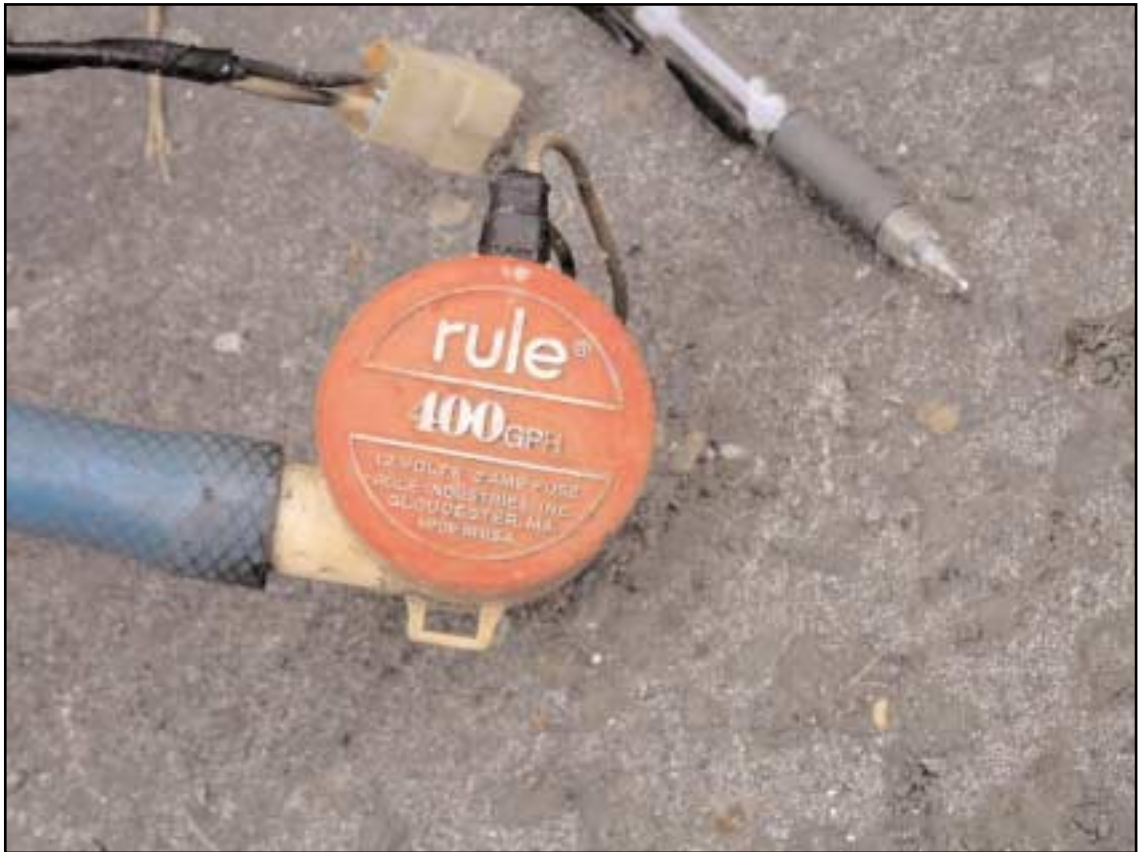
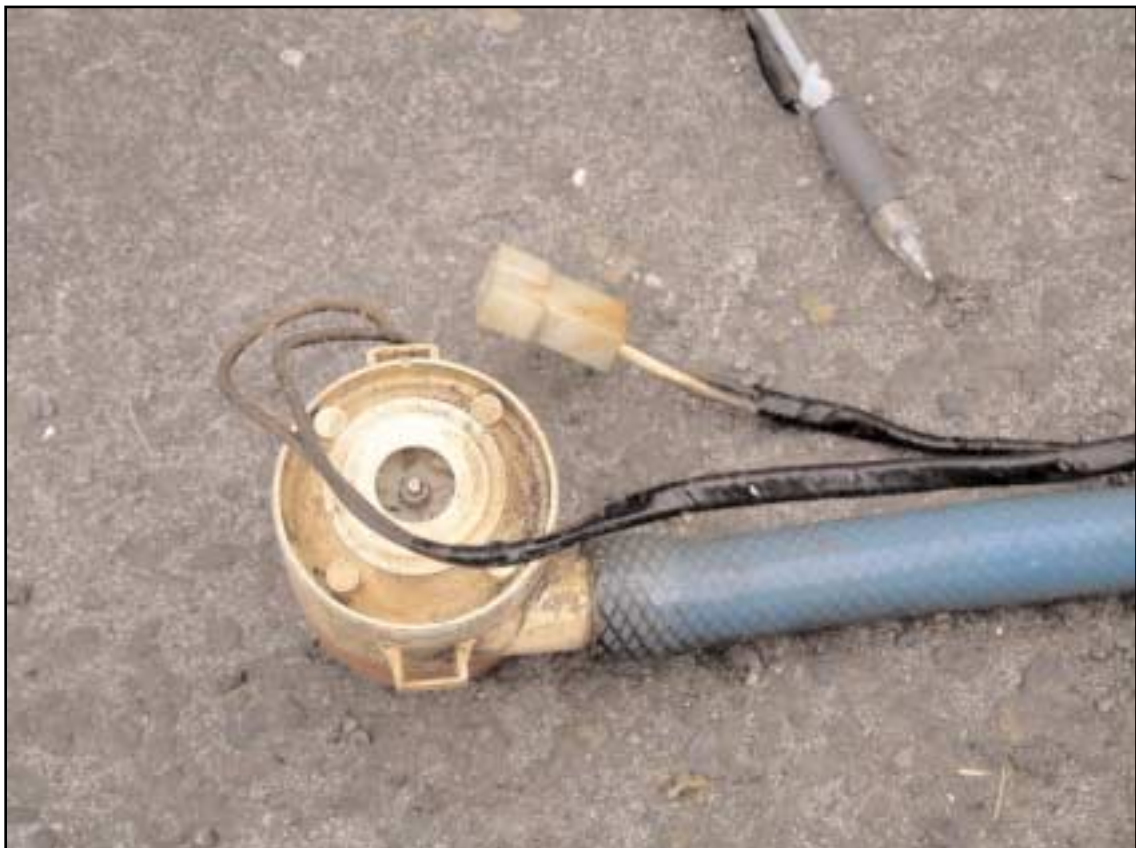
Photograph 13

A test was also carried out on the bilge pump. A 12-volt car battery, which was in good condition, was used as the power supply. Initially, when the pump was connected to the battery, it could be heard clicking, but the impeller did not rotate. However, once the impeller had been freed, by nudging it with a small screwdriver, the pump started to operate. It was then tested twice; 8 litres were pumped in 20 and 23 seconds respectively, which is an average rate of 1339 litres per hour. The bilge pump was rated at 400 US gallons per hour (1514 litres per hour) (**Photographs 13 & 14**).

Bilge pump
