Report on the investigation of
the collision between
Hyundai Dominion and Sky Hope
in the East China Sea
21 June 2004

Marine Accident Investigation Branch
Carlton House
Carlton Place
Southampton
United Kingdom
SO15 2DZ

**Report No 17/2005
August 2005**

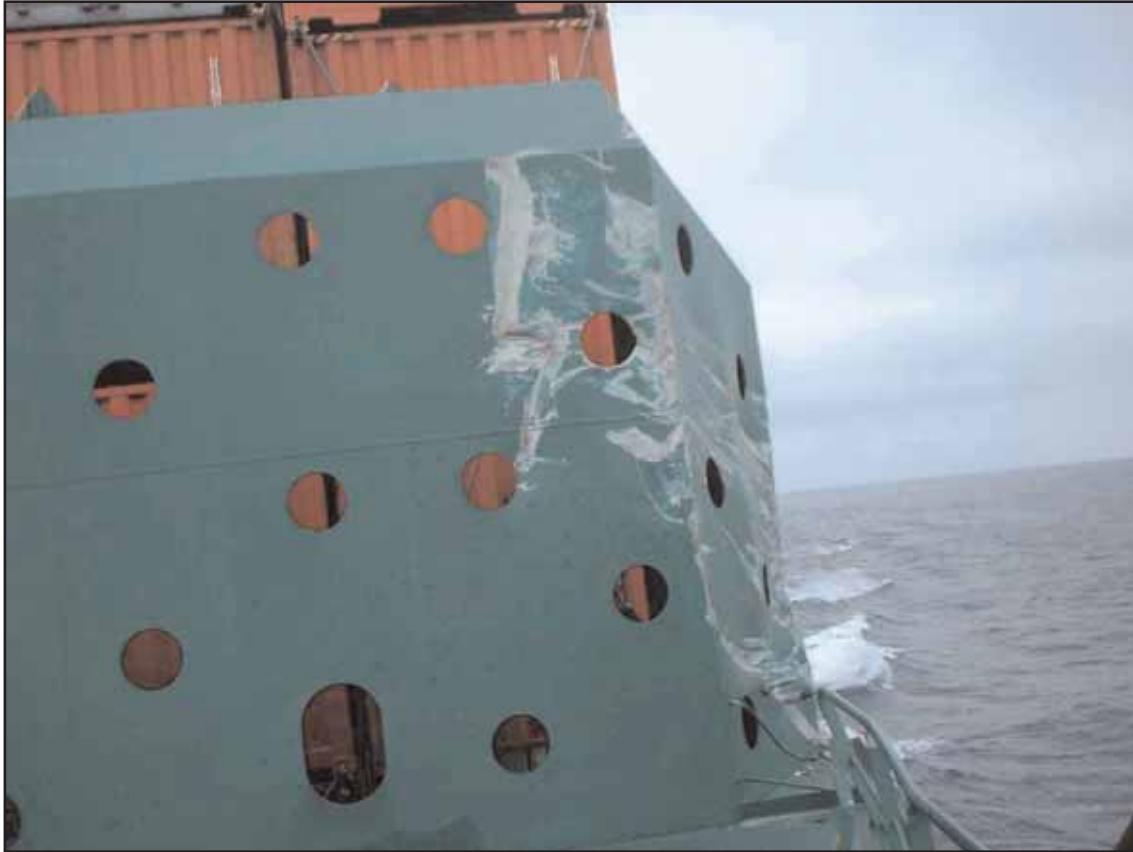
Figure 4

The damage to *Hyundai Dominion* was limited to slight indentation of a breakwater on her port bow, distorted handrails on the forward deck, and scratches to the paintwork on her port bow (**Figures 4 and 5**).

Damaged breakwater - *Hyundai Dominion*

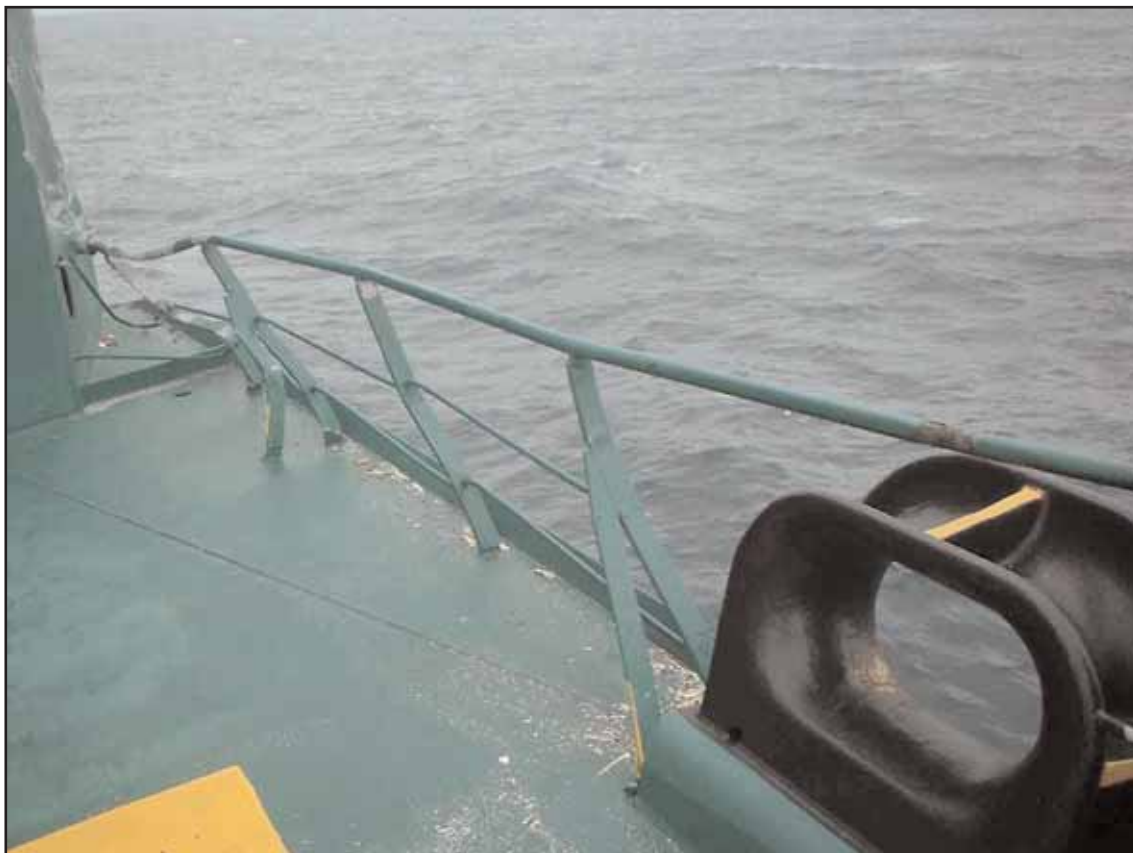
Figure 5

Damaged guardrails - *Hyundai Dominion*

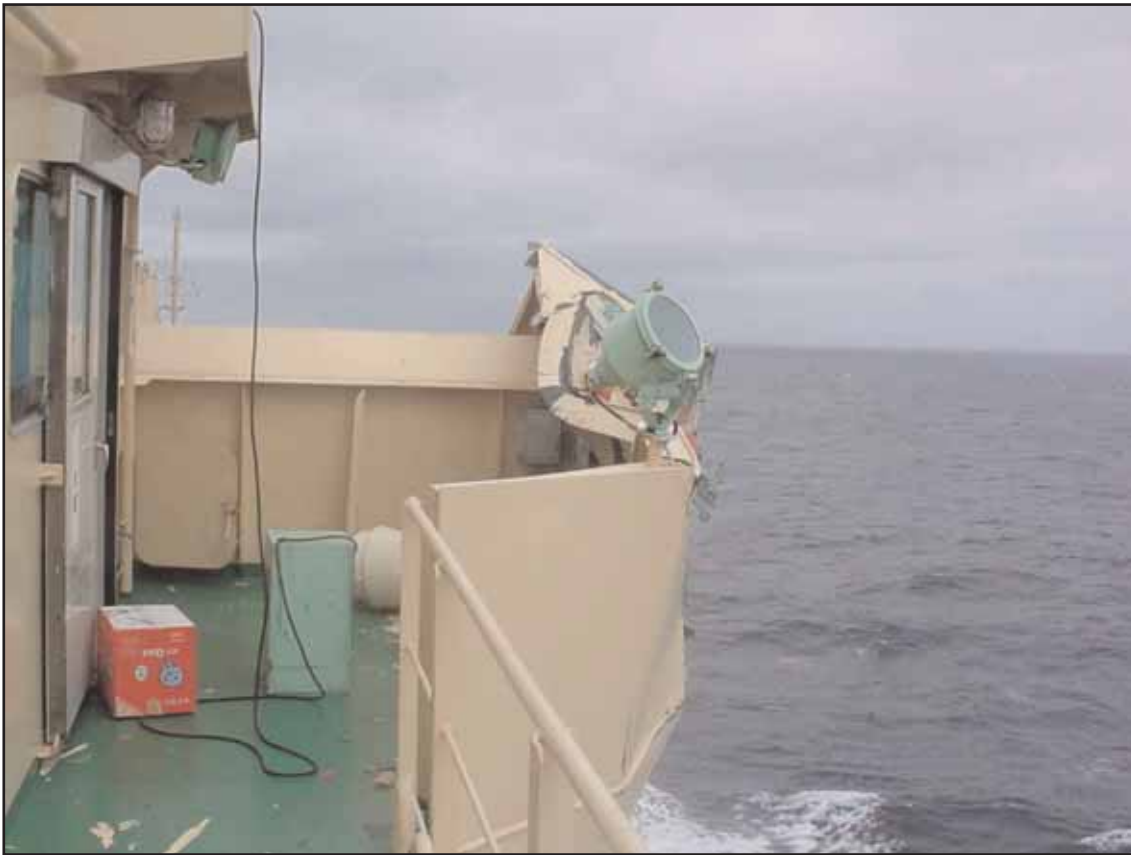
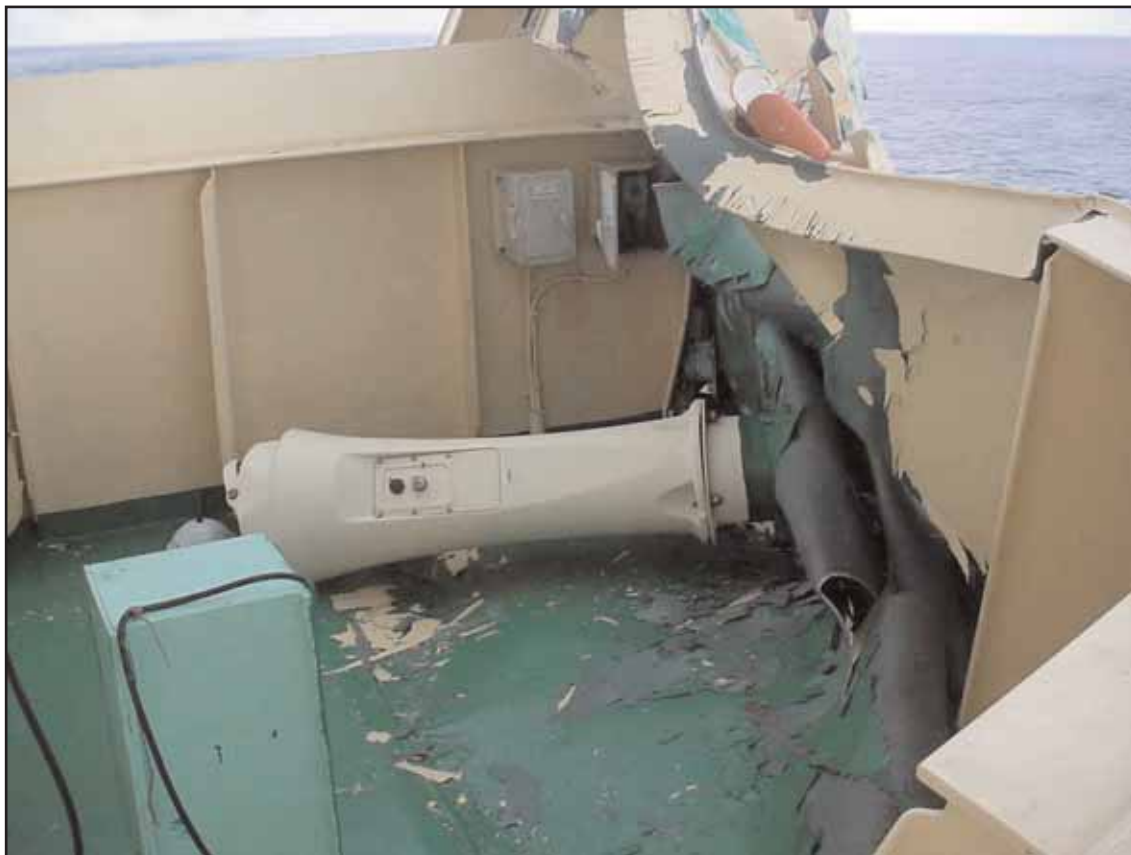
The damage sustained by *Sky Hope* was more extensive and included: the starboard bridge wing crushed inwards; starboard "C" and "D" deck railings crushed or bent and the deck corners badly dented; the davit arm for the freefall lifeboat badly crushed and the lifeboat shell cracked; one liferaft damaged; one cargo container crushed (**Figures 6, 7, 8 and 9**).

Damaged starboard bridge wing - *Sky Hope*

1. Quick release for the lifebuoy on the navigation bridge deck (renewed).
2. Sidelight and its housing assembly (renewed).
3. Deformed parts of the freefall davit for the lifeboat (renewed).
4. Fractured sections of the lifeboat starboard side shell were repaired and the acrylic window renewed.
5. Gyro compass repeater stand (renewed).

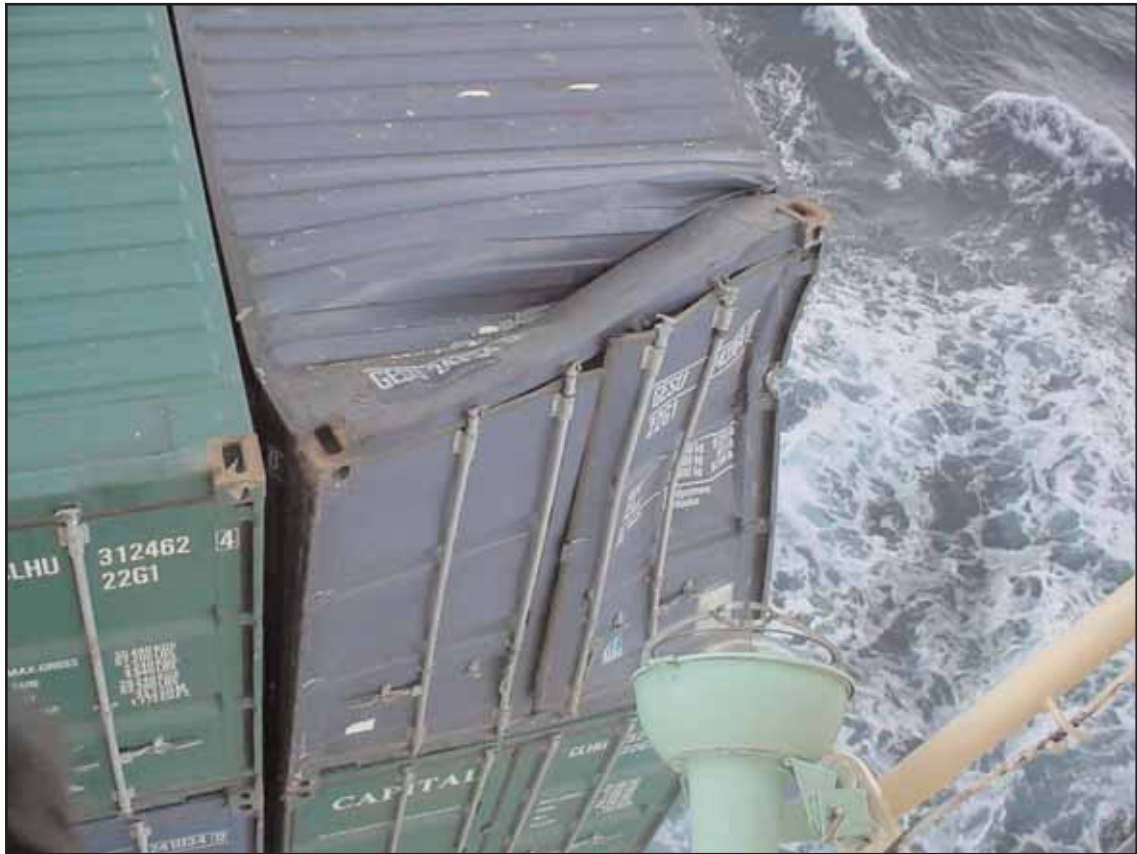
Figure 8

Damaged container - *Sky Hope*

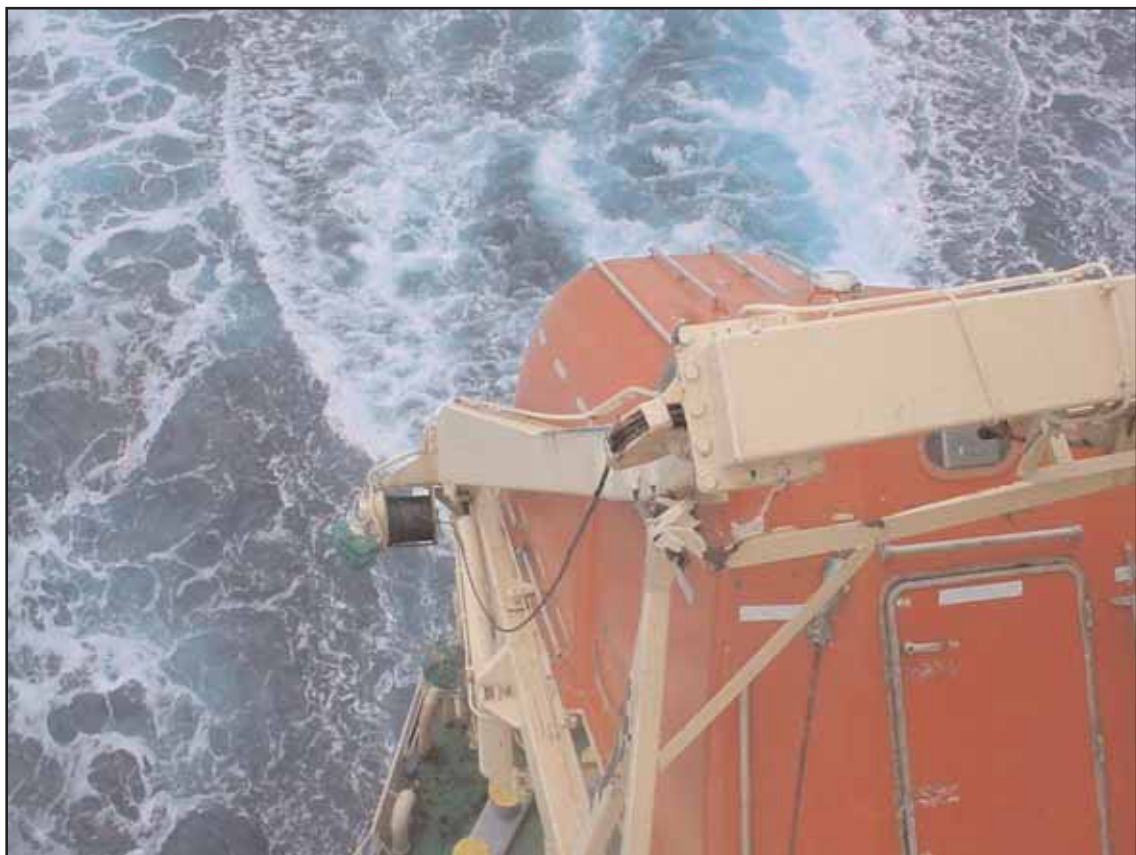
Figure 9

Damaged lifeboat davit - *Sky Hope*

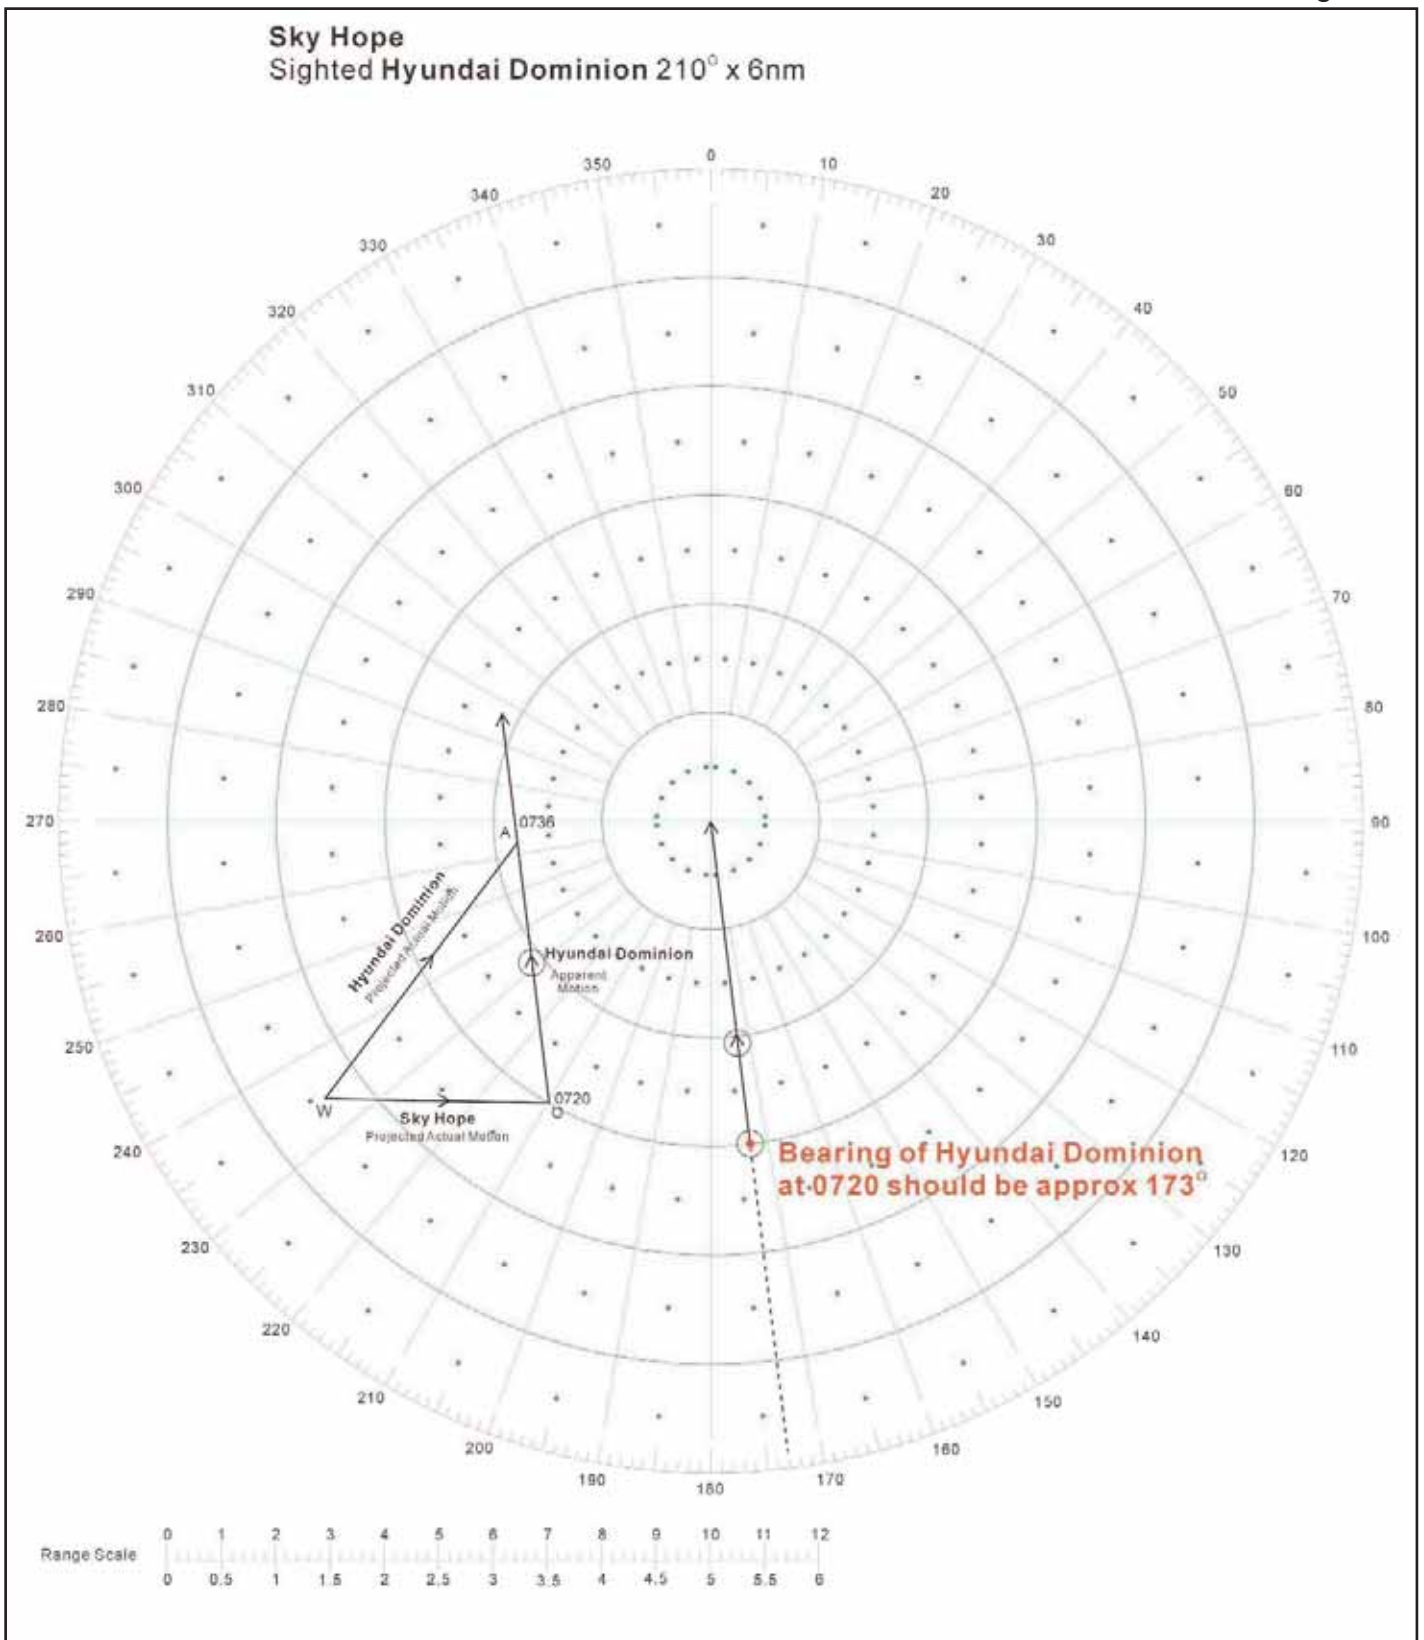
For *Hyundai Dominion* to have been an overtaking vessel, she needed to approach *Sky Hope* from an angle greater than 22.5° aft of the beam. As *Sky Hope* was on a heading of 091°, *Hyundai Dominion* needed to be approaching at an angle greater than 91°+112.5° (or greater than 203.5°). In other words, if *Hyundai Dominion* was observed at 0720 on a bearing of 210°, it was 7° or 8° behind prescribed limit and, thus, could be regarded as an overtaking vessel.

As 173° was forward of the starboard beam of *Sky Hope*, this was a crossing, not an overtaking situation as assessed by *Sky Hope*'s OOW.

Relative motion vector plotted through position of *Hyundai Dominion* observed from *Sky Hope*

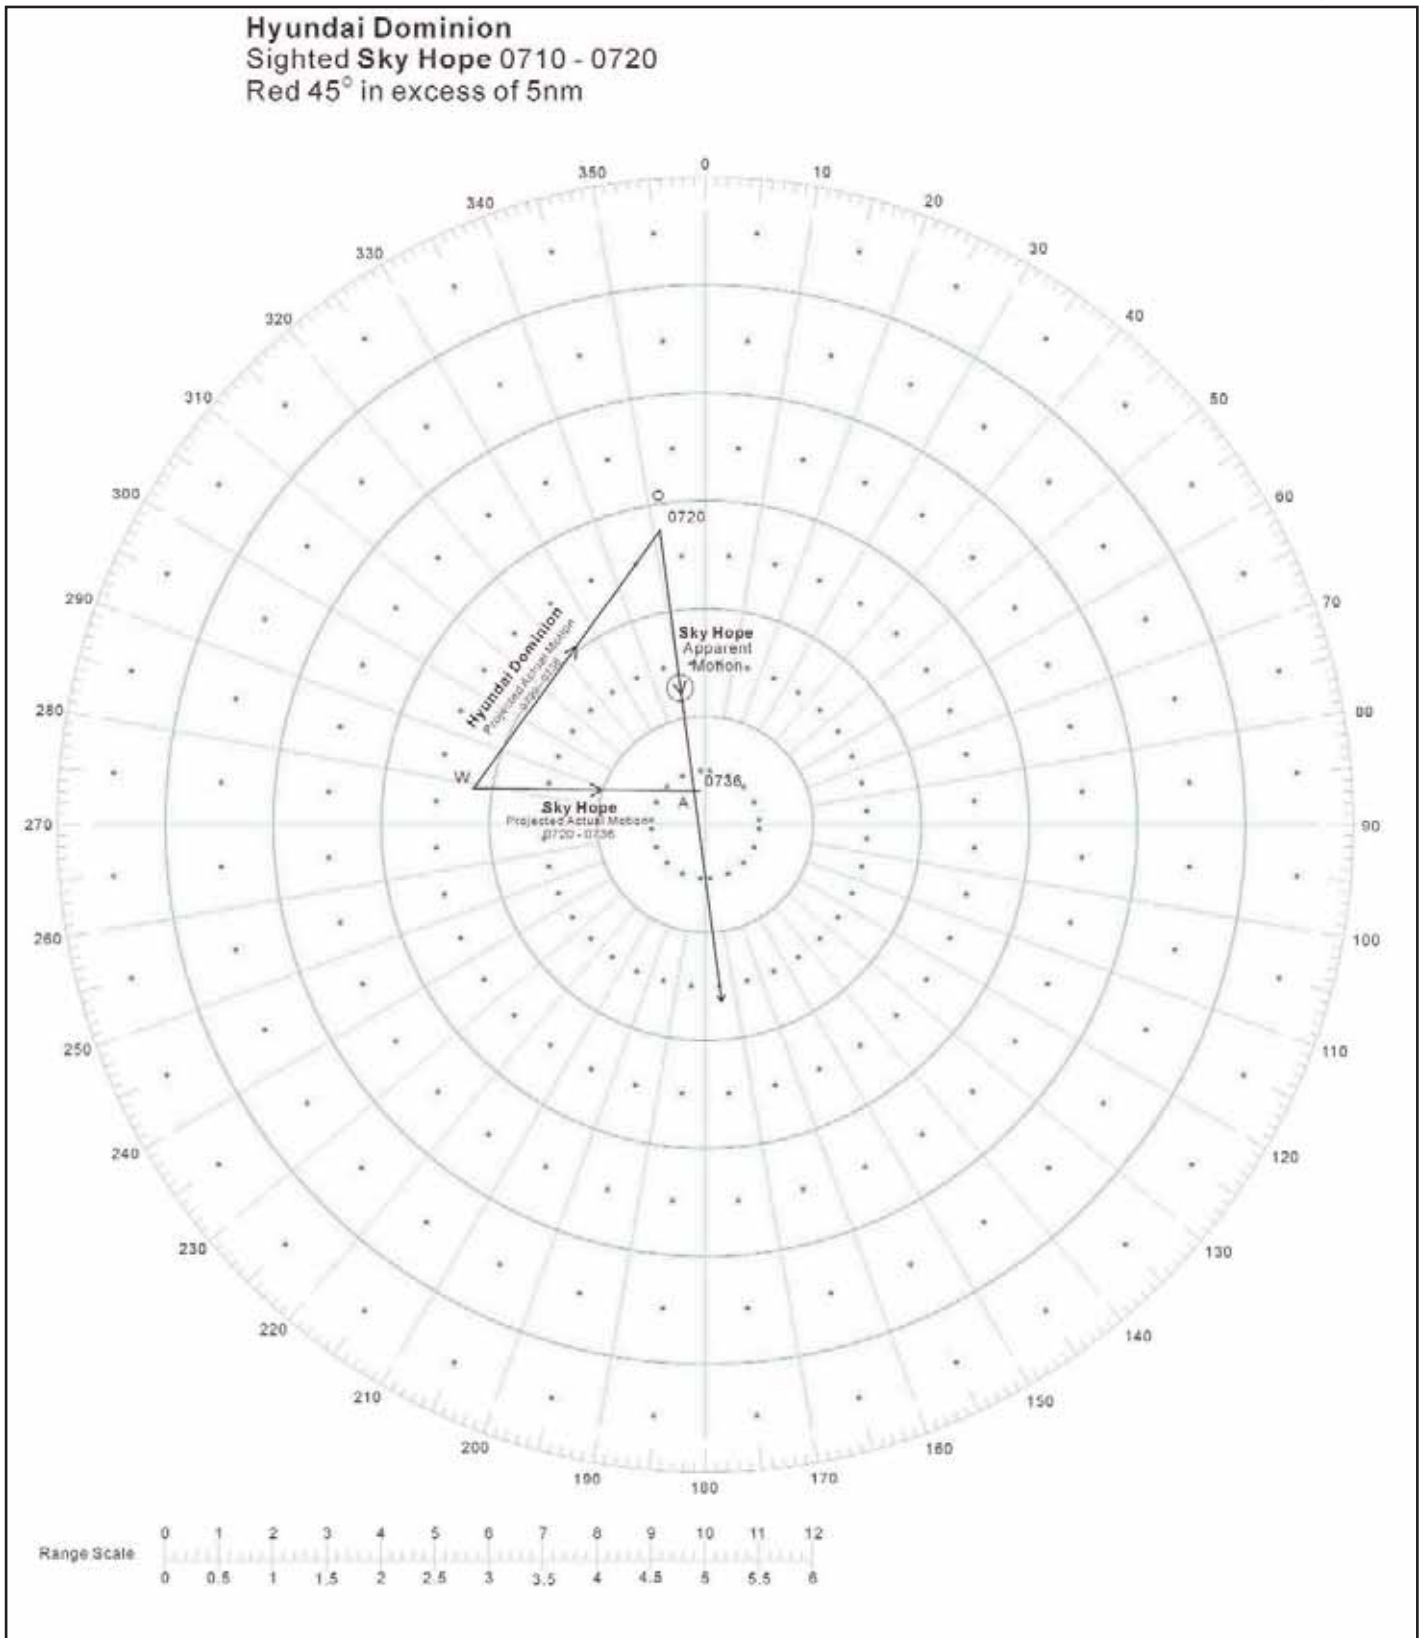
Relative motion vector plotted through position of *Sky Hope* observed from *Hyundai Dominion*

The OOW of *Hyundai Dominion* considered his own ship was the stand-on vessel, which appears to have been correct. However, this did not prevent him from taking earlier avoiding action in accordance with Rule 17(a)(ii) of the COLREGS (**see Annex**) when he found that *Sky Hope* was not taking the appropriate action. *Hyundai Dominion* did not take action to alter course until 0736, when *Sky Hope* was in such close range that any action taken by the latter vessel would not have prevented the collision. This is considered to be in accordance with Rule 17(b) of the COLREGS.
