Report on the investigation of
the collision between
Hyundai Dominion and Sky Hope
in the East China Sea
21 June 2004

Marine Accident Investigation Branch
Carlton House
Carlton Place
Southampton
United Kingdom
SO15 2DZ

**Report No 17/2005
August 2005**

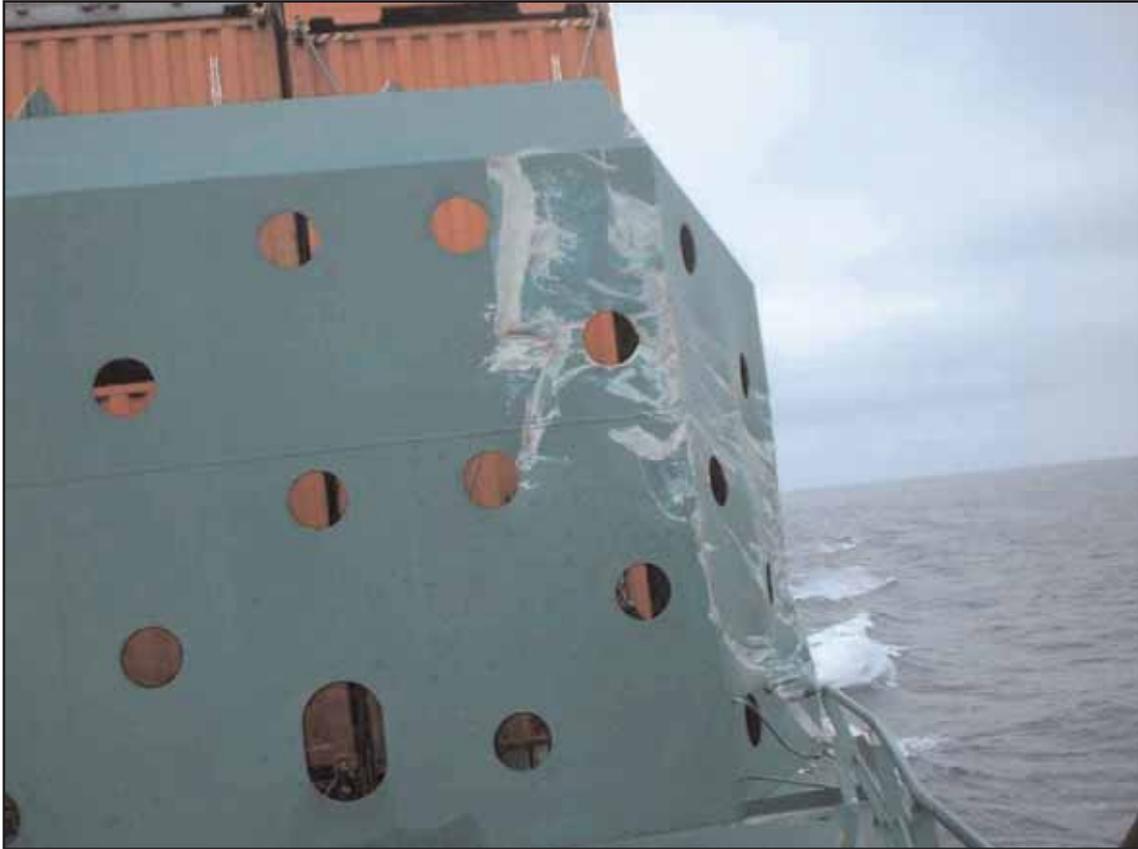
Figure 4

The damage to *Hyundai Dominion* was limited to slight indentation of a breakwater on her port bow, distorted handrails on the forward deck, and scratches to the paintwork on her port bow (**Figures 4 and 5**).

Damaged breakwater - *Hyundai Dominion*

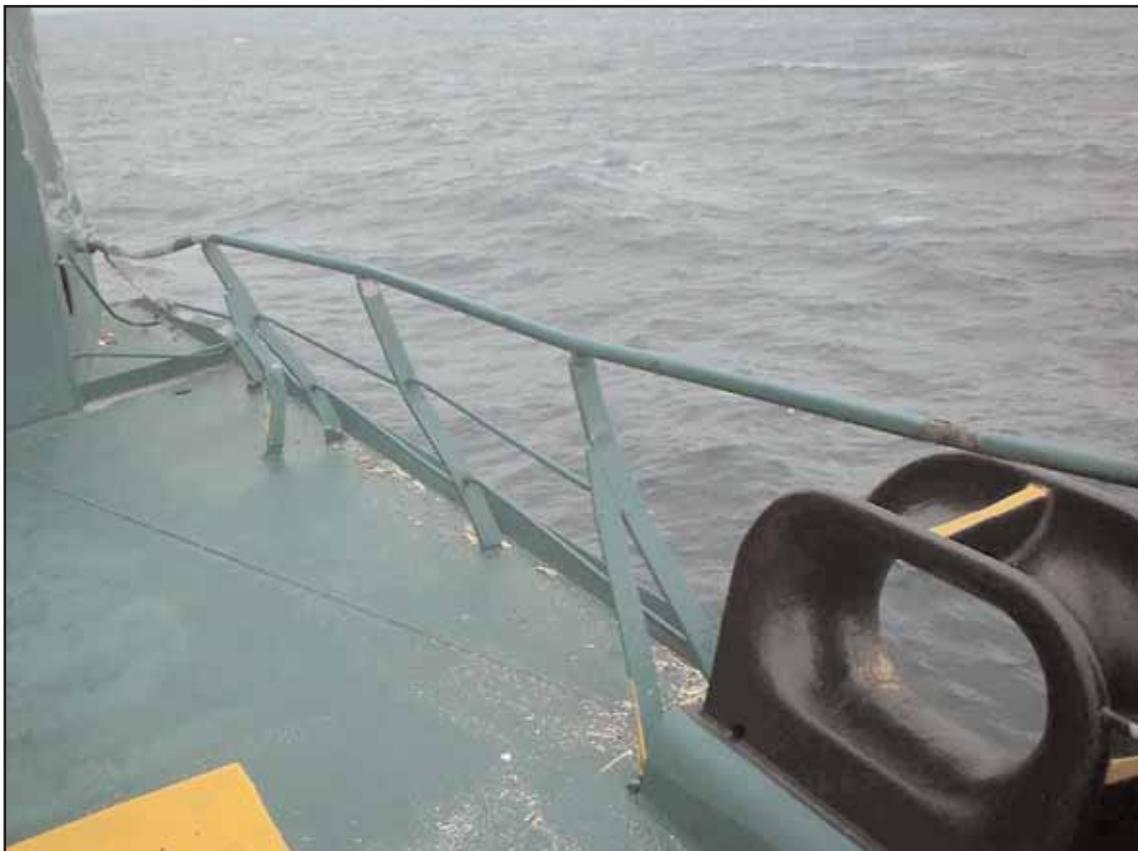
Figure 5

Damaged guardrails - *Hyundai Dominion*

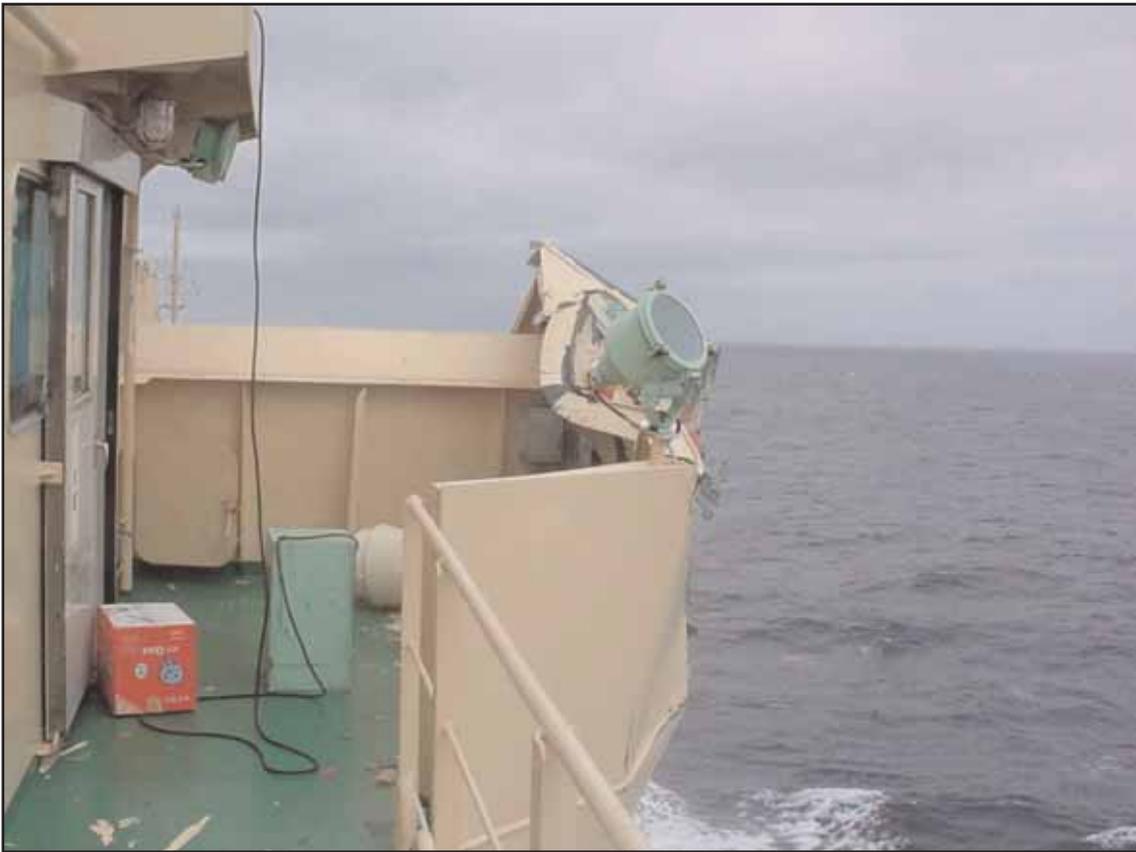
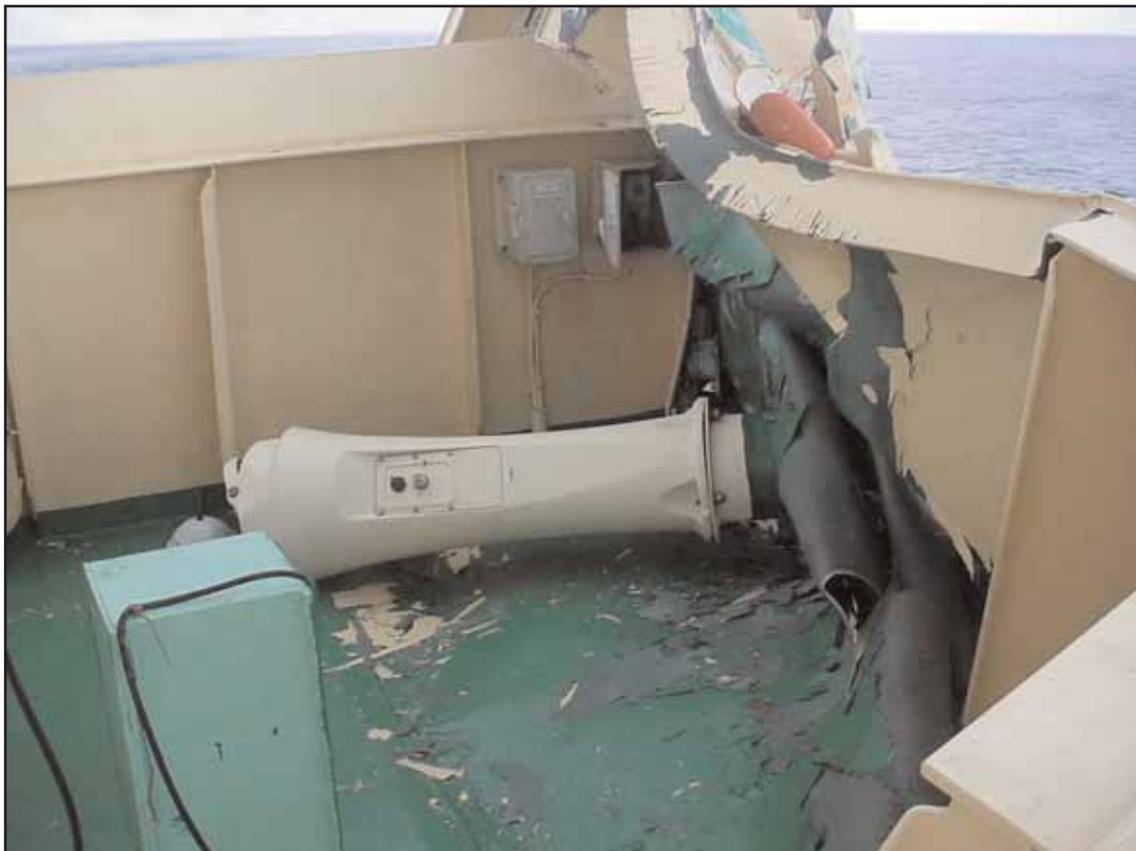
The damage sustained by *Sky Hope* was more extensive and included: the starboard bridge wing crushed inwards; starboard "C" and "D" deck railings crushed or bent and the deck corners badly dented; the davit arm for the freefall lifeboat badly crushed and the lifeboat shell cracked; one liferaft damaged; one cargo container crushed (**Figures 6, 7, 8 and 9**).

Damaged starboard bridge wing - *Sky Hope*

1. Quick release for the lifebuoy on the navigation bridge deck (renewed).
2. Sidelight and its housing assembly (renewed).
3. Deformed parts of the freefall davit for the lifeboat (renewed).
4. Fractured sections of the lifeboat starboard side shell were repaired and the acrylic window renewed.
5. Gyro compass repeater stand (renewed).

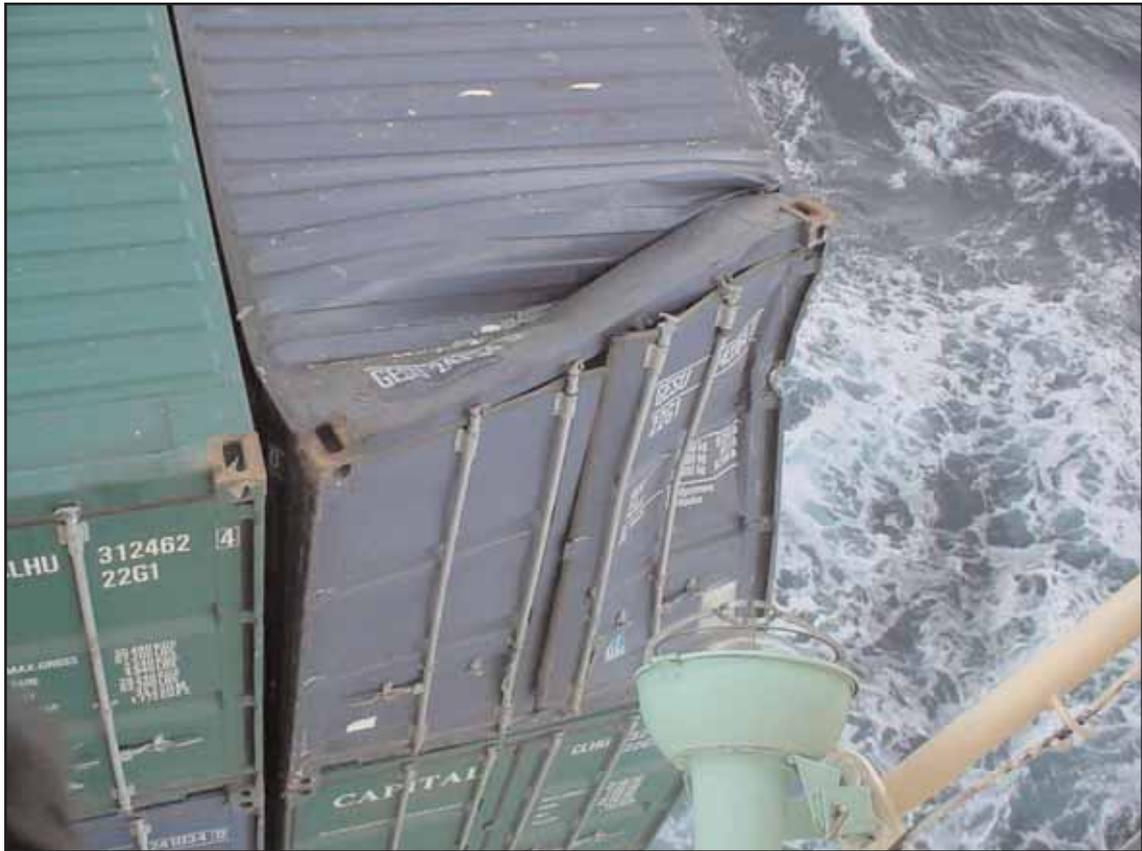
Figure 8

Damaged container - *Sky Hope*

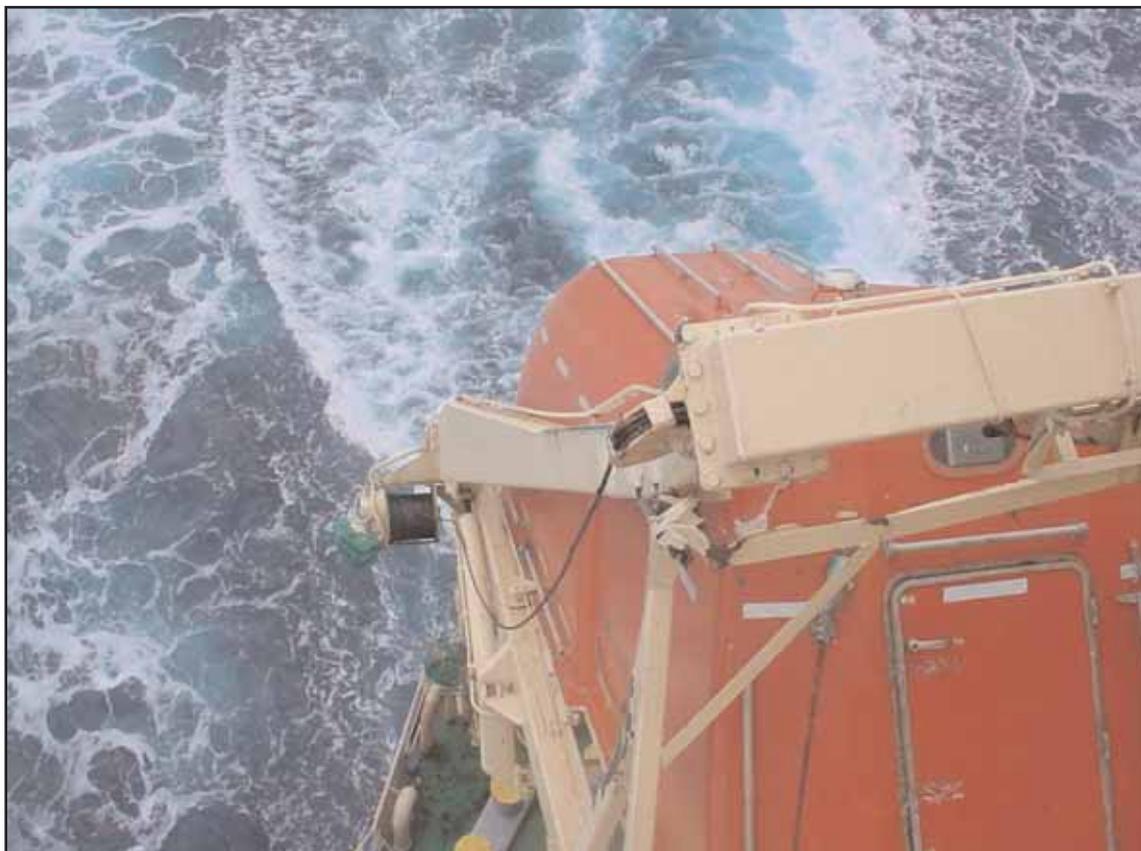
Figure 9

Damaged lifeboat davit - *Sky Hope*

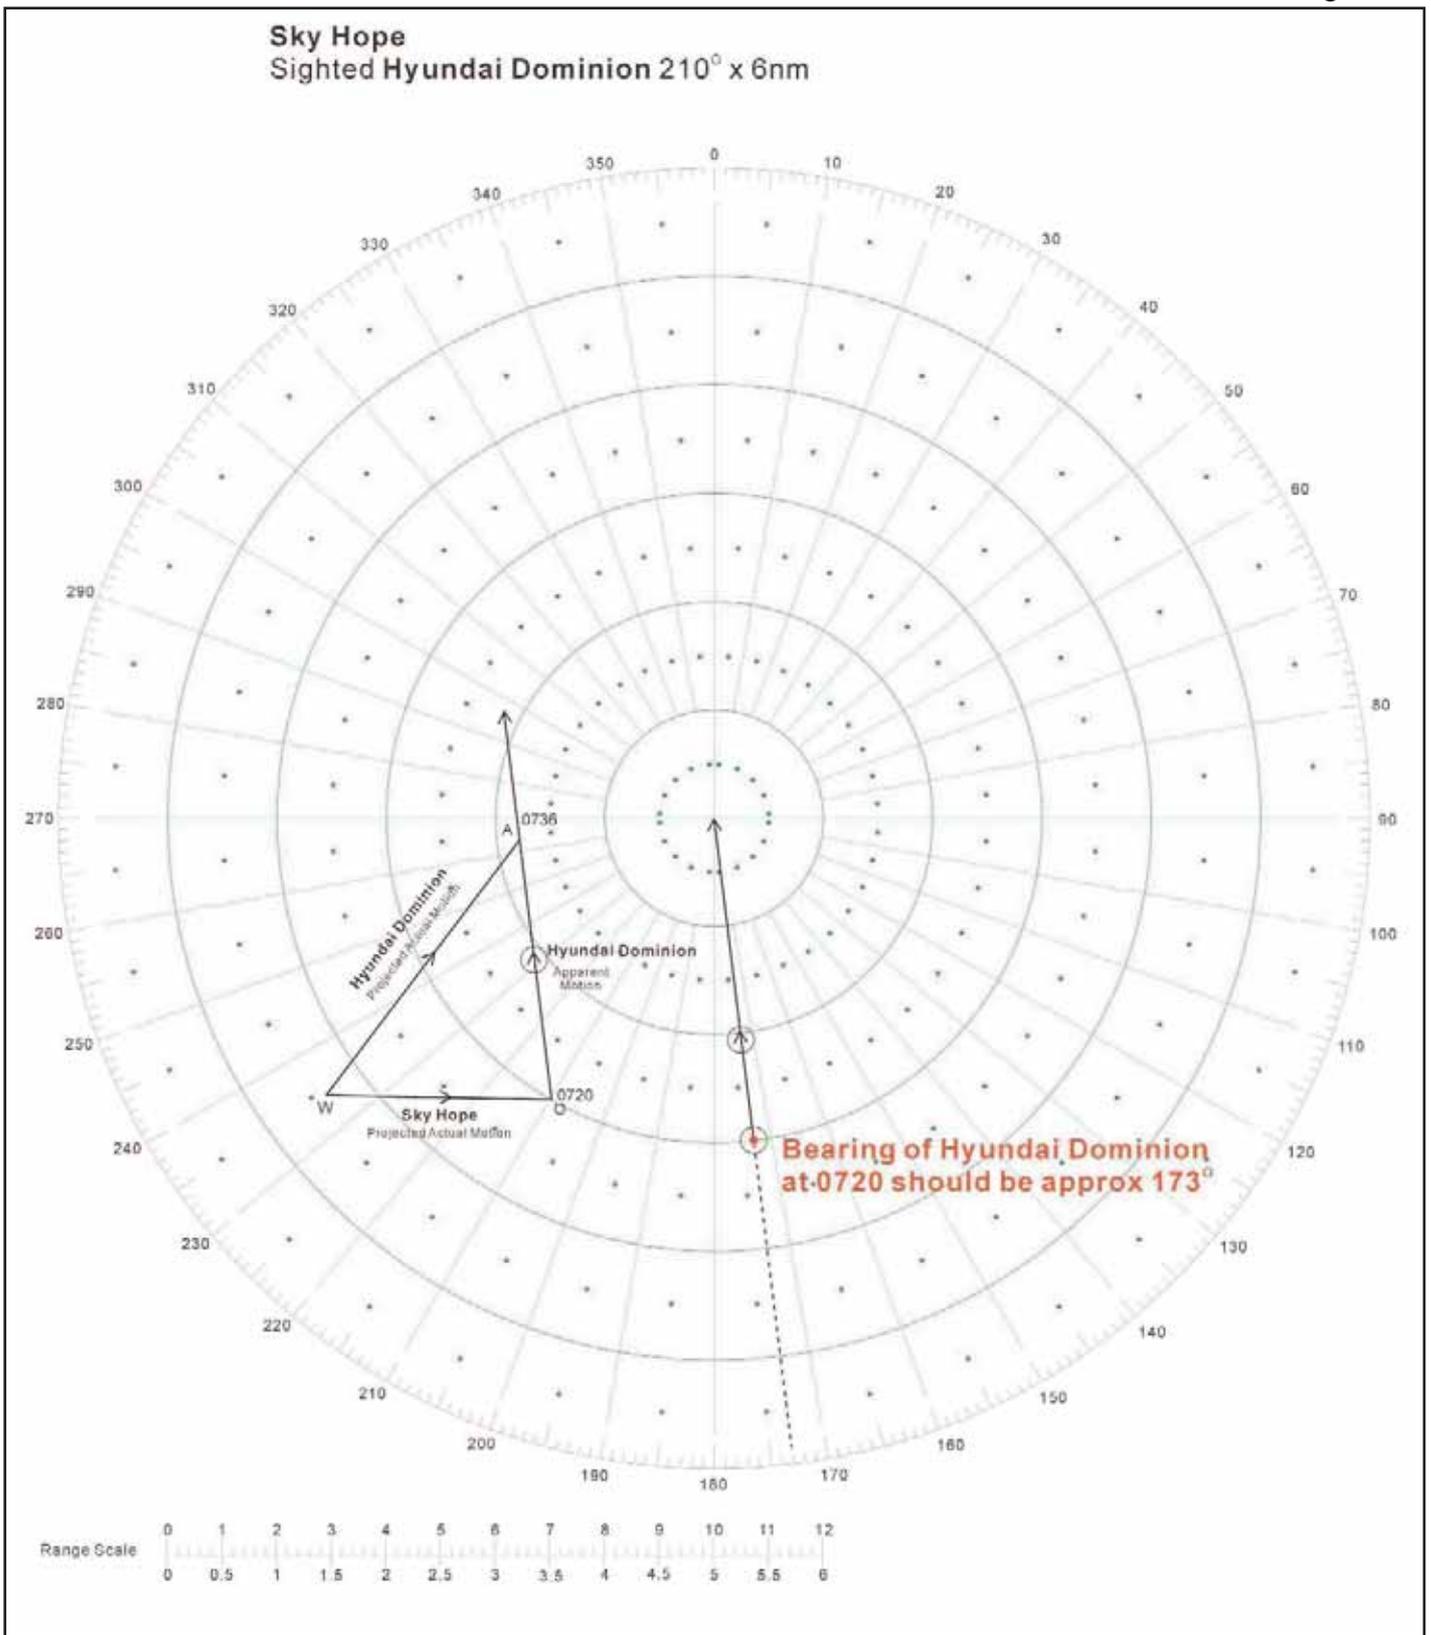
This relative vector has been transferred through the initial ranges and bearings of the other vessel, as observed by each OOW (**Figures 11 and 12**).

As 173° was forward of the starboard beam of *Sky Hope*, this was a crossing, not an overtaking situation as assessed by *Sky Hope*'s OOW.

Relative motion vector plotted through position of *Hyundai Dominion* observed from *Sky Hope*

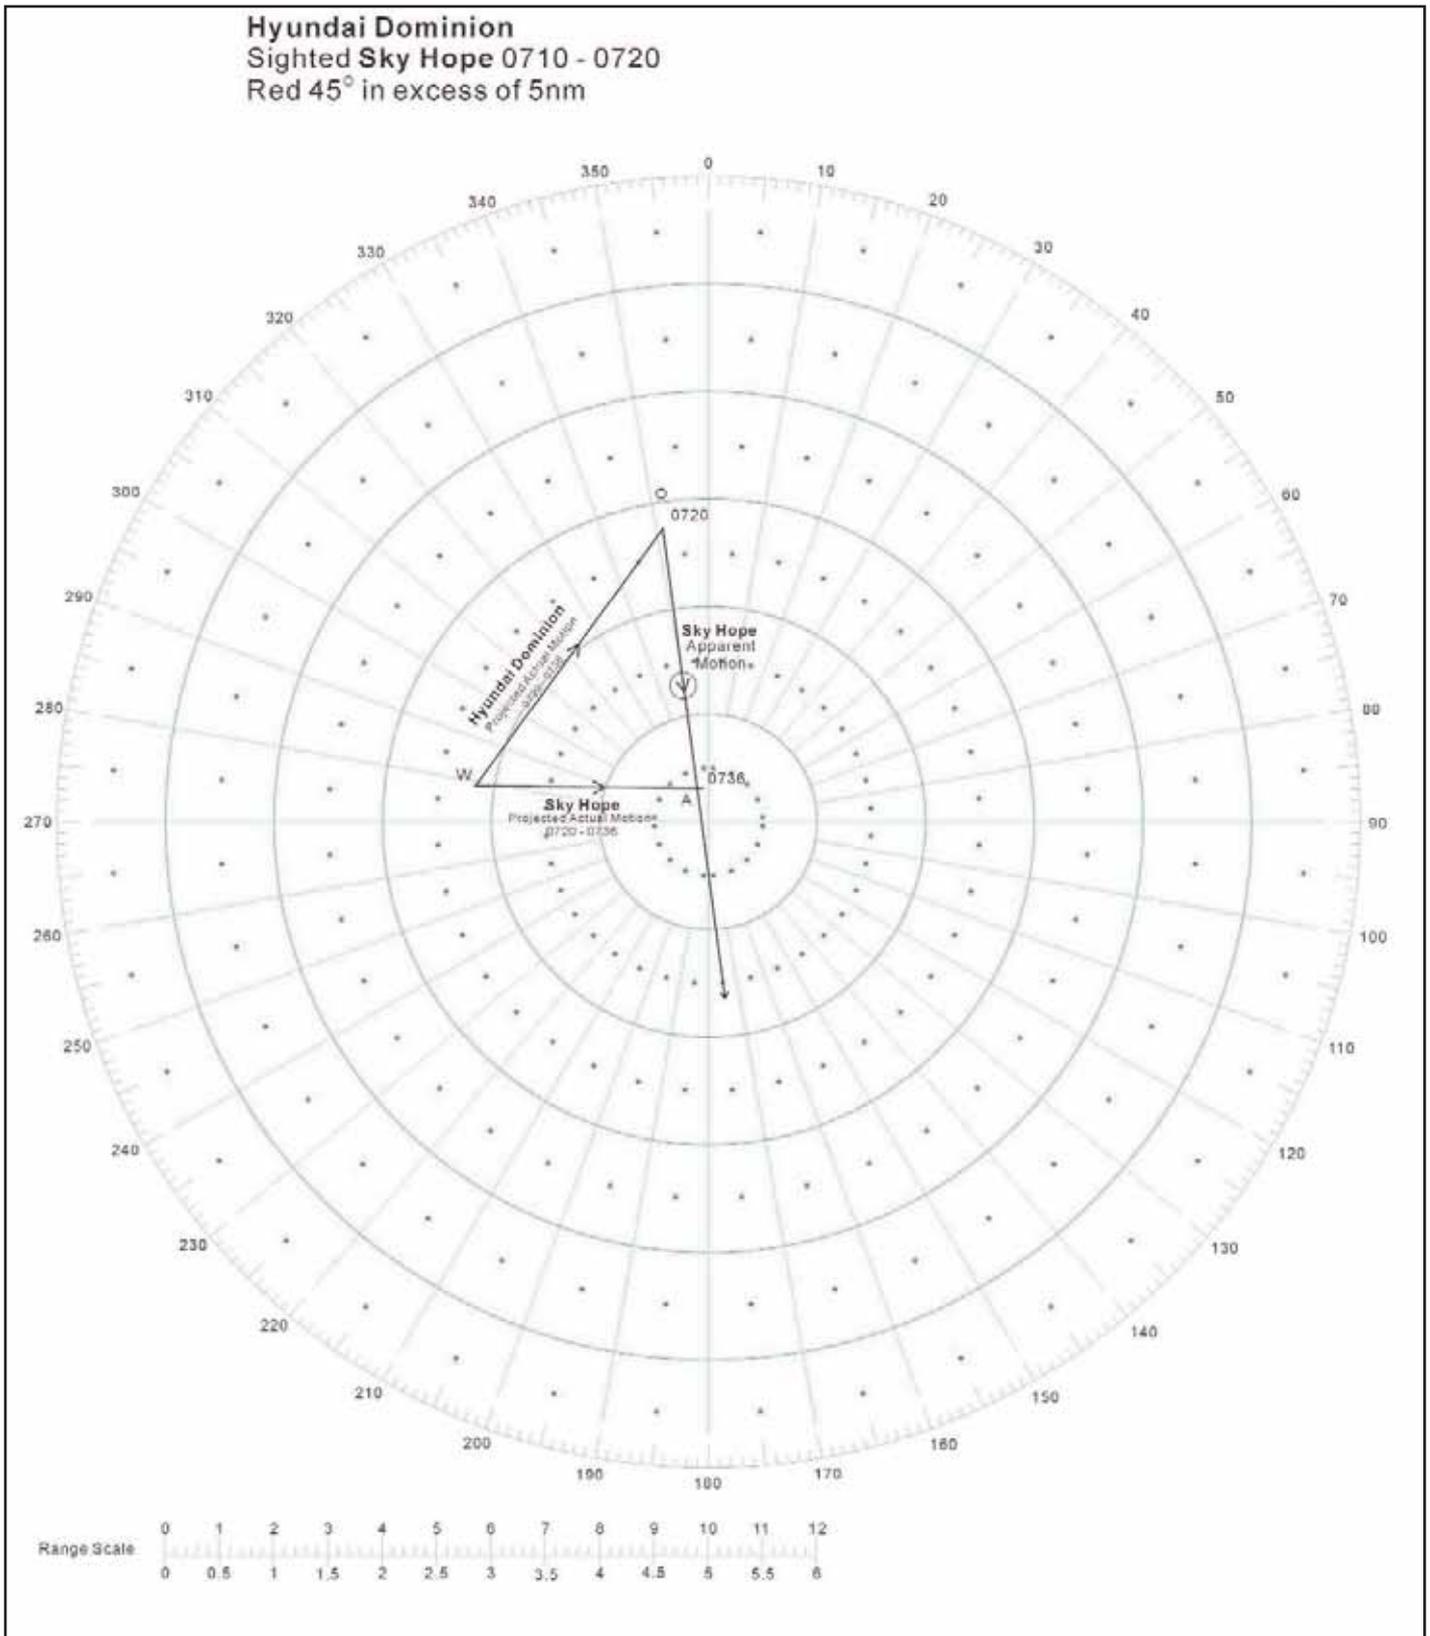
Relative motion vector plotted through position of Sky Hope observed from Hyundai Dominion
