Report on the investigation of
the grounding of the passenger vessel

Waverley

South of Sanda Island

**Report No 1/2005
January 2005**

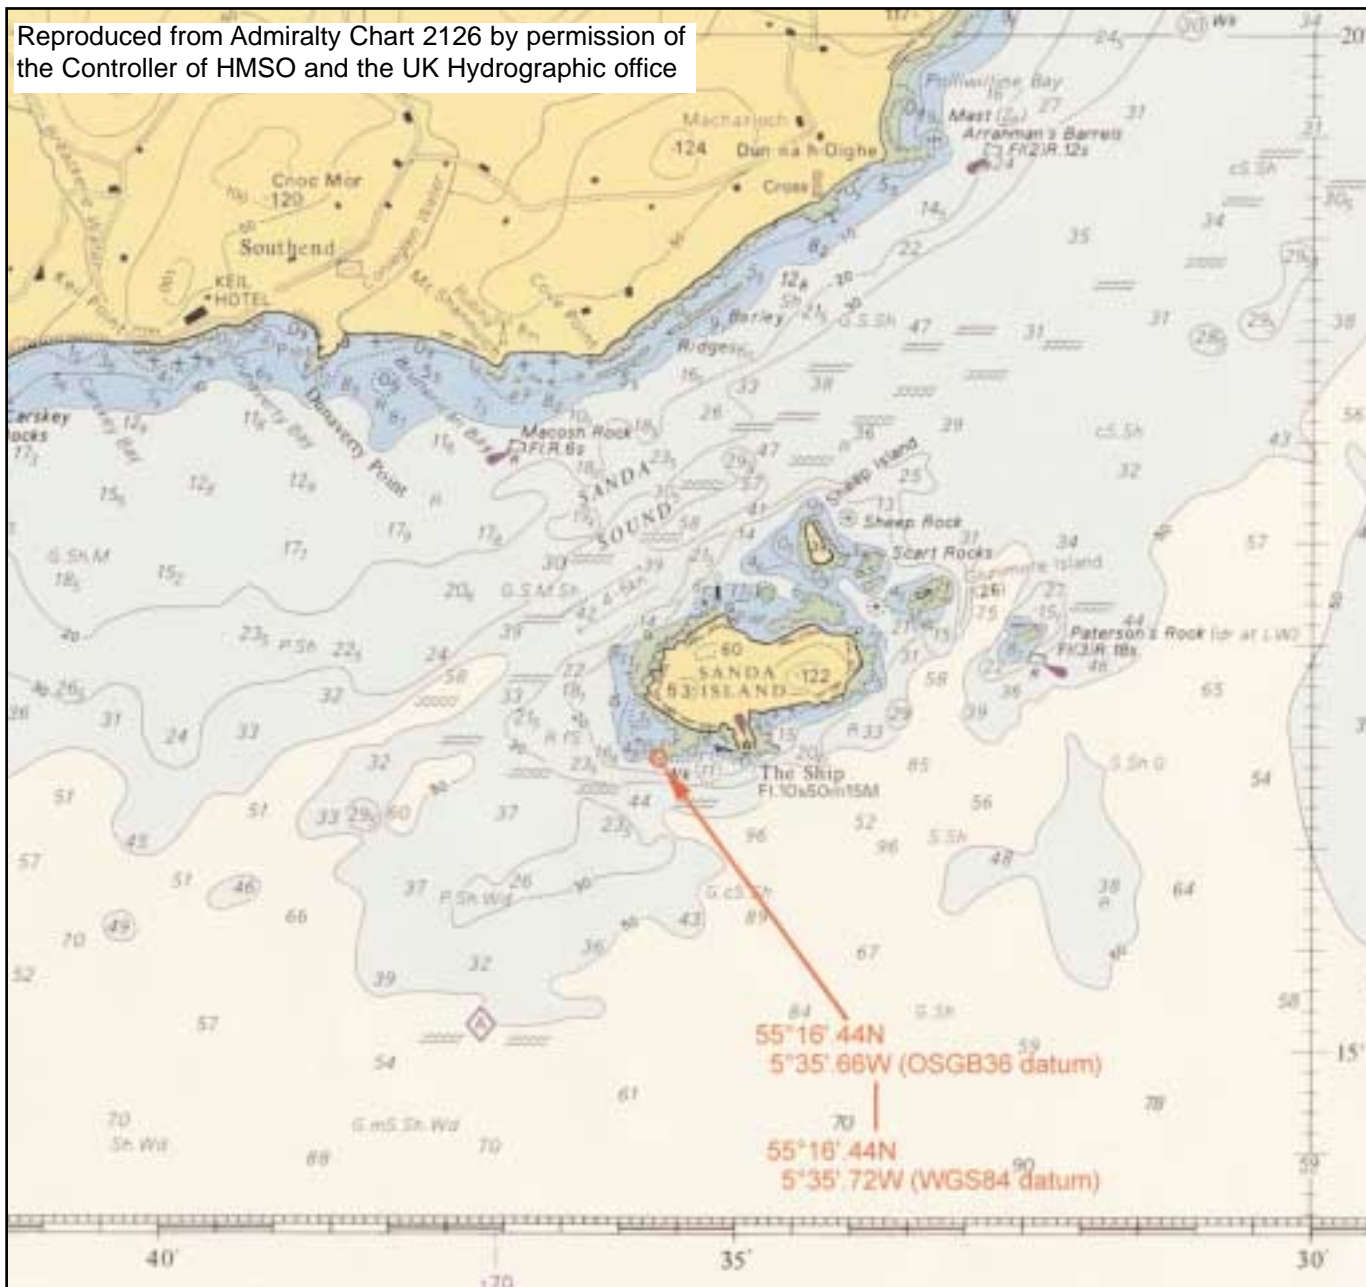
The master left the bridge and went below to discuss the situation with the vessel's engineers. En route, he met one of the passengers he knew to be a Clyde pilot, and asked him to go to the bridge to assist the chief officer if required. The master was aware that the pilot was not able to take charge of the vessel's navigation, but thought his experience would be of benefit. When the pilot arrived on the bridge, he estimated the vessel was about 2 cables off Sanda Island, but did not check this range by radar. The fix obtained by GPS at 1615, which was noted in the deck log by the chief officer immediately following the vessel being stopped, showed the vessel to be at 55°16.44N, 005°35.72W **(Figure 3)**.

Figure 3 shows that *Waverley*'s position, as noted in the deck log at 1615, was on the danger line¹ marking Boiler Reef, and 2 cables from the nearest point of land. This was consistent with the distance off Sanda Island estimated by the Clyde pilot. Given this position, together with a draught in excess of 2.1m due to squat, a height of tide of 1.58m, and her south-easterly course, it is almost certain that the damage to *Waverley*'s hull was caused by her touching the rocky bottom of Boiler Reef. This is supported by the most significant damage sustained. The black marks found on the hull could have been caused by either the hull coming into contact with debris from wrecks or discarded fishing gear on the edge of Boiler Reef, or by contact with other external objects since her last docking in April 2004.

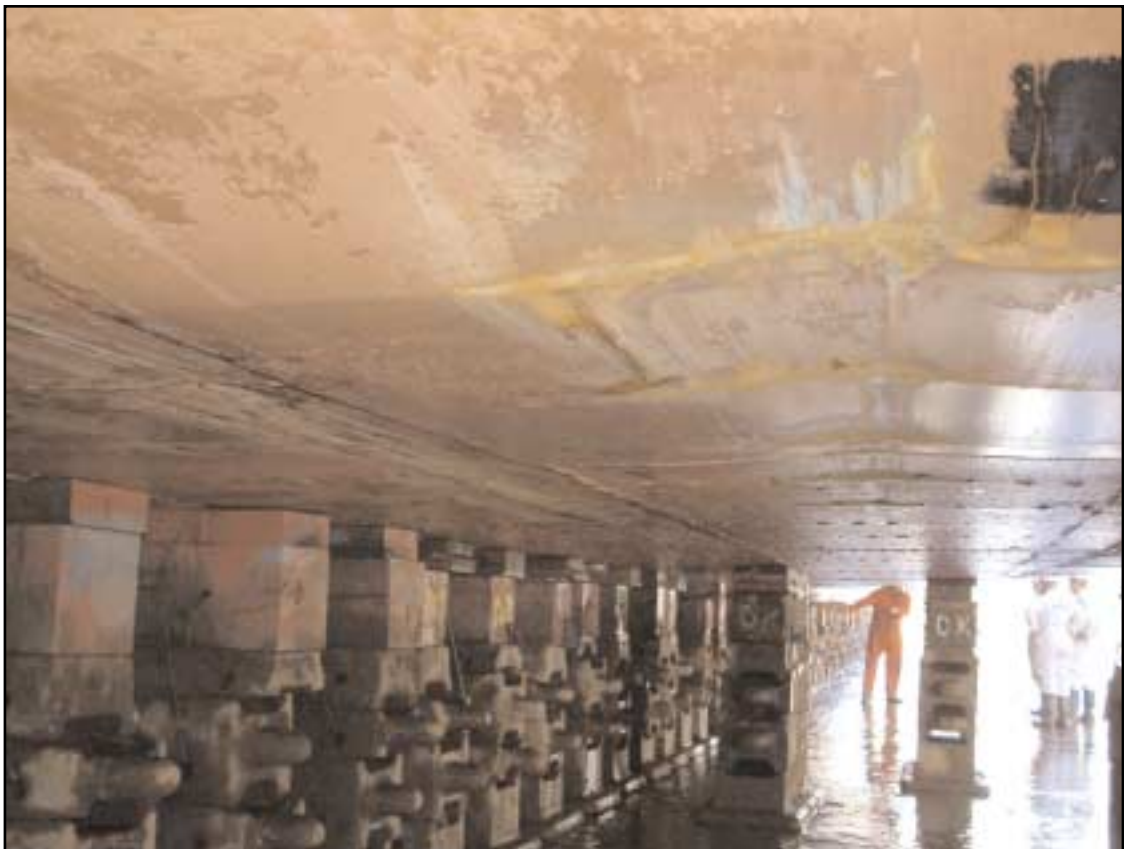
Figure 4

The most significant area of damage was on the flat bottom, on the port side of the hull, in line with the forward end of the port paddle box (**Figure 4**), where a large indentation in the hull had caused some buckling of an internal bulkhead. From this point there were several longitudinal scratches and scrapes along the lowest points of the hull all the way to the aft keel area (**Figure 5**). Similar scratches were also found on the starboard side of the flat underside of the hull, but these started further aft than on the port side (**Figure 6**). Two slight grooves, along with paint scrapes, also extended along the aft third of the narrow keel, which is the lowest point of the hull (**Figure 7**). A small amount of a black deposit was also found on the keel at various points. The horizontal plates attached to the lower edge of the rudder and just forward of the rudder had some paint scraped off (**Figure 8**). The forward section of the hull up to the port paddle box was clear of any significant damage, although there were two thin

Indentation damage to *Waverley's* hull - port side midships, looking aft

1. Given the vessel's position on the south-western edge of Boiler Reef, together with a draught in excess of 2.1m due to squat, a height of tide of 1.58m, and her south-easterly course, it is almost certain that the damage to *Waverley's* hull was caused by her touching the rocky bottom. [2.3]

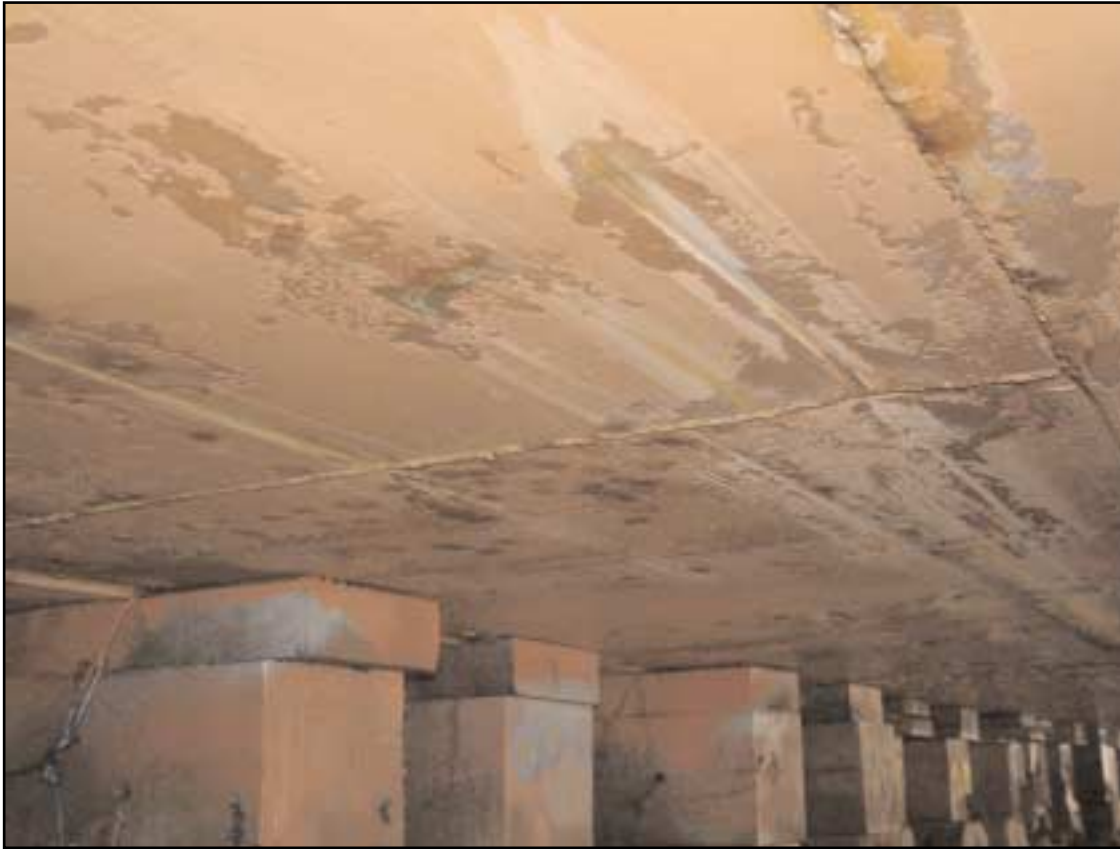
Figure 5

Scratching and scrape damage, port side, looking aft

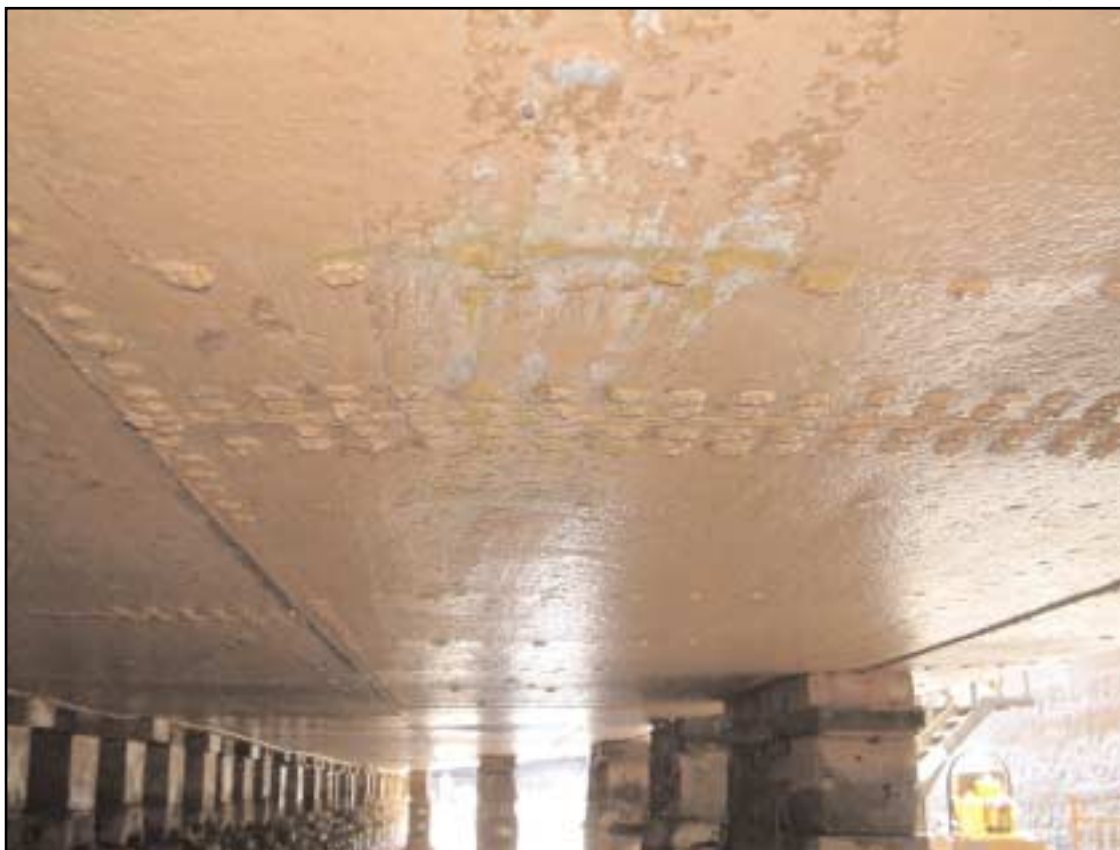
Figure 6

black streaks found on the starboard bow near the keel. WEL arranged for samples of this paint, along with samples of the black deposit to be analysed by a chemist. This analysis determined that the black deposit was a rubber compound, and that the paint did not contain any traces of sand or gravel.

Scrape damage starboard side, looking forward

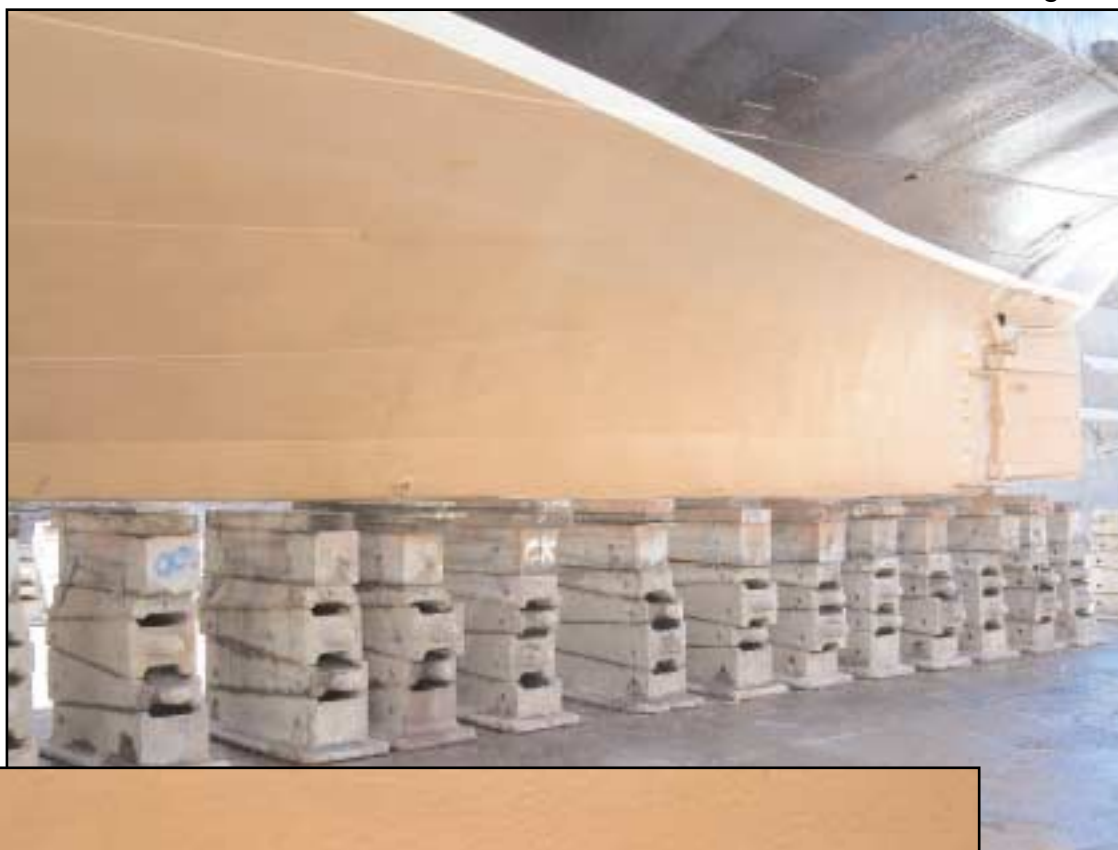
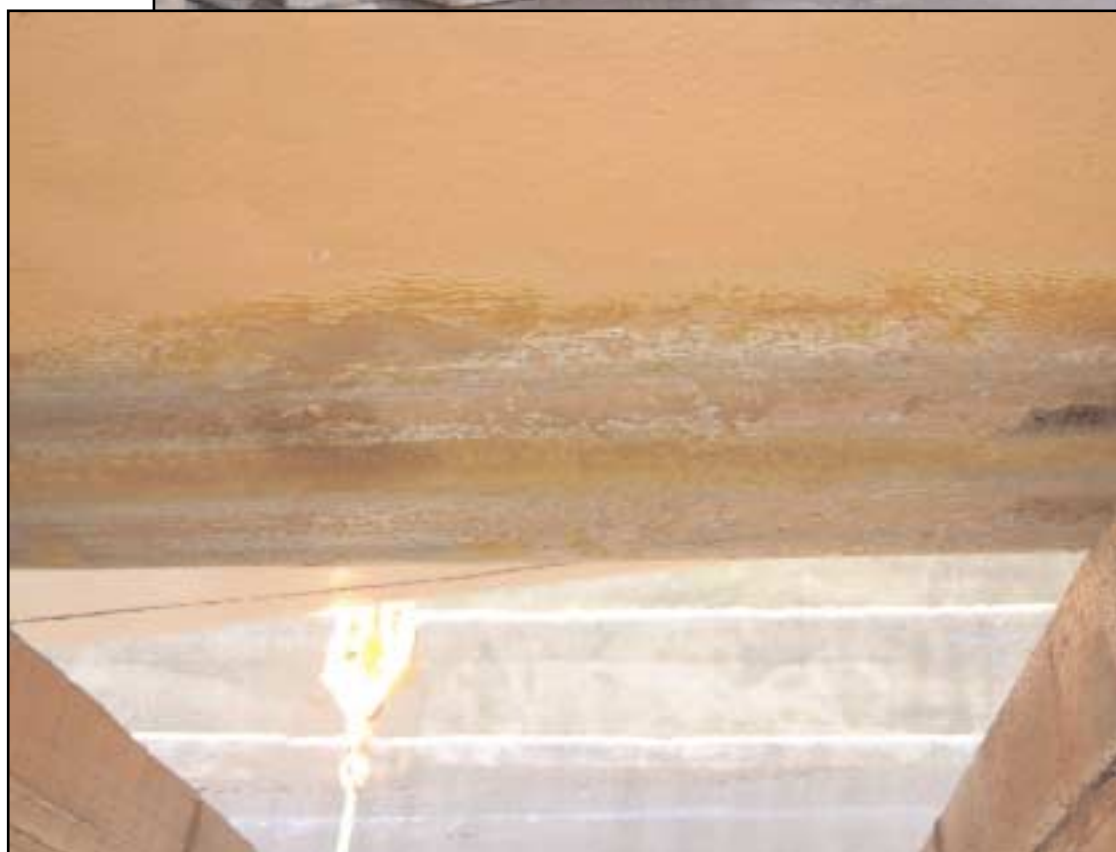
Figure 7

Small indentation damage to keel at aft end

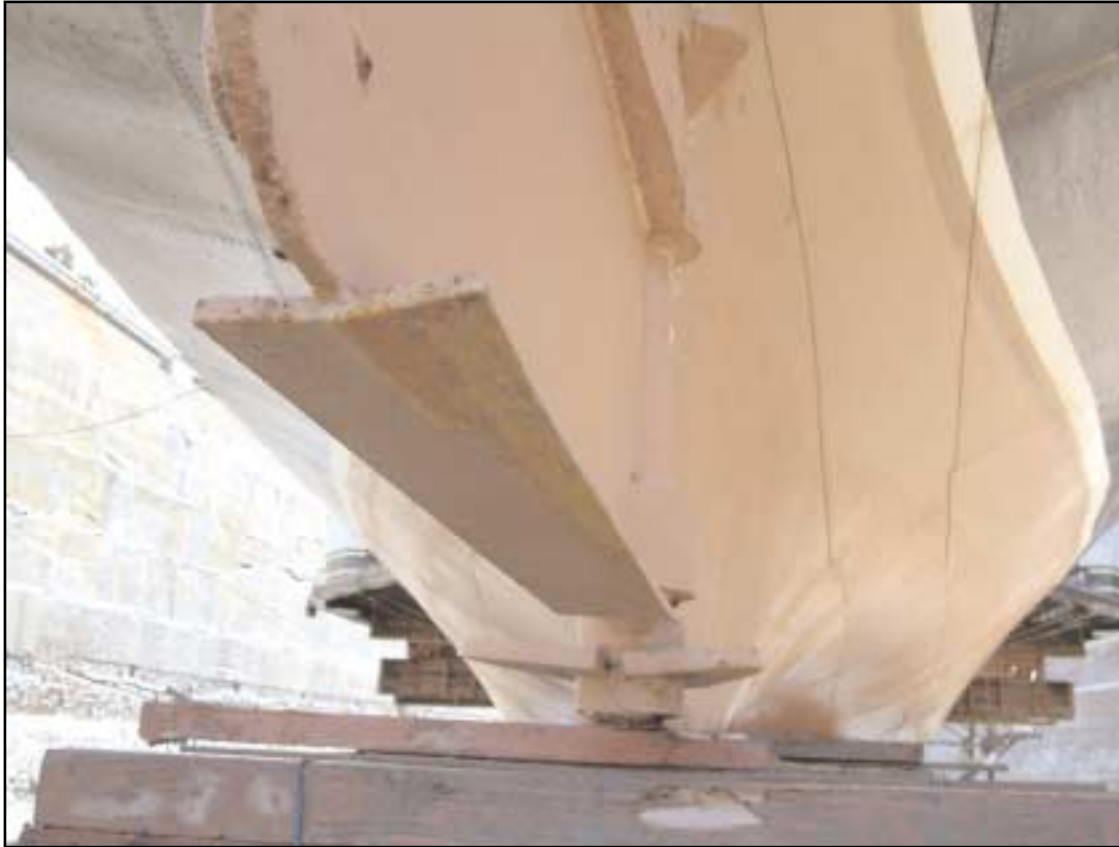
Figure 8

Damage to underside of *Waverley's* rudder

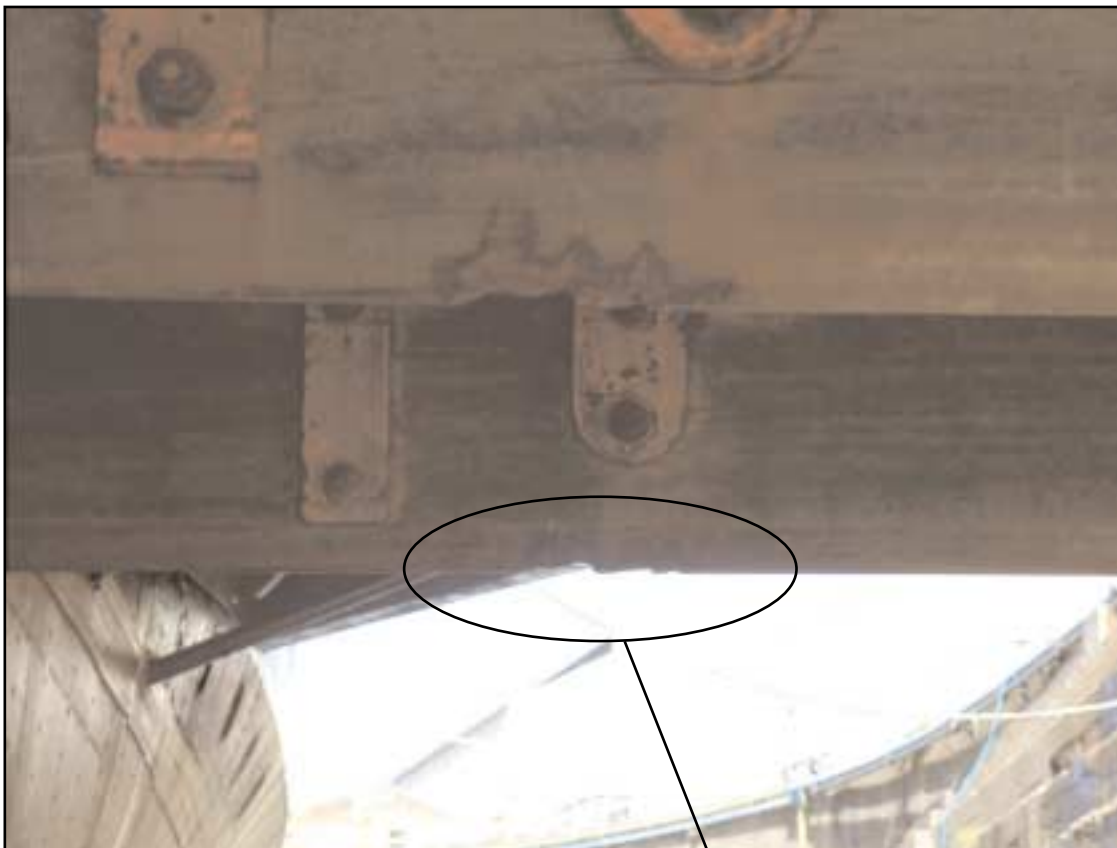
Figure 9

The paddles were also inspected whilst in dock. The port side paddle had sustained some minor damage to its floats, consisting of small notches of varying size in the same position on each float (**Figure 9**). It was thought that this might have been caused by chain used to rotate the paddles during the winter lay up. The only other damage noted was to the timber belting around the starboard paddle box. This was thought to have been sustained during its many previous berthings.

Damage to port side paddle floats

After the vessel had returned to Campbeltown, the only damage found during the underwater survey was the minor damage to three paddles on the port wheel. This damage accorded with the master's view that the vessel had run over something. The master was aware that the diver had been unable to look at the underside of the hull, but as there was no evidence of water ingress into the hull, or degradation of her manoeuvrability, the master considered the vessel to be safe to continue her voyage. Based on the information available, this appears to have been a reasonable assessment, although had a close inspection of the charted position at the time of the accident been conducted, the probability that the vessel had touched the bottom would have been obvious.

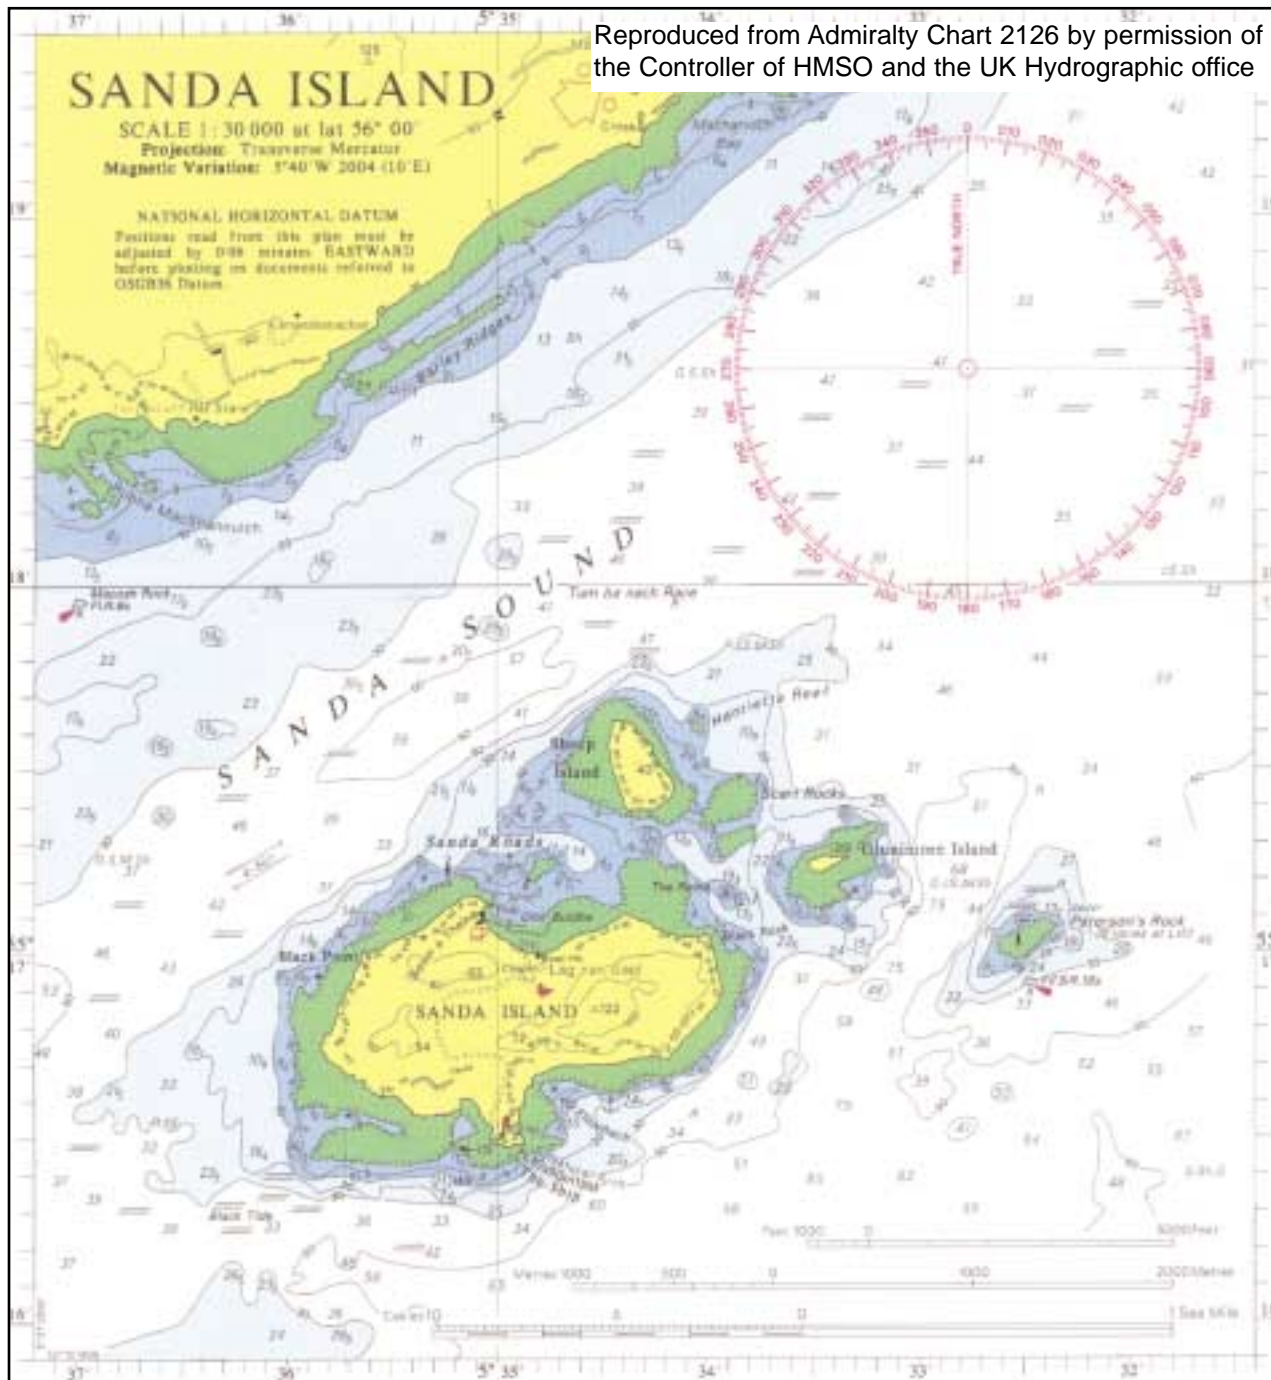
Figure 12

The Hydrographic Office is producing a 1:30 000 scale plan of Sanda Island as an insert on Chart 2126 in response to numerous groundings which have occurred in the area. A draft version of this chart is at **Figure 12**.
