Report on the investigation of
the grounding of the
Italian registered chemical tanker
Attilio levoli
on Lymington Banks in the west Solent,
South Coast of England
3 June 2004

Marine Accident Investigation Branch
First Floor
Carlton House
Carlton Place
Southampton
United Kingdom
SO15 2DZ

**Report No 2/2005
February 2005**

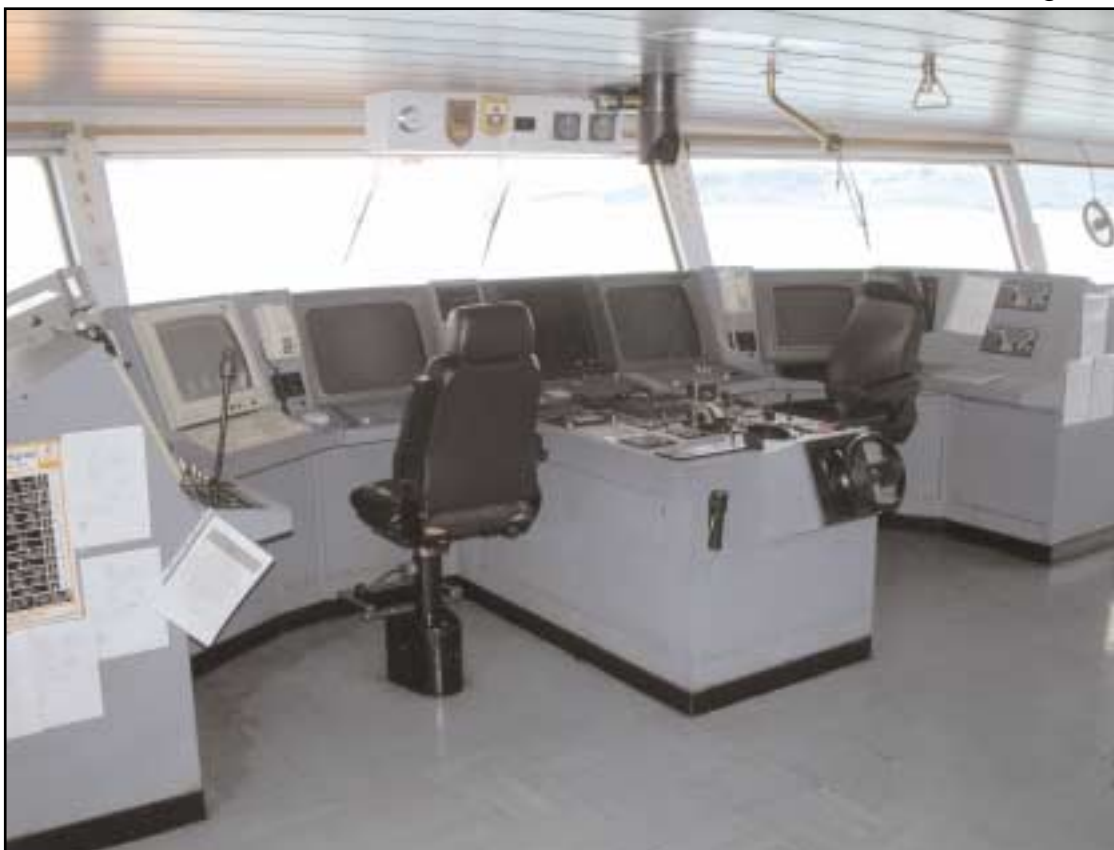
Conning position

The pilot boarded the vessel at 1445, and discussed the plan for departure with the master. The pilot was expecting *Attilio Ievoli* to depart via the east Solent, however, the master advised him that he planned to use the shorter, west Solent route, the next port being Barcelona. At 1500, the engines were brought to stand-by and the un-mooring process started. At 1515, the vessel was clear of the berth. The pilot, master, second officer, cadet and chief engineer officer were on the bridge. The pilot was conning the vessel, the master was in command, the second officer was keeping a check on position on the chart and the cadet was steering. The master was sitting in the starboard chair at the integrated conning console. His view ahead was impaired by the navigation console in front of him, which necessitated the chair being in its highest position. The chief engineer played no part in the bridge team as he was monitoring the UMS alarms from the port side of the forward integrated conning console (**Figure 2**). With the chief engineer sitting at the port conning console, the port radar was not available for use by the bridge team, so ranges required for the position fixes were obtained from the starboard radar. This necessitated leaning across the master to reach the controls of the radar.

Just before the pilot was due to disembark *Attilio levoli*, he received a message from the pilot boat that a flag was flying very close to the vessel's radar scanner. He passed the message to the master, who instructed the second officer to move the flag. The cadet was instructed to escort the pilot to the pilot ladder, and the steering was changed over to the autopilot. The pilot disembarked *Attilio levoli* at the western boarding point, south of the East Lepe Buoy (**Figure 3**). The master continued to con the vessel from his seat behind the starboard radar.

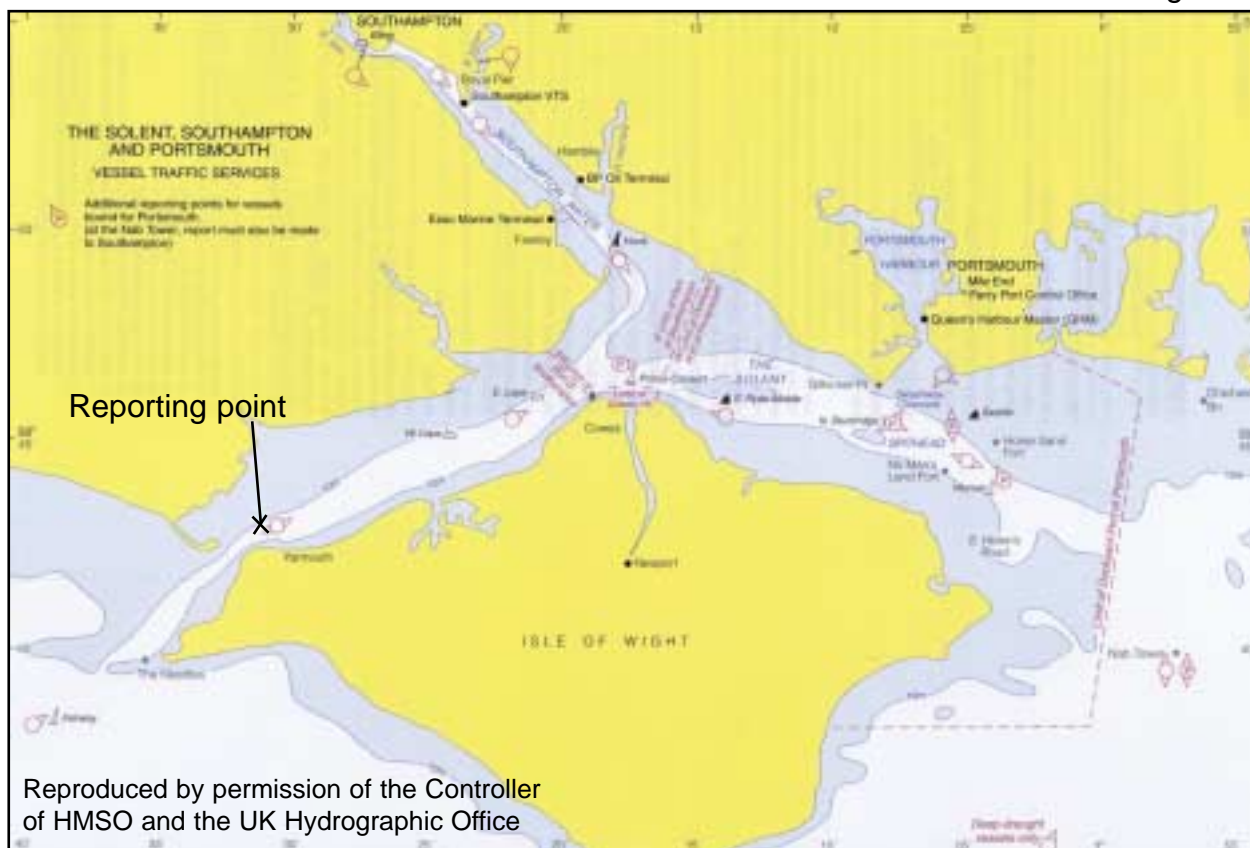
Figure 4

remembers who plotted this. At 1631, on passing Yarmouth, the master reported his position to Southampton VTS (**Figure 4**). Shortly afterwards, *Attilio levoli* started to vibrate, and her engine began to labour. The chief engineer left the bridge to go to the engine room, and the master noted that Hurst Point Castle was on his port bow. He changed the automatic steering to manual and put the helm to port, but this had no effect as the vessel was already aground on Lymington Banks, approximately 0.5 mile north of the planned track.

Southampton VTS area

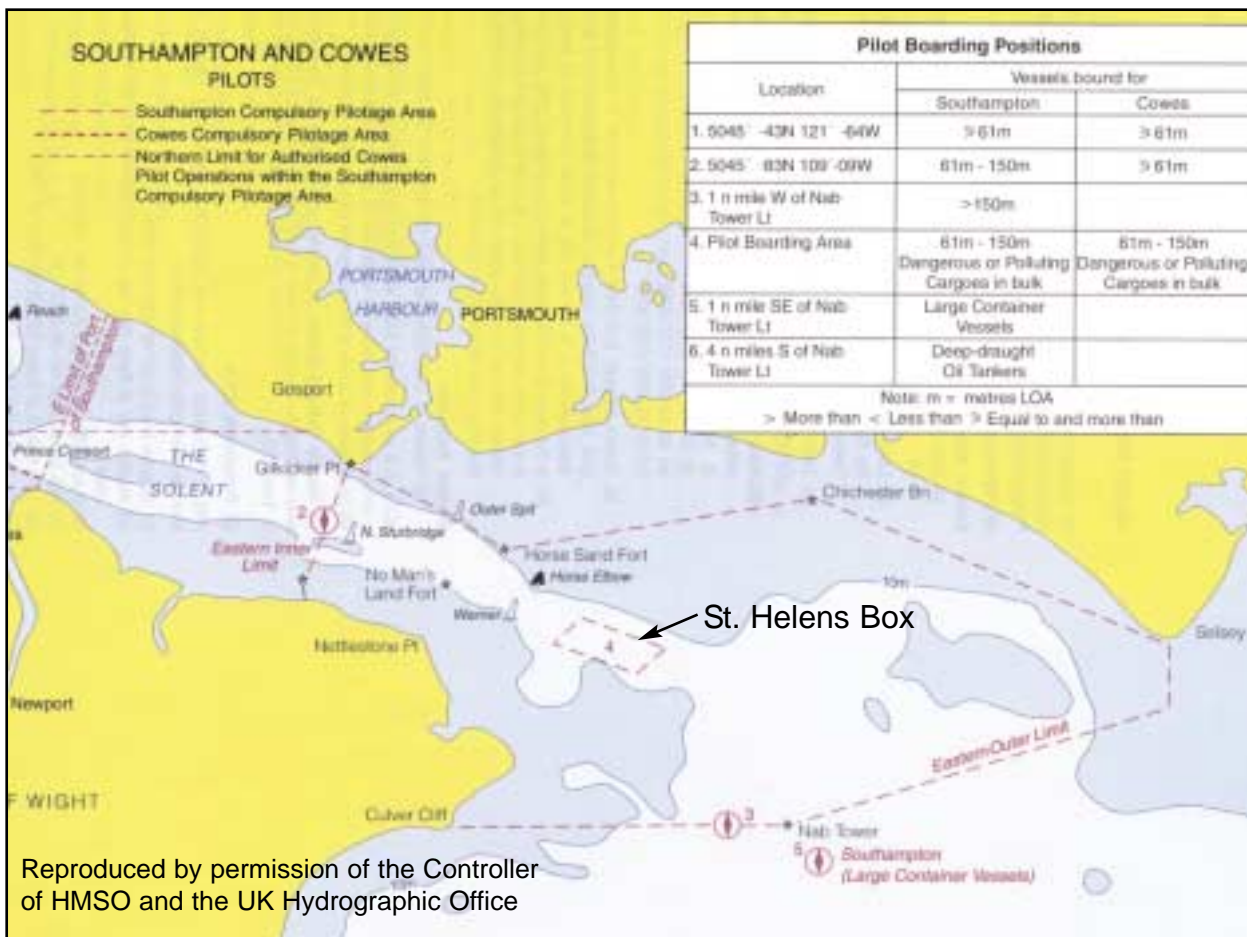
Figure 7

As a result of two previous near miss navigational incidents in the east Solent, and in consultation with ABP Southampton, a company instruction was issued requiring all Marnavi operated vessels to take a pilot from the Nab Tower when using Fawley Marine Terminal. A further incident, involving an injury to a pilot boarding these relatively small vessels at the Nab Tower, caused the instruction to be changed, and pilots were required to embark and disembark at St Helens Box, which is a more sheltered area in the eastern approaches to the Solent (Figure 7).

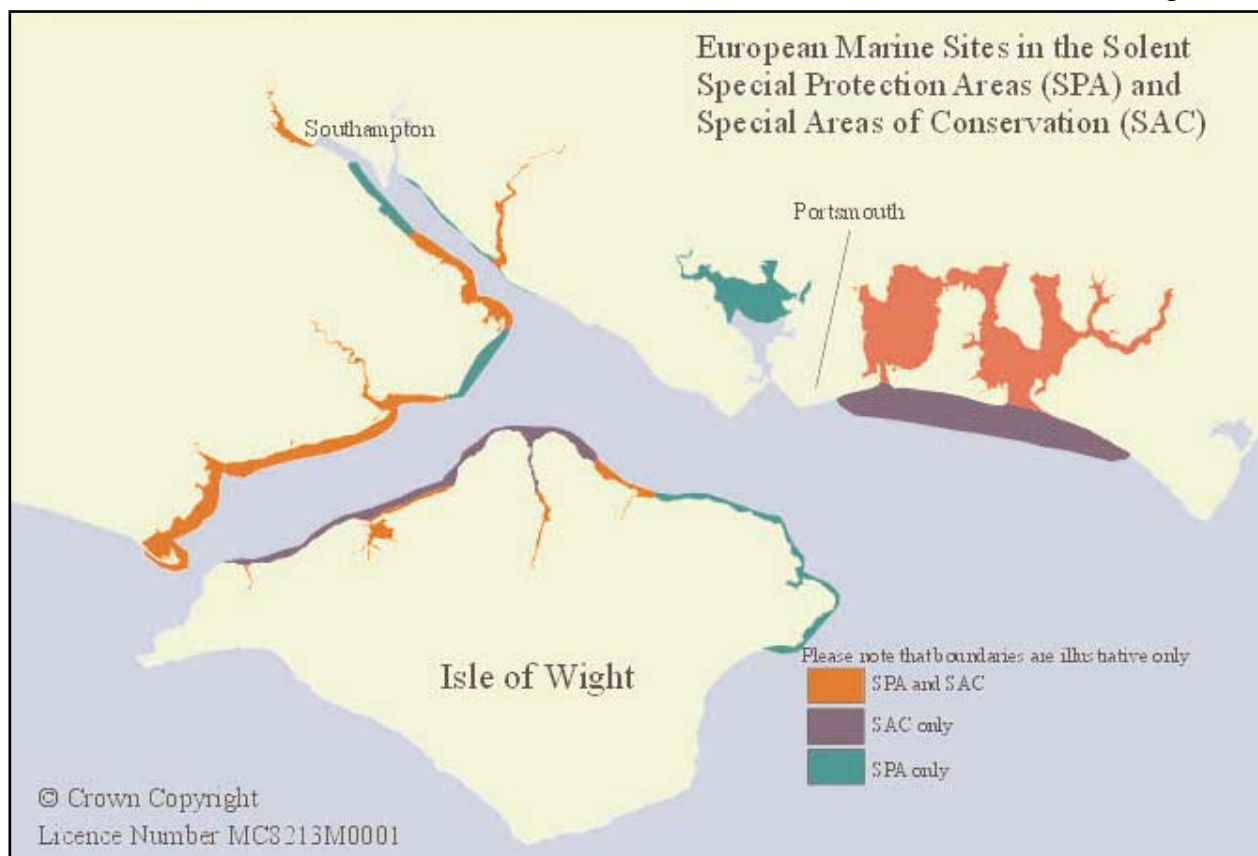
The foreshore on both sides of the west Solent is designated as either a *Special Protection Area*, a *Special Area of Conservation*, or both (**Figure 10**). The potential for severe environmental consequences, following a marine accident in this conservation and protection area, are clear. It was fortunate that *Attilio Ievoli* ran aground on shingle, which, while damaging the vessel's external paintwork, did not lead to penetration of her hull.

Special conservation areas

The MAIB believes the need for effective control of shipping in the west Solent and Needles Channel is compelling if a major accident is to be avoided in the future. It further believes the decision of the public inquiry to deny ABP the opportunity to extend its port limits to the west and, either by powers of direction, or through the provision of a pilotage service, provide effective control of shipping in the area, should be revisited. In this respect, the MAIB recommends the Department for Transport to ensure the establishment of traffic control measures for all commercial vessels over 500gt using the west Solent and its approaches.
