Report on the investigation
of the failure of a mooring bollard from the
Class V passenger vessel
Star Clipper
resulting in a fatal accident at
St Katharine's Pier, River Thames, London
on
2 May 2004

Marine Accident Investigation Branch
Carlton House
Carlton Place
Southampton
United Kingdom
SO15 2DZ

Report No 3/2005
February 2005

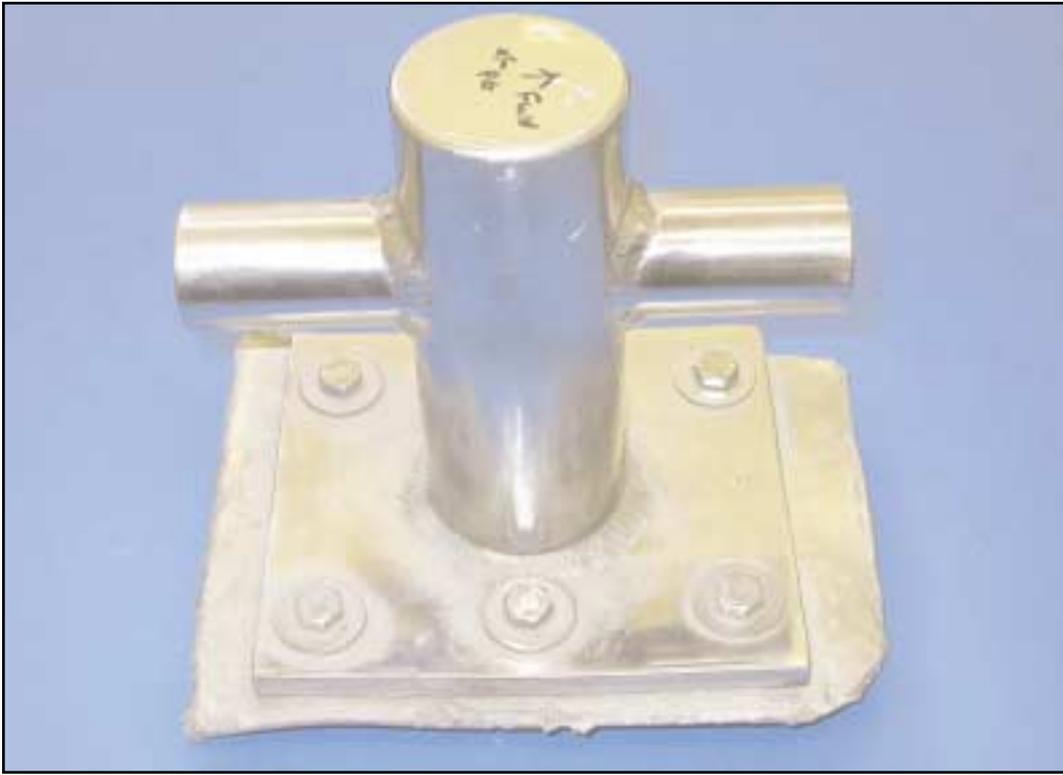
Figure 6

At 1300, when *Star Clipper* was just under 1m from the pier edge, the mooring bollard and supporting insert plate (**Figure 6**) were ripped from the deck and catapulted over the 1.1m safety fence, into a group of waiting passengers. The mooring rope, having become detached from both the pier and vessel's mooring bollards, was reported to have "snaked" through the air, and landed among the passengers. At the same time, the mate looked down at the passenger access platform and saw a hole where the bollard had previously been (**Figure 7**). He then looked down the pier and saw a female passenger laying approximately 2.13m from the pier bollard position. She was surrounded by other waiting passengers. As the bollard failed, the vessel moved about 1m along the pier where the captain held her in position using her engines.

Displaced stainless steel mooring bollard and insert plate

Mkl bollard base plate remains

The stainless steel mooring bollard was recovered by the Metropolitan Police and was still connected to the 6mm aluminium insert plate by 6 x M10 stainless steel bolts and associated washers, nuts and lock nuts. The arrangement had been repaired, and the weld securing the insert plate to the supporting structure had failed. Weld material with signs of porosity was found on the edges of the insert plate.

There was also considerable distortion of the bollard stainless steel base plate and aluminium insert plate. The latter had suffered the greatest deformation. There did not appear to be any damage to the bolts, bollard, vertical and horizontal pins, or associated pin fillet welds. However, all but one of the washers had suffered severe deformation.

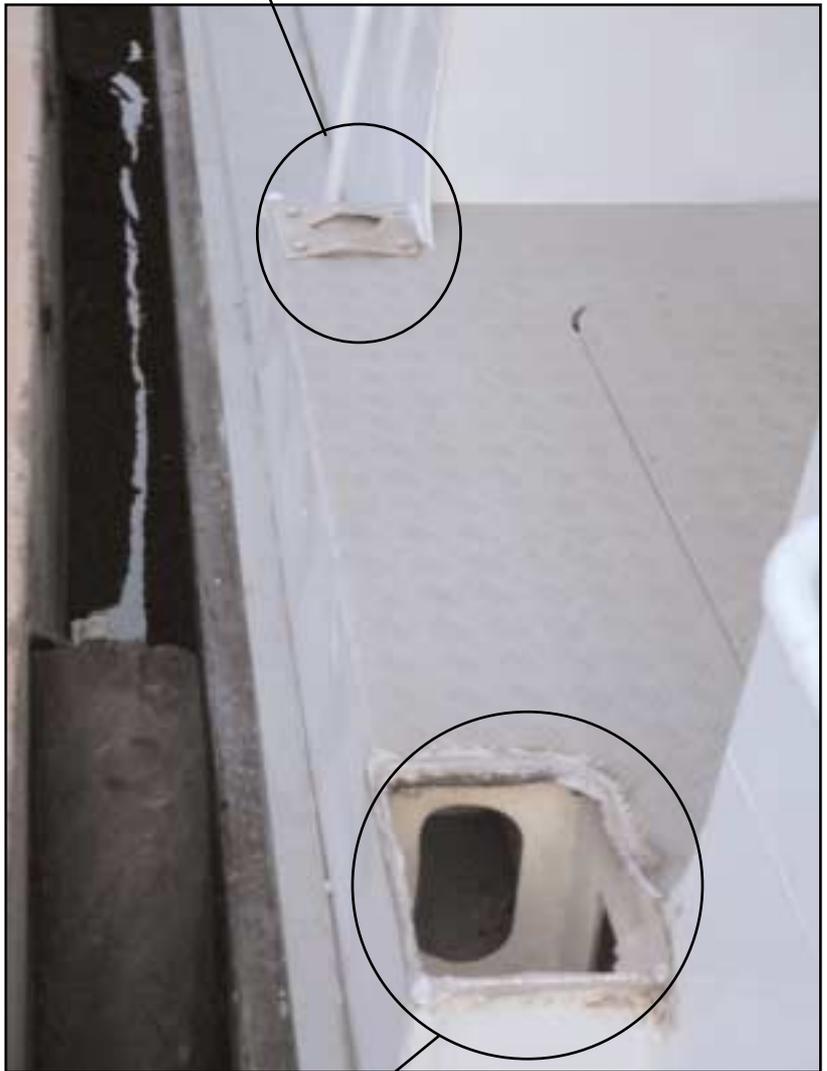
Figure 7

Position of displaced bollard

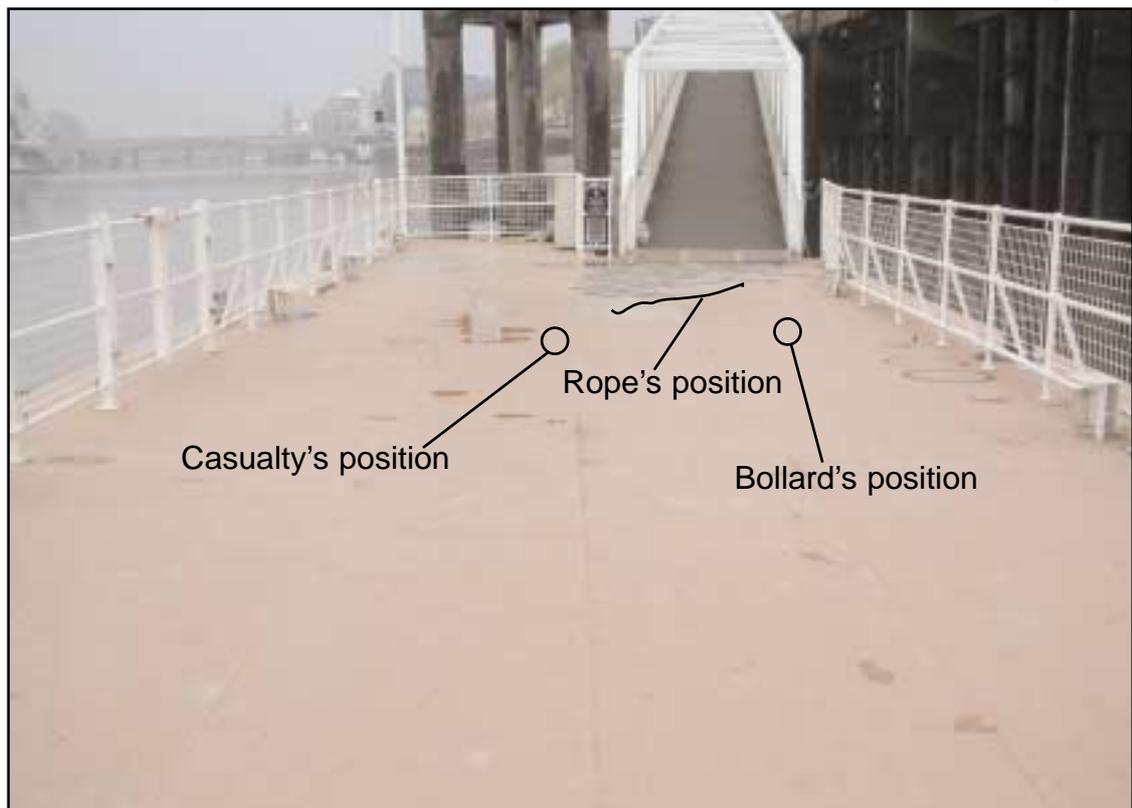
Figure 8

Westbourne’s crew, now aware of the accident, attended to the casualty with two off-duty trauma nurses who were also on the pier. The coxswain noted that *Star Clipper*’s bollard and mooring rope were laying close by the casualty (**Figure 8**).

Approximate position of casualty, bollard, and rope

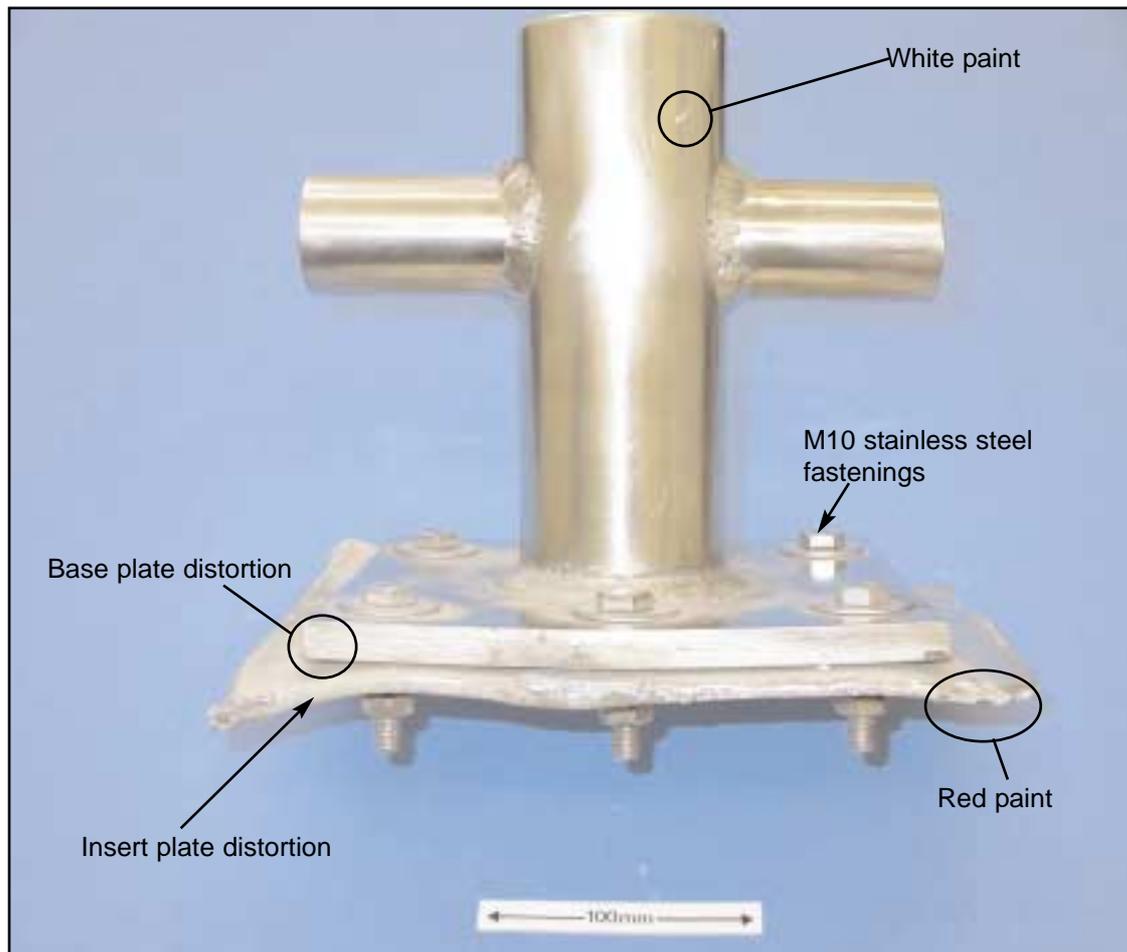
Figure 14

Location of red and white paint, fastenings and insert plate distortion

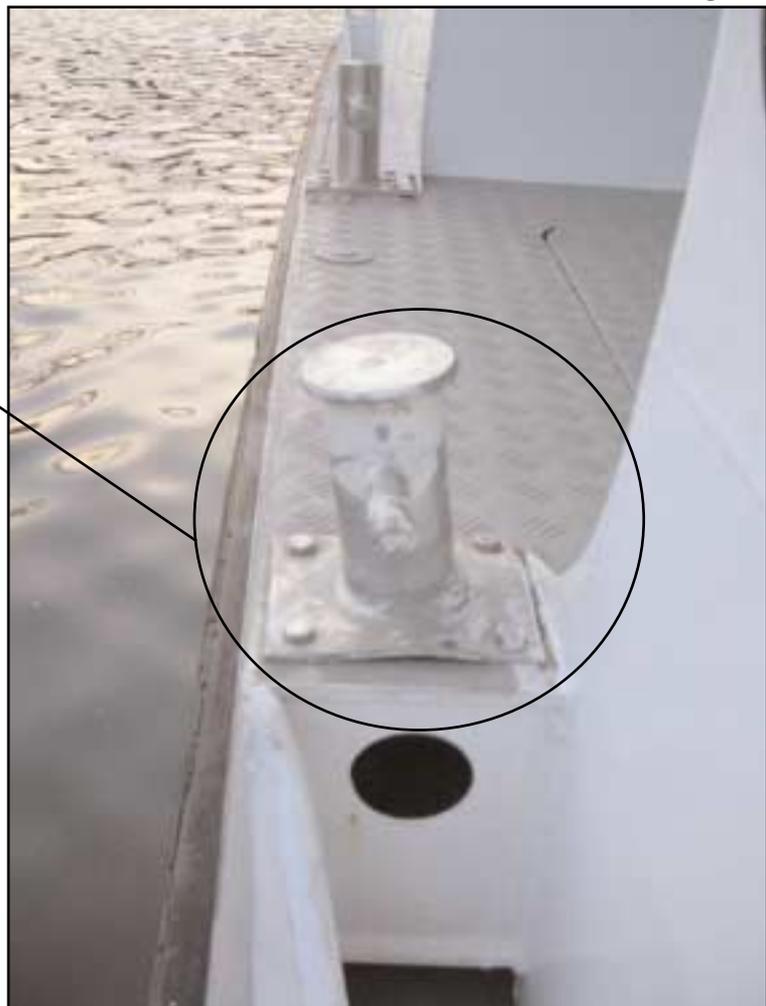
Figure 16

Aluminium bollard showing distortion to base plate and vertical pin

View of Mk1 hollow aluminium bollard

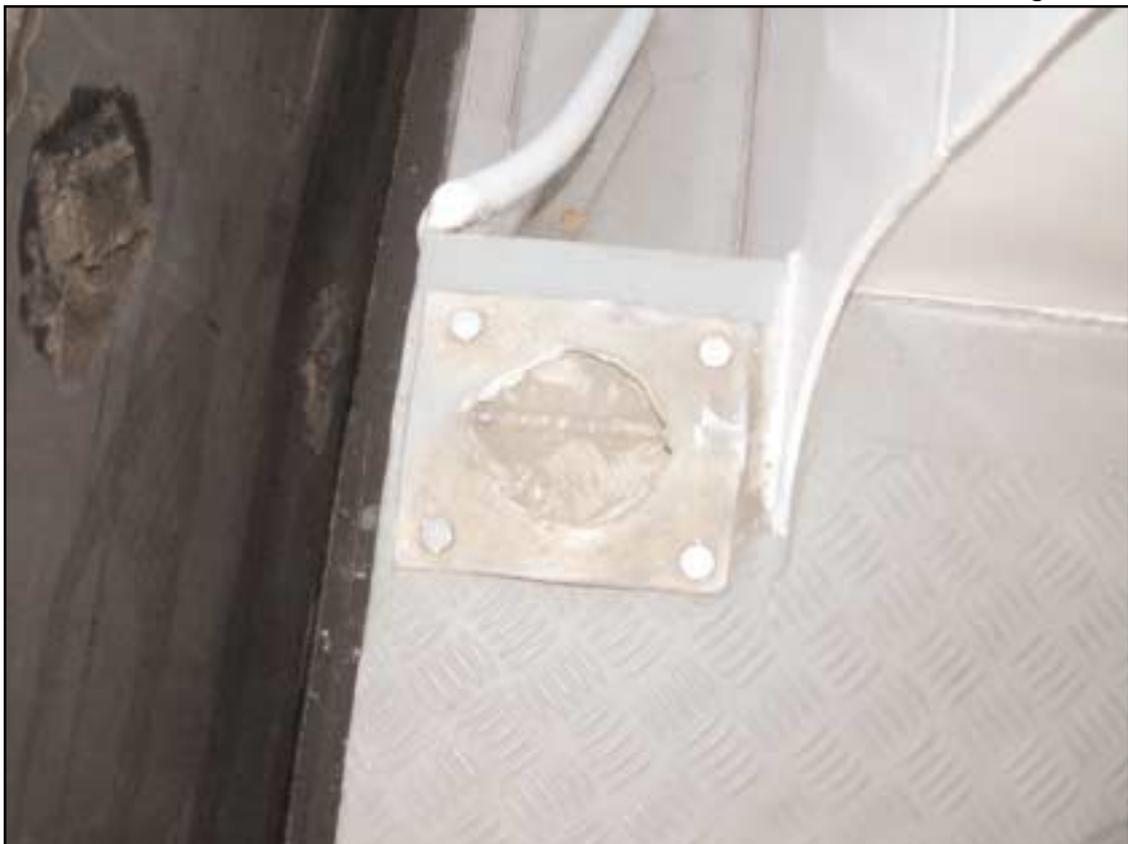
Figure 17

On taking ownership of *Sky Clipper*, CRE replaced the **Mk I** aluminium bollards fitted to the passenger access areas, some of which had already failed (**Figure 17**). Two **Mk II** bollards were fitted to the after end of the access as it was found that the forward two were not required for the River Thames operation. However, within 6 weeks of service, the weld at the base of the bollards' vertical pin began to fracture and the base plates deformed. The bollard design was subsequently changed, and the defective bollards were replaced with **Mk III** bollards. The increase in base plate thickness resolved the base plate distortion, but the bollard vertical pin still suffered deformation.

Failed Mk I bollard

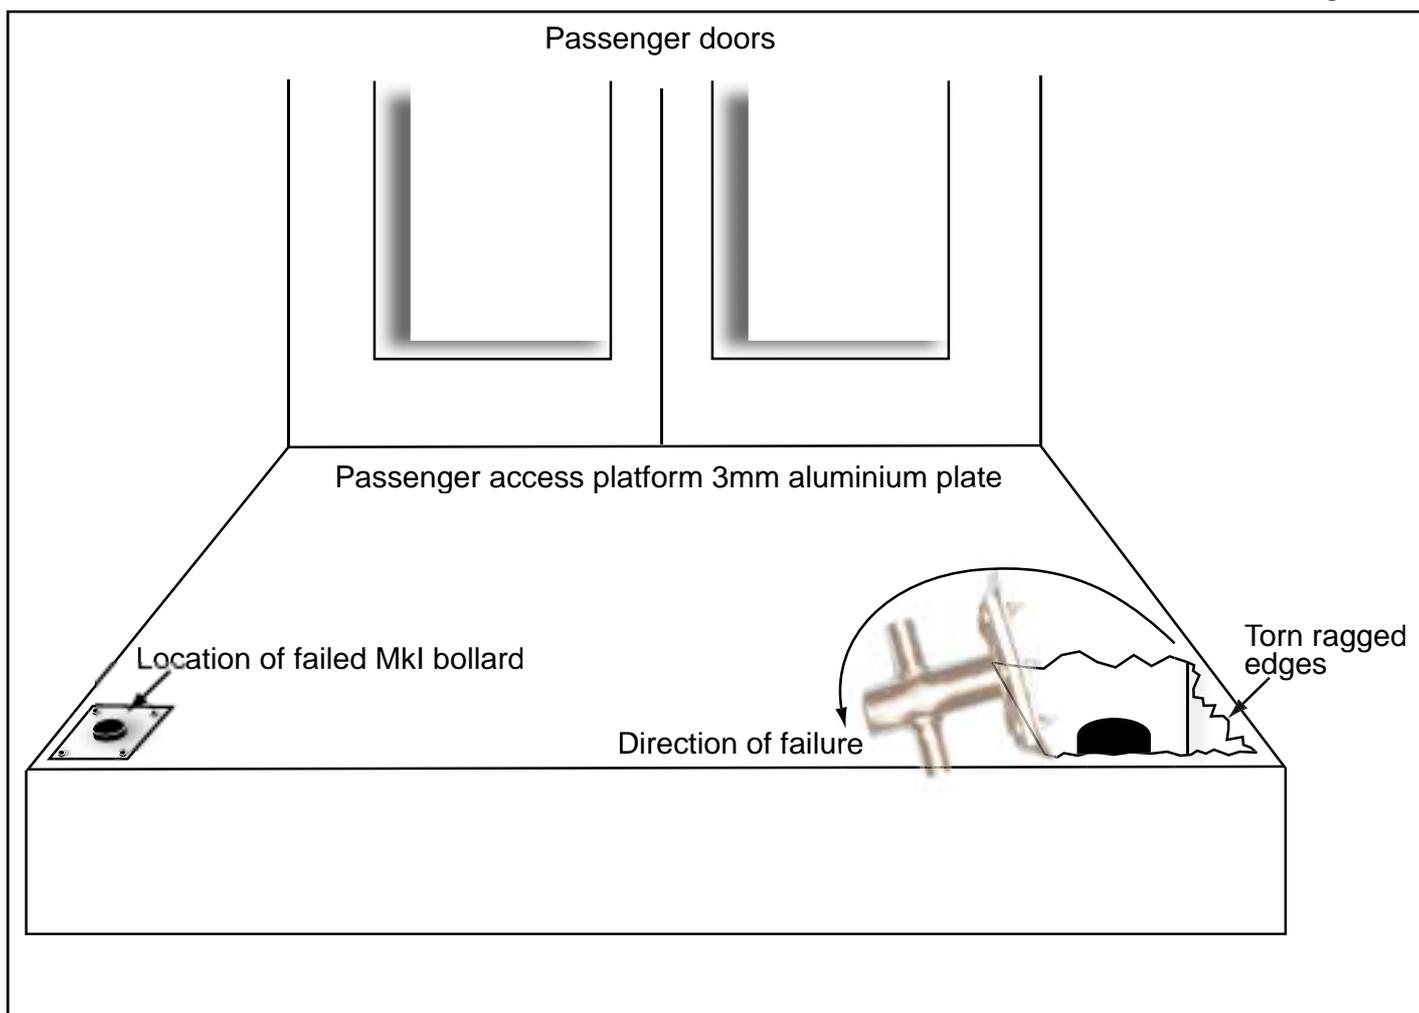
On 9 April 2004, the port after **Mk IV** type bollard in *Star Clipper's* passenger access was torn from the deck. Whilst leaving a pier, the eye of the mooring rope caught on both the pier bollard and the vessel's bollard. As the vessel went astern, force was exerted onto the after face of the vessel's bollard, tearing up three sides of the supporting 3mm aluminium deck checker plate (**Figure 18**).

Damage to bollard arrangement sustained on 9 April 2004

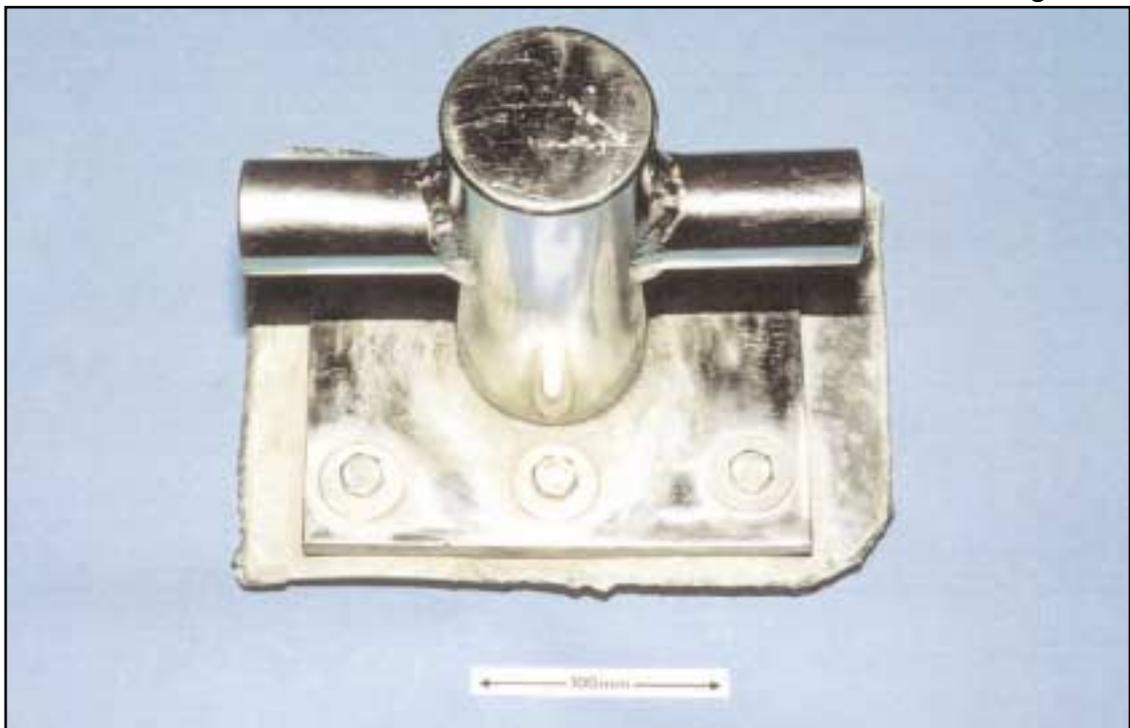
Figure 19

By the time the Alweld representative arrived on site, CRE engineers had already removed the bollard from the damaged 3mm aluminium deck plate and had hammered down the edges of the torn deck section. The Alweld employee fitted the bollard to a thicker, 6mm aluminium mounting plate, which was drilled and secured to the bollard base plate with 6 x M10, 316 stainless steel bolts with washers, nuts and locking nuts (**Figure 19**). The damaged deck area was dressed to facilitate fitting of the insert/doubler plate, which was cut to size on site.

Bollard and insert plate fastening arrangements viewed from inboard side

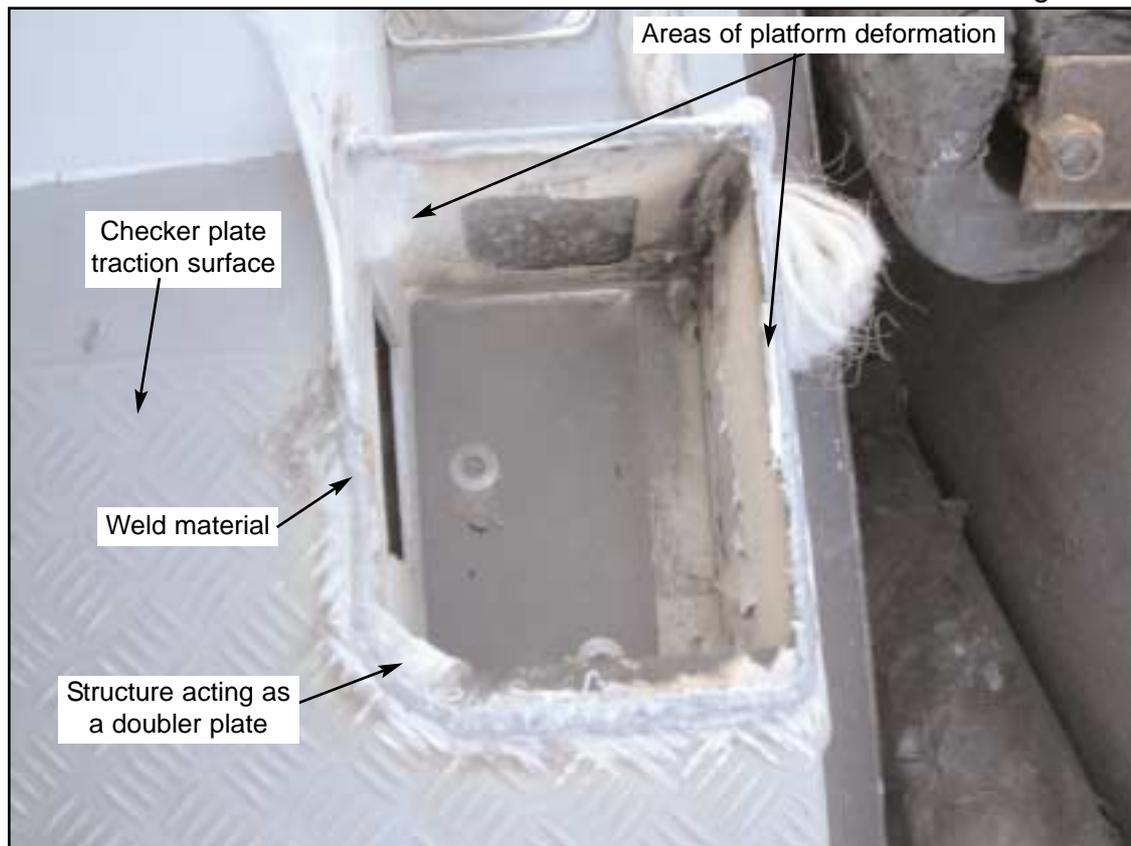
The platforms are constructed in a traditional "box" configuration made up of transverse and longitudinal flat aluminium plates. The construction is finished with a 3mm aluminium checker top plate, providing a traction surface for passengers and crew. The platforms were not designed or constructed to support mooring bollards, and were not designed to withstand the stresses imposed by routine use of the bollards.

Passenger access platform - structural arrangement

Initial examination of the damaged structure confirmed the insert plate fillet weld had failed. Much of the fillet weld was still in evidence, both on the vertical structure and on the checker plate. There was no evidence of insert plate parent material remaining. It was noted that the aluminium checker plate supported the forward end of the insert plate. This effectively formed a doubler plate arrangement at this interface.

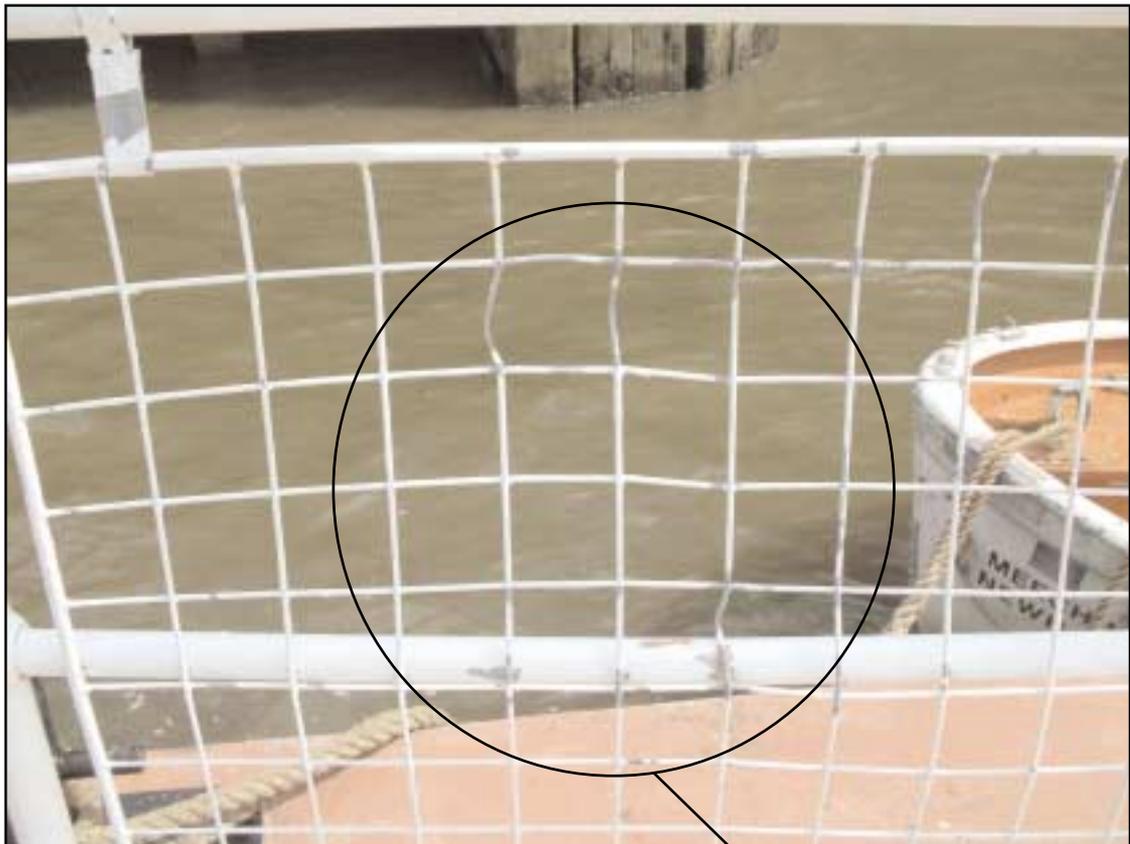
Figure 23

The results of the independent study suggest the most likely scenario was that the vessel bollard hit the pier bollard and was deflected over the riverside safety fencing. It hit the lady and then the bankside safety fence (**Figure 23**), before landing on the pier.

Damage to bankside safety fencing
